Subject: Third Quarter 2020 Progress Report

Former Rollway Bearing Corporation Facility, Liverpool, New York

Agreement Index Number: V7-1007-96-10

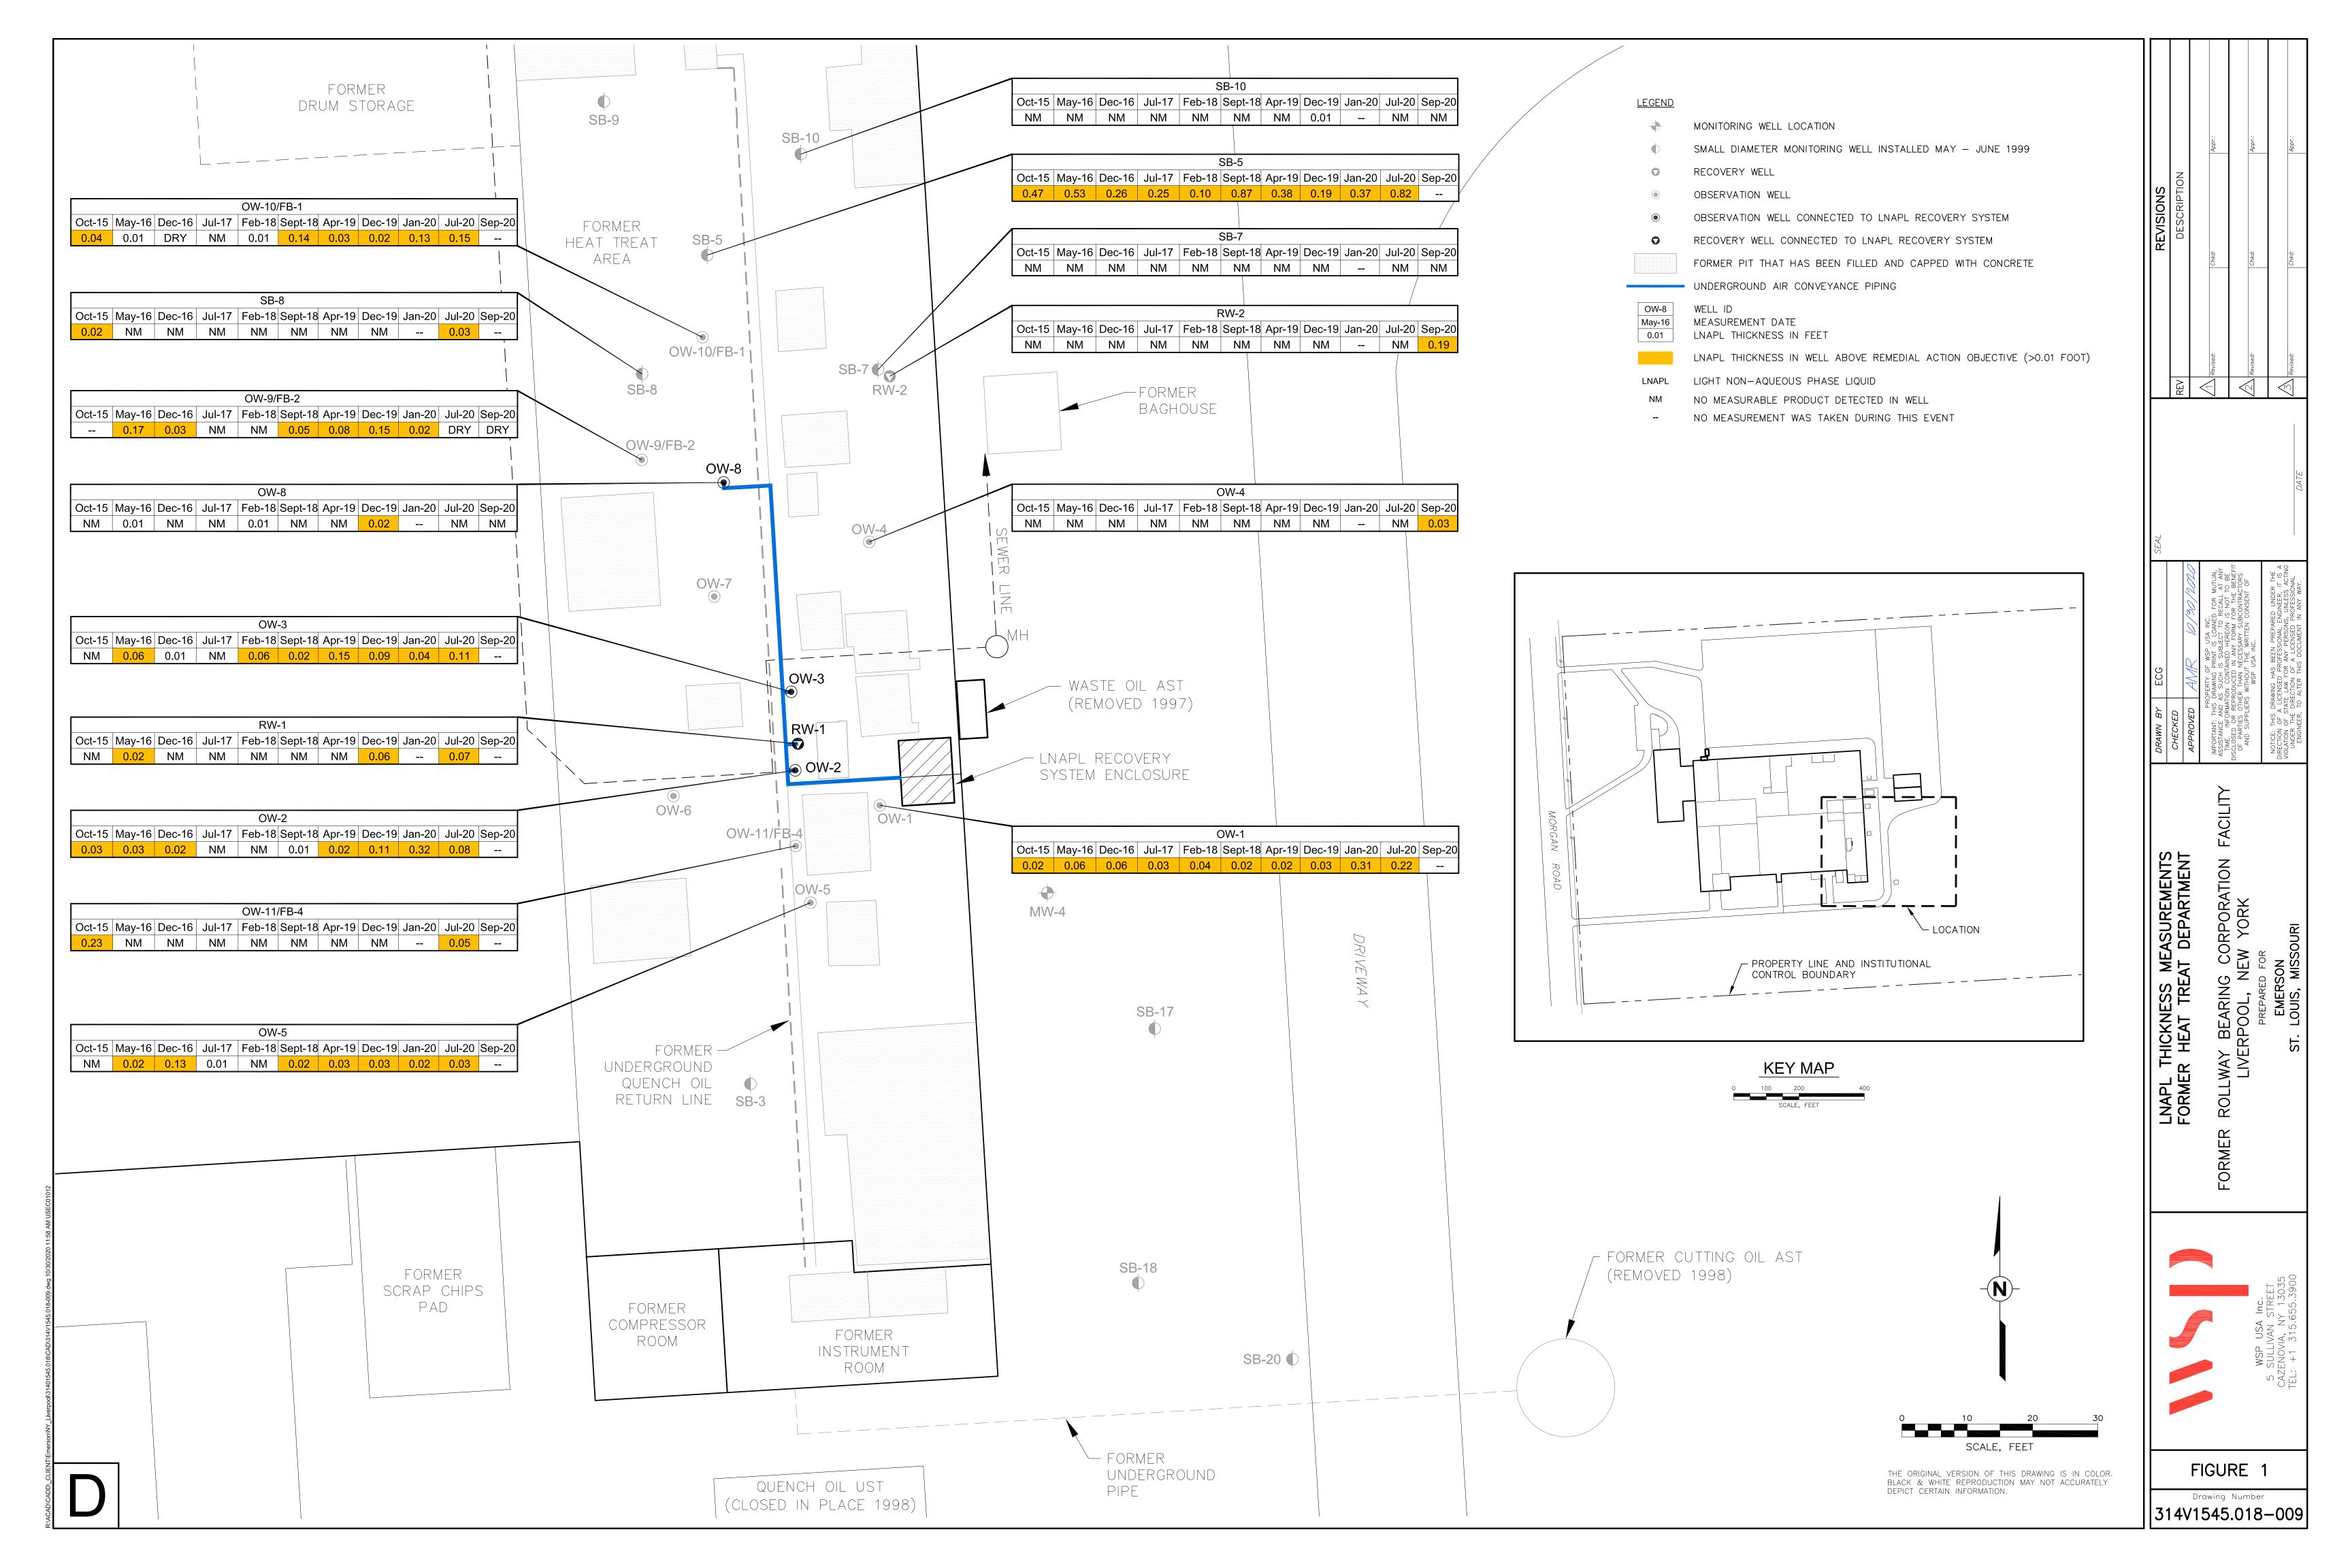
FIGURE

- During the July site visit, LNAPL thickness measurements were collected from 15 observation or recovery wells (Figure 1).
 After the LNAPL measurements were collected, new absorbents were installed in all the wells except for wells RW-2, OW-4, OW-8, SB-7, and SB-10 because no product was observed in these wells during the site visit, or during the last 4 years of monitoring.

- During the July site visit, measurable LNAPL was present in the following wells above the remedial action objective: RW-1, OW-1, OW-2, OW-3, OW-5, SB-5, SB-8, OW-10/FB-1, and OW-11/FB-4 (Figure 1). No product was observed in wells RW-2, OW-4, OW-8, SB-7, SB-10, and well OW-9/FB-2 was dry.
- The five wells that did not exhibit measurable LNAPL in July and well OW-9/FB-2 (which was dry) were inspected for LNAPL again in September. Two of the wells (RW-2 and OW-4) contained measurable product during the September site visit. Wells OW-8, SB-7, and SB-10 had no measurable product, and OW-9/FB-2 was dry (Figure 1).
- Approximately 1.1 gallons of LNAPL were removed from the wells with absorbents during the reporting period.
