EMERSON ELECTRIC CO.

## PERIODIC REVIEW REPORT

FORMER ROLLWAY BEARING CORPORATION  
FACILITY, ONONDAGA COUNTY, LIVERPOOL,  
NEW YORK - SITE NO. V00202

JULY 21, 2021

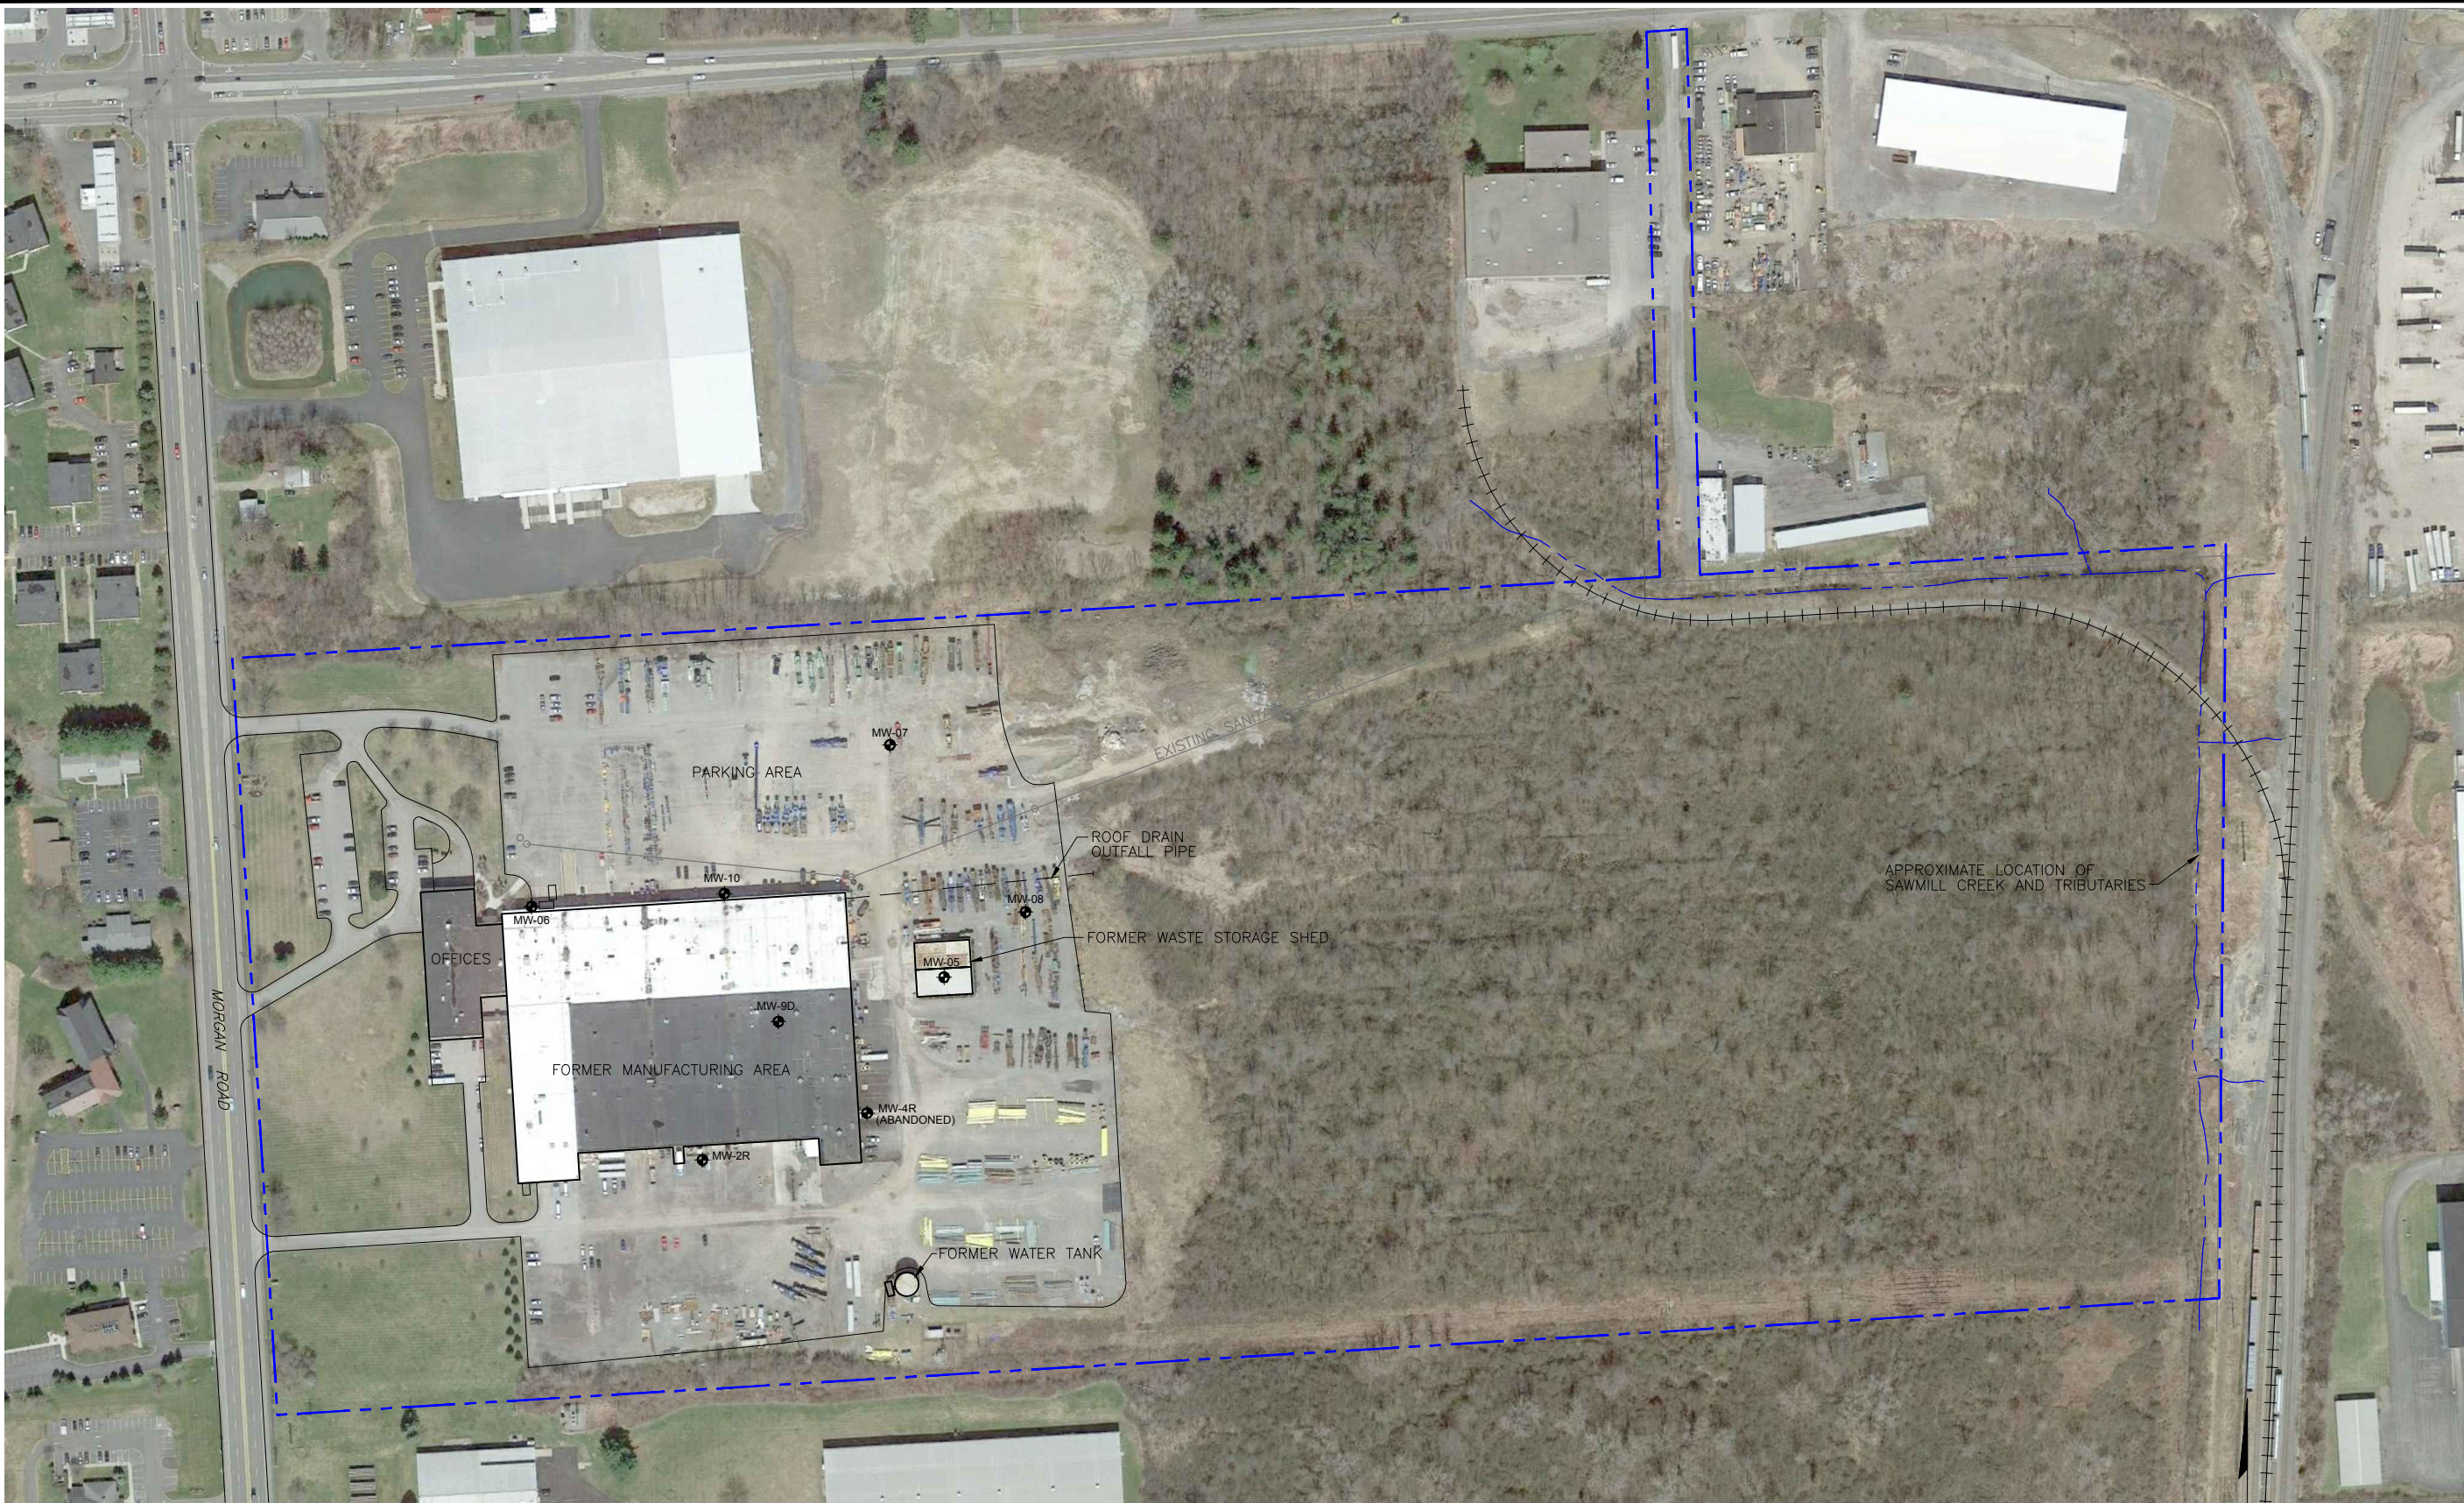
FIGURE 2

- The potential for vapor intrusion must be evaluated for any buildings developed in the area within the IC boundaries noted on Figure 2, or if the use of PCE-containing materials within the existing building changes (provided the potential for vapor intrusion has not been previously addressed to the department's satisfaction). Any potential impacts that are identified must be monitored or mitigated; and

SITE LAYOUT

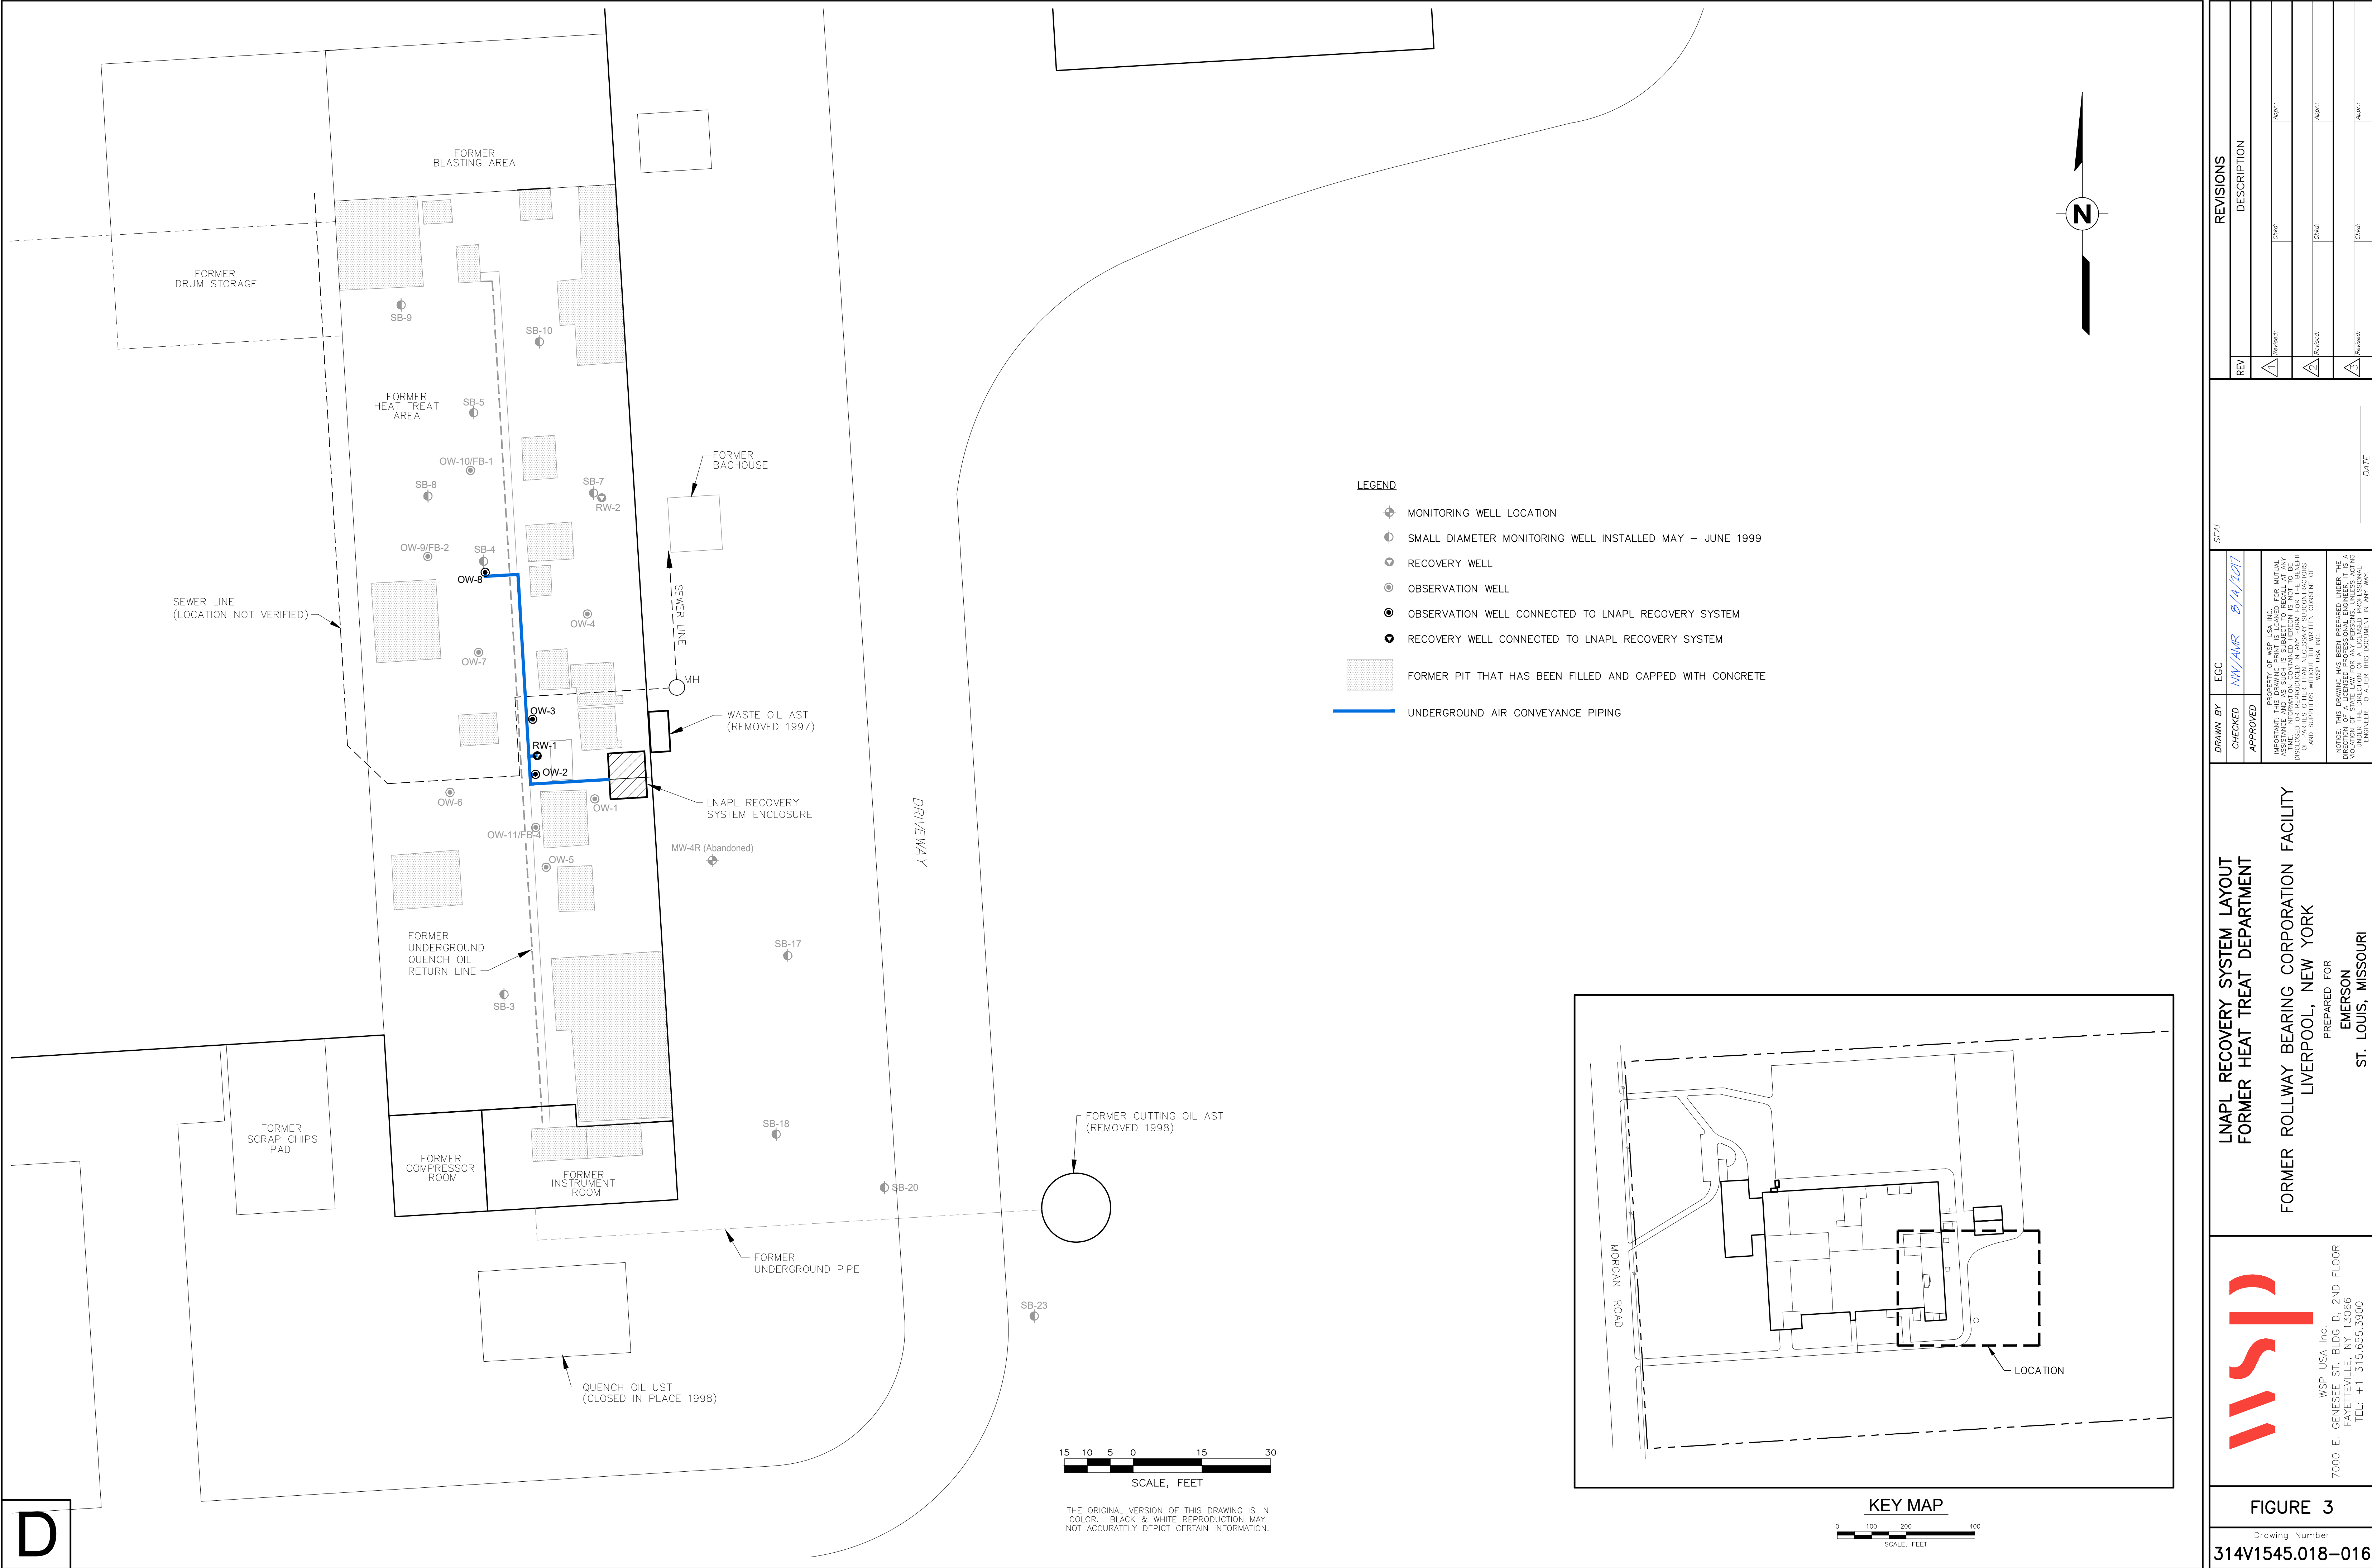
FIGURE 3

In March 2011, a focused application of pneumatic fracturing was performed in two areas within the former heat treat area to increase the density and connectivity of fractures within the weathered shale bedrock and overburden materials. Three of the open soil borings used to implement the pneumatic fracturing were subsequently converted to 4-inch inside-diameter polyvinyl chloride wells in 2016 (i.e., OW-9/FB-2, OW-10/FB-1, and OW-11/FB-4; Figure 3). The remaining soil boring was abandoned.

In November 2019, WSP redeveloped LNAPL recovery wells OW-2, OW-3, OW-8, and RW-1 to remove sediment and ensure effective communication between the well screens and the surrounding formation. The redevelopment activities consisted of surging and brushing the screened interval and bottom of the well casings to loosen any fine-grained sediment in the filter pack and adjacent aquifer material. Groundwater and sediment were then removed from the wells by pumping and subsequently disposed of offsite in accordance with state and federal requirements.

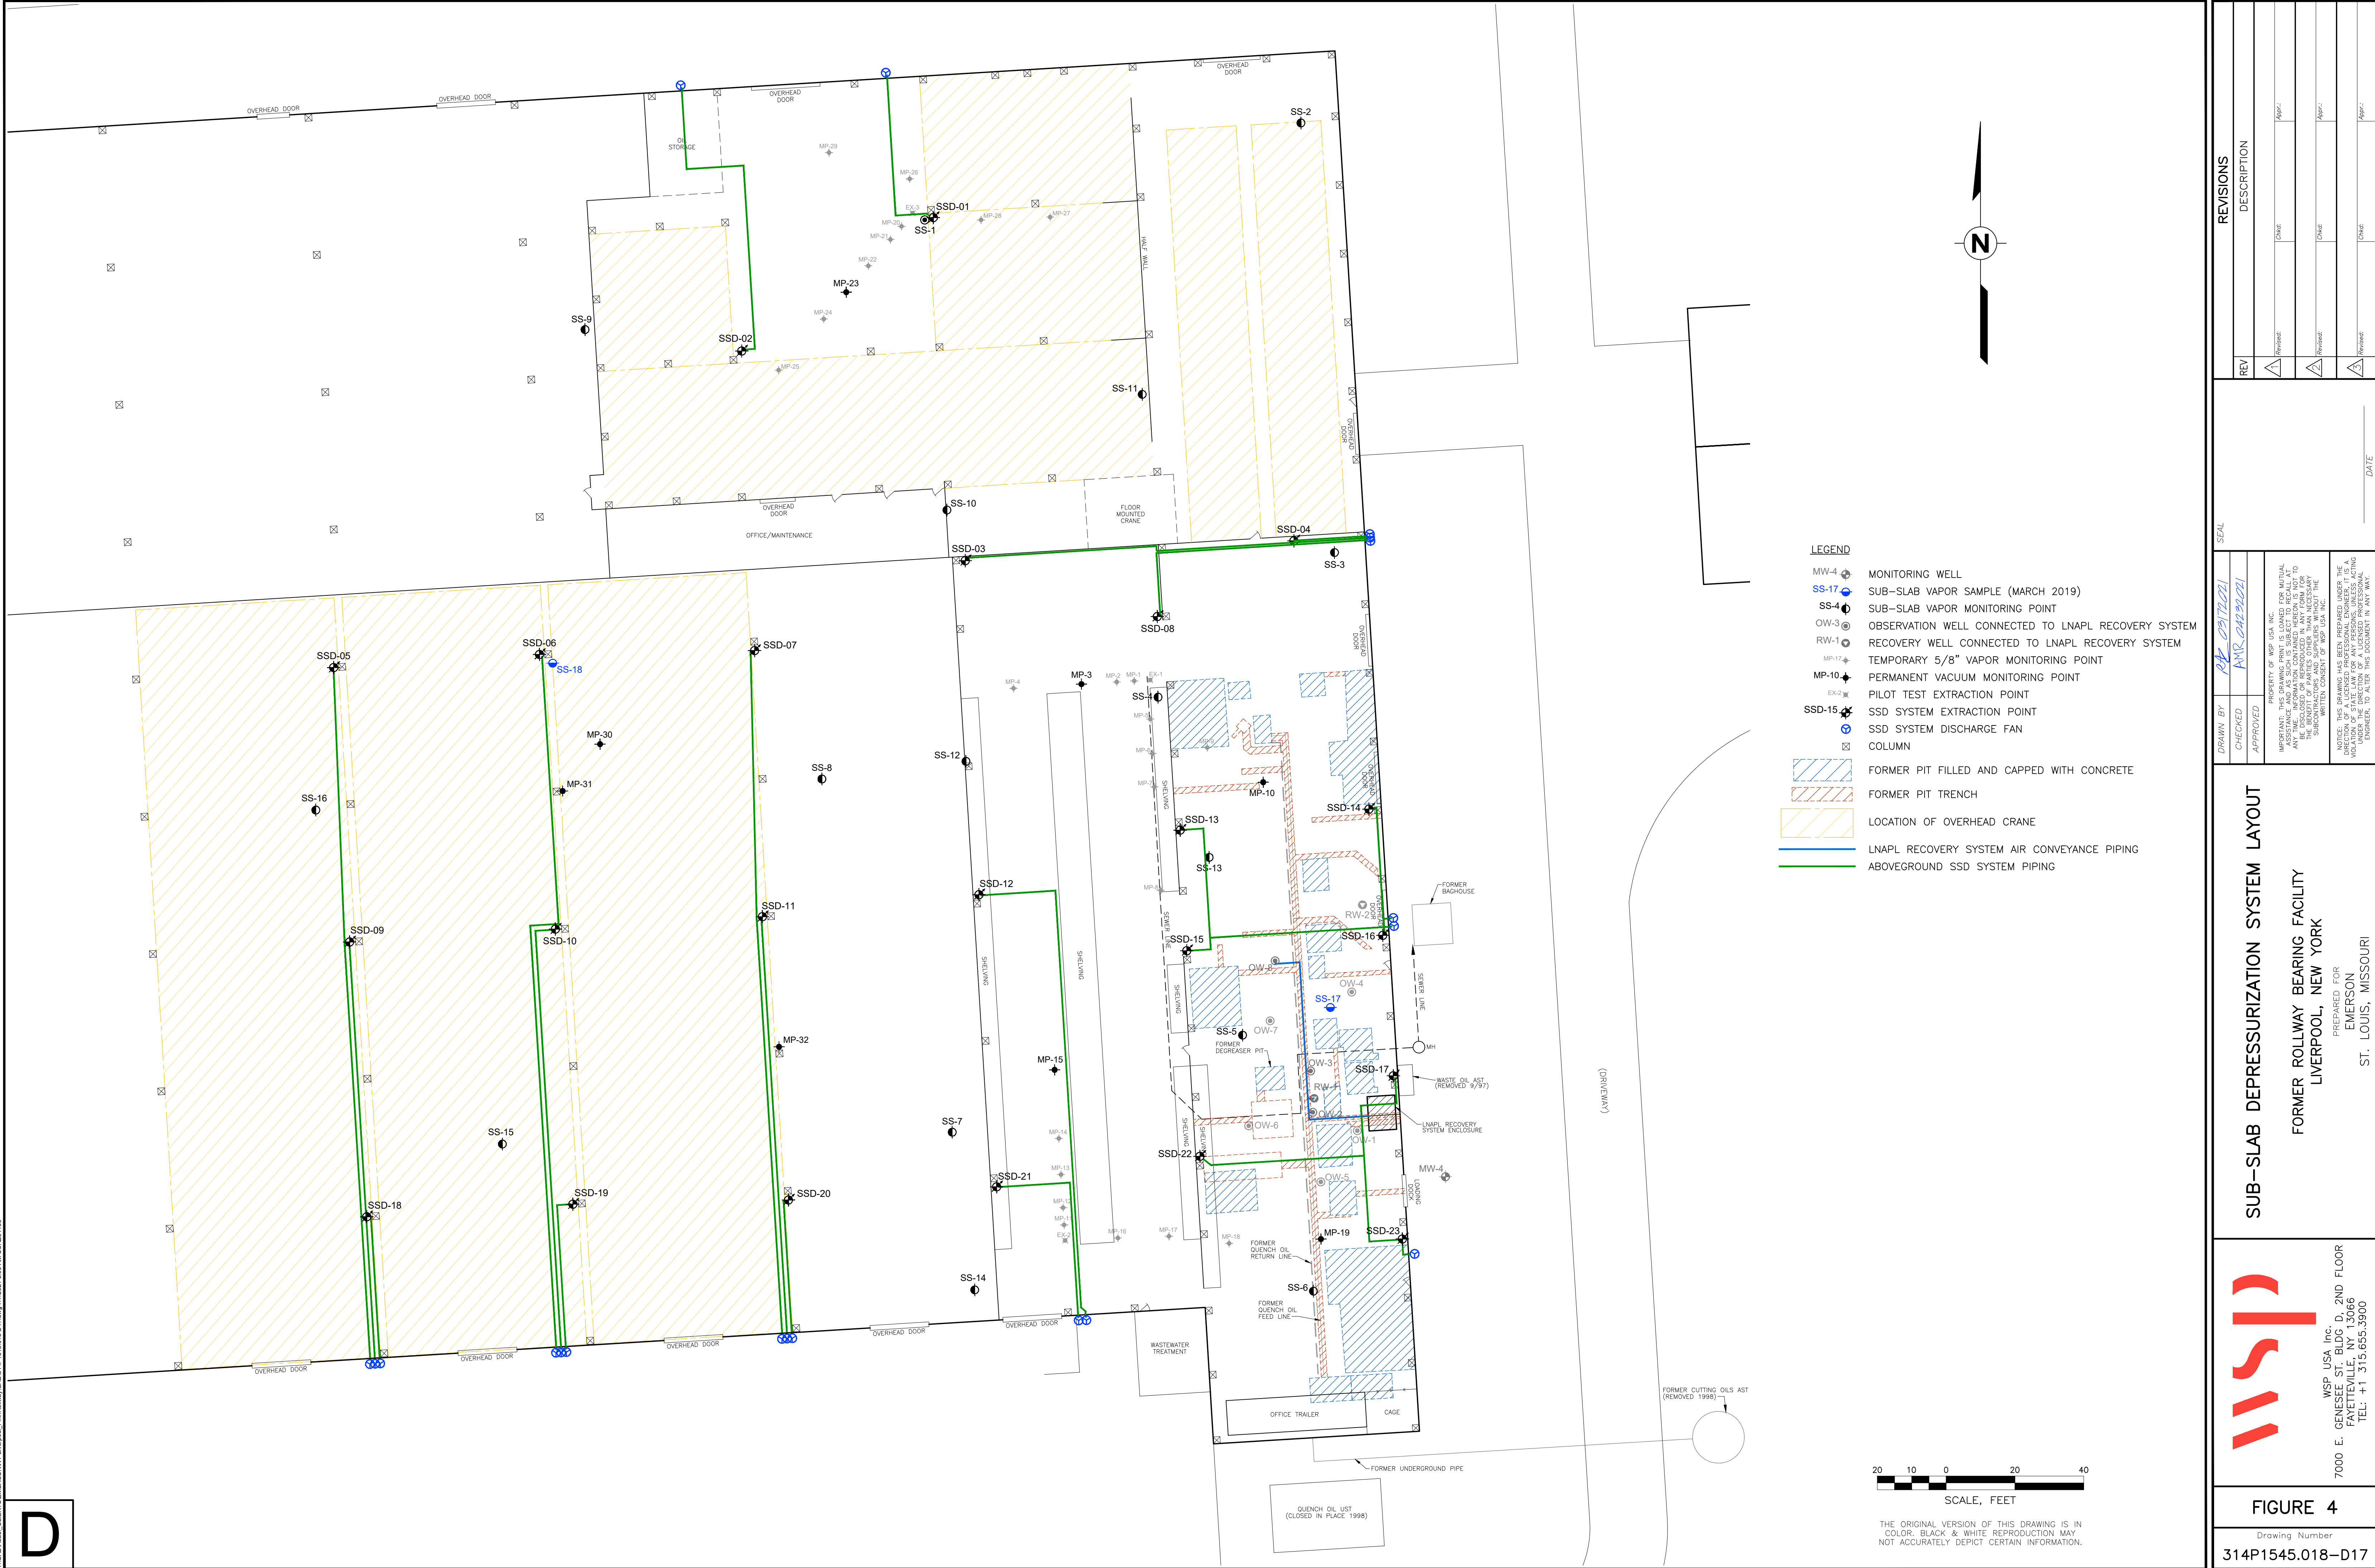
In May 2008, a vacuum-enhanced LNAPL recovery system was installed as an interim remedial measure to remove measurable LNAPL (i.e., greater than 0.01 foot) within the weathered shale under a portion of the former heat treat area of the facility (Figure 3). The main components of the system are a 30-gallon vapor-liquid separator (VLS), a skid-mounted 2-horsepower vacuum blower, a 10-micron air filter, a dilution valve with 10-micron air filter, inlet and outlet vacuum gauges, exhaust stack pressure gauge, and an exhaust stack temperature gauge. The equipment skid is housed within an enclosure inside the former heat treat area. Subsurface vacuum conveyance piping extends from the treatment system equipment to recovery wells OW-2, RW-1, OW-3, and OW-8 (Figure 3).

On May 11, 2021, the system was turned off to conduct a voluntary high-vacuum removal event using a vacuum truck to remove residual LNAPL from wells OW-1, OW-2, OW-3, OW-5, OW-9/FB-2, OW-10/FB-1, RW-2, and SB-5 and the surrounding formation (Figure 3). These wells were generally selected based on the presence of measurable LNAPL during the previous 12-month period (Figure 6). The LNAPL removal activities consisted of applying a high vacuum to each well for a period of 30 to 330 minutes over 3 days, using an air tight well cap equipped with a drop tube. The time that vacuum was applied to each well was based on field observations regarding the volume of recovered LNAPL. Liquids removed from the wells were transferred to a vacuum truck. The system was re-started on May 13, 2021.

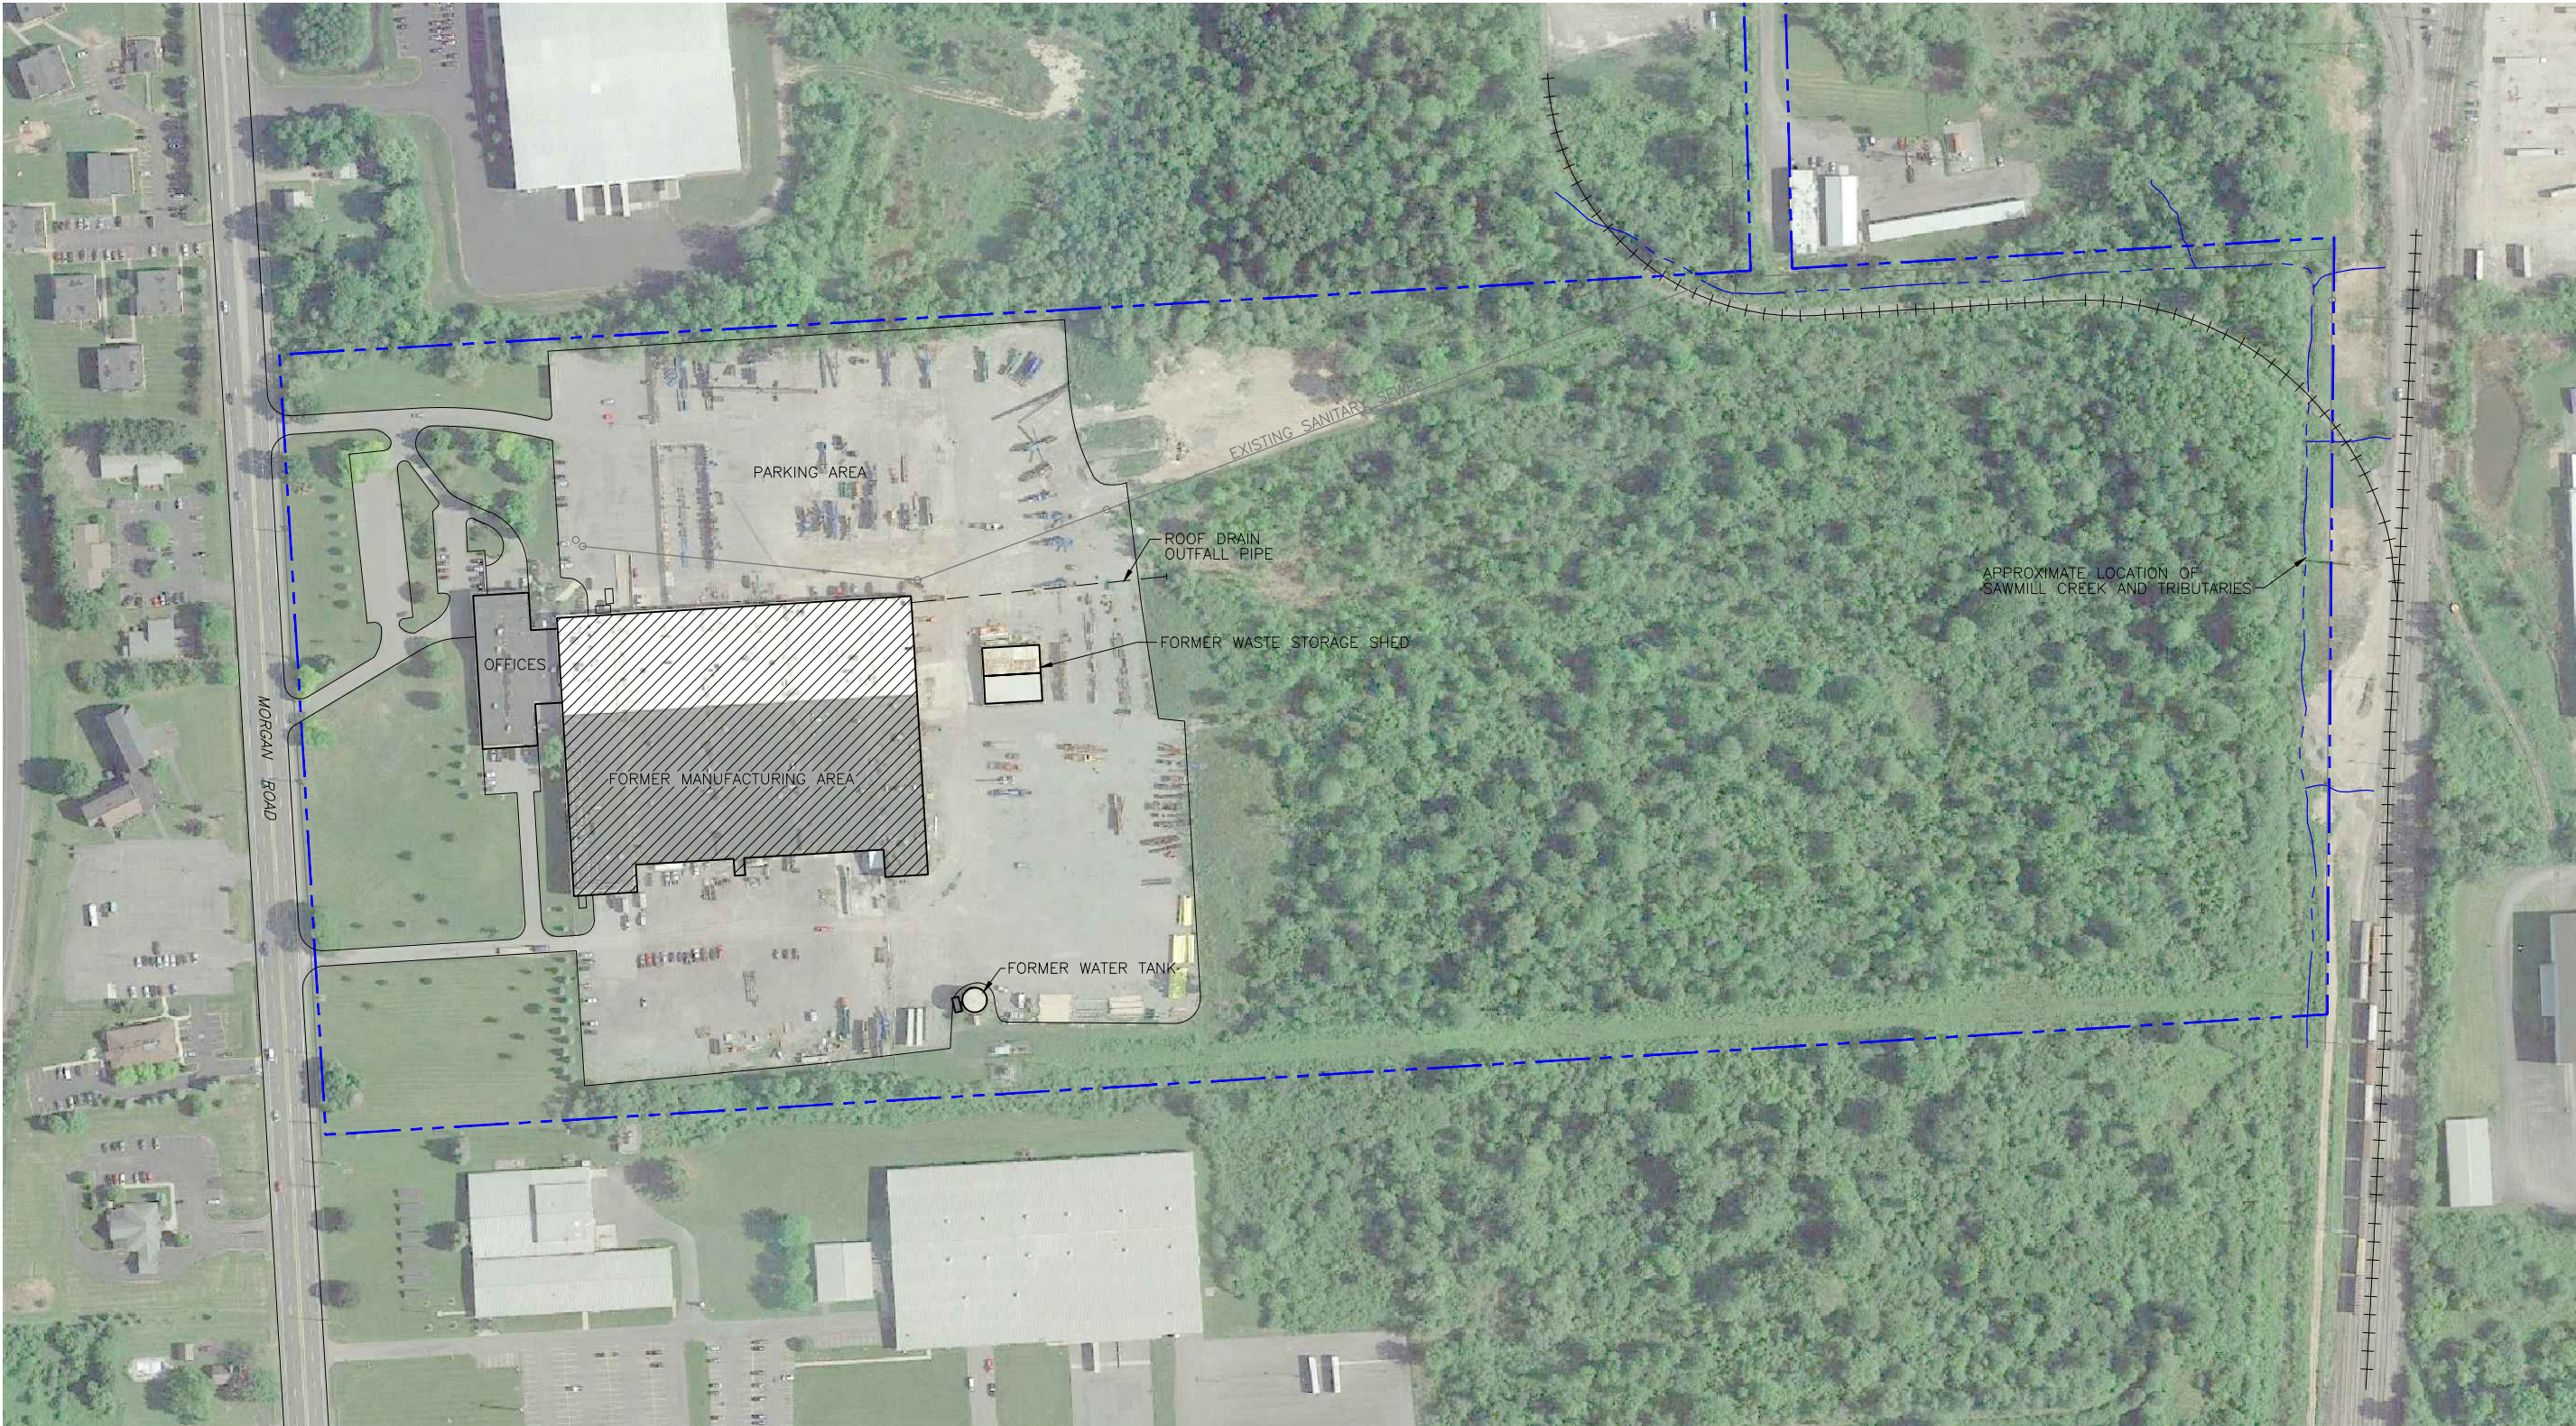
FIGURE 5  
COVER SYSTEM LOCATION

An annual site inspection was performed on June 17, 2021, to evaluate the continued effectiveness of the cover system, and the results of the annual inspection are documented on the Annual Site-Wide Inspection Form (Appendix B). During the inspection, the concrete slab comprising the cover system appeared in good condition, and no breaches or significant cracks were observed. In addition, no excavation activities were performed within the cover system area during the reporting period. However, during the installation of the SSDS in August and September 2020, the floor slab was cored at 22 locations within the eastern portion of the building. The floor slab was promptly restored in accordance with the approved work plan.

The cover system continues to perform as designed and remain effective in protecting human health and the environment. No deficiencies were identified with respect to the cover system, and no changes to the cover system are recommended at this time.
