EMERSON ELECTRIC CO.

## PERIODIC REVIEW REPORT

FORMER ROLLWAY BEARING CORPORATION  
FACILITY, ONONDAGA COUNTY, LIVERPOOL,  
NEW YORK - SITE NO. V00202

JULY 21, 2021

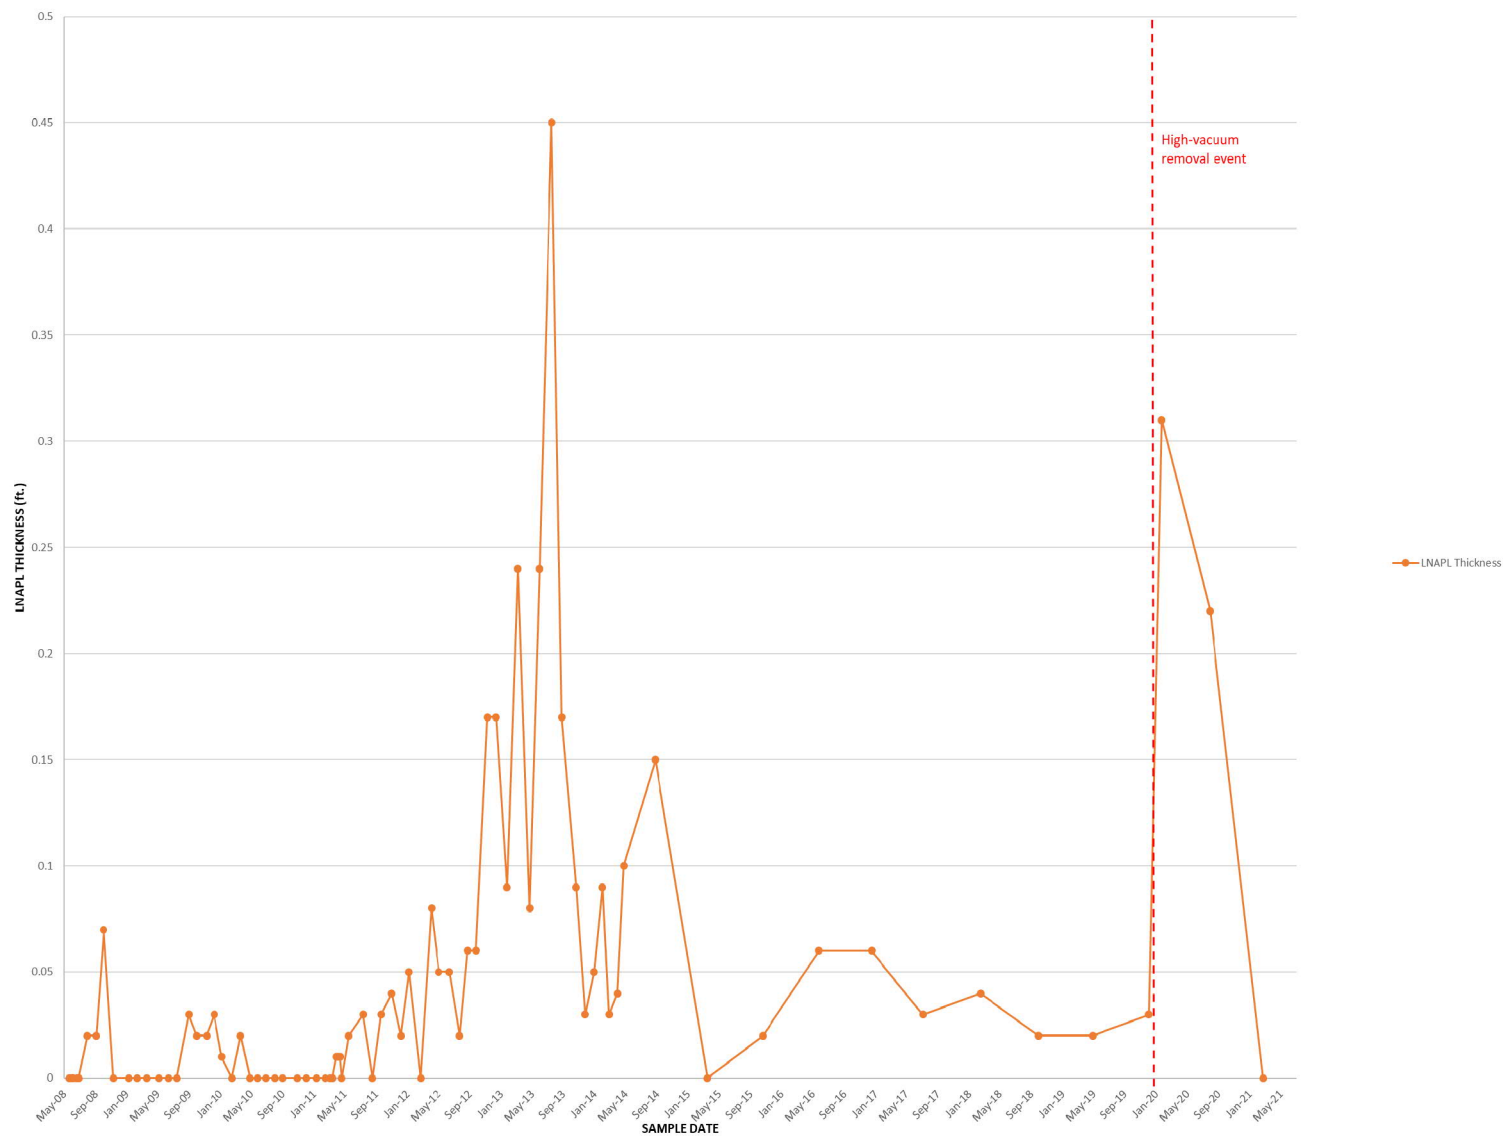
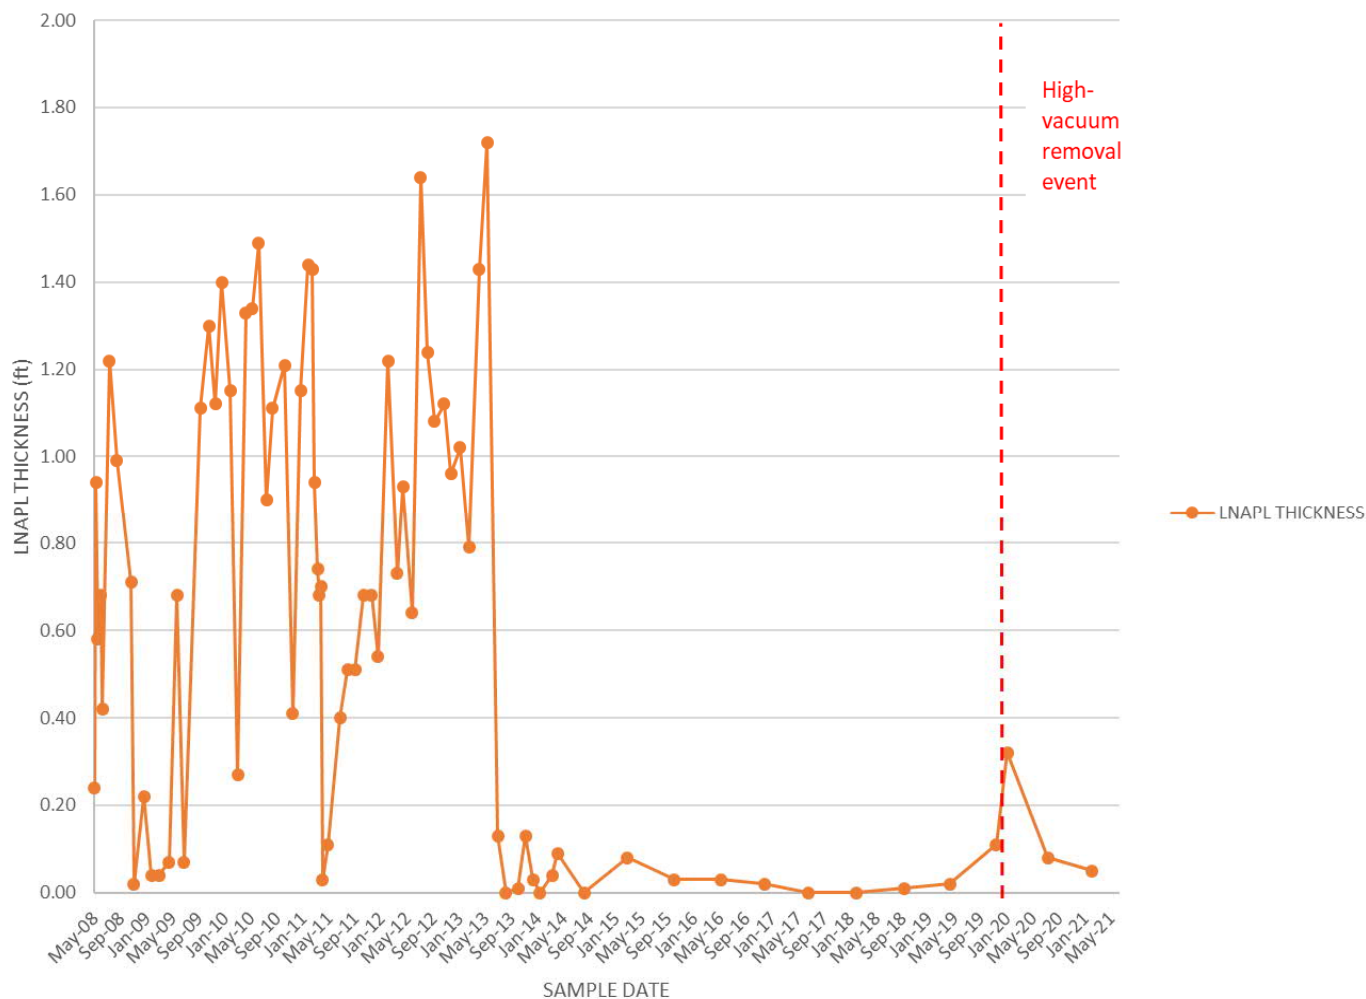
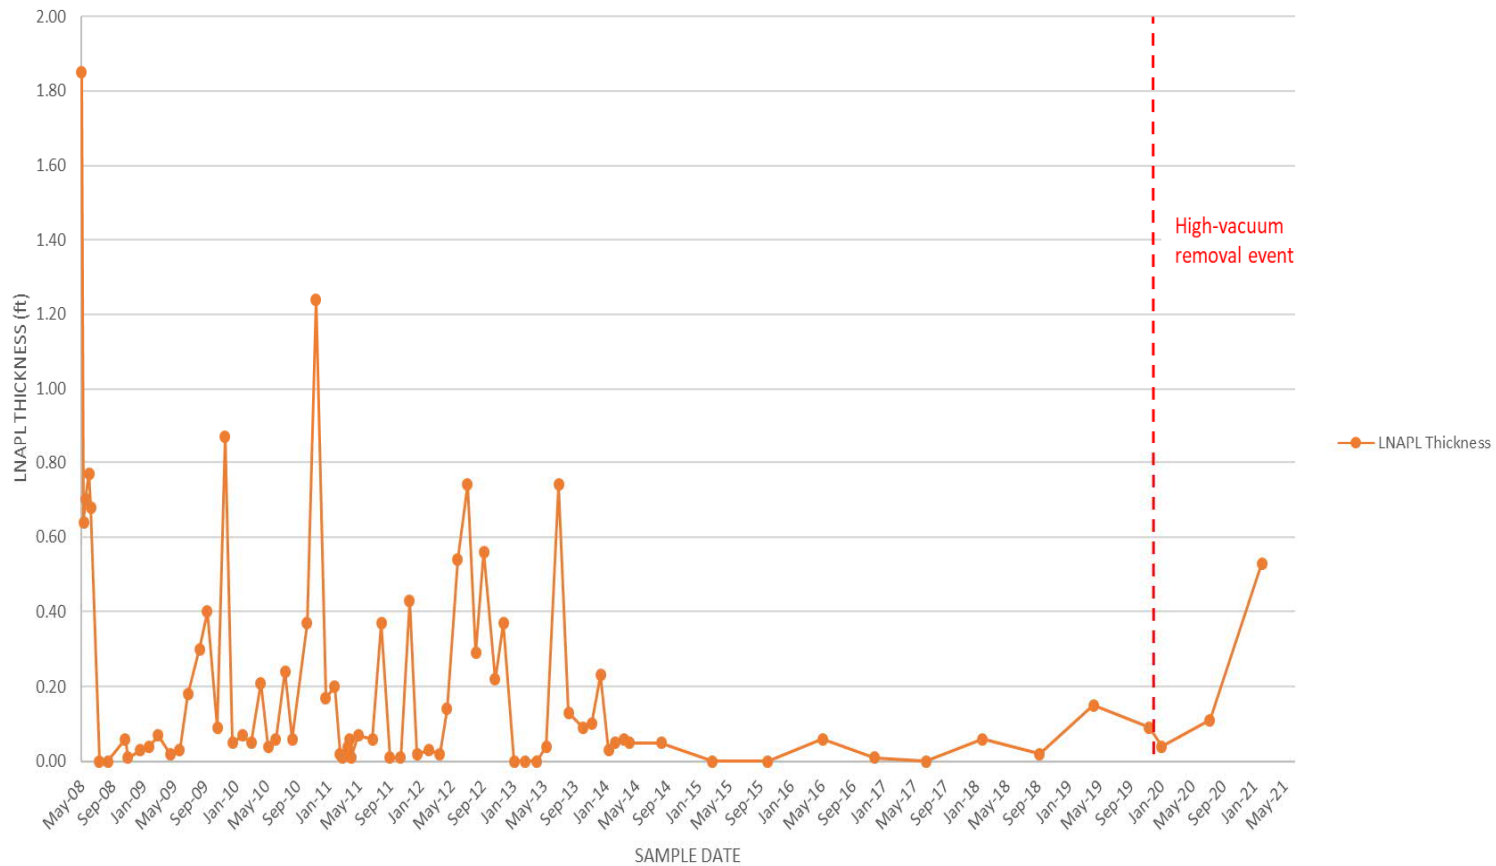
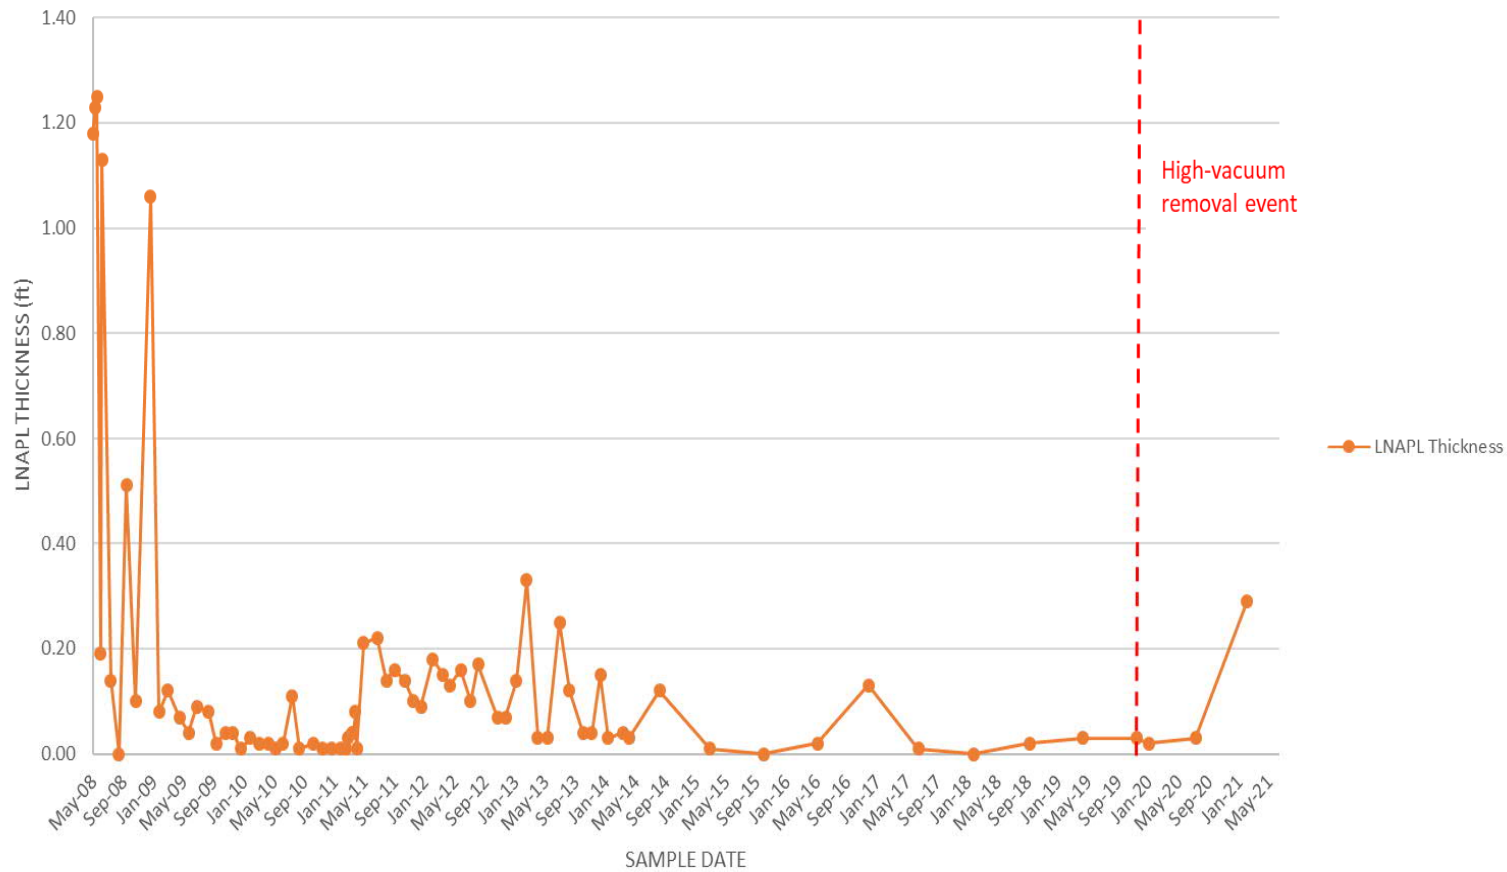
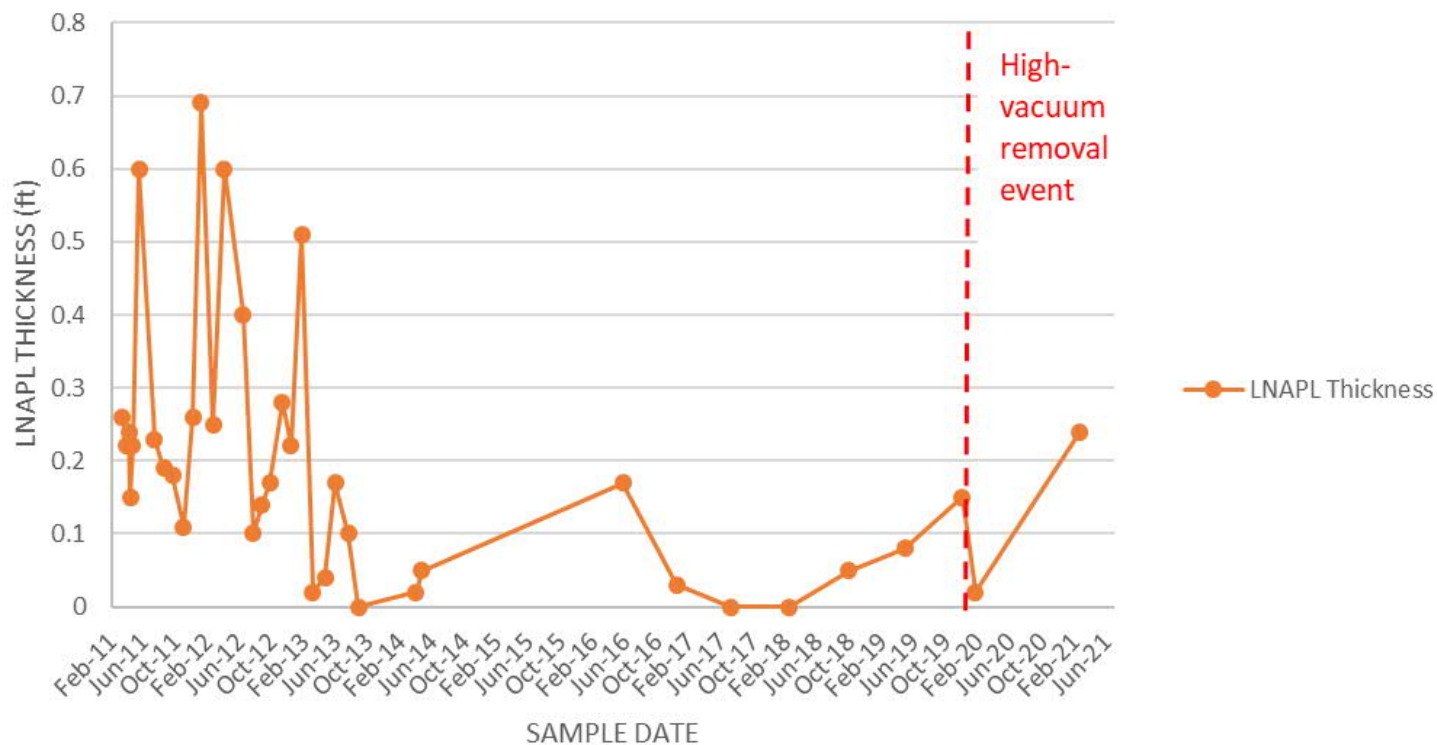
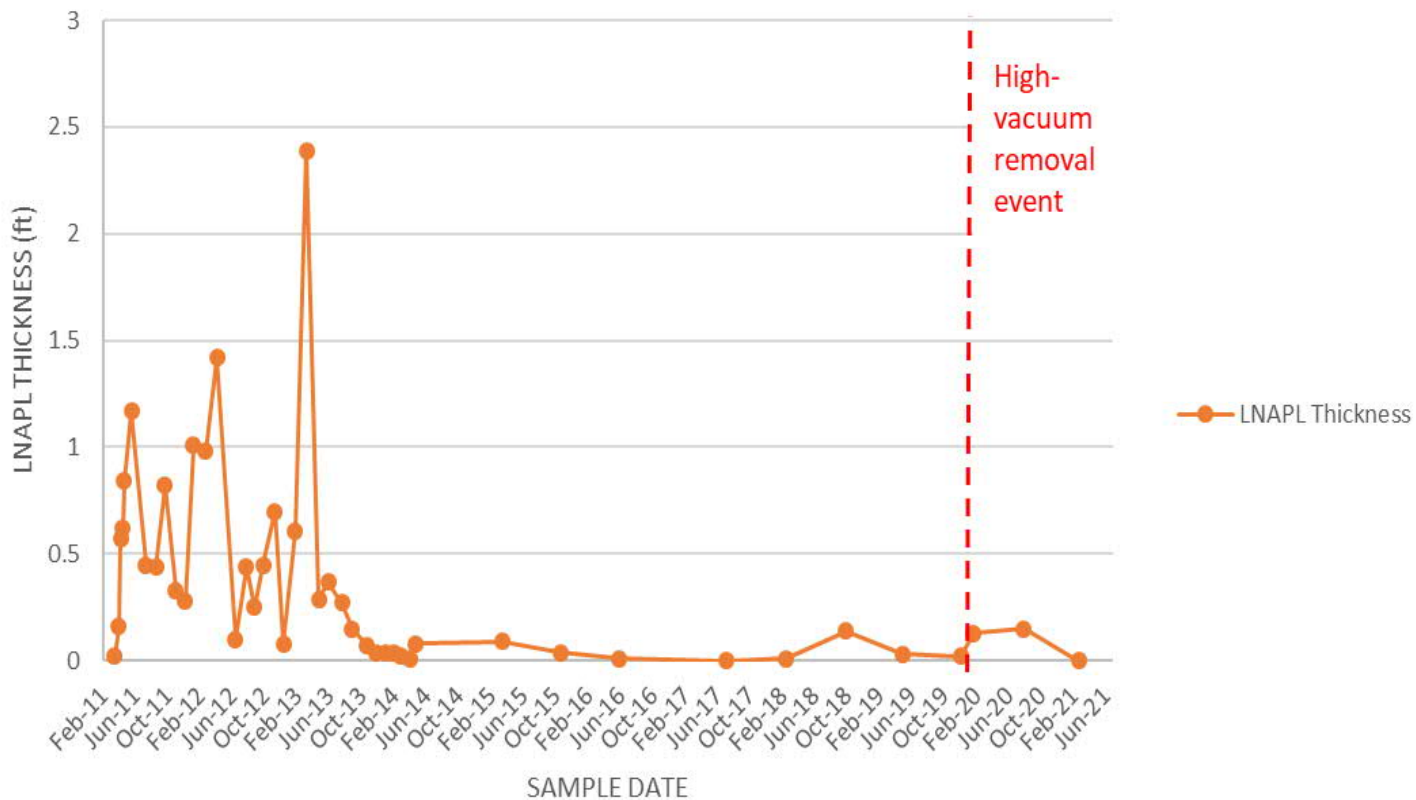
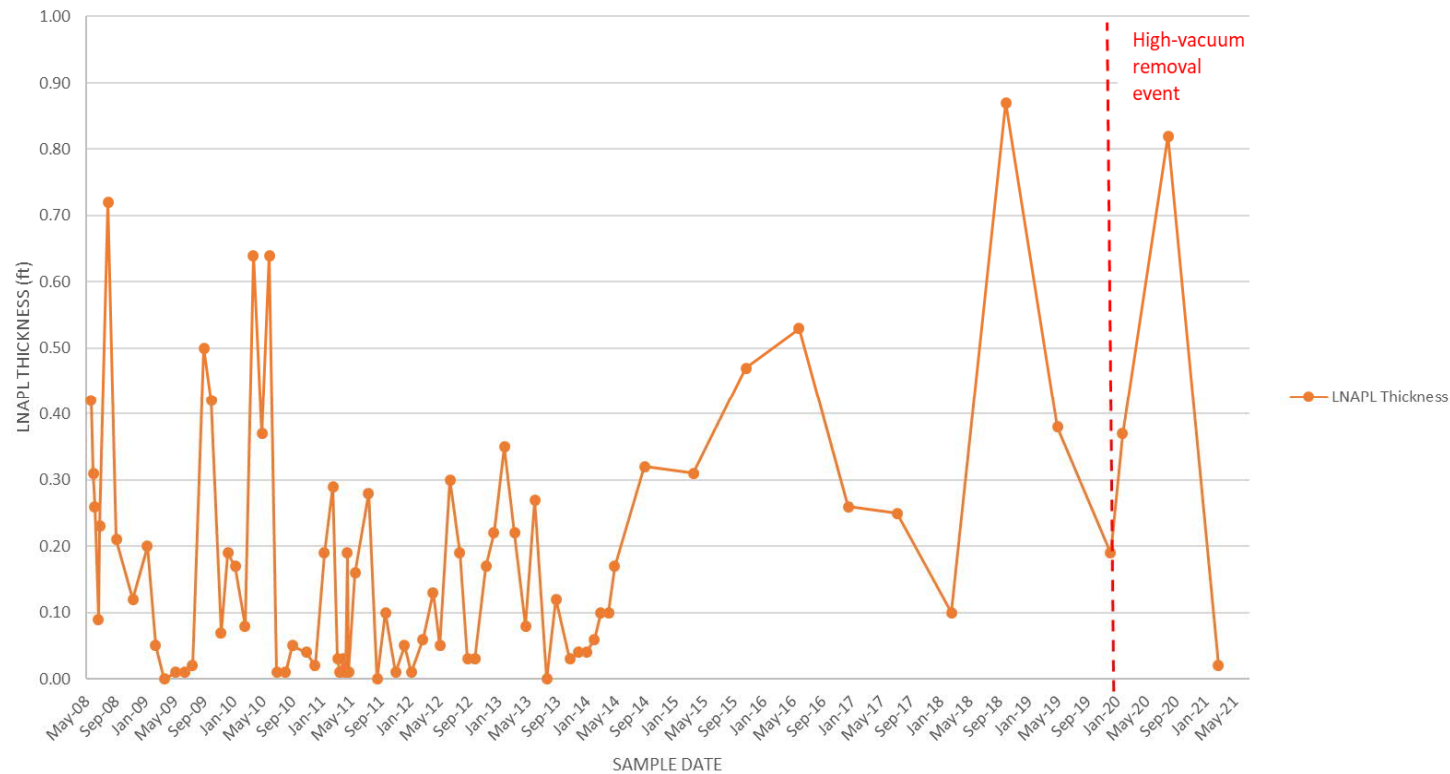
## G LNAPL THICKNESS GRAPHS

- Based on a statistical trend analysis as described in Section 5.2.3, the LNAPL thickness in wells OW-2 and OW-5 show a downward trend from May 2008 (when the system became operational) to the present. The LNAPL thickness in wells OW-9/FB-2 and OW-10/FB-1 show a downward trend from March 2011 (when the soil borings were first installed to implement pneumatic fracturing<sup>1</sup>) to the present. The LNAPL thickness in wells OW-3 and SB-5 showed no significant trend.

Graphs of LNAPL thickness versus time for select wells that have historically contained measurable LNAPL over consecutive occasions are provided in Appendix G. The graphs for OW-1, OW-2, OW-3, OW-5, and SB-5 start in May 2008 when the vacuum-enhanced LNAPL recovery system began operating. The graphs for OW-9/FB-2 and OW-10/FB-1 start in March 2011 when the soil borings were installed to implement pneumatic fracturing and were later converted to observation wells in May 2016.
