# PERIODIC REVIEW REPORT

FORMER ROLLWAY BEARING CORPORATION  
FACILITY, ONONDAGA COUNTY, LIVERPOOL,  
NEW YORK – SITE NO. V00202

JULY 11, 2022

PROJECT NO.: 31401545.018  
DATE: JULY 11, 2022

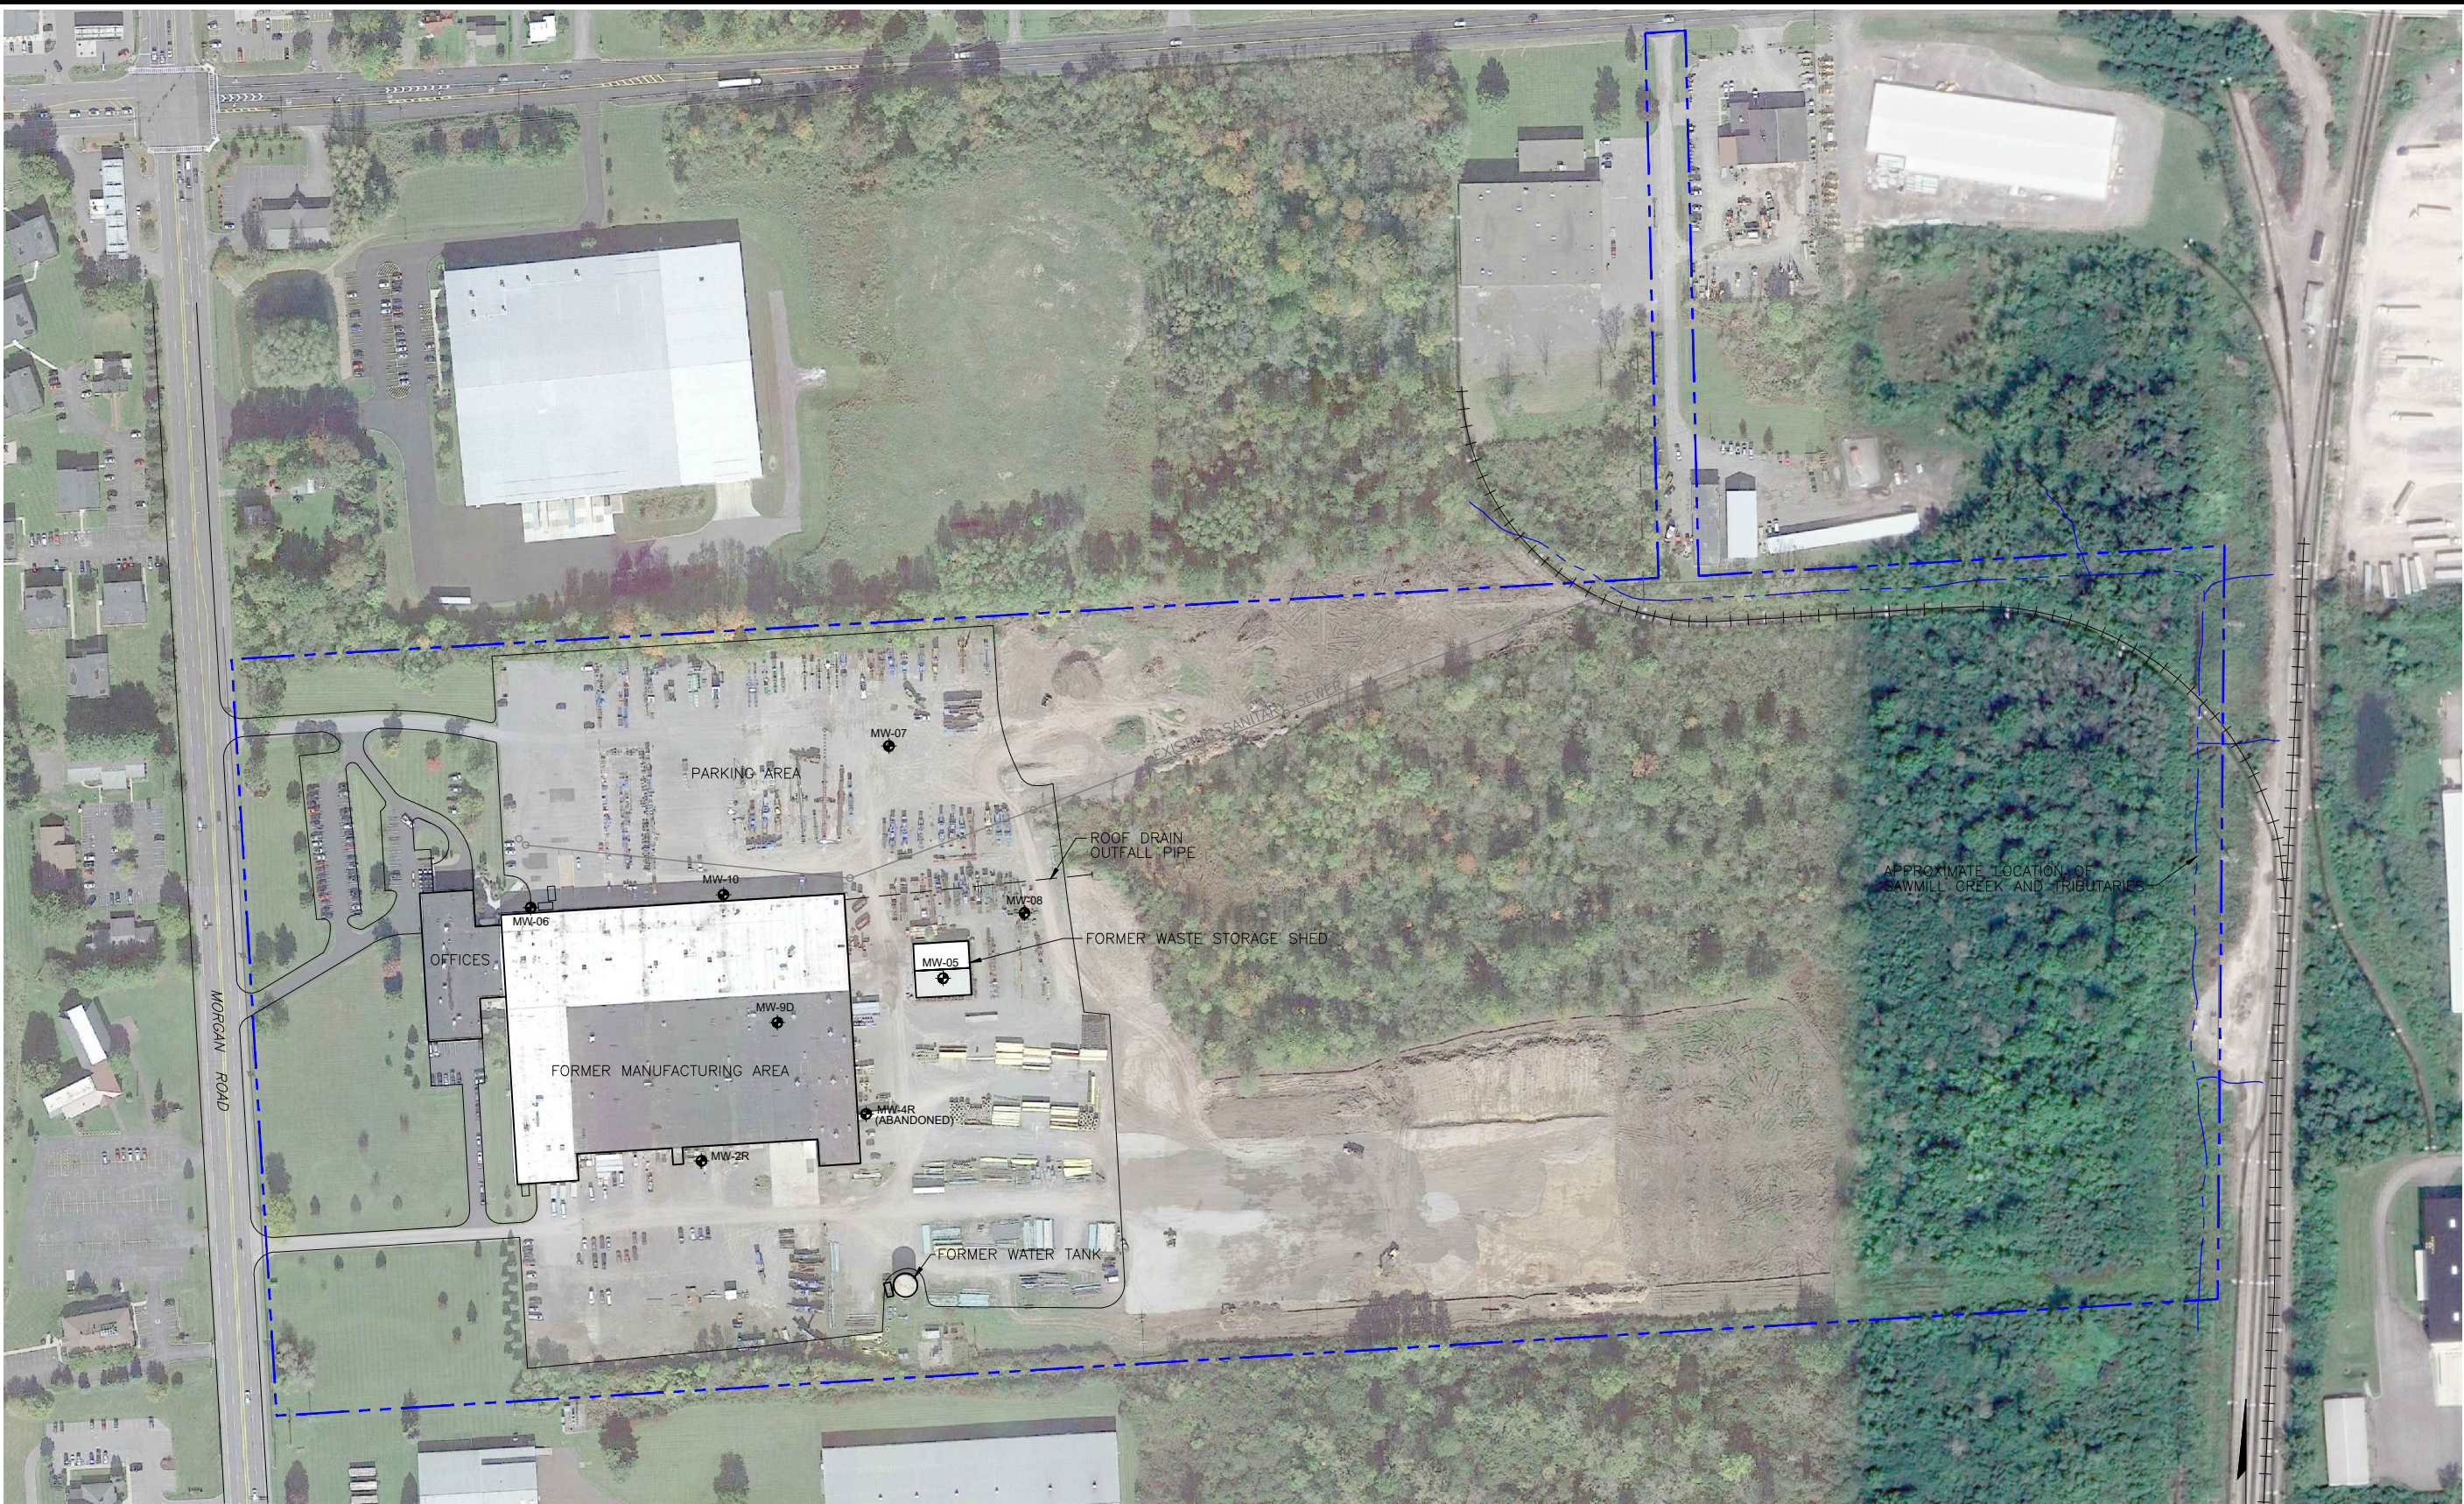
FIGURE 2

SITE LAYOUT

- The potential for vapor intrusion must be evaluated for any buildings developed in the area within the IC boundaries noted on Figure 2, or if the use of PCE-containing materials within the existing building changes (provided the potential for vapor intrusion has not been previously addressed to the department's satisfaction). Any potential impacts that are identified must be monitored or mitigated; and
