FINAL INVESTIGATION SITE ASSESSMENT REPORT

*500 Mamaroneck Avenue
Harrison, New York 10528
(Volume I)*

April 2000

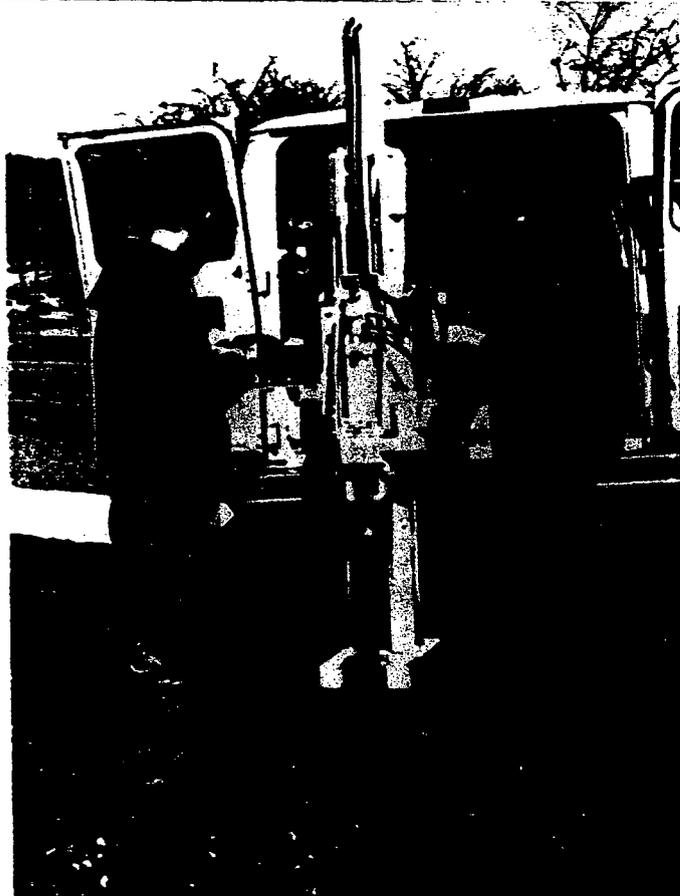
Photo #2 – Geoprobe sampling vehicle – Brooks Laboratories, Inc.
