**CONTINUED SOIL & GROUNDWATER INVESTIGATION
& REMEDIAL MEASURE**

BAYVILLE VILLAGE CLEANERS

BAYVILLE, NEW YORK

Prepared By: P.W. Grosser Consulting Engineer & Hydrogeologist, P.C.

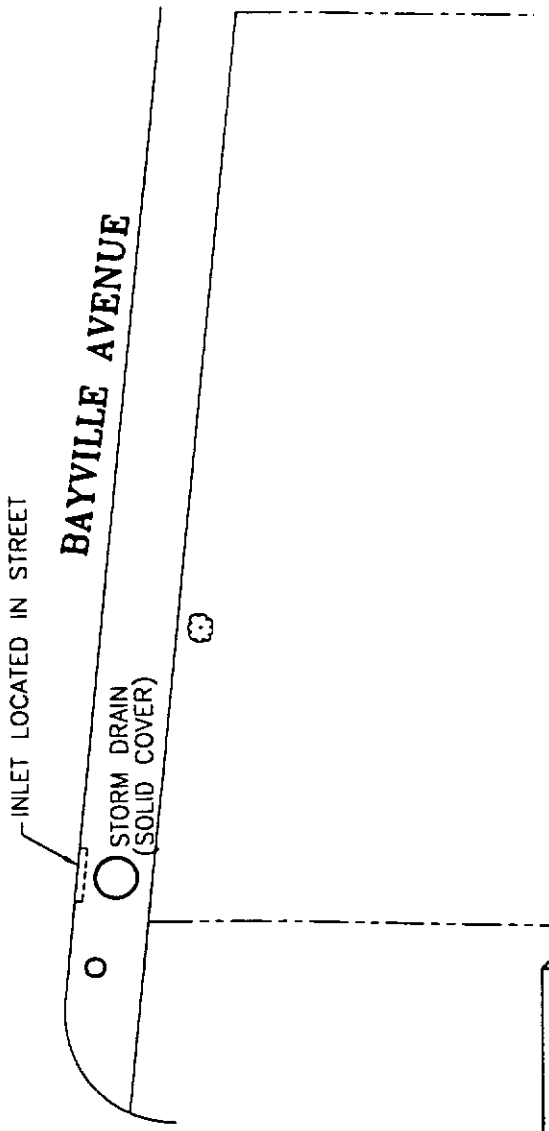
2

- LEGEND**
- BORING LOCATION
 - REMEDIATE TO 5'
 - REMEDIATE TO 8' OR UNTIL THE CAPILLARY FRINGE IS ENCOUNTERED

SITE PLAN
ORIGINAL SOILSAMPLING LOCATIONS & RESULTS
 MAY 22, 1996
 290 BAYVILLE AVE.
 BAYVILLE, N.Y.

Subsequently, PWGC was retained by the owner of Bayville Village Dry Cleaners to delineate the vertical and horizontal extent of on site soil contamination and to determine if groundwater was impacted. A PWGC soil and groundwater investigation work plan dated April 2, 1996 was accepted by the NCDH and work was performed on April 10, 1996 in the presence of Mr. Joe DeFranco of the NCDH. The investigation included the collection of continuous soil samples from grade to the water table (approximately 8.5 feet below grade) at 9 soil boring locations. Two boring locations were chosen to coincide with the approximate locations originally taken by the NCDH. The original NCDH sample locations correspond to the former locations of two pipes exiting the west side of the building, above the flower bed, from two separate unit processes. The first unit process (located over the southern portion of the flower bed) is a vacuum system which captures water vapor during clothes pressing. The second process was an evaporator unit located over the northern portion of the flower bed which was designed to release vapor through a pipe (see Figure 2). The two unit processes are

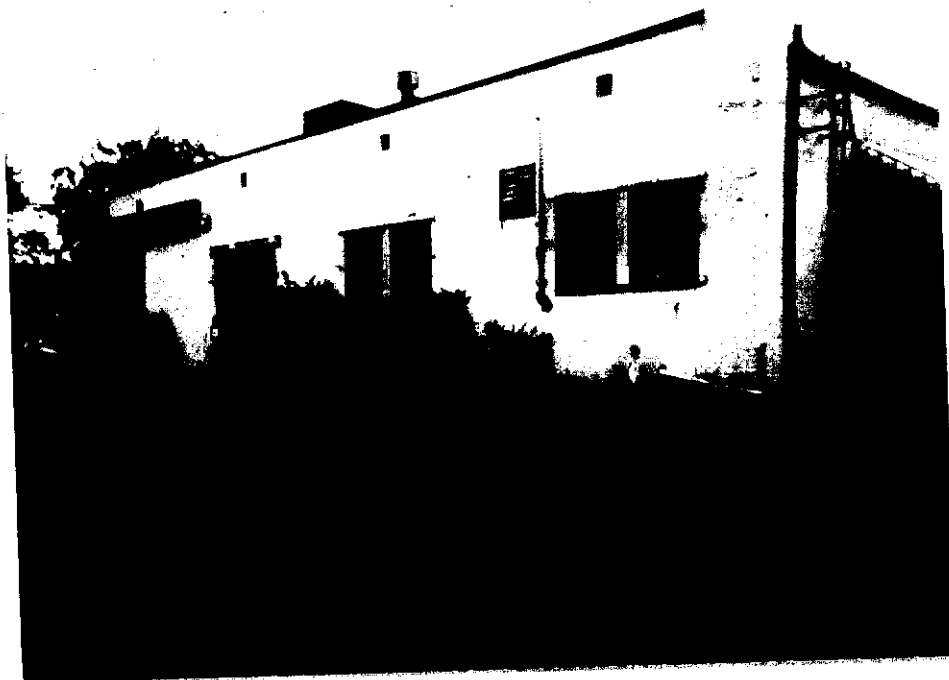
Photo 1 - Western Side of the Bayville Village Cleaners Building Prior to Excavation.

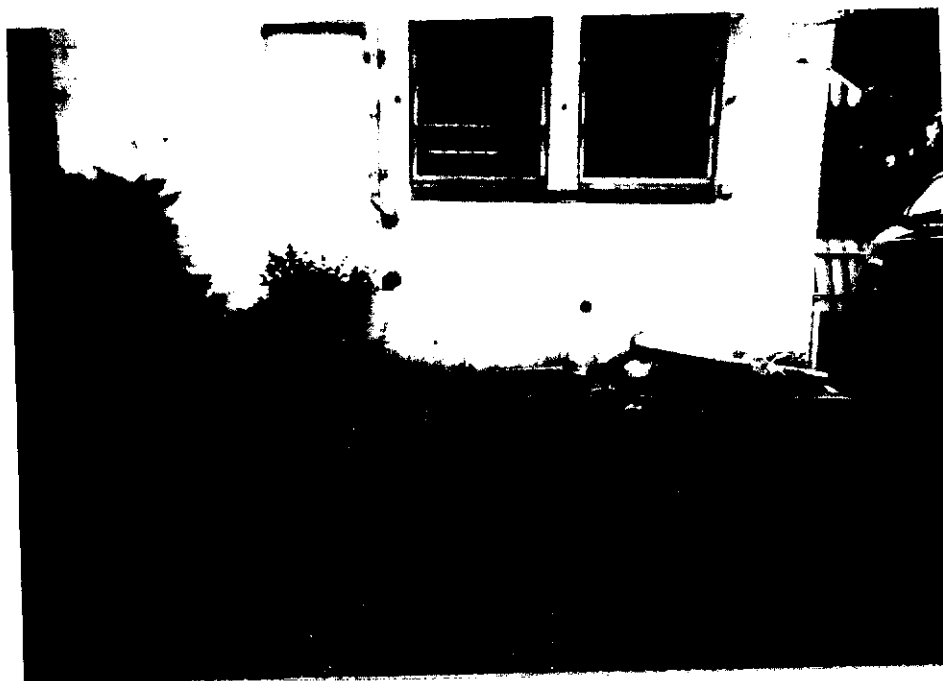
Photo 2 - Former Location of Vacuum Unit Discharge.

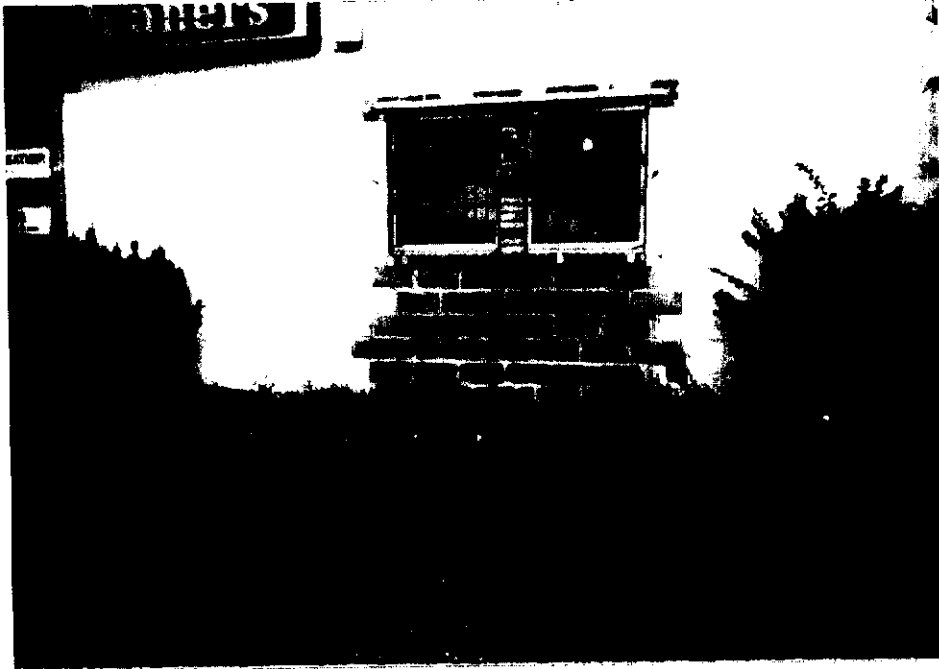
Photo 3 - Former Location of Evaporator Unit Discharge.

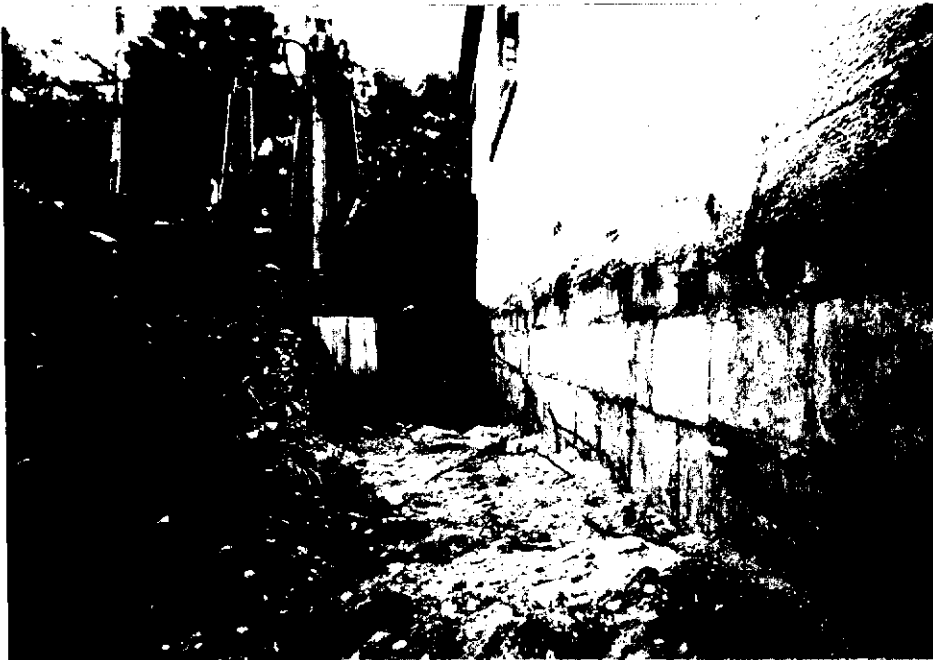
Photo 6 - Excavated Area Between the Two Former Unit Discharge Locations.

The area in between the two unit discharges was excavated to a depth of 2.5 feet and approximately 2.5 feet west of the building (see Photo # 6). Excavation in this area necessitated the removal of several shrubs to remove potentially impacted surface soils not previously sampled due to limited access.

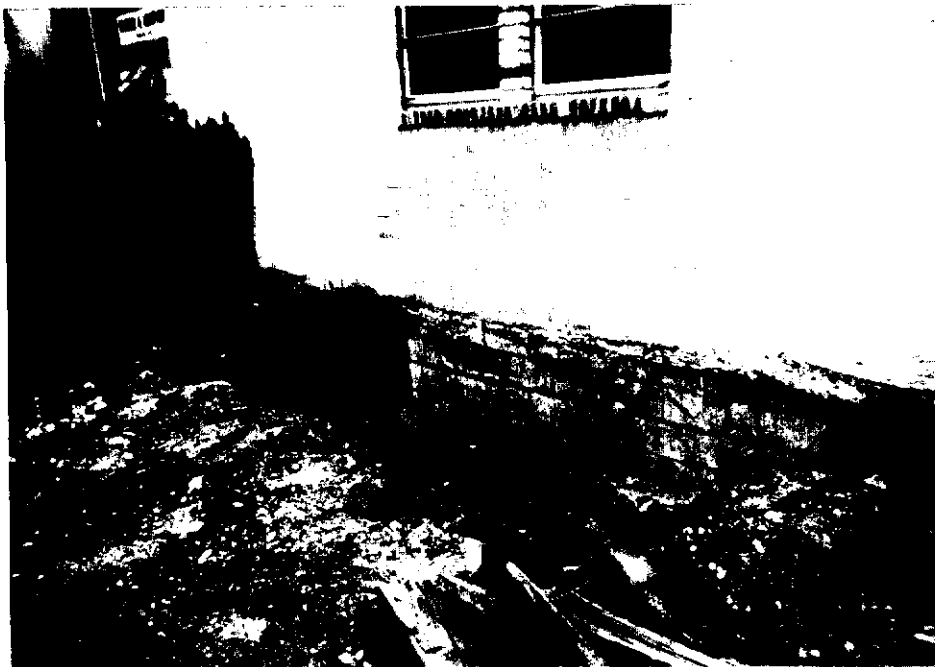
Photo's 7 & 8 - Area of the Excavation Corresponding to the Former Evaporator Unit Discharge.

The excavation in the area of the former evaporator unit discharge was widened to approximately 6 feet and extended to approximately 5.5 feet deep, directly in line with the former discharge pipe (see Photo's # 7 and # 8). Though soil quality in this area was documented as being within NYSDEC TAGM soil cleanup objectives, the excavation was performed in an attempt to remove remaining impacted on site soil. Again, as can be seen in Photo # 8, groundwater was not encountered in the excavation.

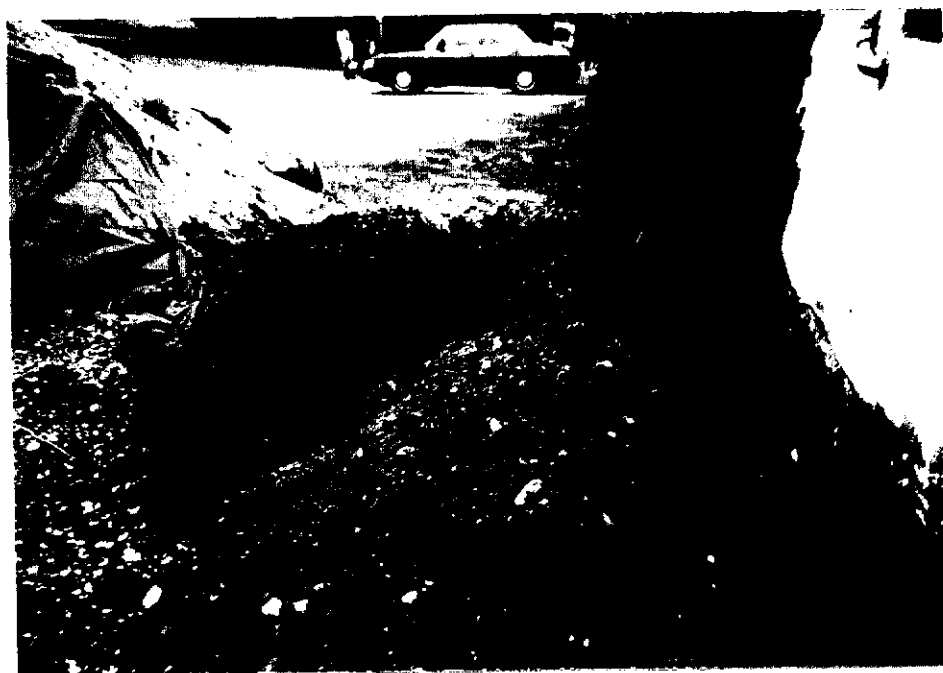
Photo's 9 & 10 - Lining & Backfilling of the Excavation.

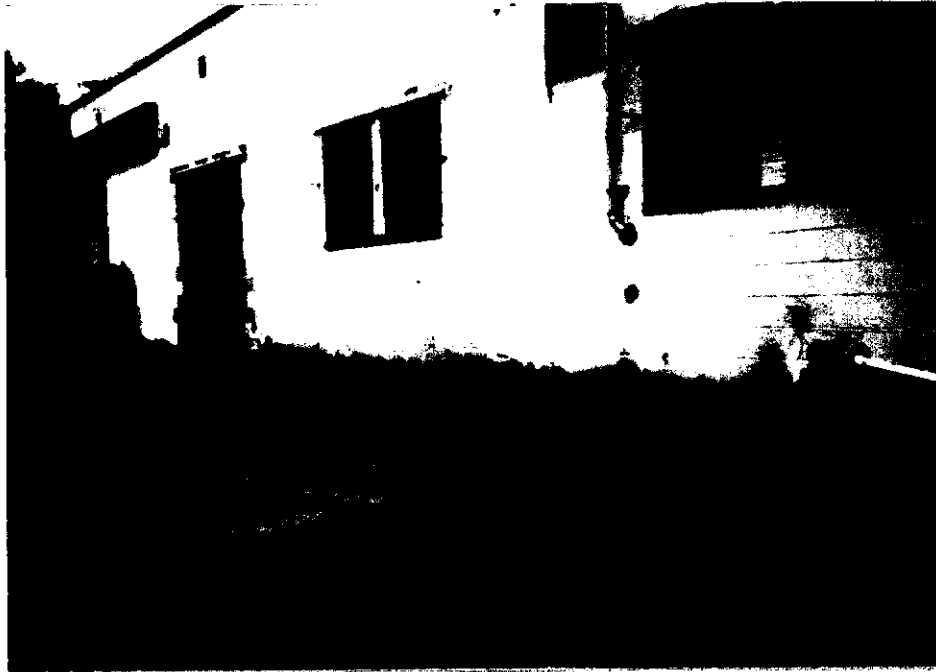
Photo 11 - Completed Backfilled Excavation.

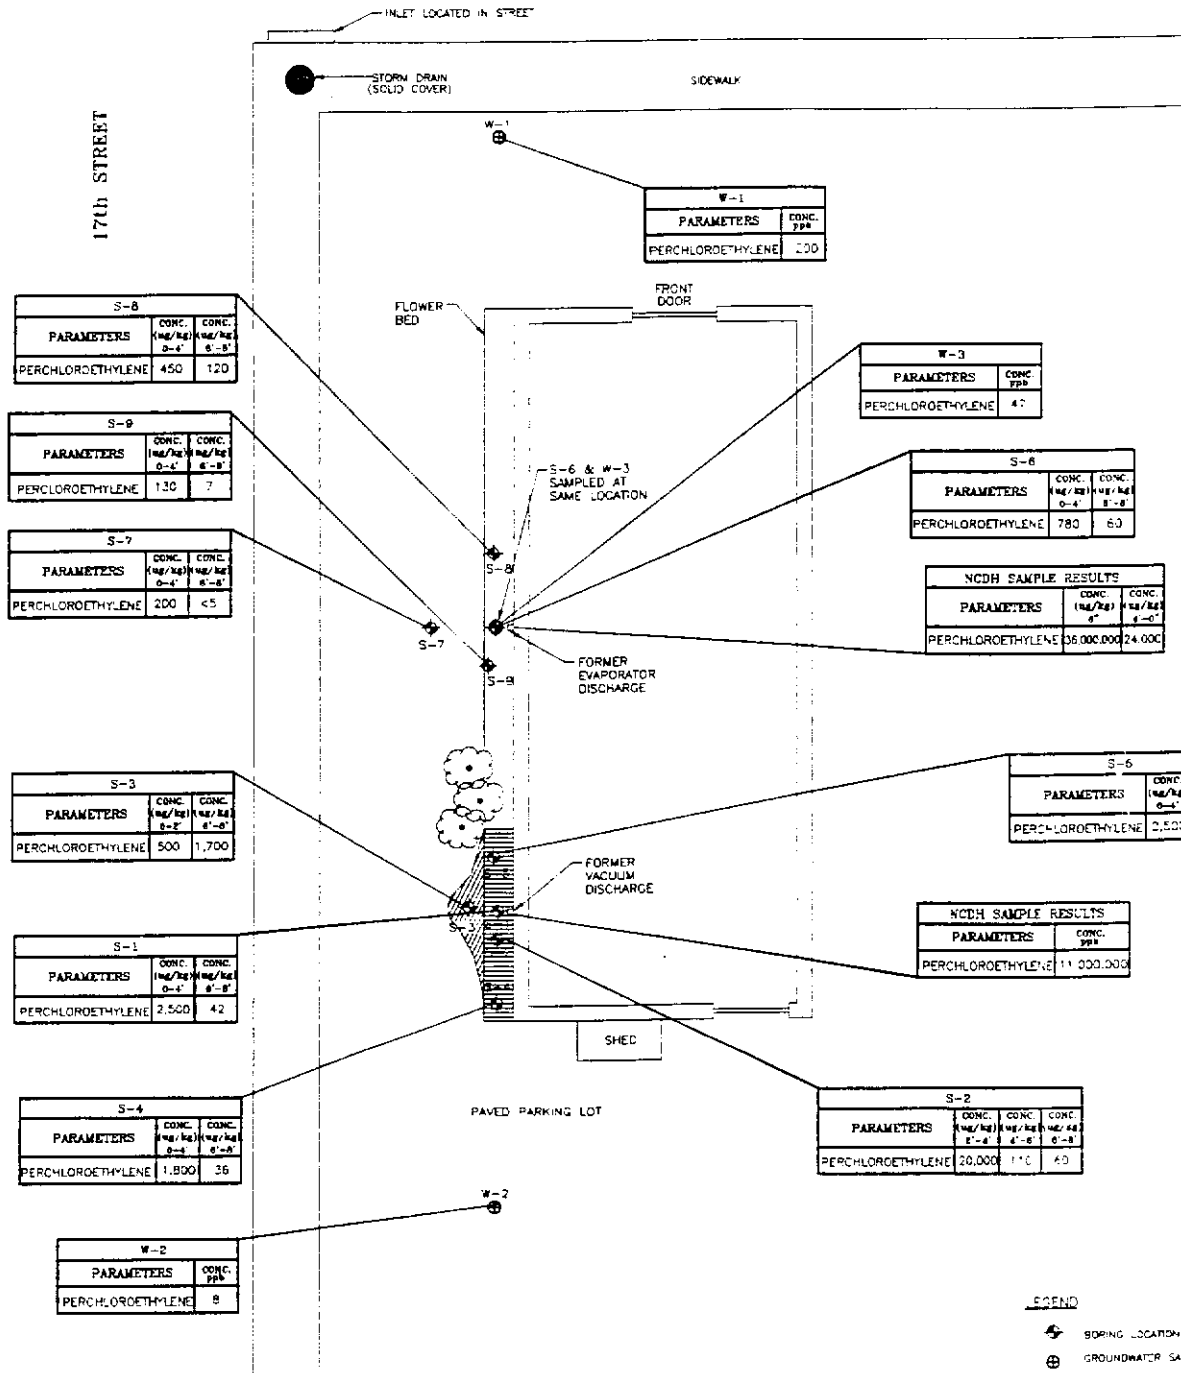
- LEGEND
- BORING LOCATION
 - GROUNDWATER SAMPLING LOCATION
 - REMEDIATE TO 5'
 - REMEDIATE TO 8' OR UNTIL THE CAPILLARY FRINGE IS ENCOUNTERED

After analyzing the laboratory data obtained on soil samples collected from the Site, it has been recommended to excavate the soils in the area of the former vacuum discharge to a depth of five feet. The soils near S-3 and west of S-2 will be excavated to a depth of 8 feet. The soils in the vicinity of the former evaporator discharge are in no need of remediation. The soils will be excavated in the presence of the NCDH and the contaminated soils will be properly disposed of to a treatment plant facility. During excavation, soils will be screened with a PID to aid in the excavation activities and determine when clean soils are encountered. In addition, the structural integrity of the building will be considered during excavation, since the flower bed containing the soils to be excavated runs immediately adjacent to the building. The excavation may have to be performed in small sections so as to not undermine its foundation.

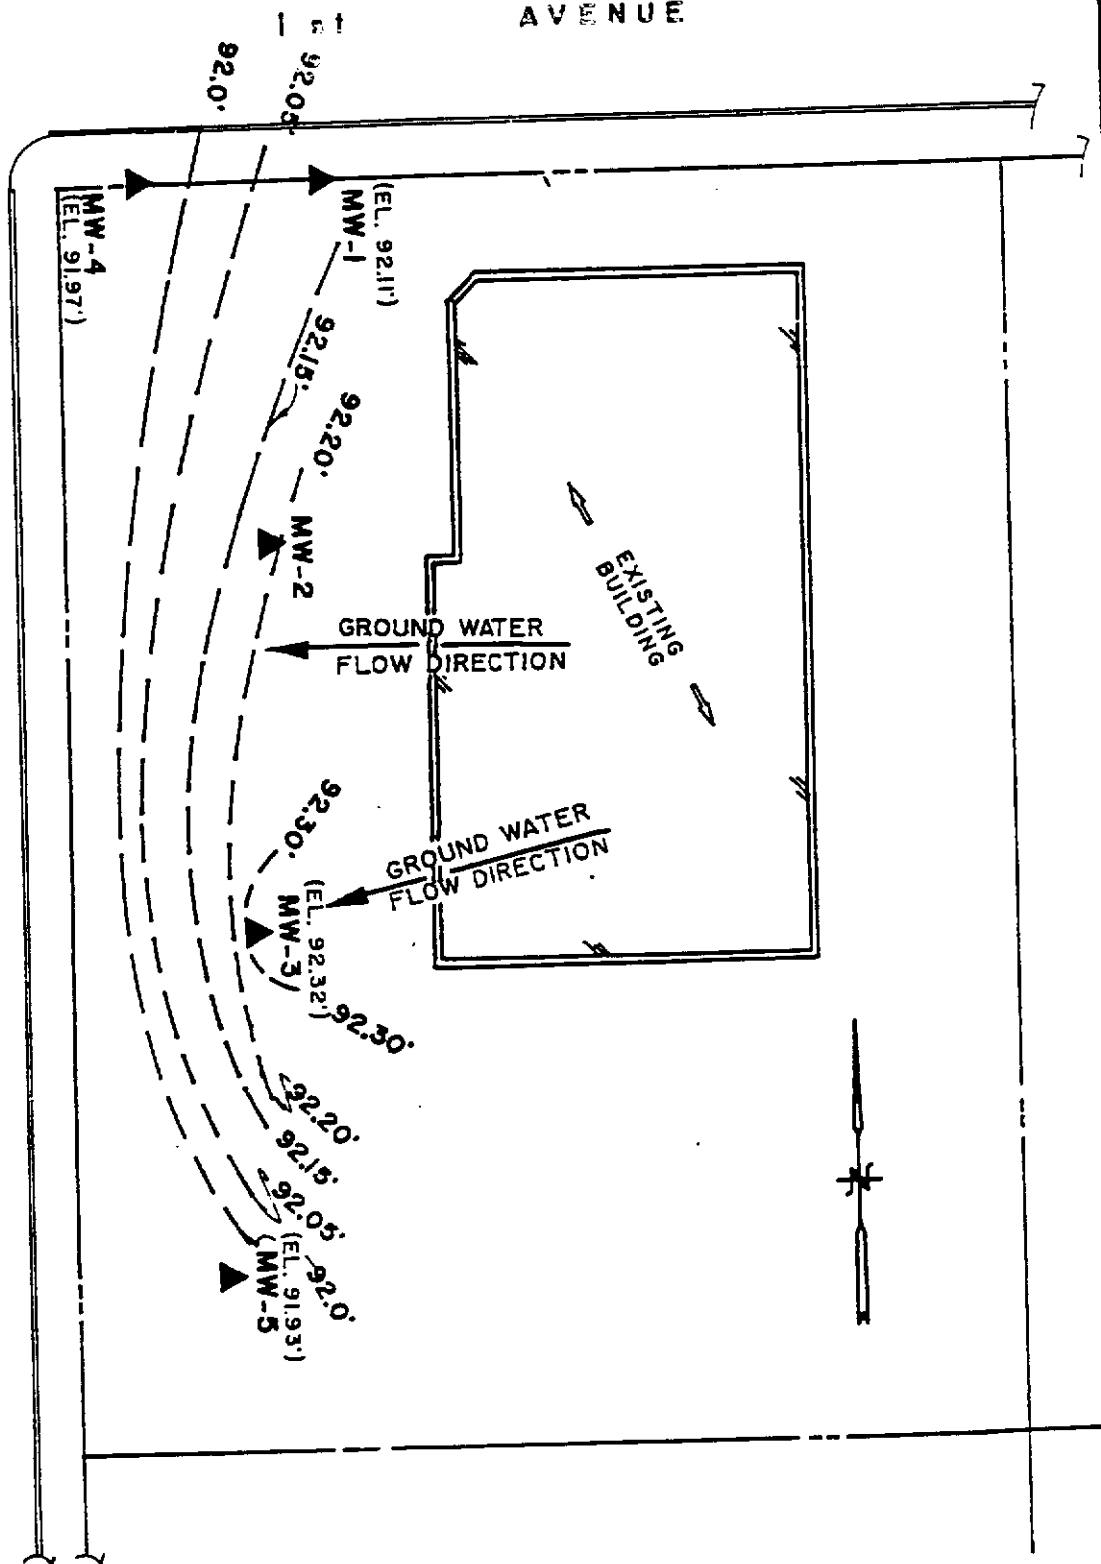
GROUND WATER CONTOUR MAP
TWIN HARBOR AUTO REPAIR
BAYVILLE, NEW YORK
