**BAYVILLE VILLAGE CLEANERS**  
**SITE NUMBER: V00220**  
**290 BAYVILLE AVENUE**  
**BAYVILLE, NASSAU COUNTY, NEW YORK 11709**

**Periodic Review Report**

CASHIN TECHNICAL SERVICES, INC.  
1200 VETERANS MEMORIAL HIGHWAY  
HAUPPAUGE, NEW YORK 11788  
(631) 348-7600

**Revised September 26, 2025**

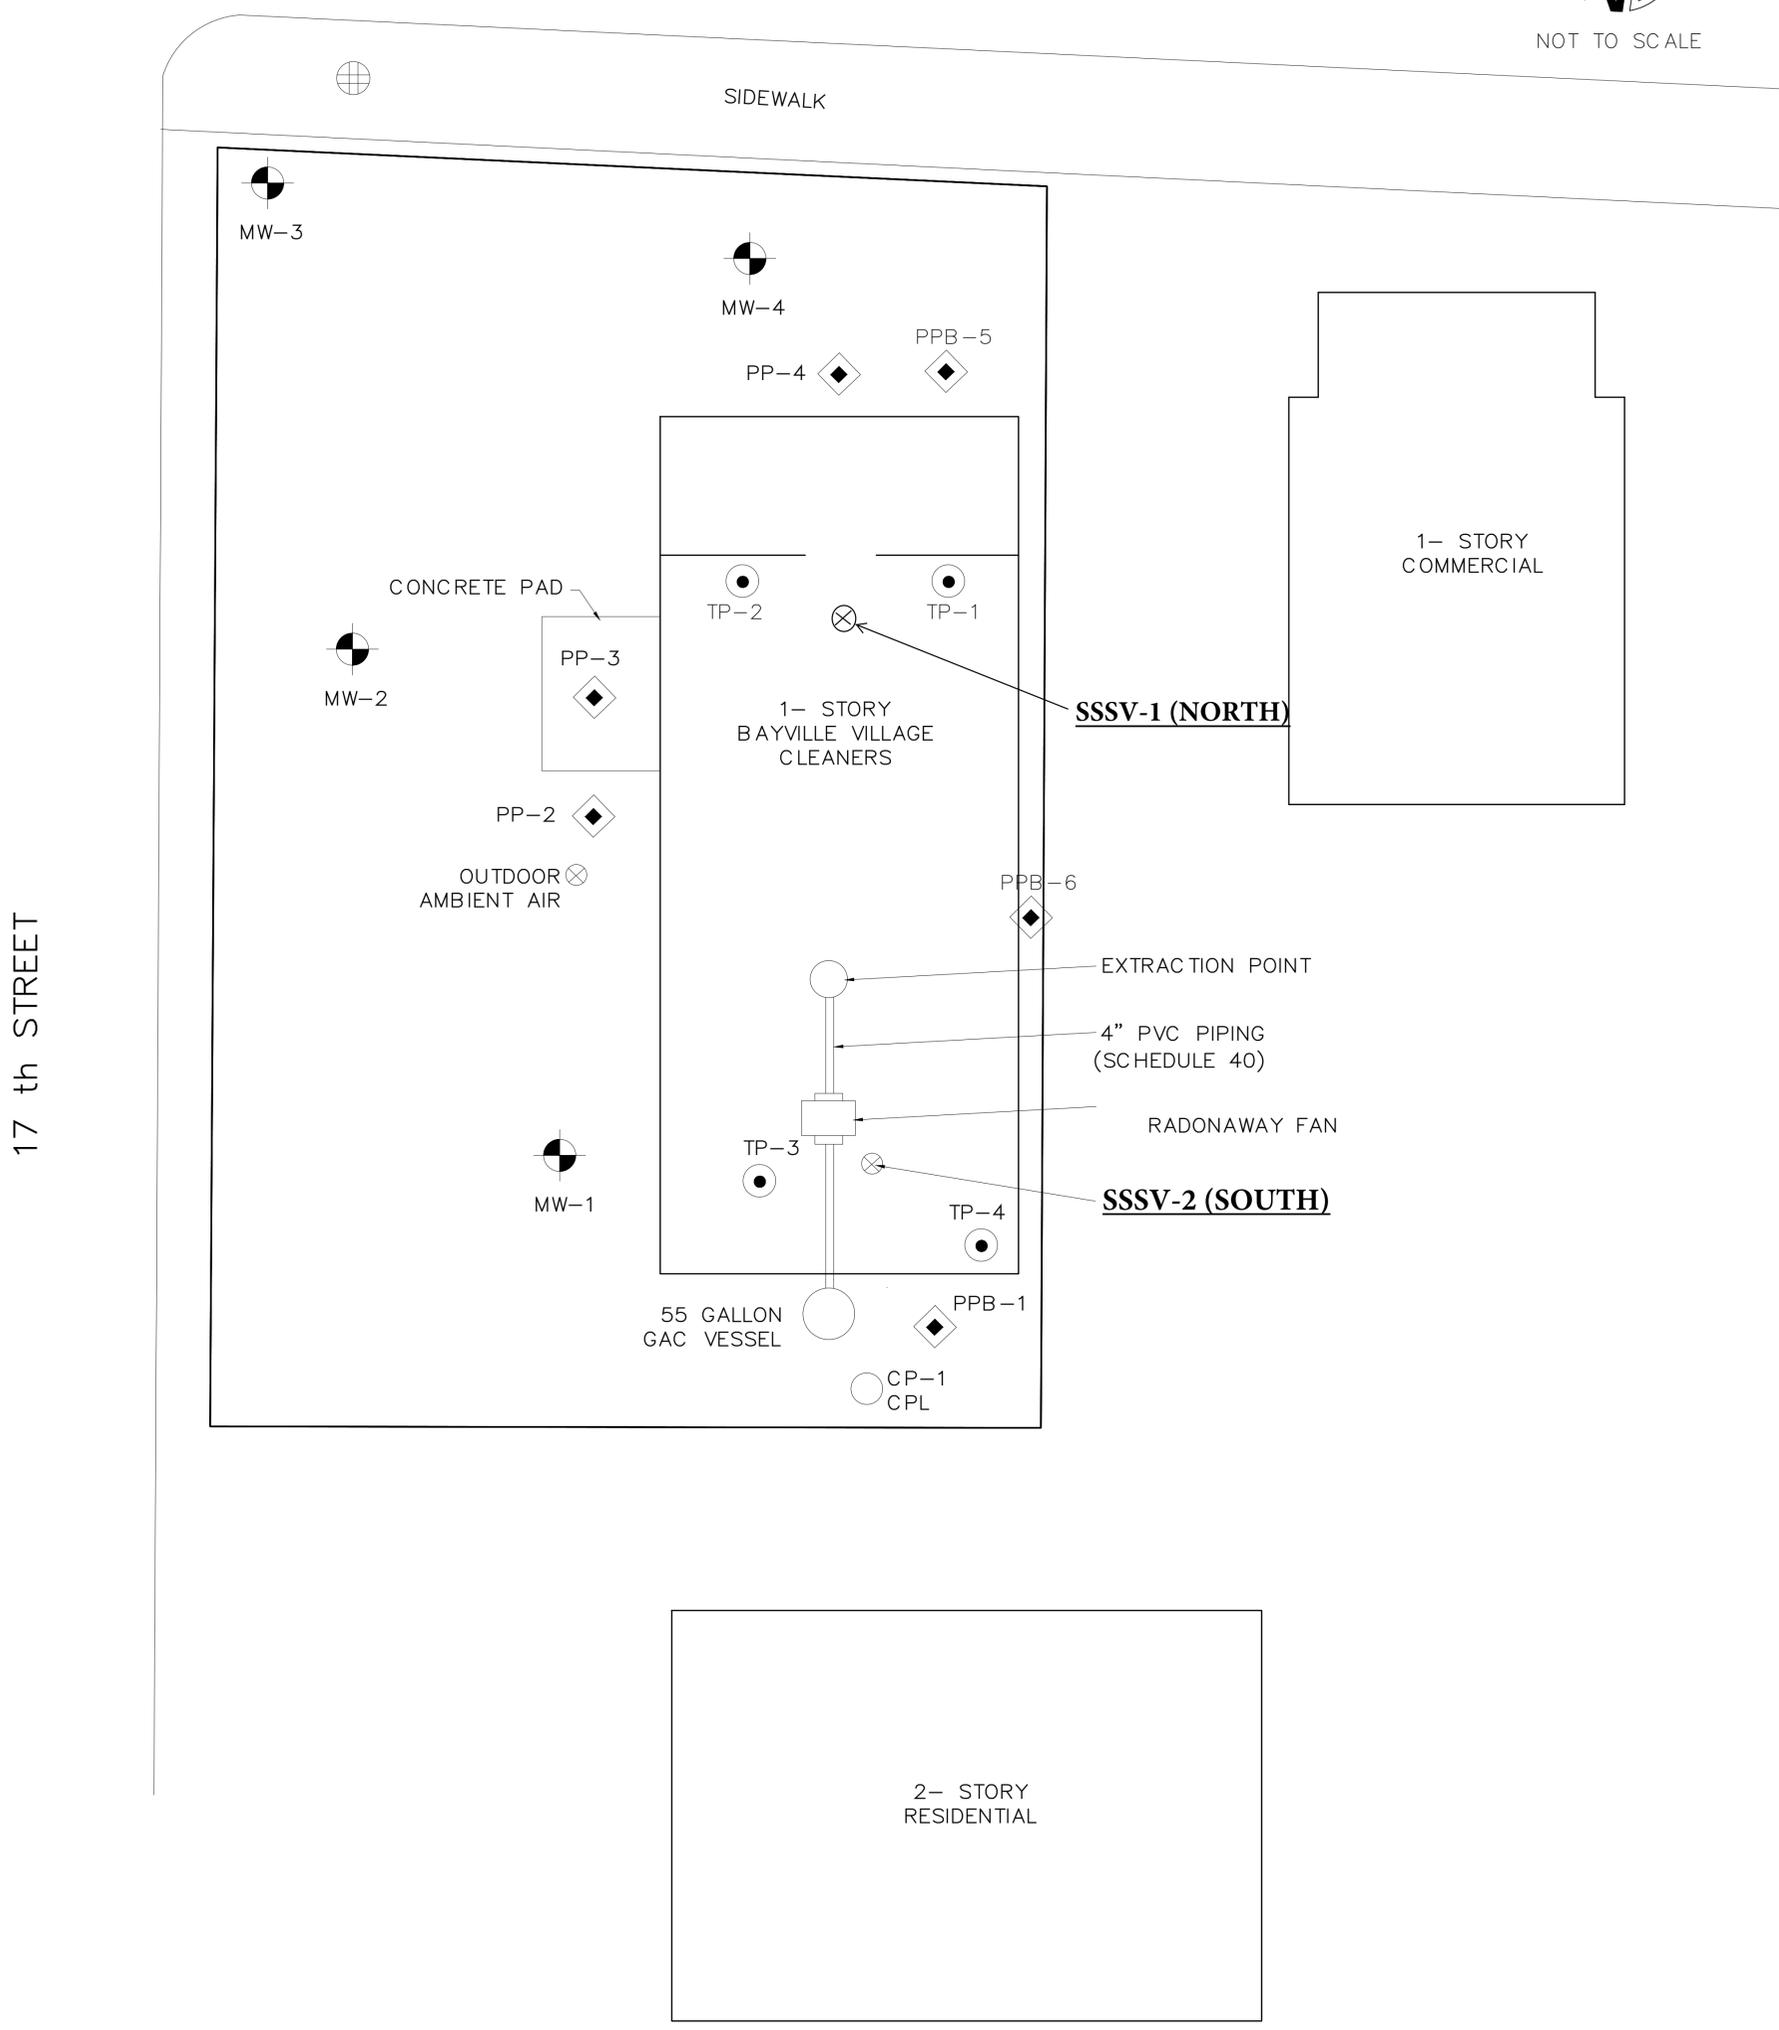
Figure 1 – Site Sampling Sketch

- VACUUM TEST POINT
- MONITORING WELL
- PERMANANT SOIL GAS SAMPLING POINT
- STORM DRAIN
- CESSPOOL
- SSSV / INDOOR AIR SAMPLING POINTS

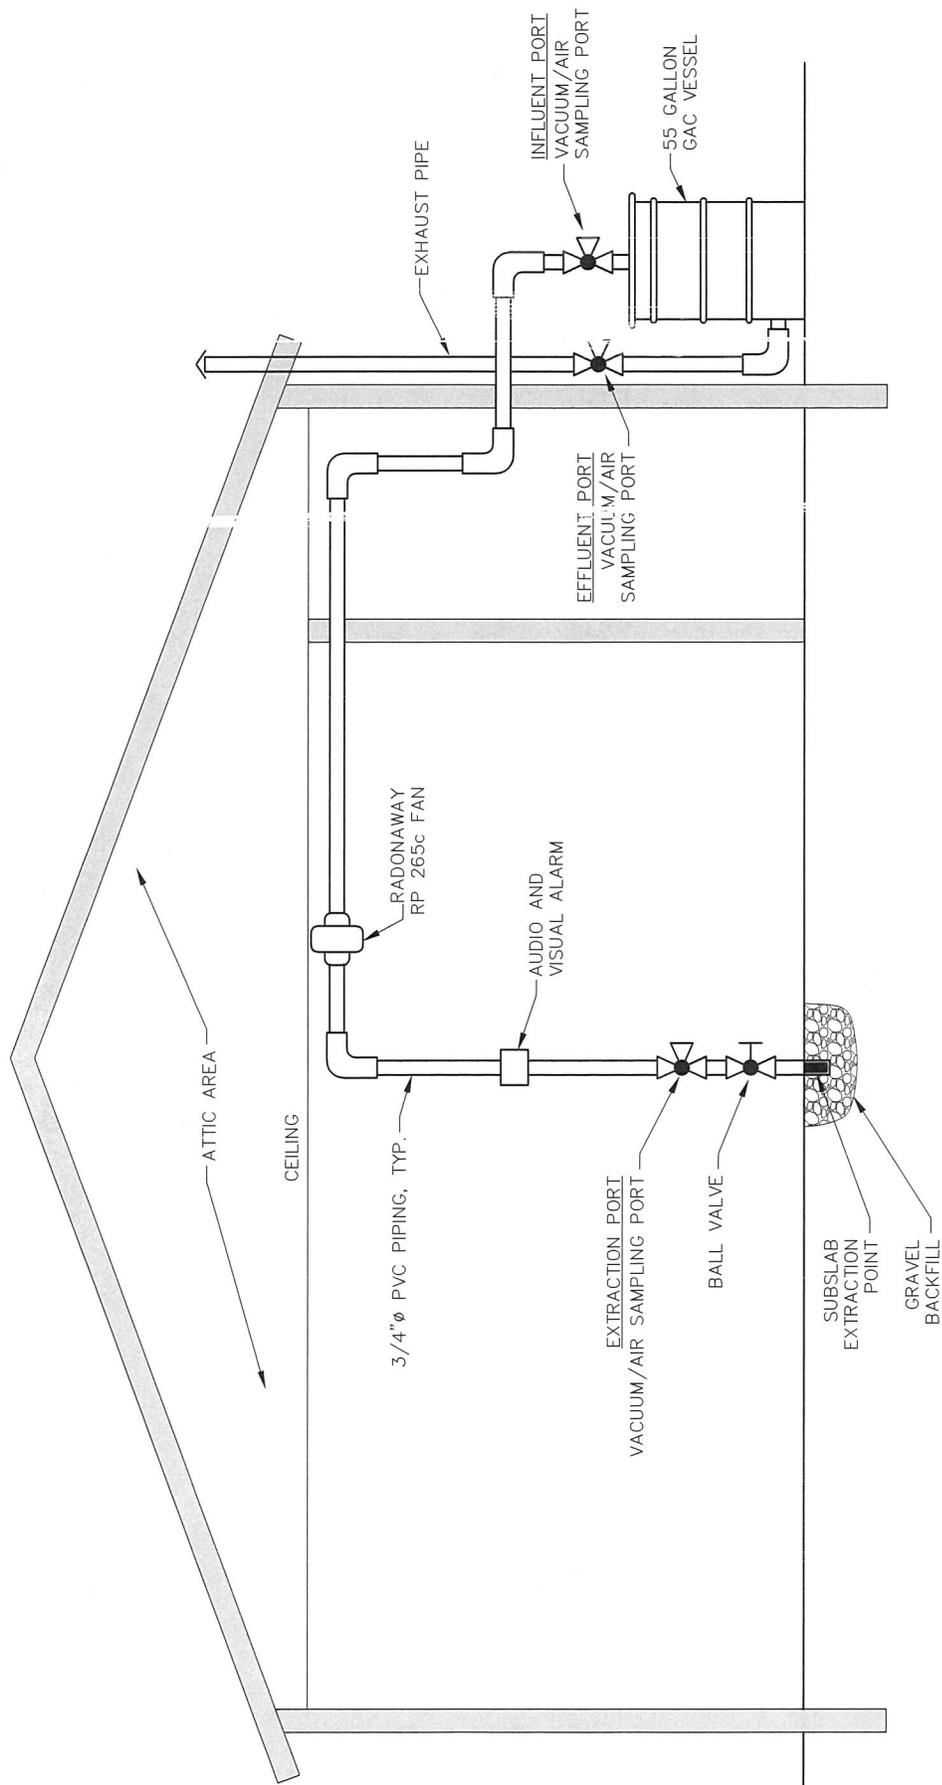
FIGURE 2

SSDS SITE SAMPLING SKETCH

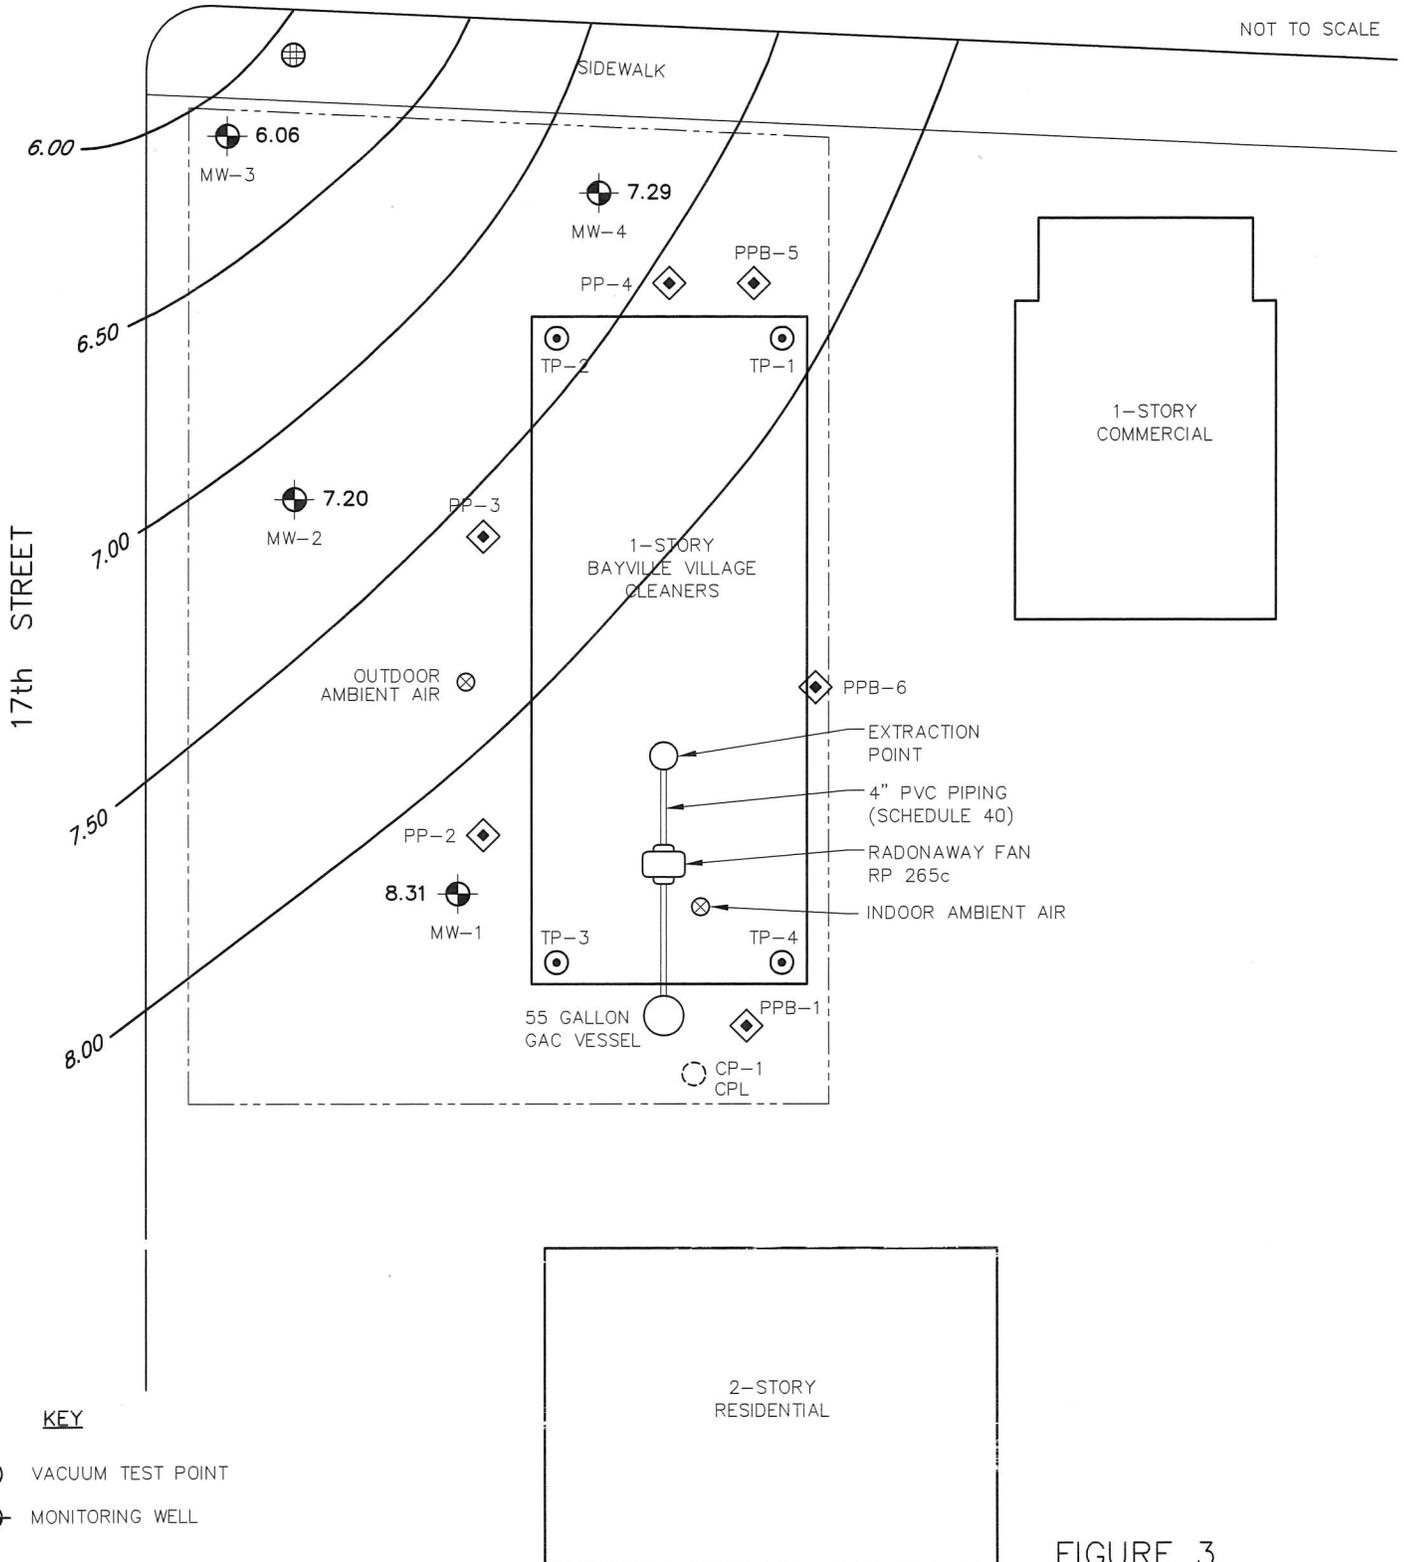
- VACUUM TEST POINT
- MONITORING WELL
- PERMANENT SOIL GAS SAMPLING POINT
- STORM DRAIN
- CESSPOOL
- AMBIENT AIR SAMPLING POINT
