FINAL ENGINEERING REPORT
VCA SITE V00223-6

575 East Mill Street
City of Little Falls
Herkimer County, New York

September 2003

BUCK ENGINEERING

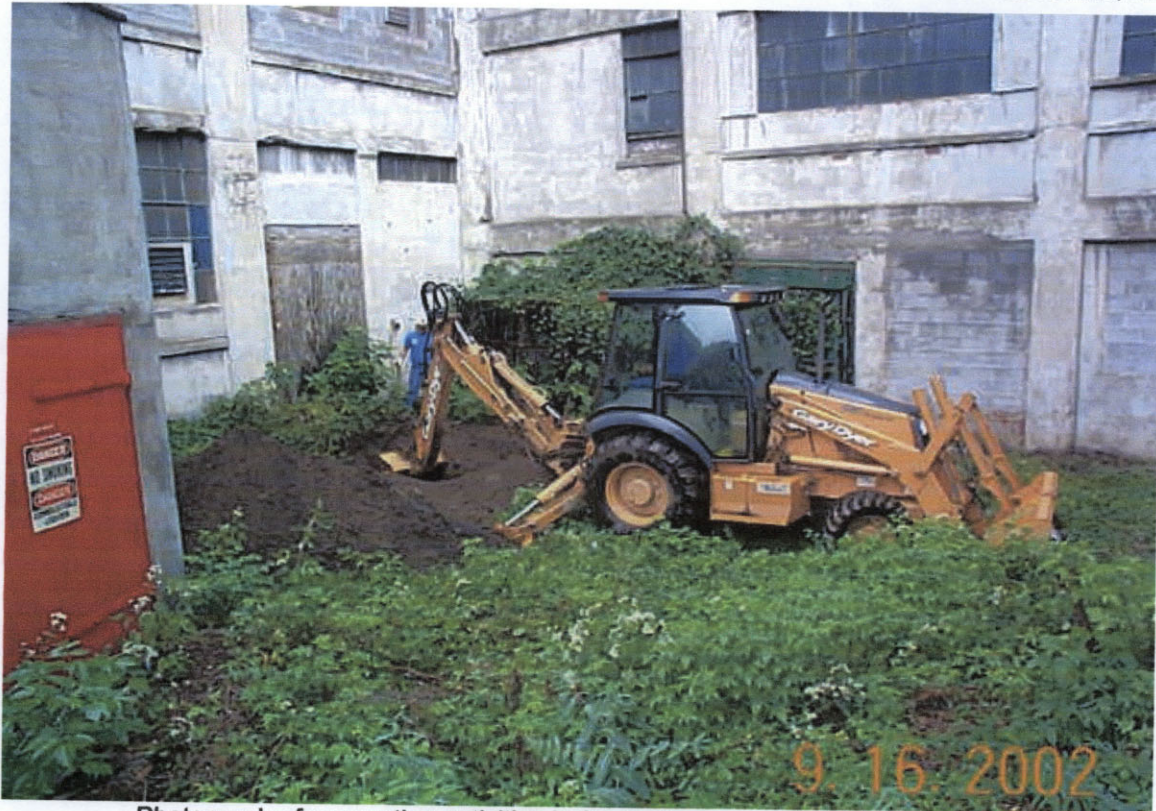
Photograph of excavation activities in former tannery area of SPX property.

The excavation activities, which extended approximately 4.5 feet below grade to bedrock, uncovered a relatively small amount of tar-like material overlaid with fill material. The tar-like material was generally less than two inches thick over an area approximately 20 sf in size and was lying directly on the bedrock. A photoionization detector was used to determine if volatile hydrocarbons were present in the soil, and readings were consistently less than 1 ppm. The tar-like material, which was characteristically black and easily identifiable against the surrounding fill material, was subsequently excavated by backhoe and shovel and drummed for later off-site disposal. One 55-gallon drum of contaminated soil was removed from the site by Safety Kleen on November 5, 2002 and disposed of at a landfill facility in Smithfield, Kentucky. Because the contaminated material in the excavation was lying on uneven bedrock and had a somewhat sticky texture, a small amount of the material could not be removed from the various minute bedrock crevices and some staining was observed on the bedrock. Mr. Philip Waite, P.E. was present and determined by visual observation that as much material as was practicable was removed from the excavation. Soil samples were obtained for laboratory analysis from the south and north sidewalls of the excavation, approximately 2" off bedrock (SS#1 and SS#2, respectively).

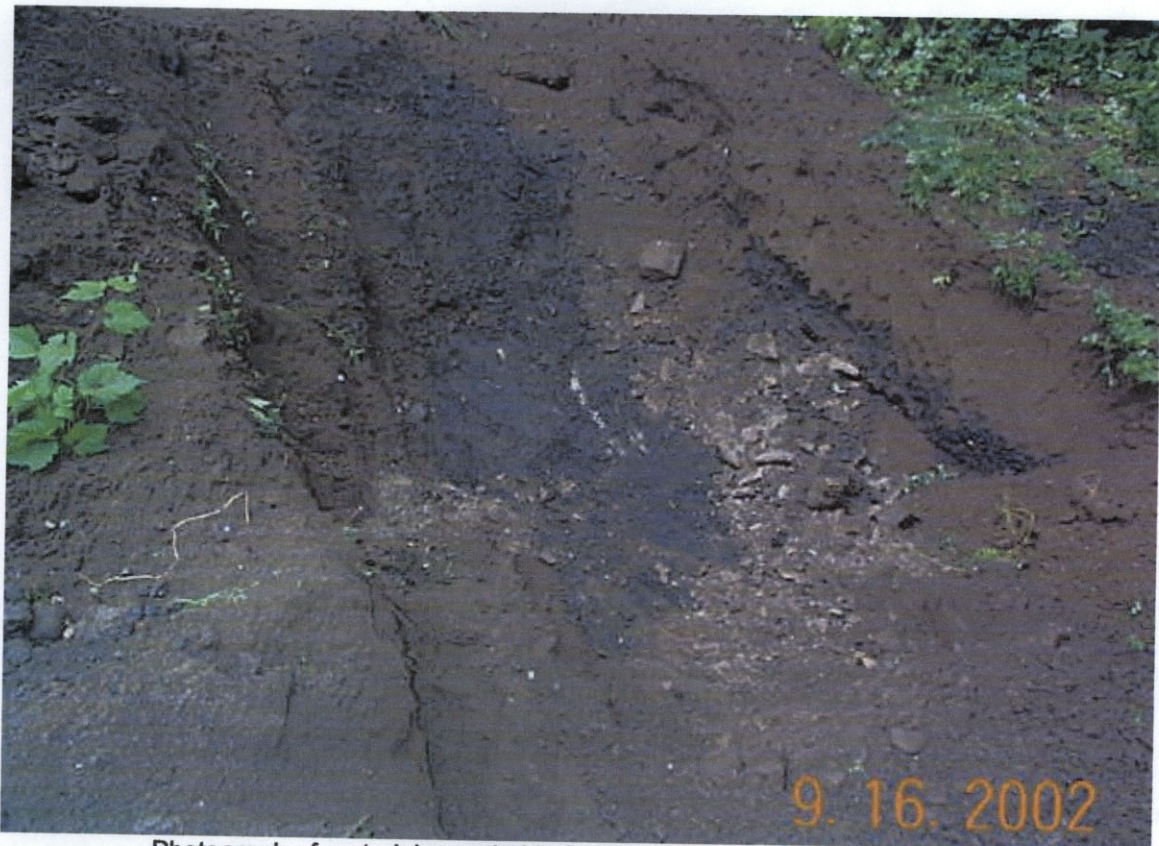
Photograph of material sampled in former tannery area of SPX property.

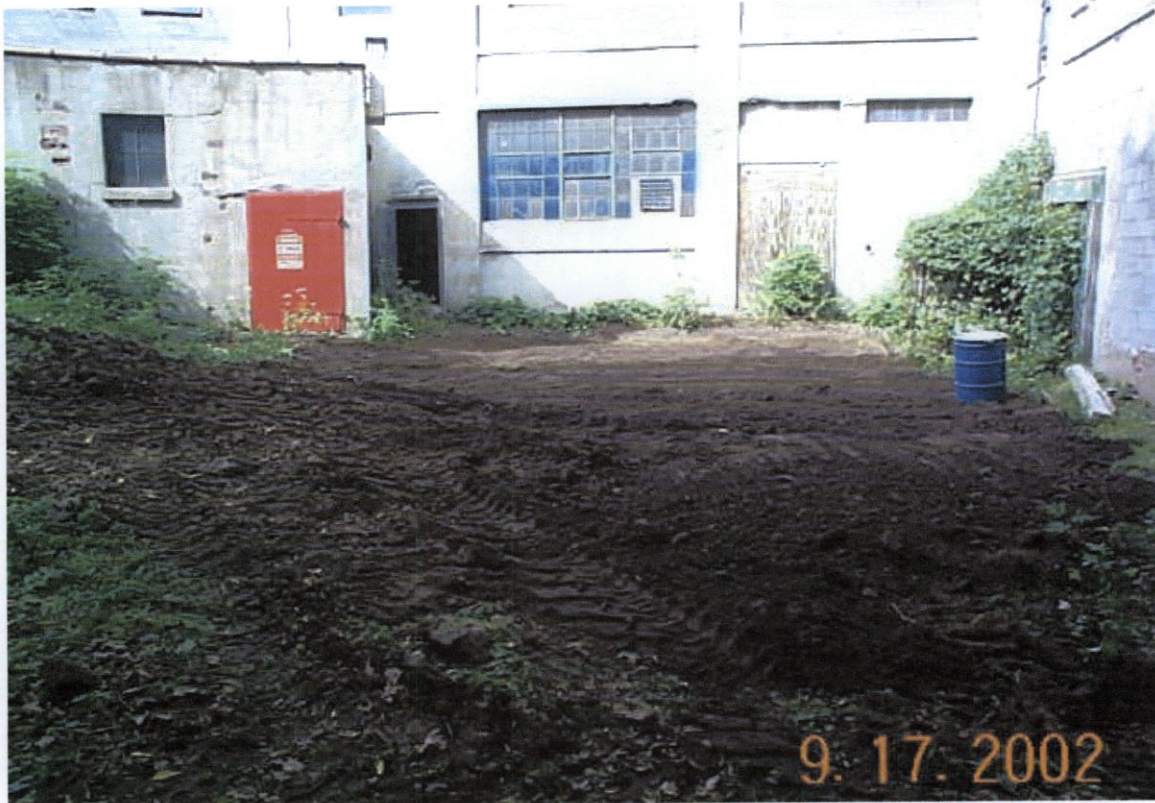
Photograph of former tannery area on SPX property; post-excitation.

After obtaining the two soil samples, the excavation was backfilled and the area was re-graded.

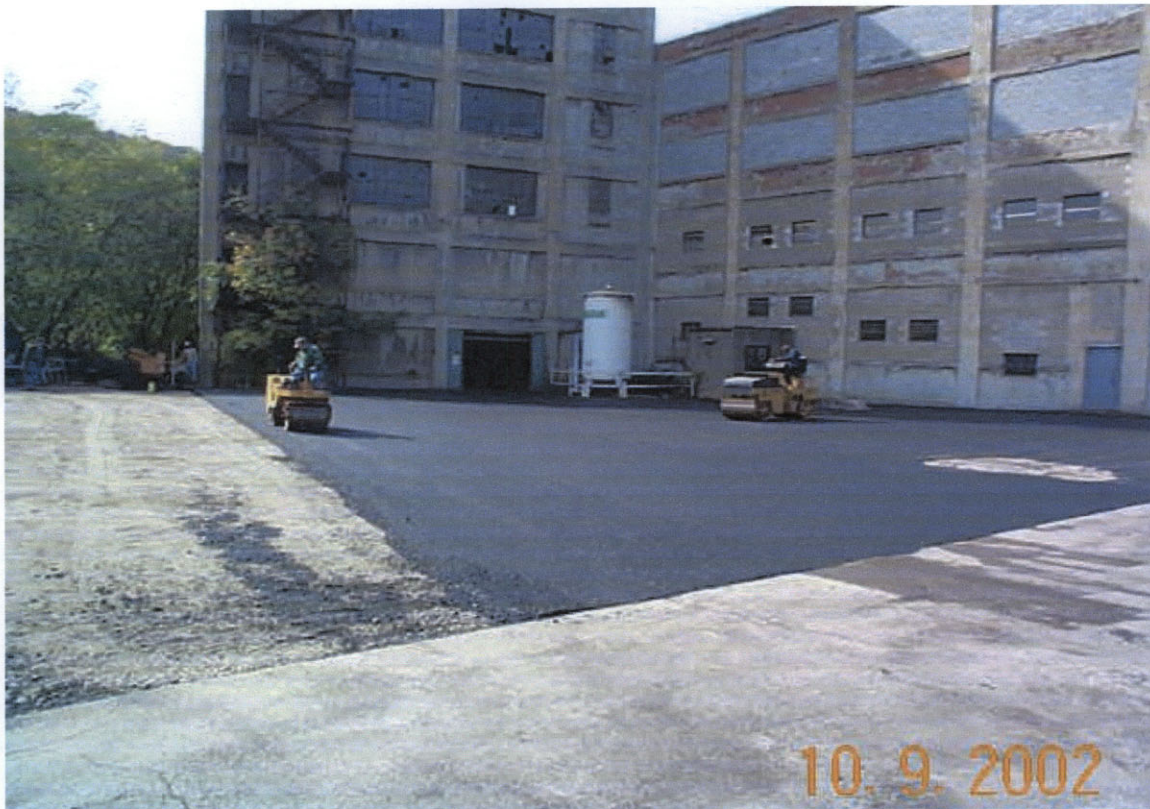
Photograph of paving activities in northeast portion of SPX property
over chromium-contaminated soils.

The prior investigative activities performed in this portion of the property identified Chromium in the surface soils in the driveway north of the unused 7-story tannery structure. One sample from TP-3-1 had measurable hexavalent chromium. The Chromium is likely to have originated from the former tannery operations, which concluded at the site more than 80 years ago. Because of the material's age, the absence of a further contaminant source, and absence of off-site contaminant migration, a asphalt cap was designed. After grading the area on October 7, 2002, Tri-County Paving performed the paving operations over the Chromium contaminated area on October 9, 2002. Approximately 3 inches of asphalt was placed and compacted over an area encompassing more than 3,000 SF in the northeast portion of the subject property (former tannery area). The area that was asphalt-paved for remediation purposes is shown on the map included in an appendix. Upon completion of the remediation paving activities, the remainder of the parking area (encompassing nearly 10,000 SF) was paved. These activities were visually confirmed by Buck Engineering, LLC. Photographs of the asphalt-paving activities have been included in an appendix.

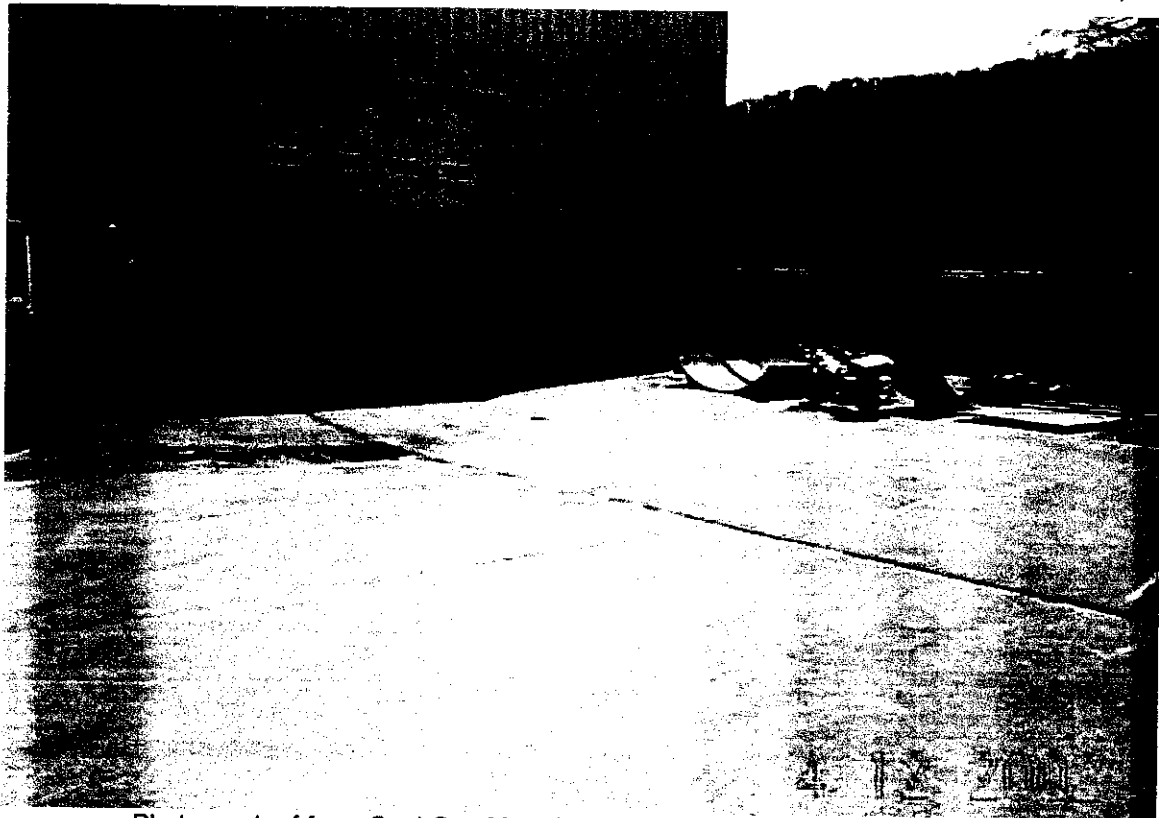
Photograph of form Coal Gas Manufacturing area; pre-excavation activities.

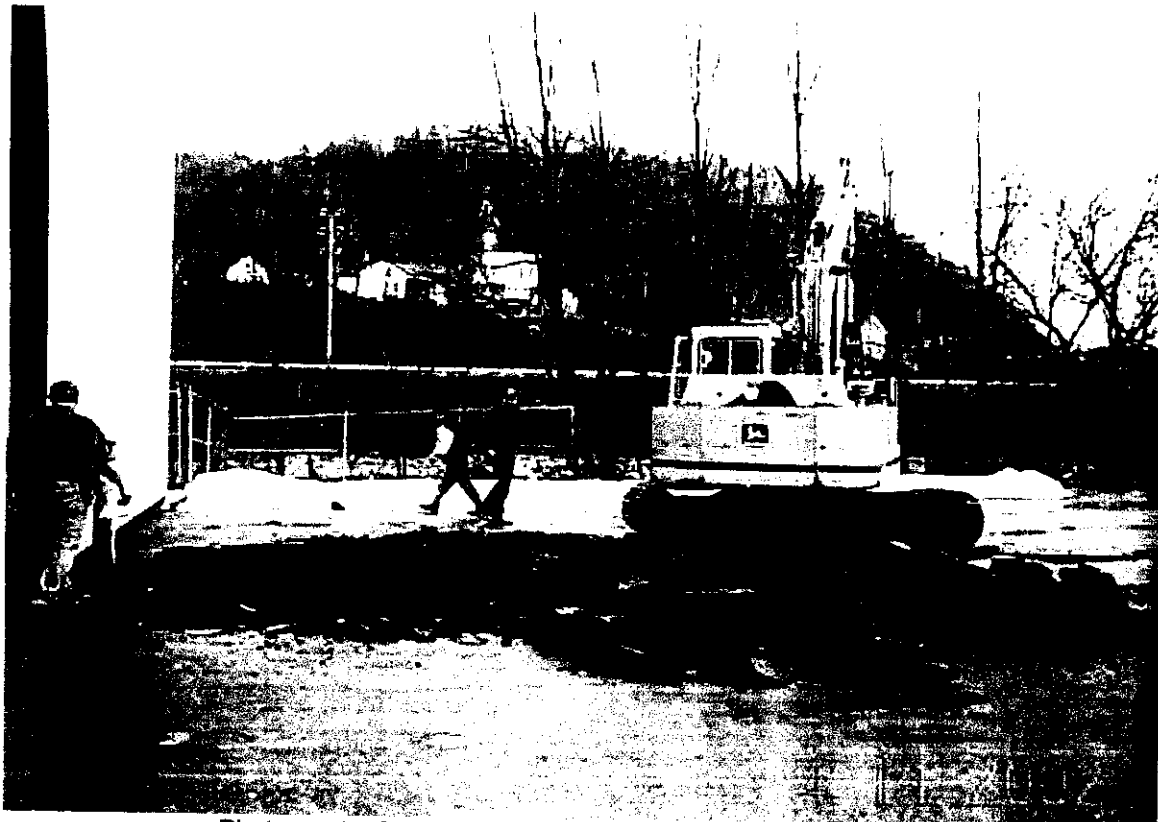
Photograph of pavement broken up by excavation contractor.

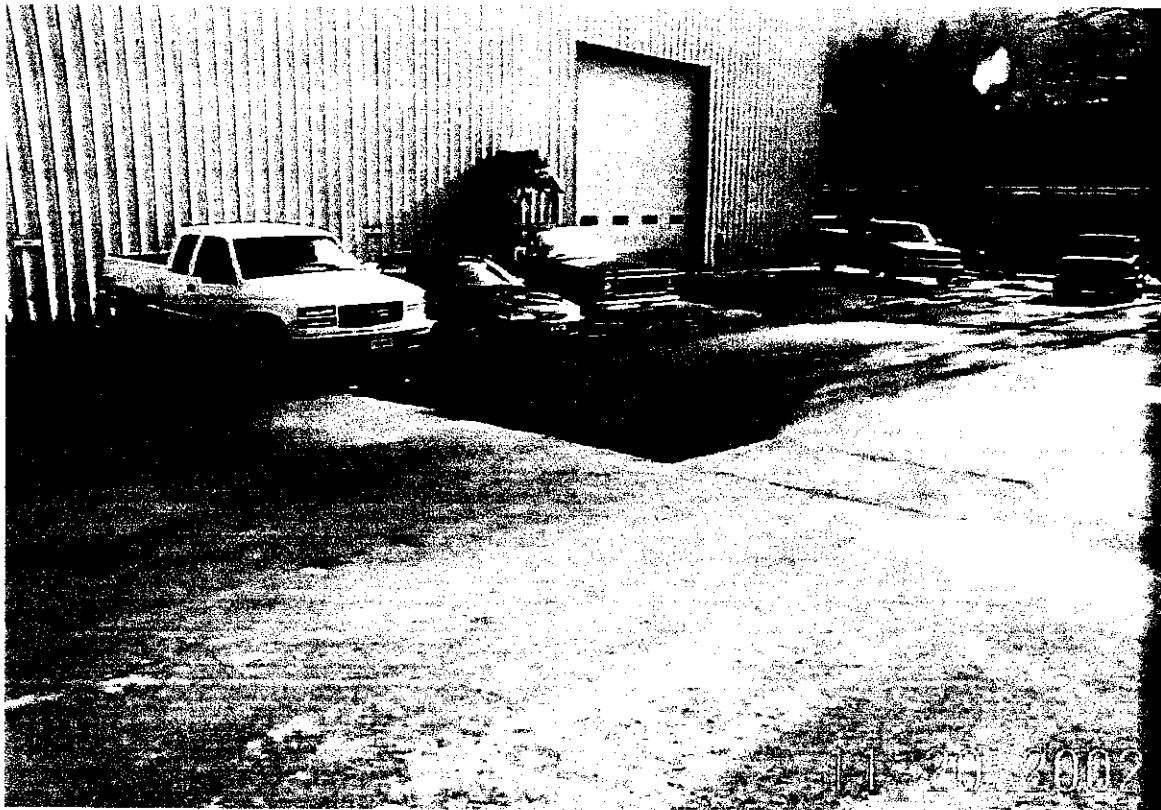
Photograph of completed post-excavation paving in former coal gas manufacturing location.

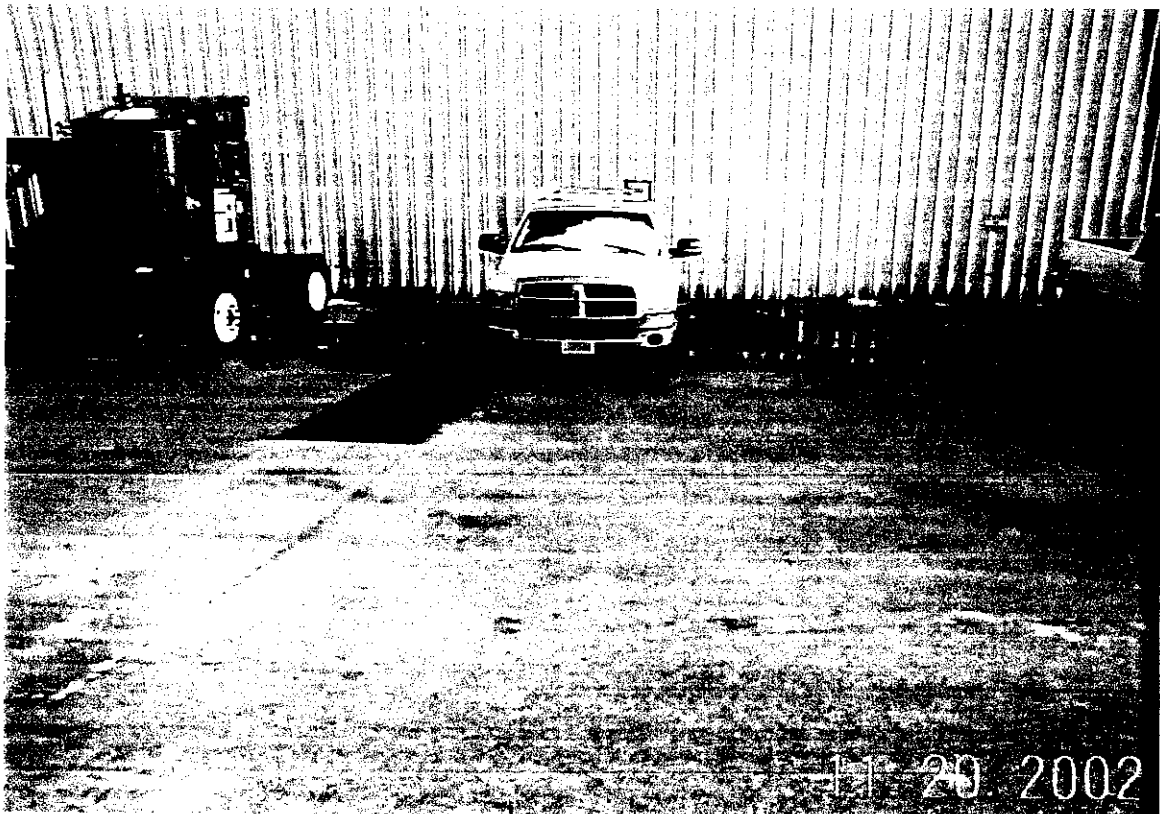
Photograph of completed paving over northernmost trench in former coal gas manufacturing area.

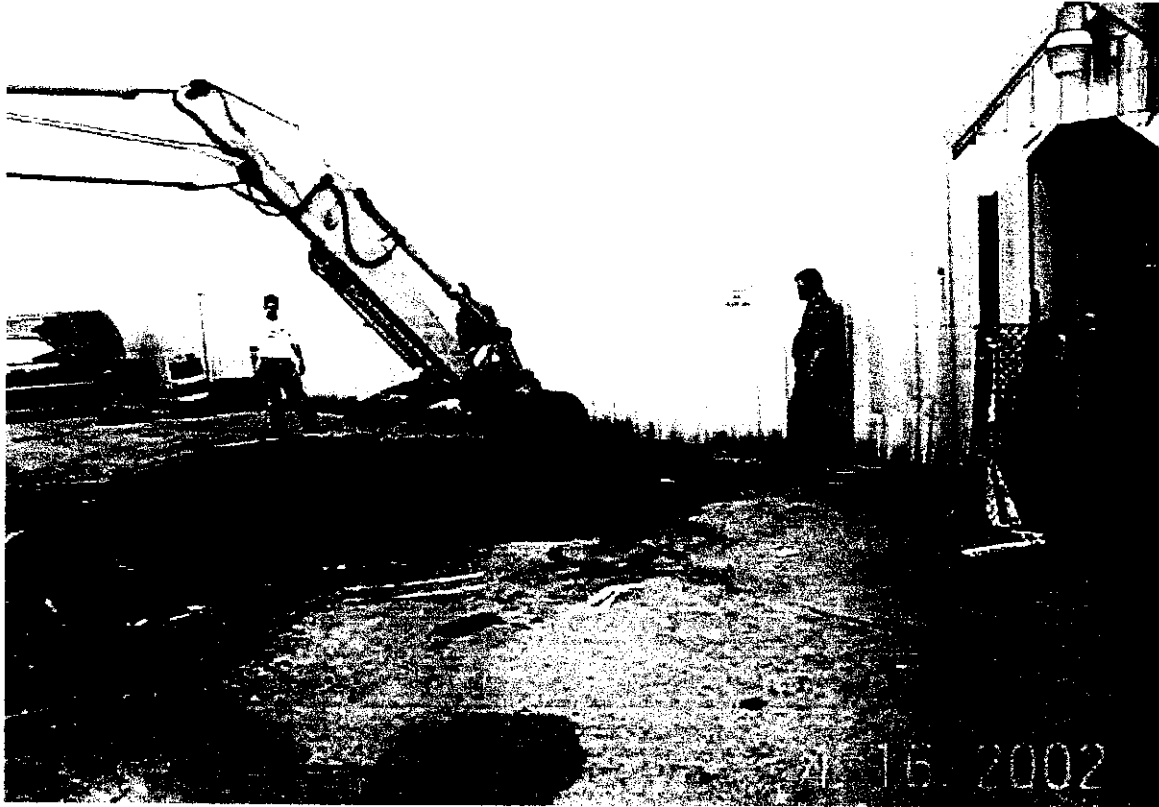
Photograph of second trench north of gasometer excavation.
