REMIEDIAIL WORK PLAN

New York State Department of Environmental Conservation VOLUNTARY CLEANUP PROGRAM

101,105, 107 WEST STREET BROOKLYN, NEW YORK

JULY 1999

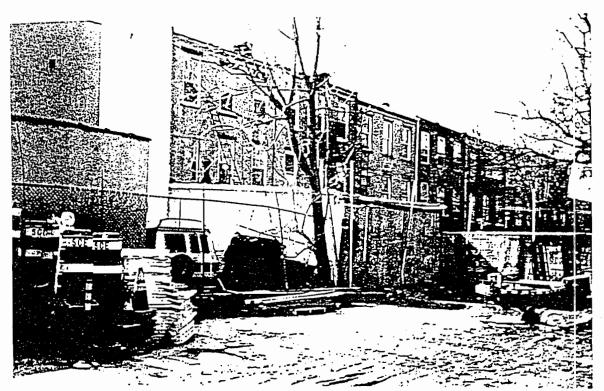
Photo 5: View of the south side of the storage area showing construction materials and traffic cones and barricades. Note the apartments in the second and third floors of the adjacent buildings. The first floors are occupied by stores.

Photo 6: View of the north side of the property showing pipes, other construction materials, and some debris.

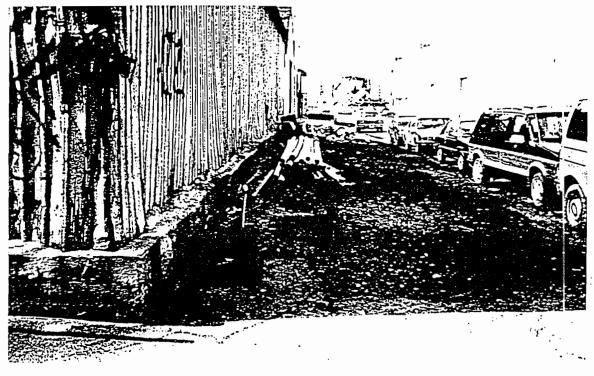
Photos 7 & 8: Views of the test pit excavation. The top layer is brown sand with a dark-stained layer at its base. The middle layer is brown sandy silt. Both layers are composed of fill material. The bottom layer, native material, is visible in the bottom of the excavation in photo 8.

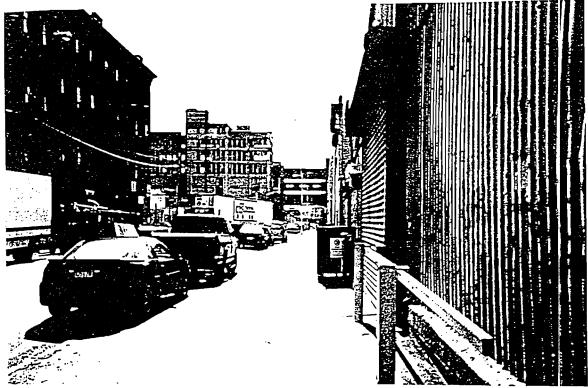
Photo 9: View looking south from the site along West Street. The neighborhood consists of warehouses.

Photo 10: View looking north from the site along West Street. The neighborhood consists of warehouses.

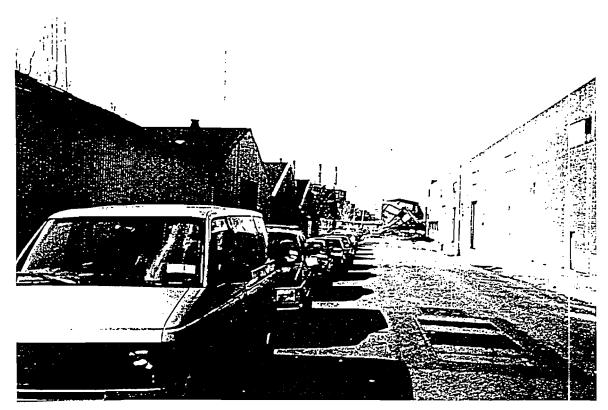
Photo 11: View from the site looking west along Kent Street. The neighborhood consists of warehouses. Note the catch basin in the center of the road.

Photo 12: View from the site looking east along Kent Street. The neighborhood consists of warehouses. Note catch basins at both corners and a sewer manhole in the road.
