**2014 Periodic Review Report**

**Hunts Point Food Distribution Center**  
**Operable Unit One of Parcel A**  
Voluntary Cleanup Program Site No. V00233

New York City  
Economic Development  
Corporation

Henningson, Durham & Richardson Architecture and Engineering, P.C.  
1 International Boulevard- 10<sup>th</sup> Floor, Mahwah, New Jersey 07495

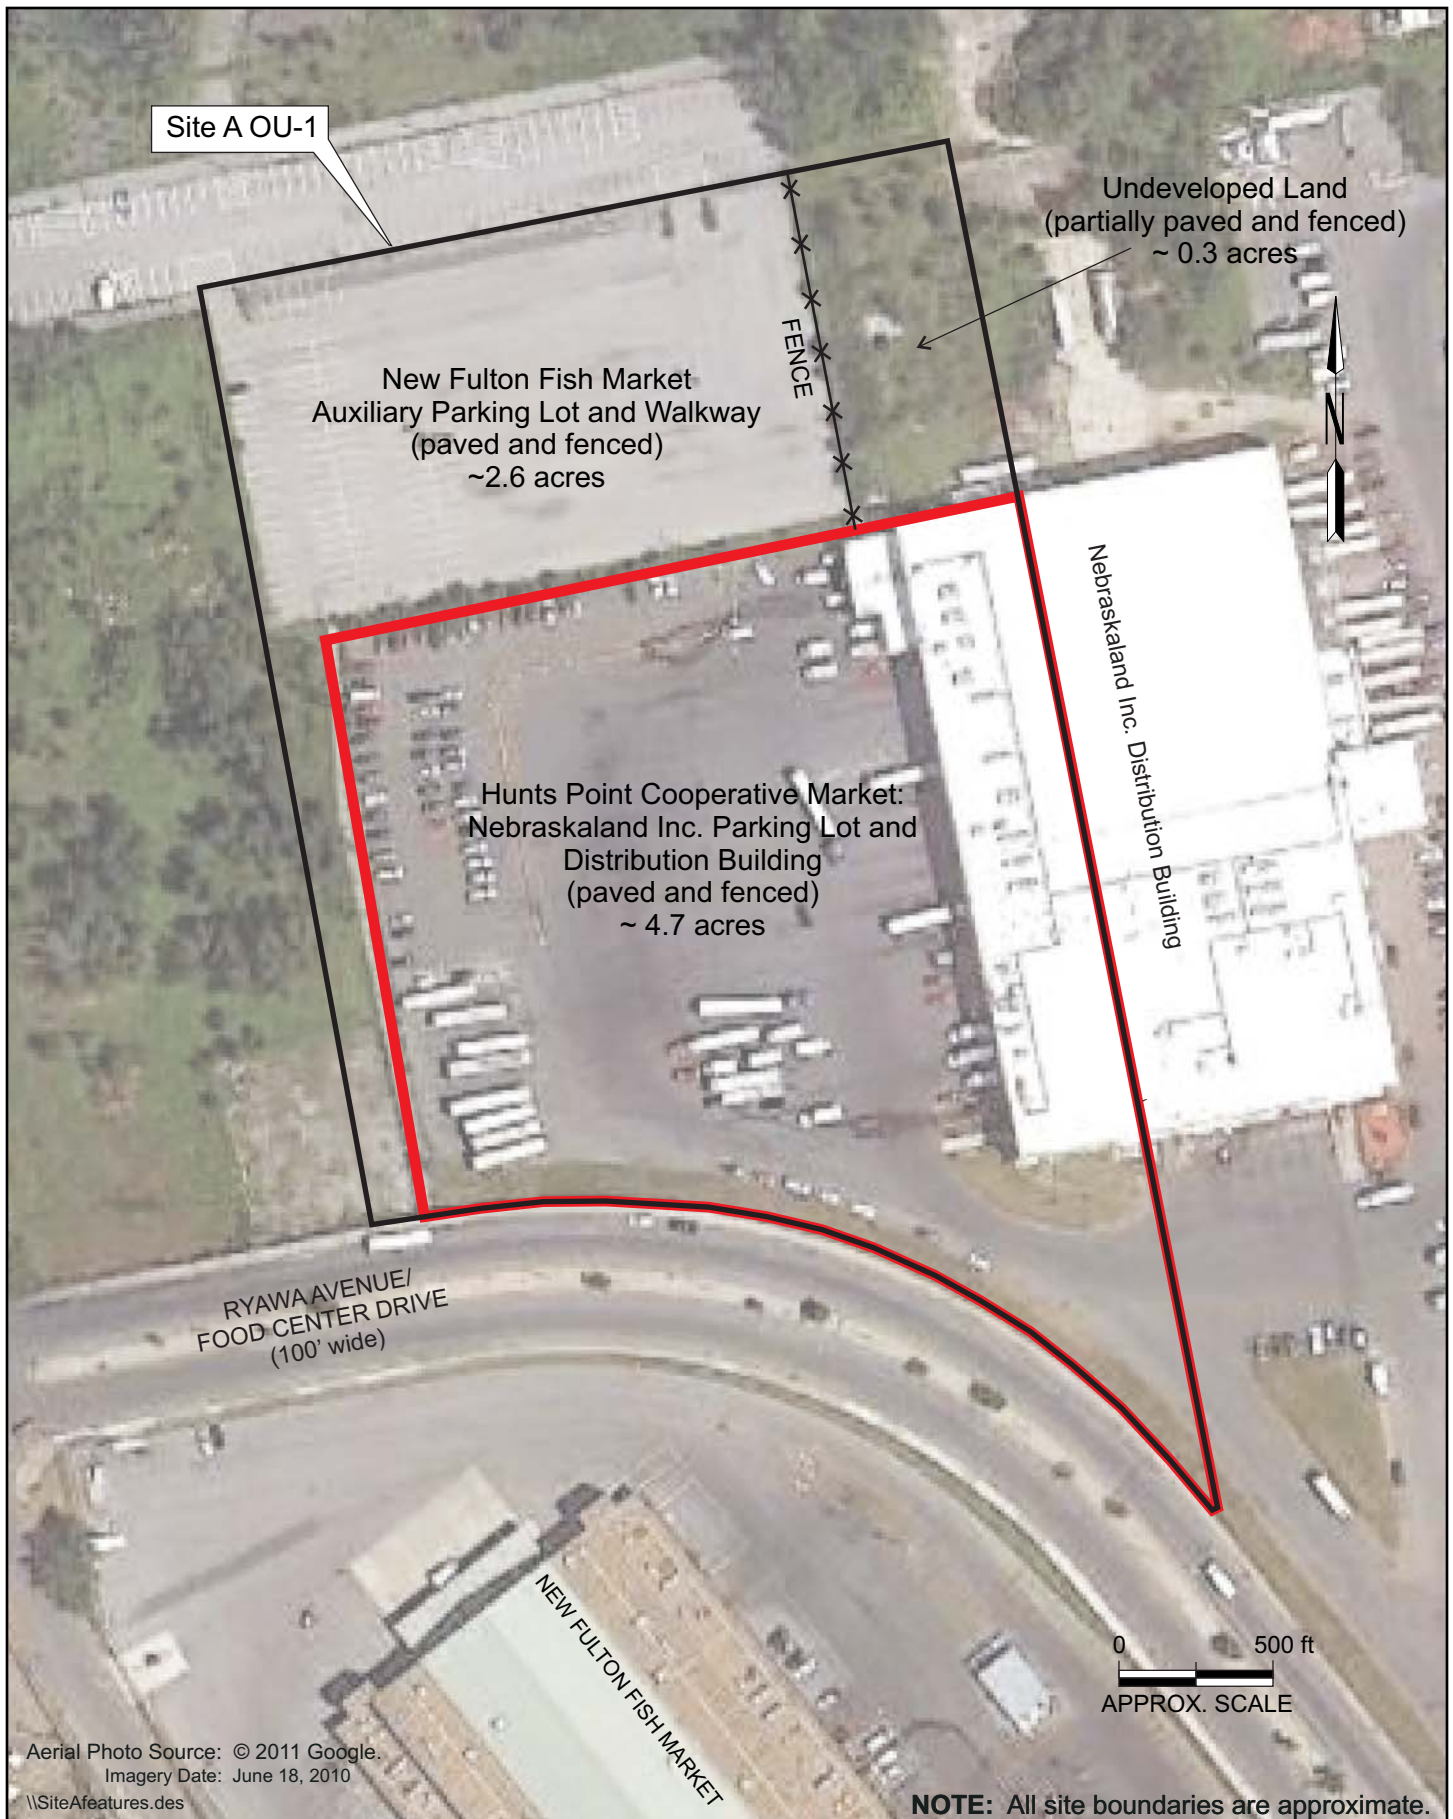
Figure  
2

Site A OU-1 consists of 7.65 acres of land that is currently fenced on the south, east and west sides of the property. The northern perimeter of the property is open to the gated and locked Halleck Street entrance of the New Fulton Fish Market Employee Parking lot. Site A OU-1 has been divided into two parcels used by different Hunts Point Distribution Center (HPFDC) tenants, The Hunts Point Cooperative Market Inc. (Nebraskaland) and the New Fulton Fish Market (Fish Market). The Nebraskaland portion of the Site (approximately 5.0 acres) includes part of the distribution building, a truck and employee parking lot and a vegetated portion measuring approximately 0.3 acres in size that remains unused and undeveloped (refer to Figure 2). The Fish Market portion of the Site

### Site A OU-1 Features

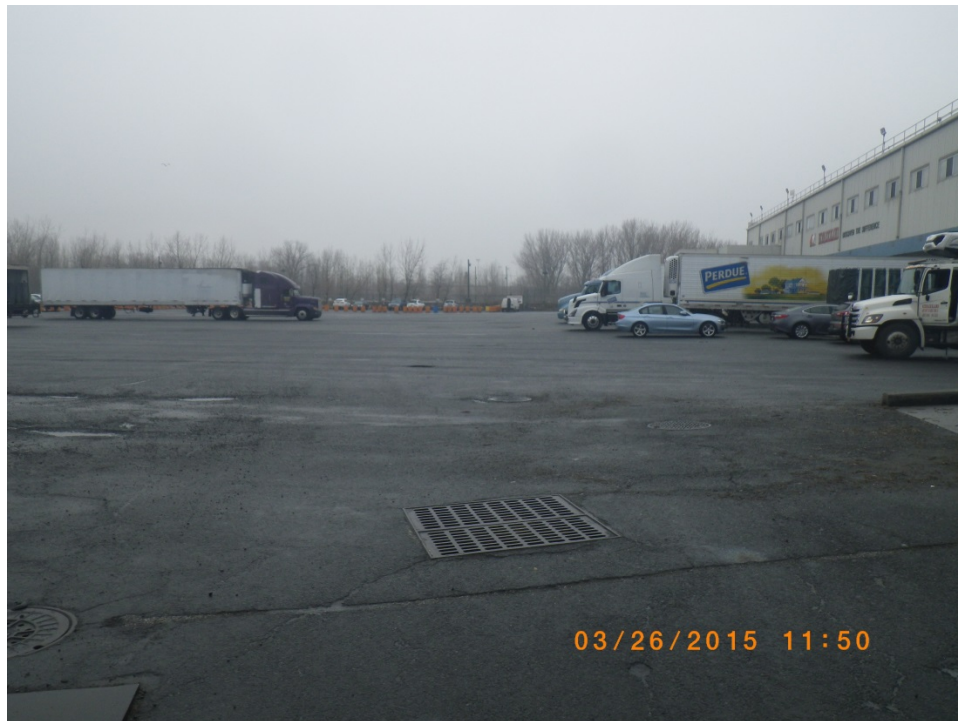
Photograph 1 – NebraskaLand truck staging area eastern portion of A-OU1 (looking north)

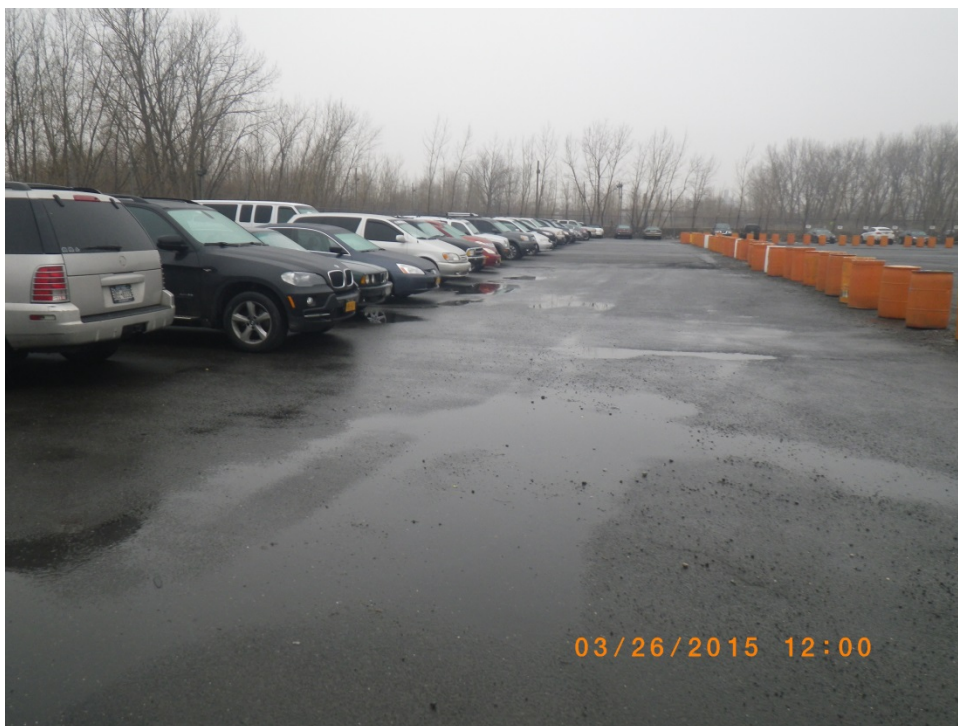
Several areas of the Nebraskaland parking lot require patching, although the holes did not extend through the binder course and no breaches of the asphalt cap were noted. As per Mr. Hill, Nebraskaland will solicit repair bids the week of March 30, 2015. It is anticipated the asphalt patching will be completed shortly after securing a contractor to perform repairs. Appendix A – Photograph Log, portrays the Hunts Point Cooperative Market, Inc. portion of Site A OU-1.

Photograph 2 – NebraskaLand Employee parking area, western portion of A-OU1 (looking north)

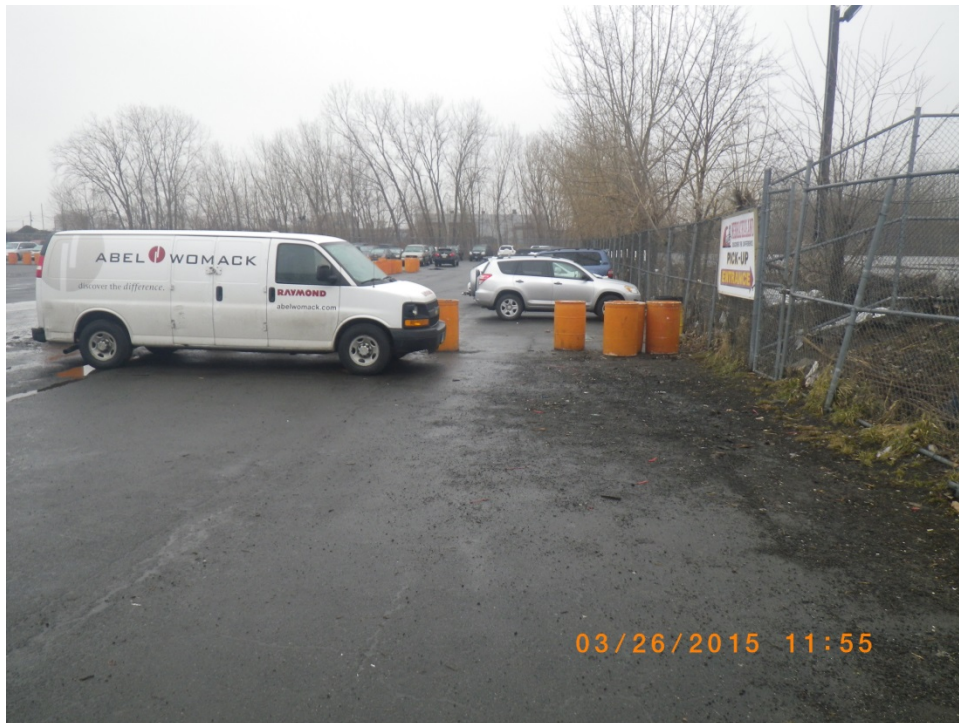
Photograph 3 – Undeveloped Strip between Fish Market parking Lot and Nebraskaland Parking Lot (looking west)

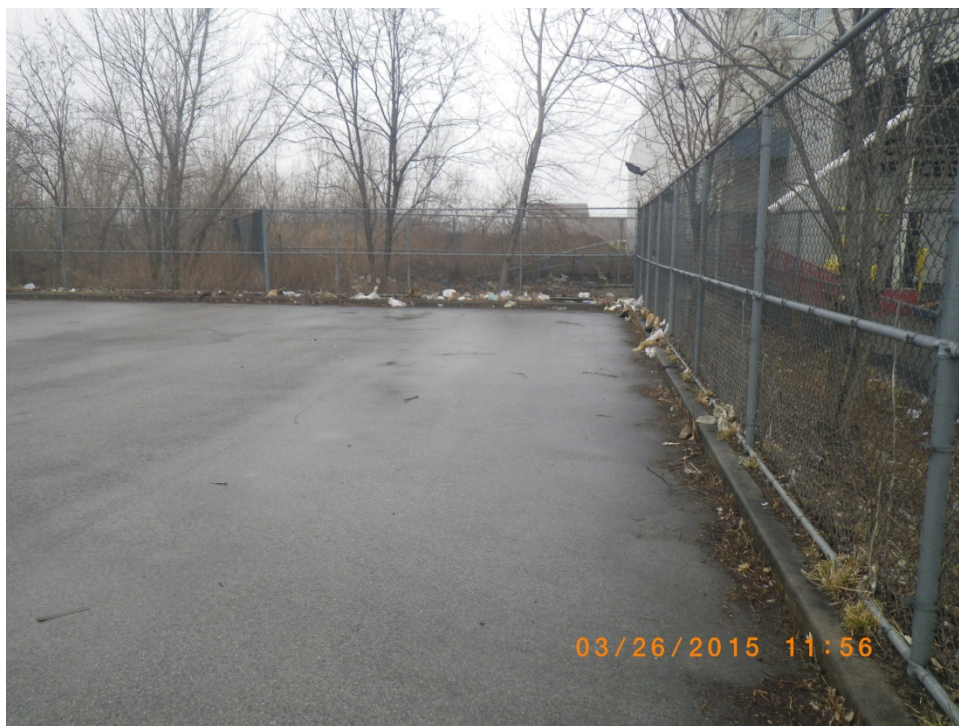
The 0.3 acres in the northeastern corner of the Site remains undeveloped. This undeveloped area is vegetated and totally enclosed with fencing. The Site fencing and vegetation prevent contact with the contamination present in the subsurface.

Photograph 4 – Undeveloped land to the northeast end of A-OU1 (looking east)

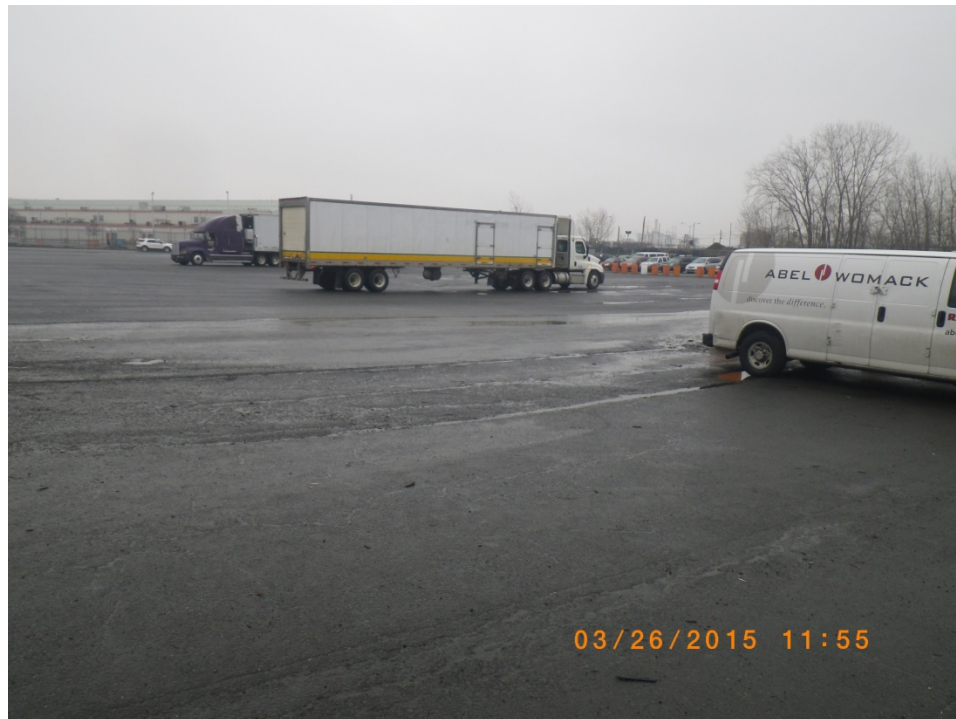
Photograph 5 – Nebraskaland leasehold (A-OU1, looking southwest)

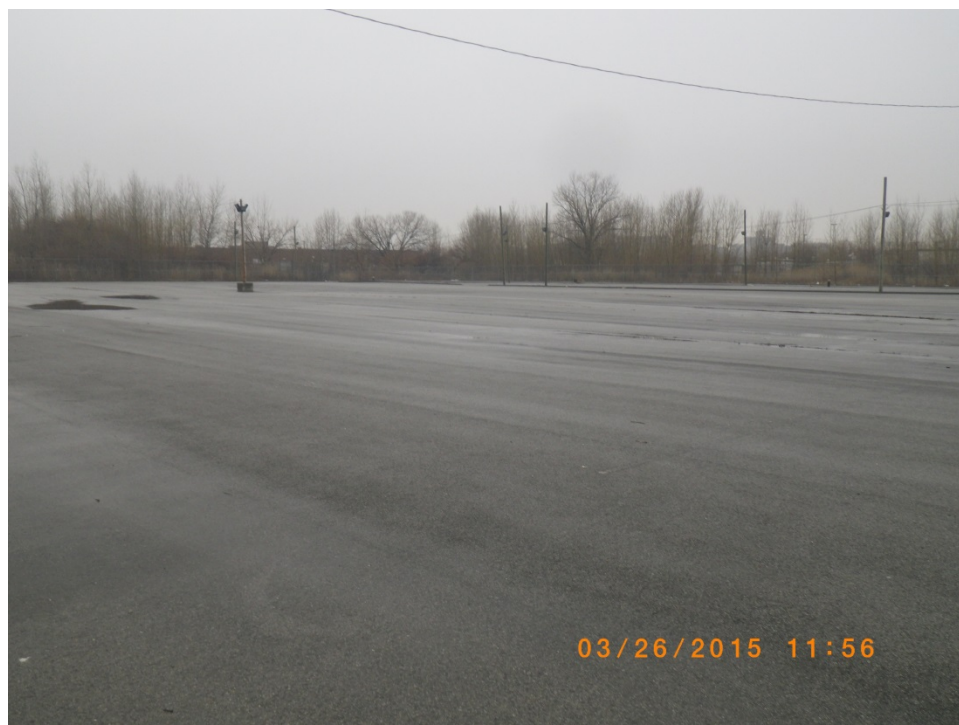
Next, HDR viewed the New Fulton Fish Market supplemental employee parking lot, which constitutes the northwestern portion of Site A OU-1. This portion of Site A OU-1 is completely surrounded by chain-link cyclone fencing and access may only be gained under escort by NYCEDC or Fish Market security personnel. The parking lot was graded and paved during the spring of 2005 during the construction of the New Fulton Fish Market (Site B to the south). During previous construction of the supplemental employee parking lot, no material was exported from Site A OU-1. Imported material was confined to base gravel and asphalt for the parking surface. No vegetated landscaping exists on this portion of Site A OU-1 and the only existing utilities are overhead electric lines servicing the parking lot lighting. It is currently un-occupied.

Photograph 6 – New Fulton Fish Market employee parking portion of A-OU1 (looking northwest)

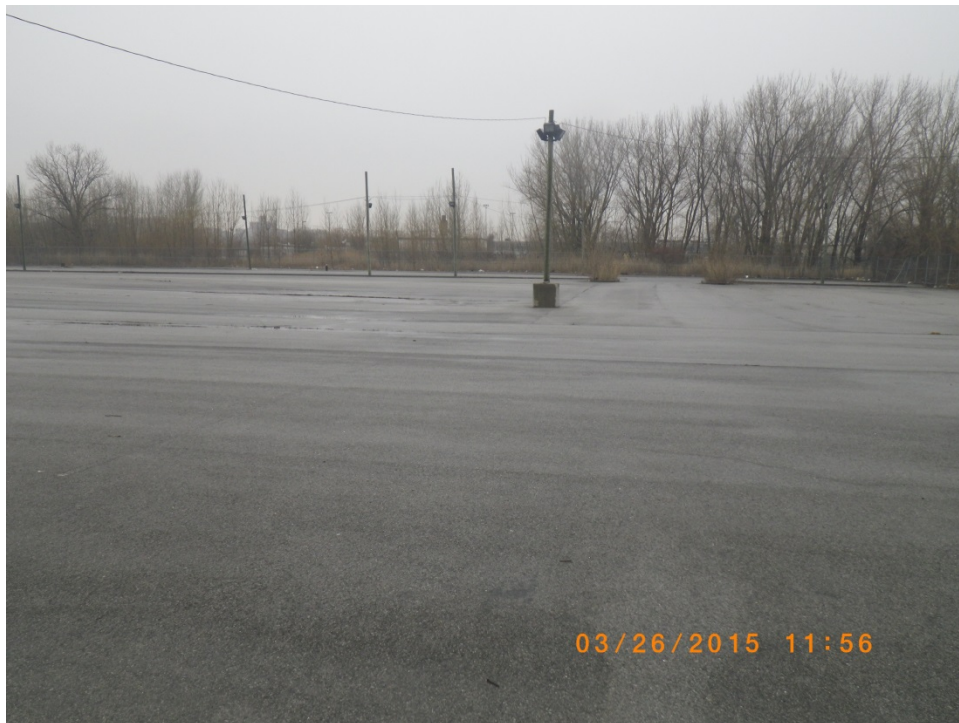
Photograph 7 – New Fulton Fish Market employee parking portion of A-OU1 (looking northeast)

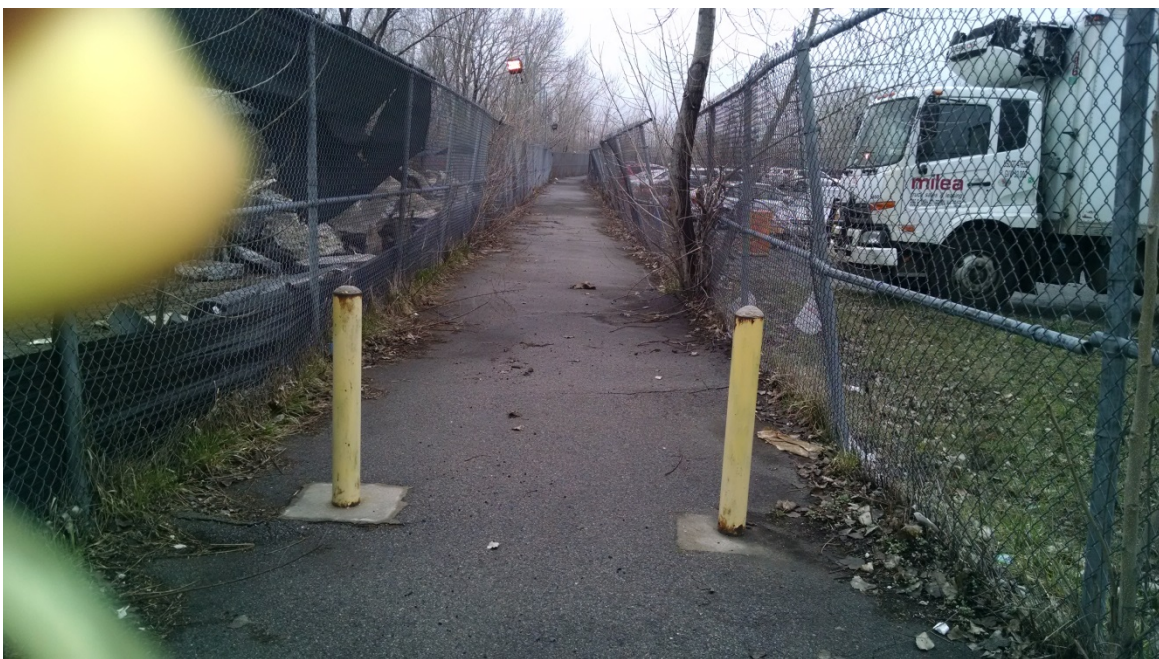
A small walkway was constructed along the western perimeter of Site A OU-1 to offer access to Fish Market employees from Food Center Drive. This walkway is between two chain link fences. Currently this lot is not used for any auxiliary employee parking. When the lot is not being used, the walkway entrance is gated and locked. No asphalt cuts were observed in the pavement of the Fish Market supplemental employee parking lot. Prior to the Site reconnaissance, HDR met with Eric Bryant, the Fish Market Maintenance Manager of the New Fulton Fish Market. As per Mr. Bryant, the New Fulton Fish Market has performed no intrusive activities within the bounds of Site A OU-1 within the past year.

Photograph 8 – New Fulton Fish Market employee parking walkway on A-OU1 (looking north)
