Hunts Point Cooperative Market Redevelopment Plan

Response Plan for the Operating Portion of Parcel A Bronx, New York

Response Plan for the Operating Unit Portion of Parcel A Bronx, NY

Prepared by: Lawler, Matusky &
Skelly Engineers LLP JULY 2000

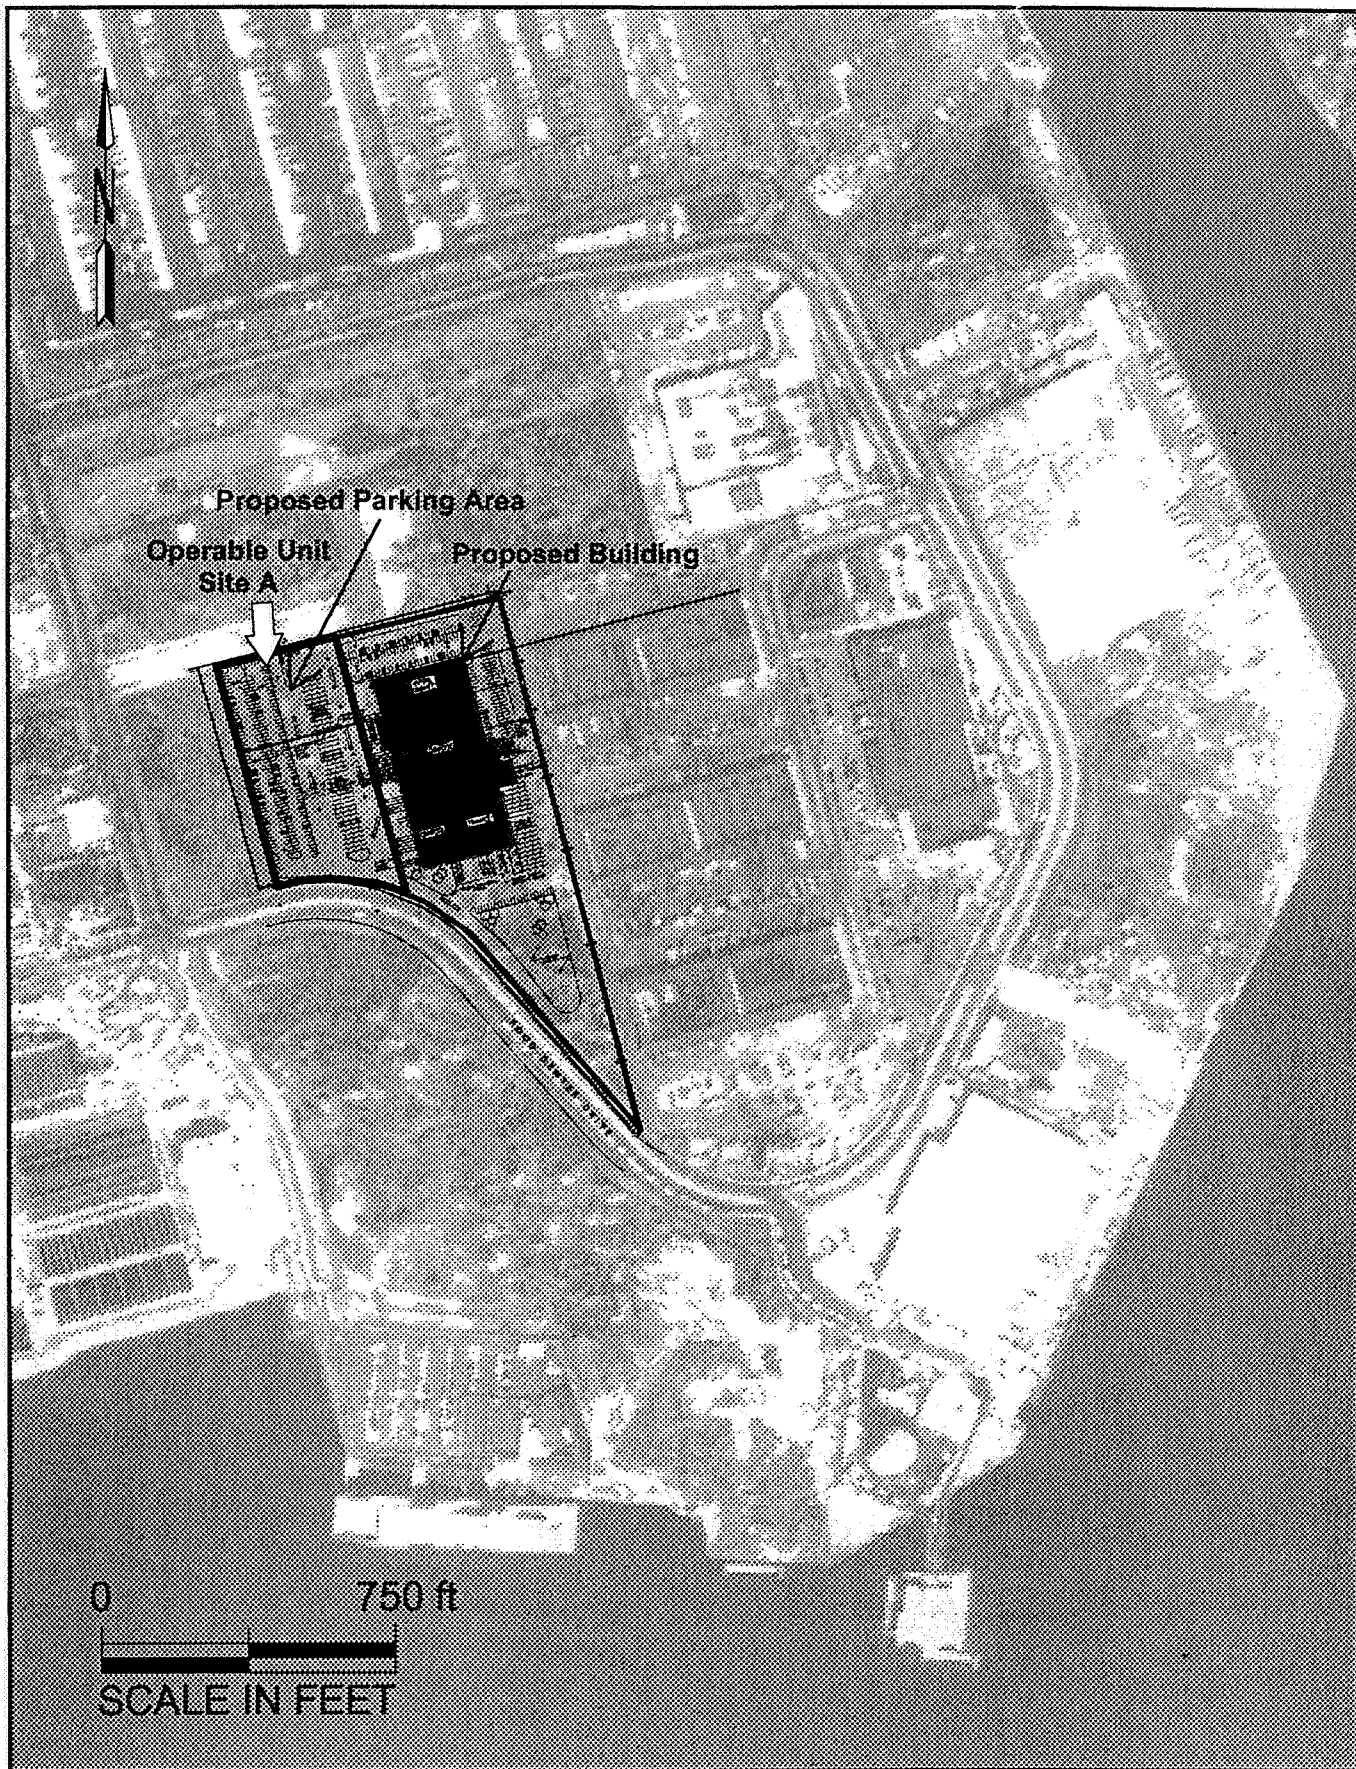
avoided during site excavation activities. They included underground combined sewer barrels, force mains and water lines. Figure 3 shows Site A and its respective location within the former coal gassification facility. The figure also shows the structures which were historically documented by Con Edison as existing on the site, as well as adjacent facility structures.

Historic Sanborn and topographic maps were used to prepare a composite showing existing conditions in relation to the historic setting (Figure 3). Historic aerial photographs (Aerial Photos 1 through 5) were also reviewed and incorporated into the composite diagram of the site. Prior to the start of investigative field work any conditions not shown on the Sanborns were taken into consideration for the actual sampling activities. The major feature noted on the historical aerial photos and Sanborn maps was the old road bed for Hunt's Point Avenue, which has been identified as containing numerous sewer and water mains.

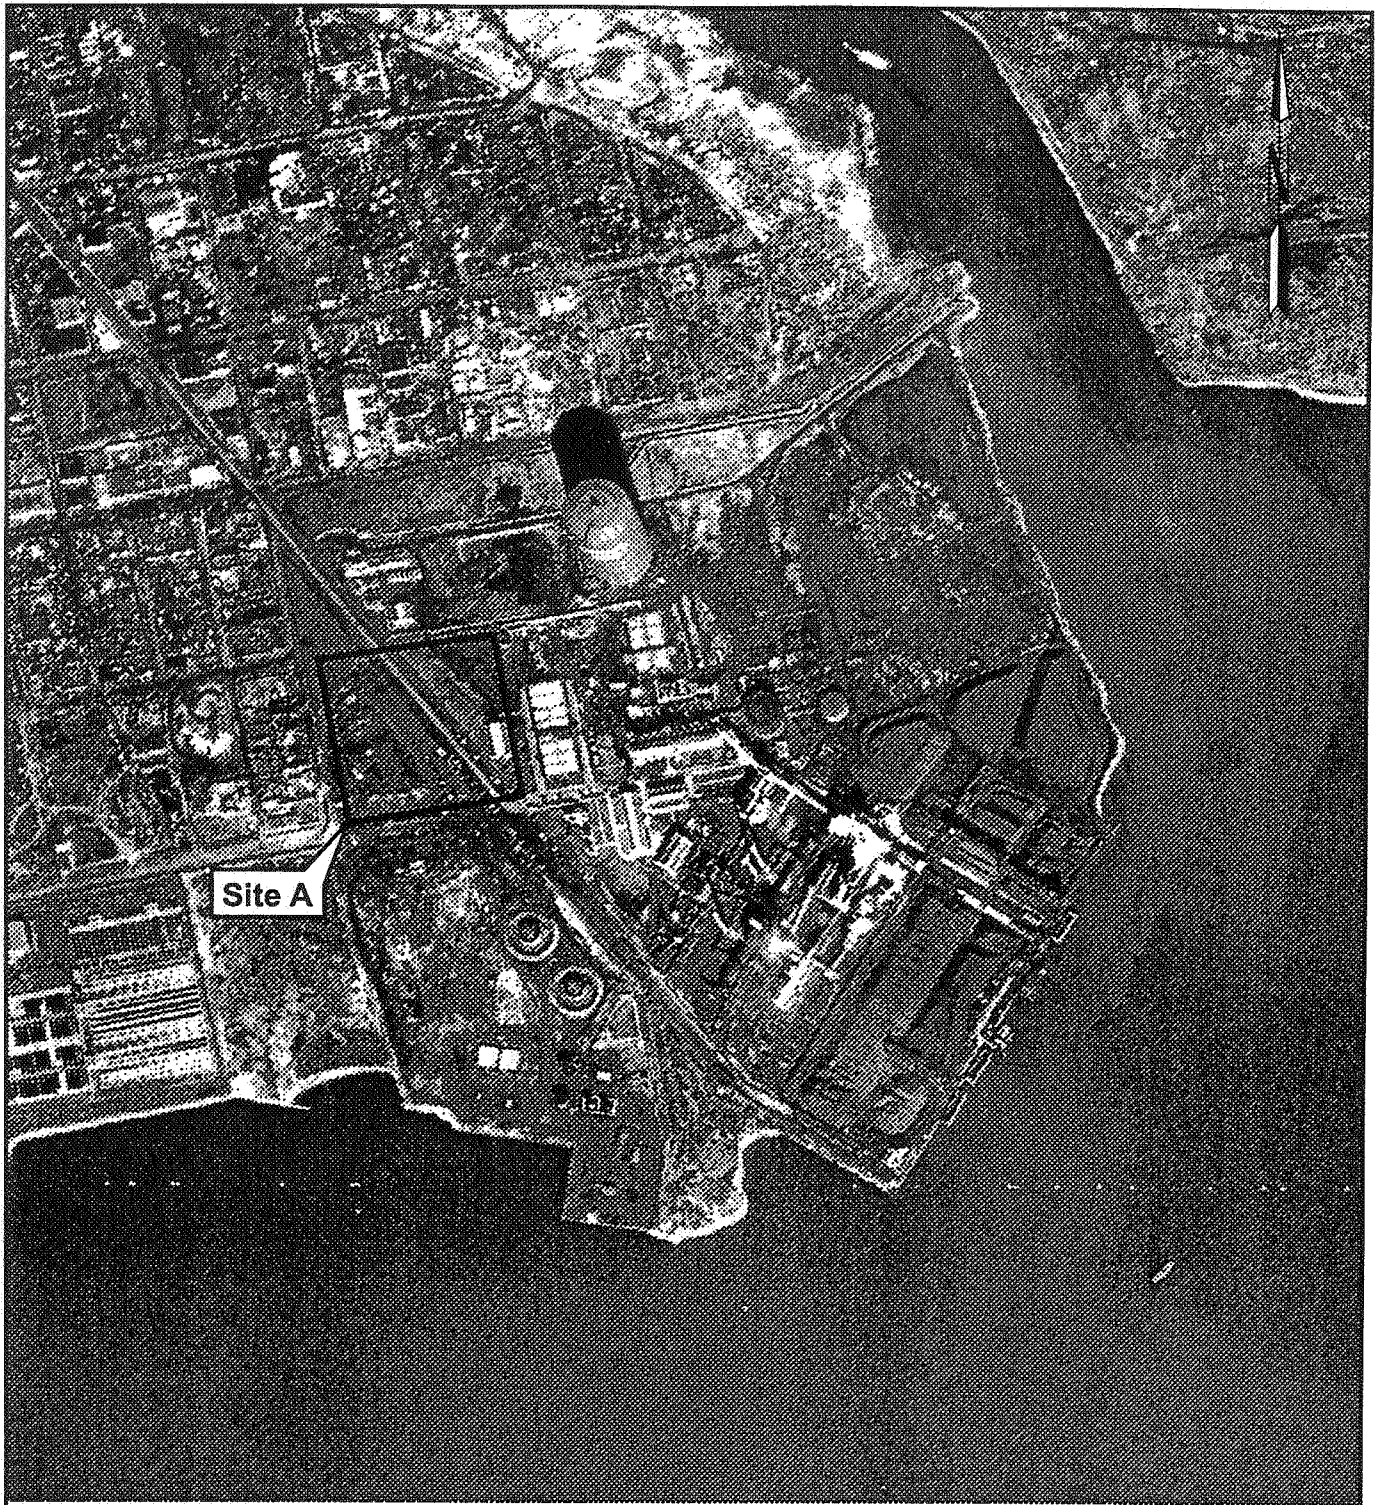
Aerial
Photo
1

Hunts Point Site A -
1954 Aerial Photograph

As was noted on the historical aerial photographs (Aerial Photos 1 through 5), and the historic Sanborn maps, the old road bed for Hunt's Point Road ran through the center portion of the OU of Site A. A New York City Department of Environmental Protection (NYCDEP) main sewer line and water mains are still present in this area. Therefore during excavation activities this area was avoided.

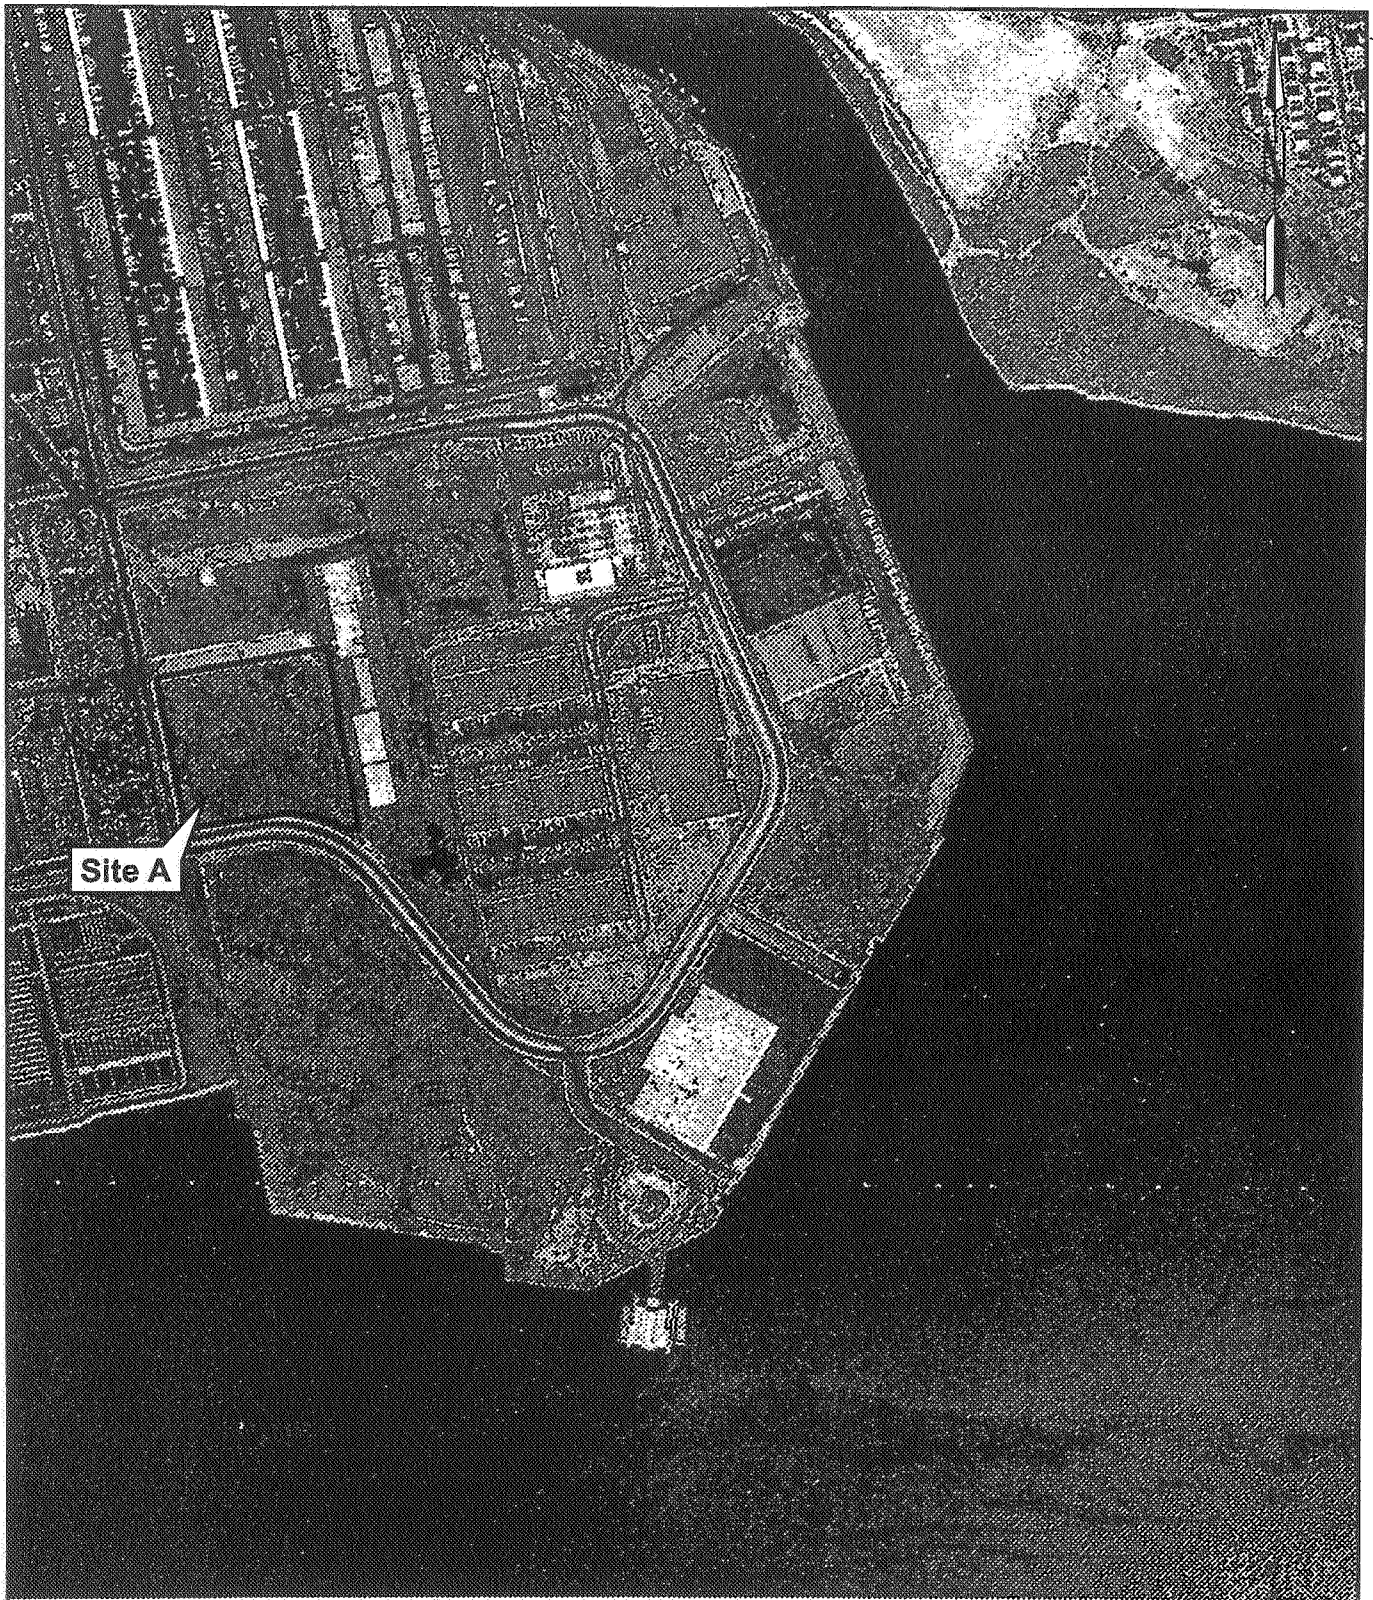
Aerial
Photo
4

Hunts Point Site A -
1984 Aerial Photograph

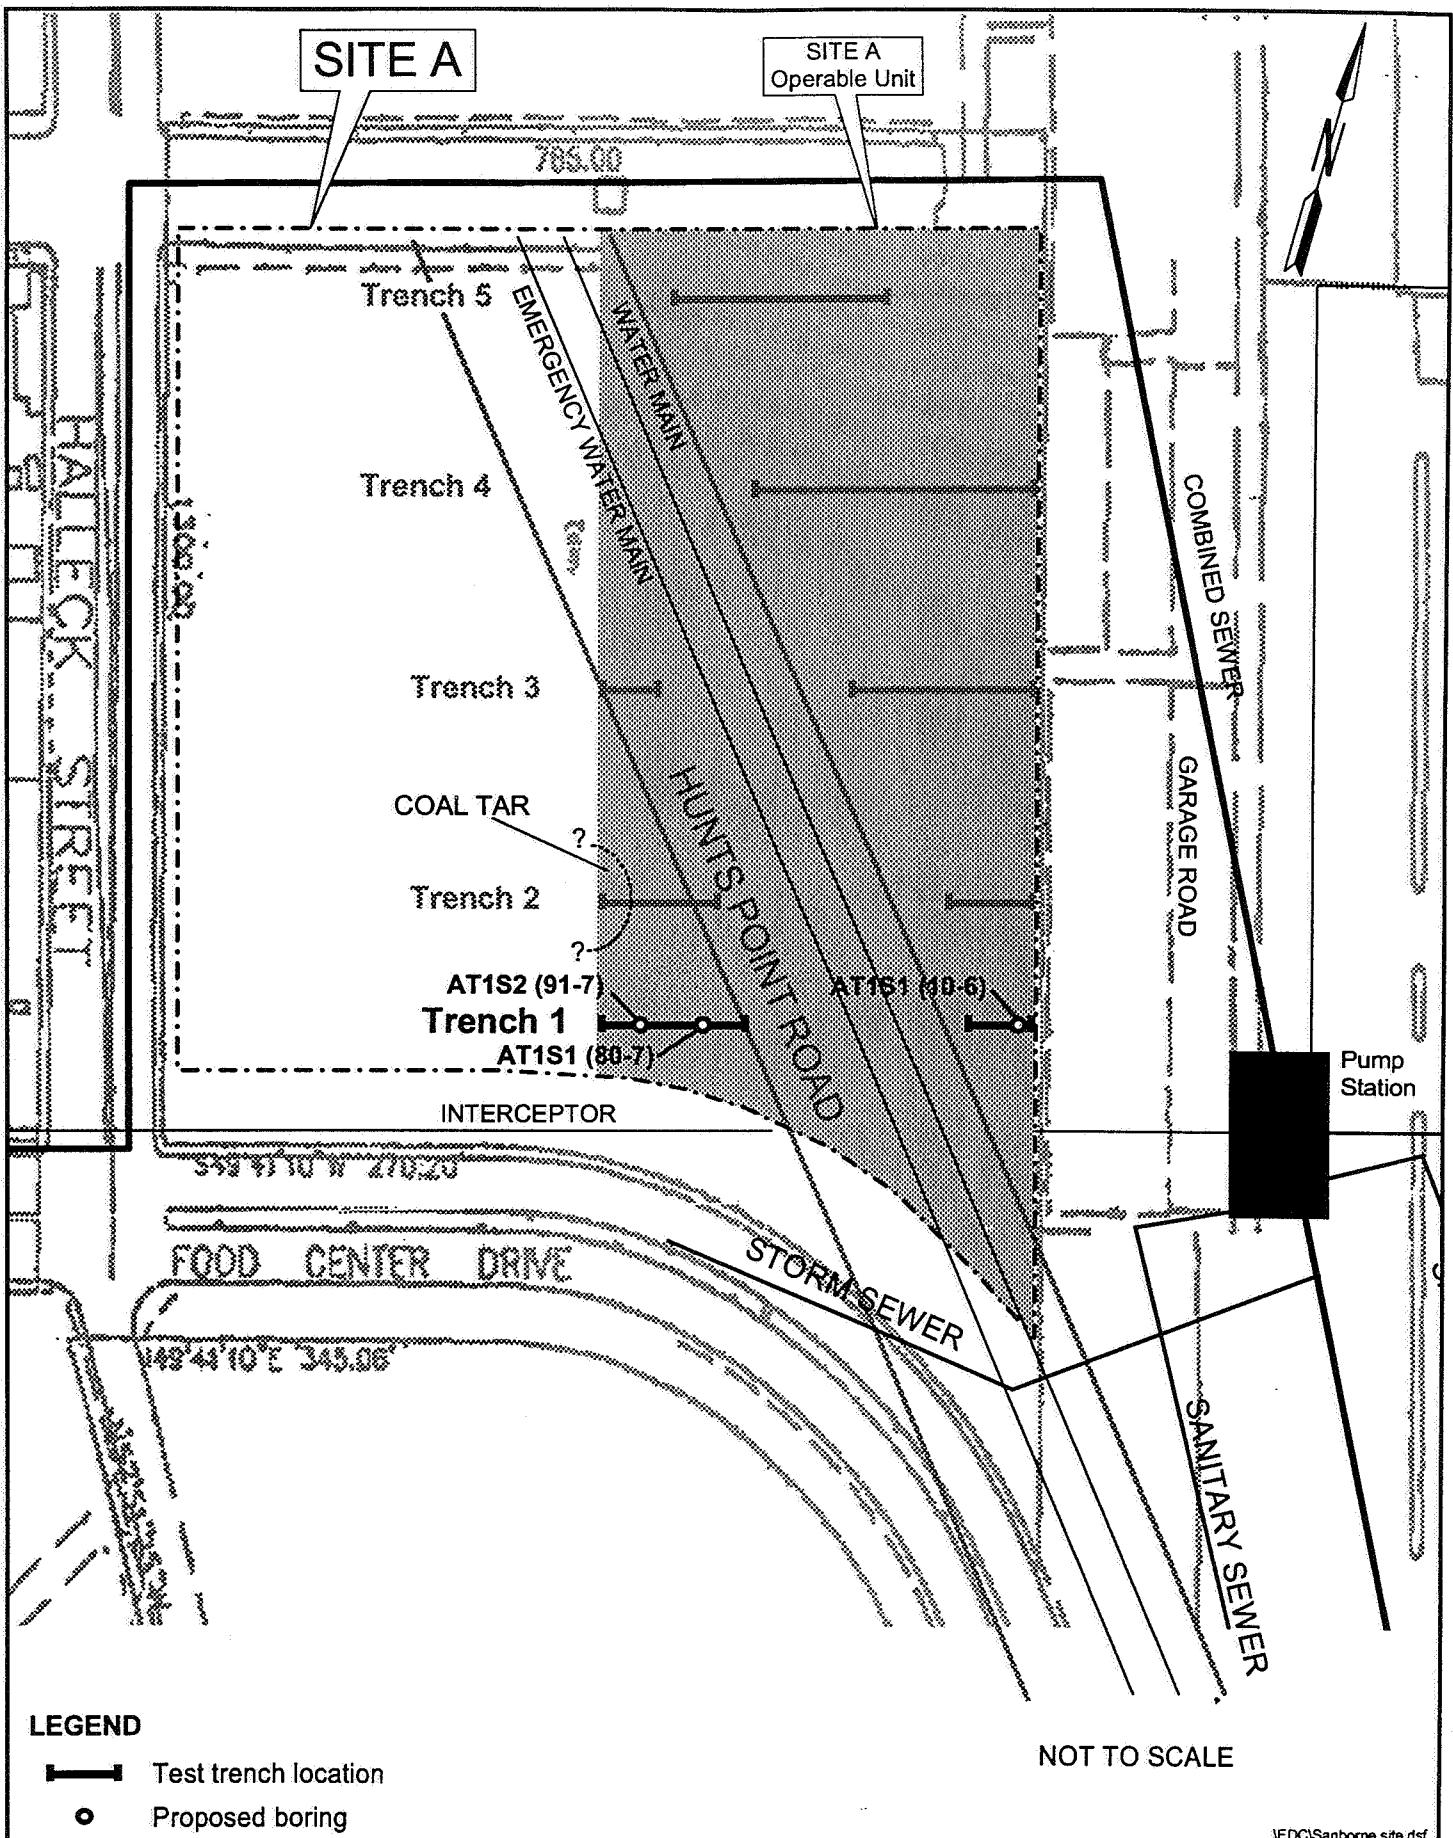
Trench 2 was installed approximately 75 feet north of Trench 1 and was a total of 150 feet in length (Figure 7). The average depth of the trench was approximately 15 feet below grade. A cross section describing the material and depths of the excavation as well as sampling locations is included as Figure 8. The fill material was more prominent in the western end of the trench and thinned out toward the east. Fill material in the western end of the trench consisted of wood pilings mixed with black silty coal ash and slag with a strong naphthalene odor. The fill material gradually changed to incinerated household garbage and ash about 60 linear feet from the western end of the trench and extended to the old roadbed. The fill material at the eastern end of the trench consisted of brown silty sand and black cinders but exhibited no odor. The clay layer was continuous throughout the trench and was encountered at about 10 feet below grade. Groundwater was encountered just above the clay layer.

The trench was left open for a number of days when the temperature consistently exceeded 95 degrees before it was backfilled. Upon a site inspection with the NYSDEC representative prior to groundwater sampling at this trench, it was noted that a small amount of the fill material in the extreme western end of the trench found to consist of mostly black coal ash and tar had oozed out from being exposed to the direct sunlight and was seeping out of the sides of the trench into the excavation. A groundwater sample was collected from the trench near this location of the coal tar seep. The seep was located approximately 4 feet below grade and was about a foot in thickness. It was decided to excavate further into the trench to see what the condition of the layer was below the subsurface. The material in the new excavation at the same depth as the liquefied material consisted of solid coal tar and ash. This leads to the conclusion

that the material encountered does not become mobile unless it is exposed to extreme high temperatures, as was the case when the trench was left open.

Samples collected from Trench 2 contained very low to non-detectable levels of VOCs, none of which exceeded the recommended soil cleanup objectives (Table 2). Semivolatile compounds were detected at very low to non-detectable concentrations, although the following compounds exceeded the recommended soil cleanup criteria: benzo(a)anthracene, chrysene, benzo(b)fluoranthene, benzo(k)fluoranthene, benzo(a)pyrene, indeno(1,2,3-cd)pyrene, and dibenzo(a,h)anthracene. The following metals exceeded the recommended soil cleanup objectives in the composite sample: arsenic, cadmium, chromium, copper, iron, mercury, nickel, selenium, and zinc. Pesticides and PCBs were detected at very low to non-detectable levels. No compounds exceeded the recommended soil cleanup objectives.

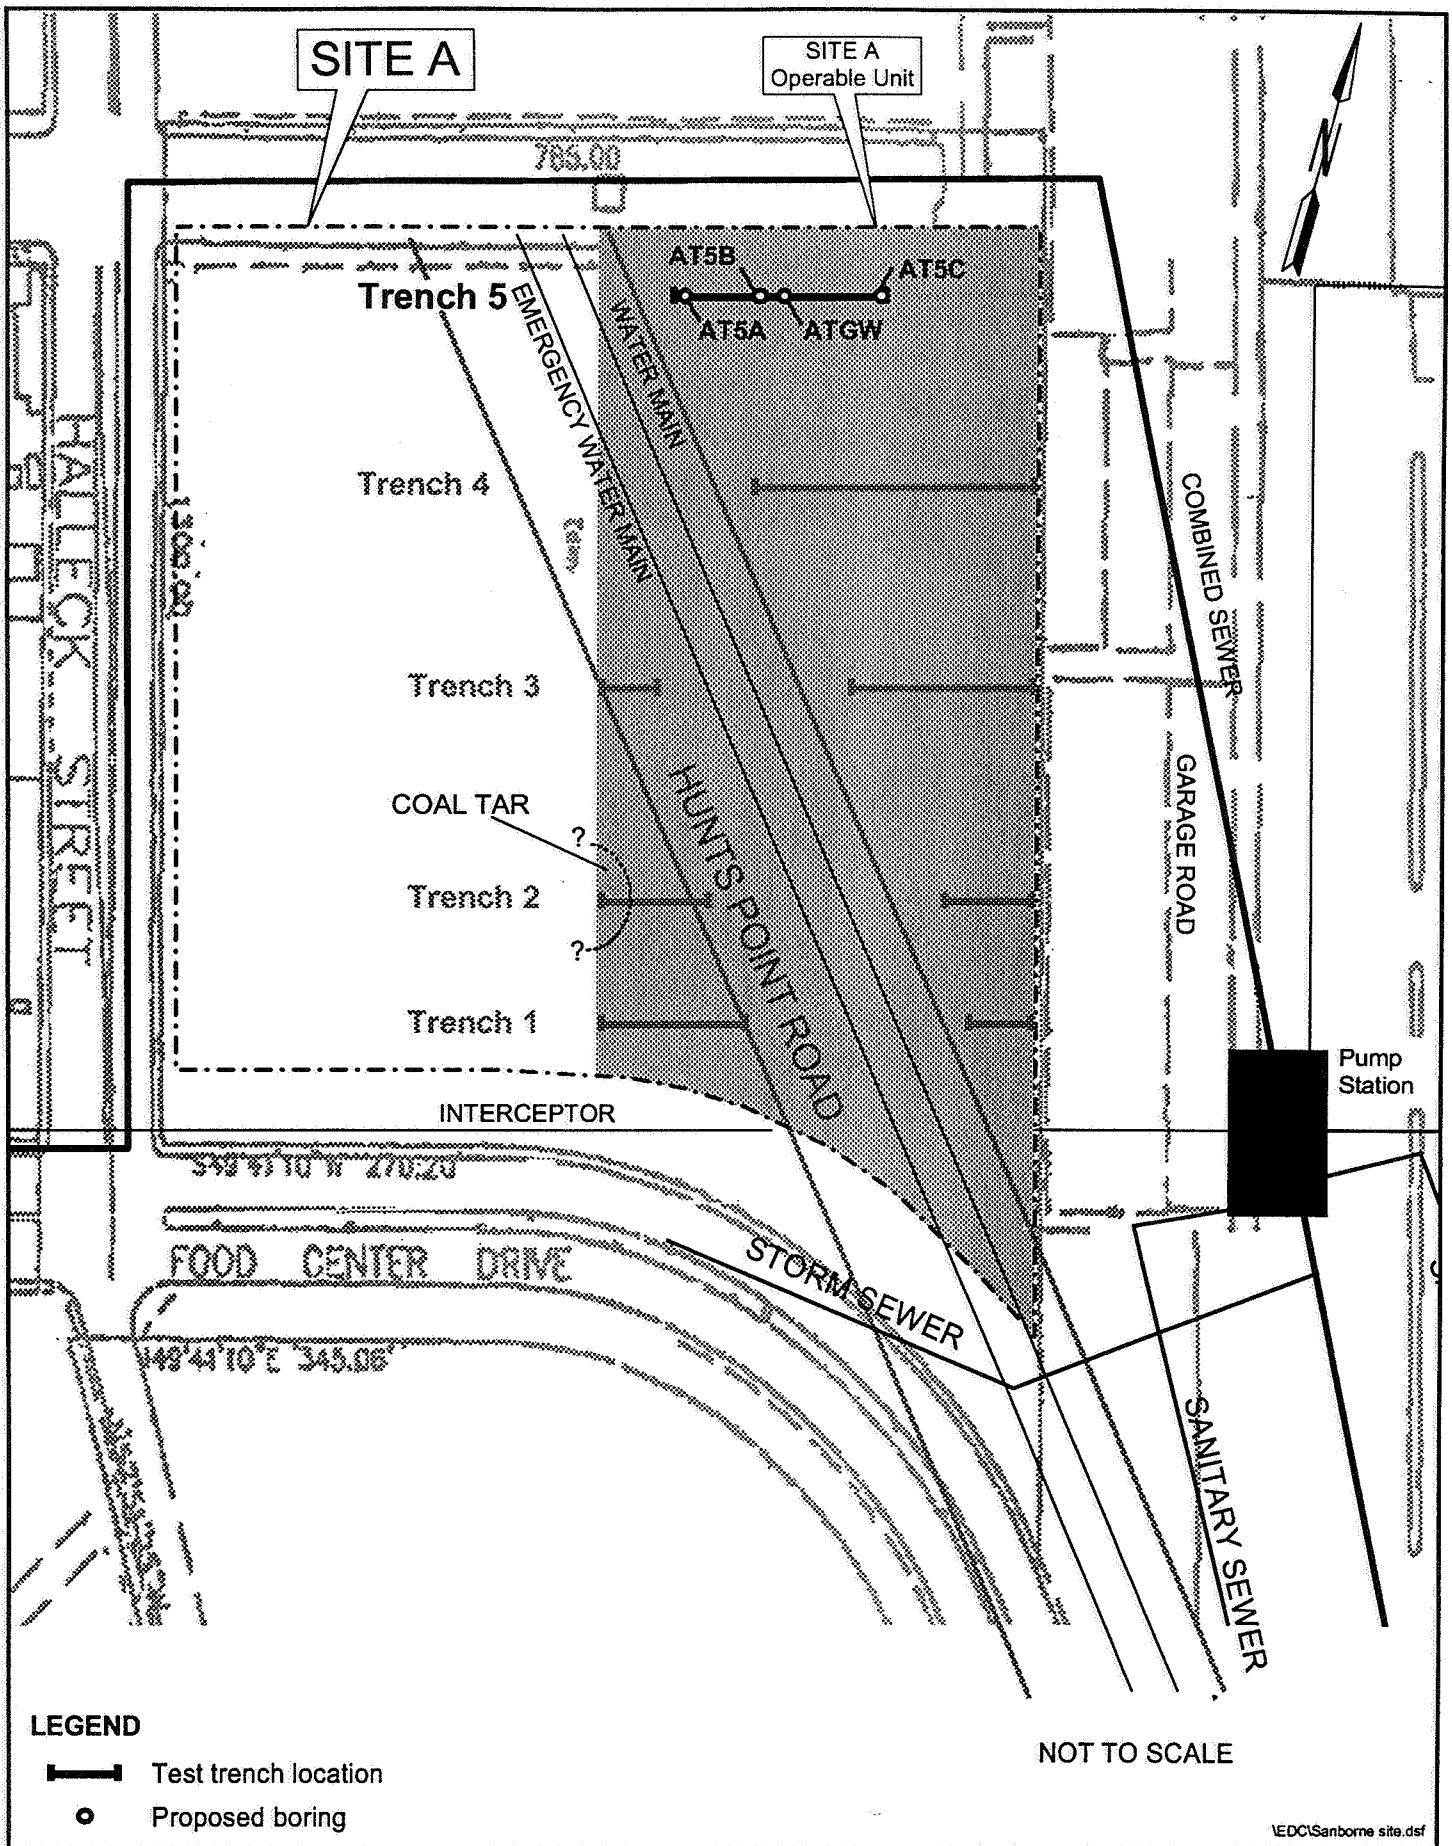
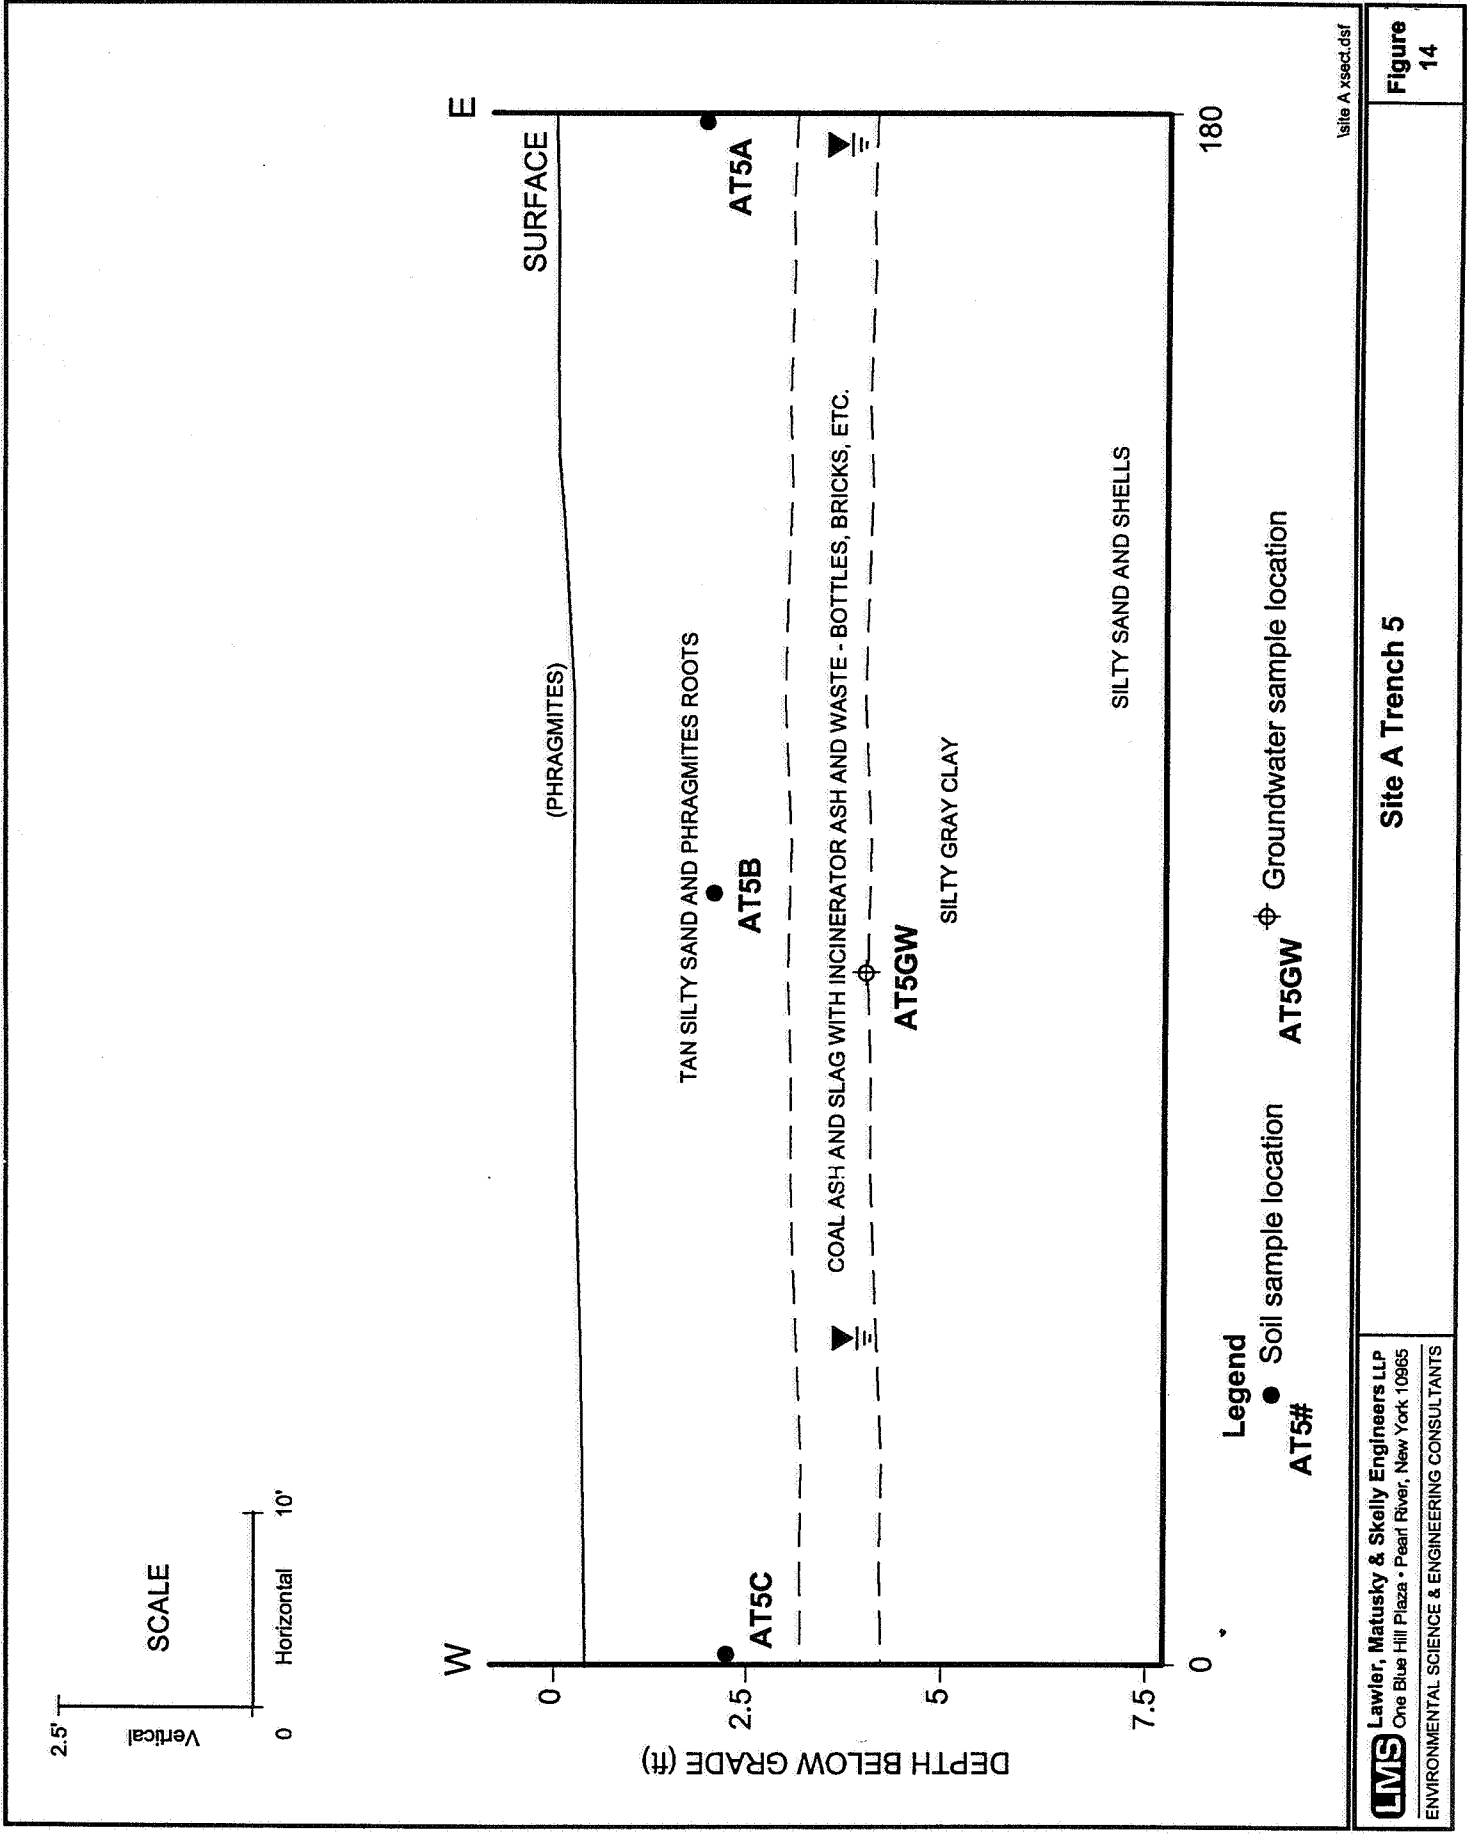
Trench 5 was installed approximately 150 feet north of Trench 4 and was a total of 80 feet in length (Figure 13). A cross section describing the depths and types of materials encountered, as well as sampling locations is included as Figure 14. The average depth of the trench was

approximately 5 feet below grade. Various debris materials were also present in the area surrounding the trench consisting of automobile parts, tires, concrete, glass and metal. Trench 5 was also installed in an area of heavy vegetation. The area and associated soil deposits extended to about 3 feet below grade along the entire length of the trench. A layer of fill material consisting of coal ash and slag with incinerator ash and miscellaneous garbage was encountered below the surface material and just above the clay layer. An upper layer of grey organic clay was encountered at about 4.5 feet below grade and was approximately 2 feet in thickness. A layer of silty sand and shells, approximately 2 feet in thickness was encountered just below the clay layer, and was underlain by the same organic clay found above. Groundwater was encountered in the fill material just above the clay layer as well as in the silty sand and shells layer just below the top clay layer. At approximately 10 feet from the western end of the trench, a large piece of concrete was encountered. When the concrete was lifted out of the trench, an organic petroleum type of odor was observed emanating from the trench. No readings were recorded on the PID, nor was a sheen observed on the groundwater. The area was limited to about 5 square feet. A groundwater sample was collected from this area of the trench. No other evidence of soil or groundwater contamination was observed in Trench 5.

Volatile compounds were detected at very low to non-detectable concentrations in the samples collected from Trench 5 (Table 5). Acetone was detected above the recommended soil cleanup criteria, but that compound was also found in associated method blanks and is a common laboratory contaminant and is not be considered indicative of site conditions. The following semivolatile compounds were detected at concentrations that exceeded the recommended soil cleanup objectives in the composite sample: benzo(a)anthracene, chrysene, benzo(b)fluoranthene, benzo(a)pyrene, and dibenzo(a,h)anthracene. The

following metals were detected above the recommended soil cleanup objectives in the composite sample: arsenic, barium, beryllium, cadmium, chromium, copper, iron, mercury, nickel, selenium, and zinc. Pesticides and PCBs were not detected above the recommended soil cleanup criteria in the composite sample from Trench 5.
