**Re: 2008 Soil Vapor Sampling at DPW, 15 Marbledale Road
NYSDEC Site #V00237-3
Kings Electronics Co., Inc./Weissman Holdings, LLC(Kings)
40 Marbledale Road
Tuckahoe, Westchester County, New York**

**Soil Vapor Intrusion Evaluation Report - 2009
Tuckahoe Department of Public Works (DPW)
15 Marbledale Road
Tuckahoe, New York**

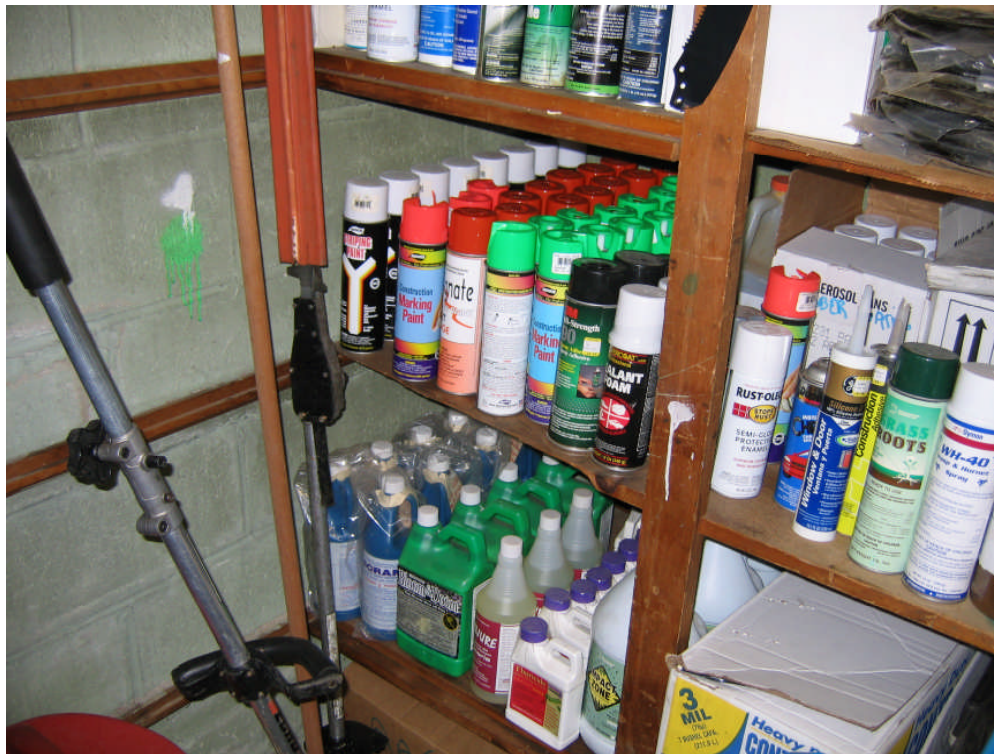
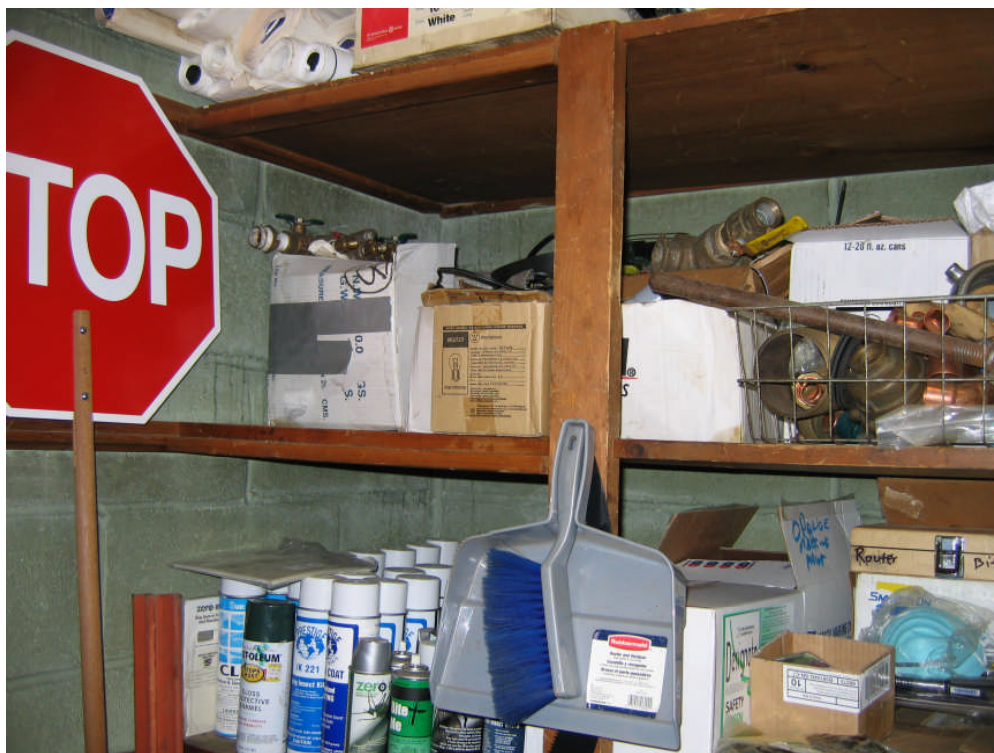
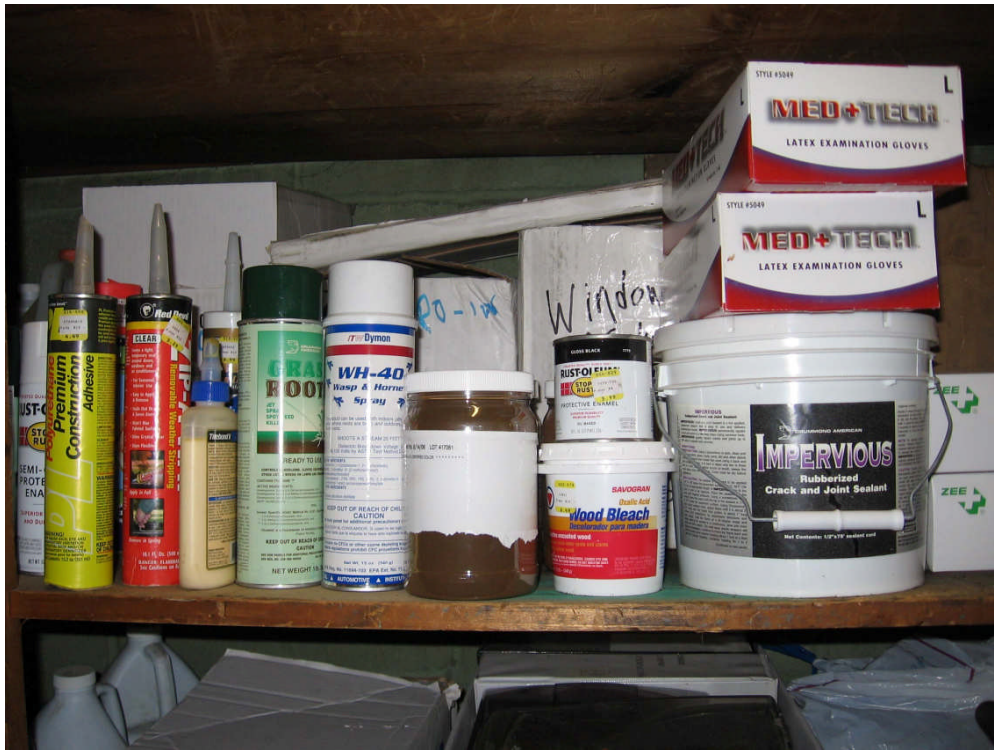
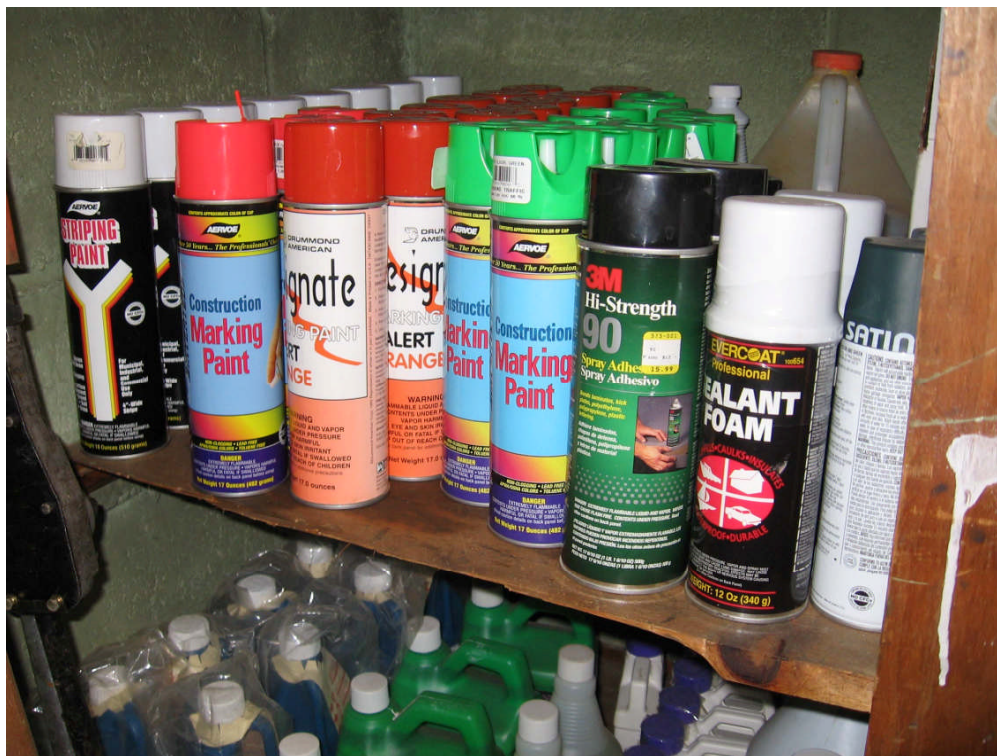
Office Storeroom

that the room contained the following: light bulbs/fixtures, “ready for use” fuel-powered tree cutting equipment and a supply of pesticides/herbicides, caulks/sealers, spray paints, cleaners, lubricants and fuel additives (all sealed and unused). A representative inventory was recorded, and photographs of the room’s contents taken. According to the foreman, the utility room door is normally closed throughout the work day. The DPW building was surveyed for volatile organic compounds (VOCs) by the use of a “ppb Rae” photo ionization detector (PID) instrument that measures both in the ppb and ppm range. Measurements were in the range of 50 to 350 ppb VOC. The highest levels, 250 to 350 ppb, were recorded within the utility/storage room when the door was initially opened. See Floor Plan, for field instrument readings, on page 6 of Attachment A. A survey of the common office area indicated 50 to 70 ppb VOC. A survey of the gas furnace area indicated 140 to 160 ppb VOC. Readings of 110 ppb VOC were obtained within a floor drain in the break/lounge area, both with and without a humidity filtering tube. The employee break/lounge area readings ranged from 120 to 130 ppb VOC; the side exit door was partially open for most of the day.

At the conclusion of sample collection, the foreman's office was resurveyed with the "ppb RAE" PID. VOC measurements ranged from 80 to 120 ppb. Within the utility/storage room (which door had been closed) measurements from 600 to 1100 ppb VOC were obtained.

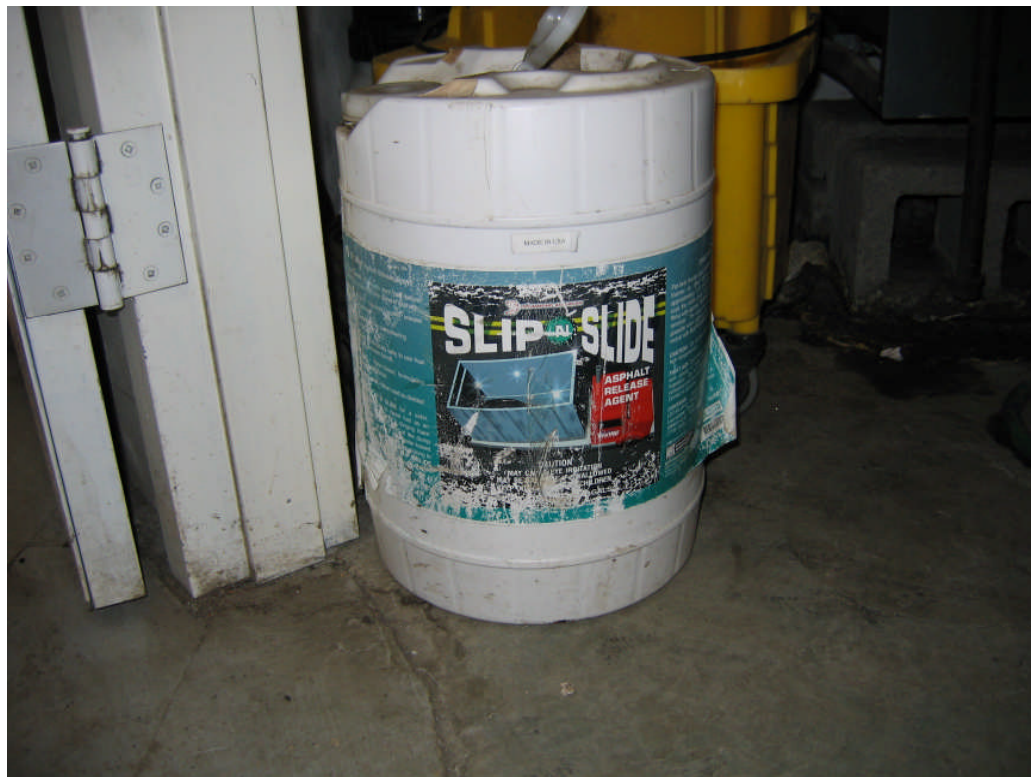
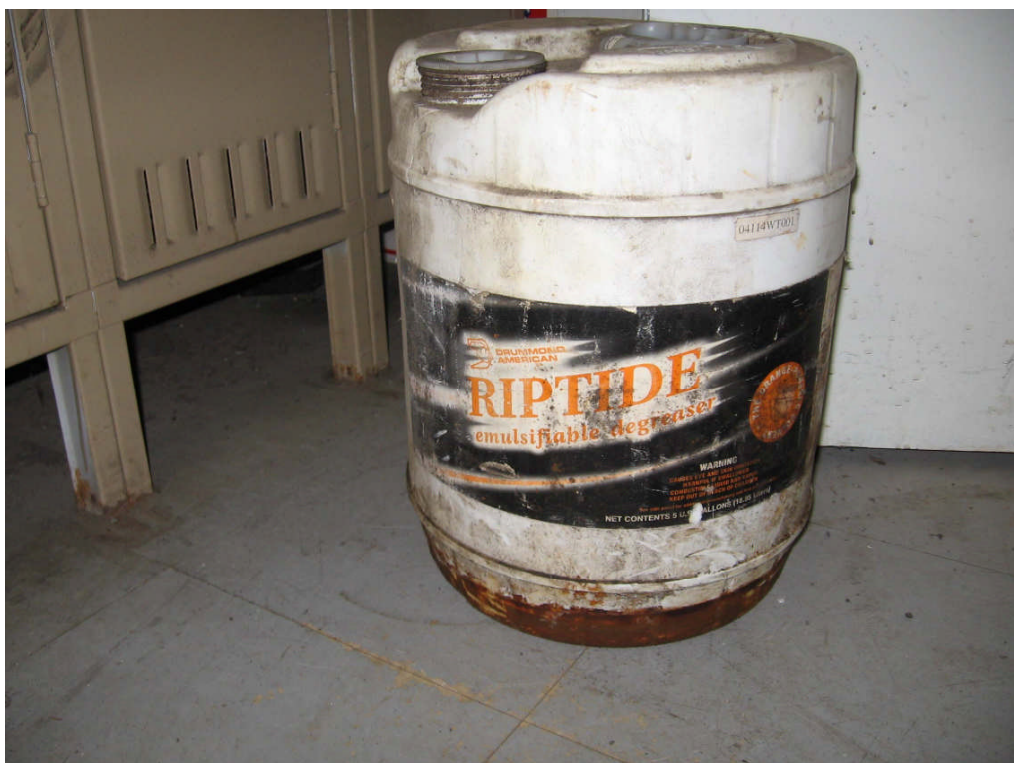
Furnace Room-Break Room

The following floor penetrations were noted and recorded in the IAQ Questionnaire (Attachment A): 3’ x 4’ x 2’ sewer cleanout box and two circular floor drains in the employee break/lounge area. Both bathrooms were finished with ceramic tile; the water supply and drain penetrations were well sealed. The gas supply line for the furnace is above ground. No cracks or floor penetrations were observed in the supervisor office area.

Sewer cleanout, 3' x 4' x 2 1/2' deep, below floor @ NE corner of "Break Room". Two floor drains in "Break Room" area.

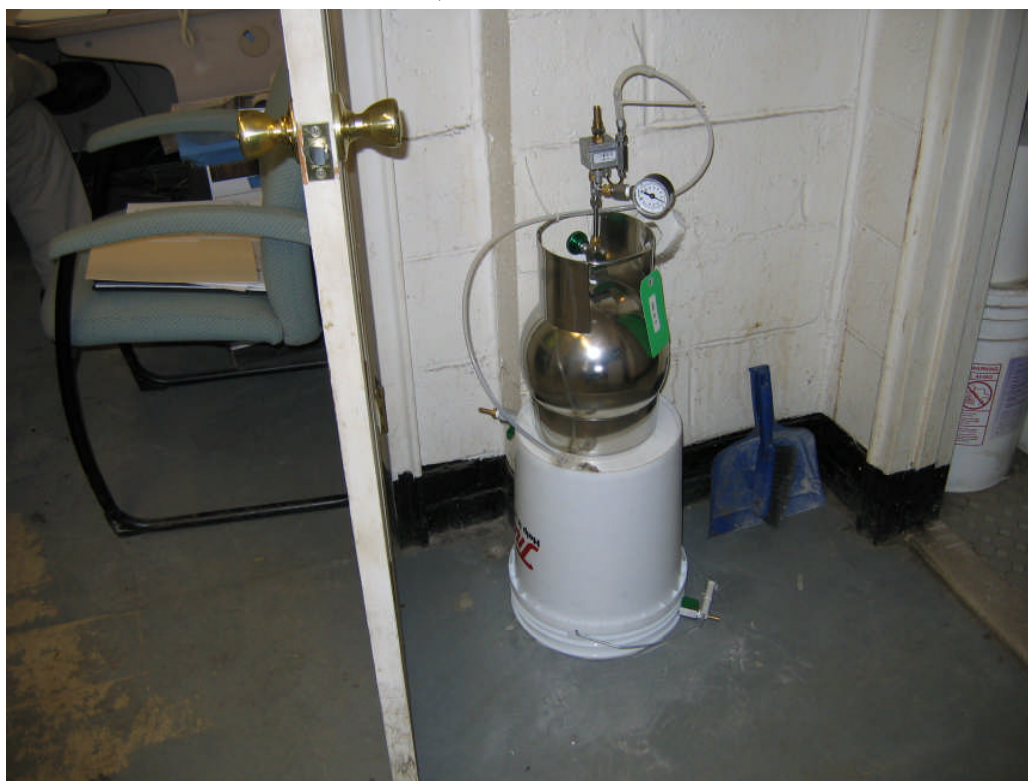
DPW-1, Sub-Slab 2009

The main office area was closely inspected to confirm that the prior year (i.e.; March 26, 2008) temporary sub-slab vapor probe position could be replicated. It was determined that the concrete floor area within the main office, near the Superintendent’s office entry, remained the best choice

At this location, Geovation drilled a 3/8" diameter hole through the concrete floor into the sub-slab aggregate. Teflon-lined polyethylene tubing of 1/4" diameter (the probe line) was inserted into the hole, extending 2" into the sub-slab material. Permagum was used to seal the tubing in the hole. The tubing was then passed through a predrilled hole in the bottom of the inverted 5-gallon bucket, and sealed in place with Permagum. The bucket was then placed over the sampling hole and the rim circumference sealed to the concrete floor with Permagum in order to create an air tight seal and limit the intrusion of ambient air to the sampling point. Immediately thereafter, a PID (Thermo Electron Model 580B OVM) was attached to the probe line and the line was purged for approximately 5-minutes until a 1 liter tedlar bag was full. The bucket was filled with Helium gas through a fitting preinstalled in the side of the bucket, near its bottom. The probe line was then connected to the MGD 2002 helium leak detector to determine the efficacy of the seal where it penetrated the floor. No Helium was detected, demonstrating that the probe line was well sealed. Directly after the Helium measurement, the probe line was connected to a Summa canister and the associated flow controller (pre-calibrated by the lab for an 8-hour sampling period, approximately 0.01 liters per minute). The flow controller valve was opened and the sample start time was recorded. The sample ID for the temporary sub-slab vapor point was labeled DPW-1 and the corresponding Canister ID and Flow Controller ID were AC00948 and FC00587, respectively. Sampling start time was approximately 7:40 a.m. and stop time was approximately 3:15 p.m. on 3/12/2009. Although DPW closes at 3:00 p.m., the Superintendent stayed until sampling was completed.

At the end of the sampling period, the canister flow valve was closed, flow controller removed, and shipping cap reinstalled at threaded inlet to canister. All data was recorded on the Field Log and the Chain of Custody. The probe hole was sealed with "quick-drying" cement and smoothed over.
