Re: Imperial Cleaners  
218 Lakeville Road  
Lake Success, NY  
Voluntary Cleanup Program Site# V-00244-1

Enclosed are four copies of the December 11, 2000 work plan for Imperial Cleaners Interim Remedial Measure, 218 Lakeville Road, Lake Success, New York. This work plan has been revised based on the comments in your letter dated November 20, 2000.

**Imperial Cleaners  
218 Lakeville Road  
Lake Success, New York**

**December 11, 2000**

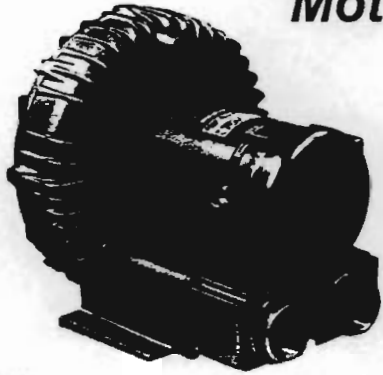
### MODEL R6150J-2

95" H<sub>2</sub>O MAX. PRESSURE, 210 cfm OPEN FLOW  
85" H<sub>2</sub>O MAX. VACUUM
