## Periodic Review Report

**Site: Former Mimi Cleaners**

**NYSDEC Site Number: V00306**

August 04, 2025 (revised March 02, 2026)

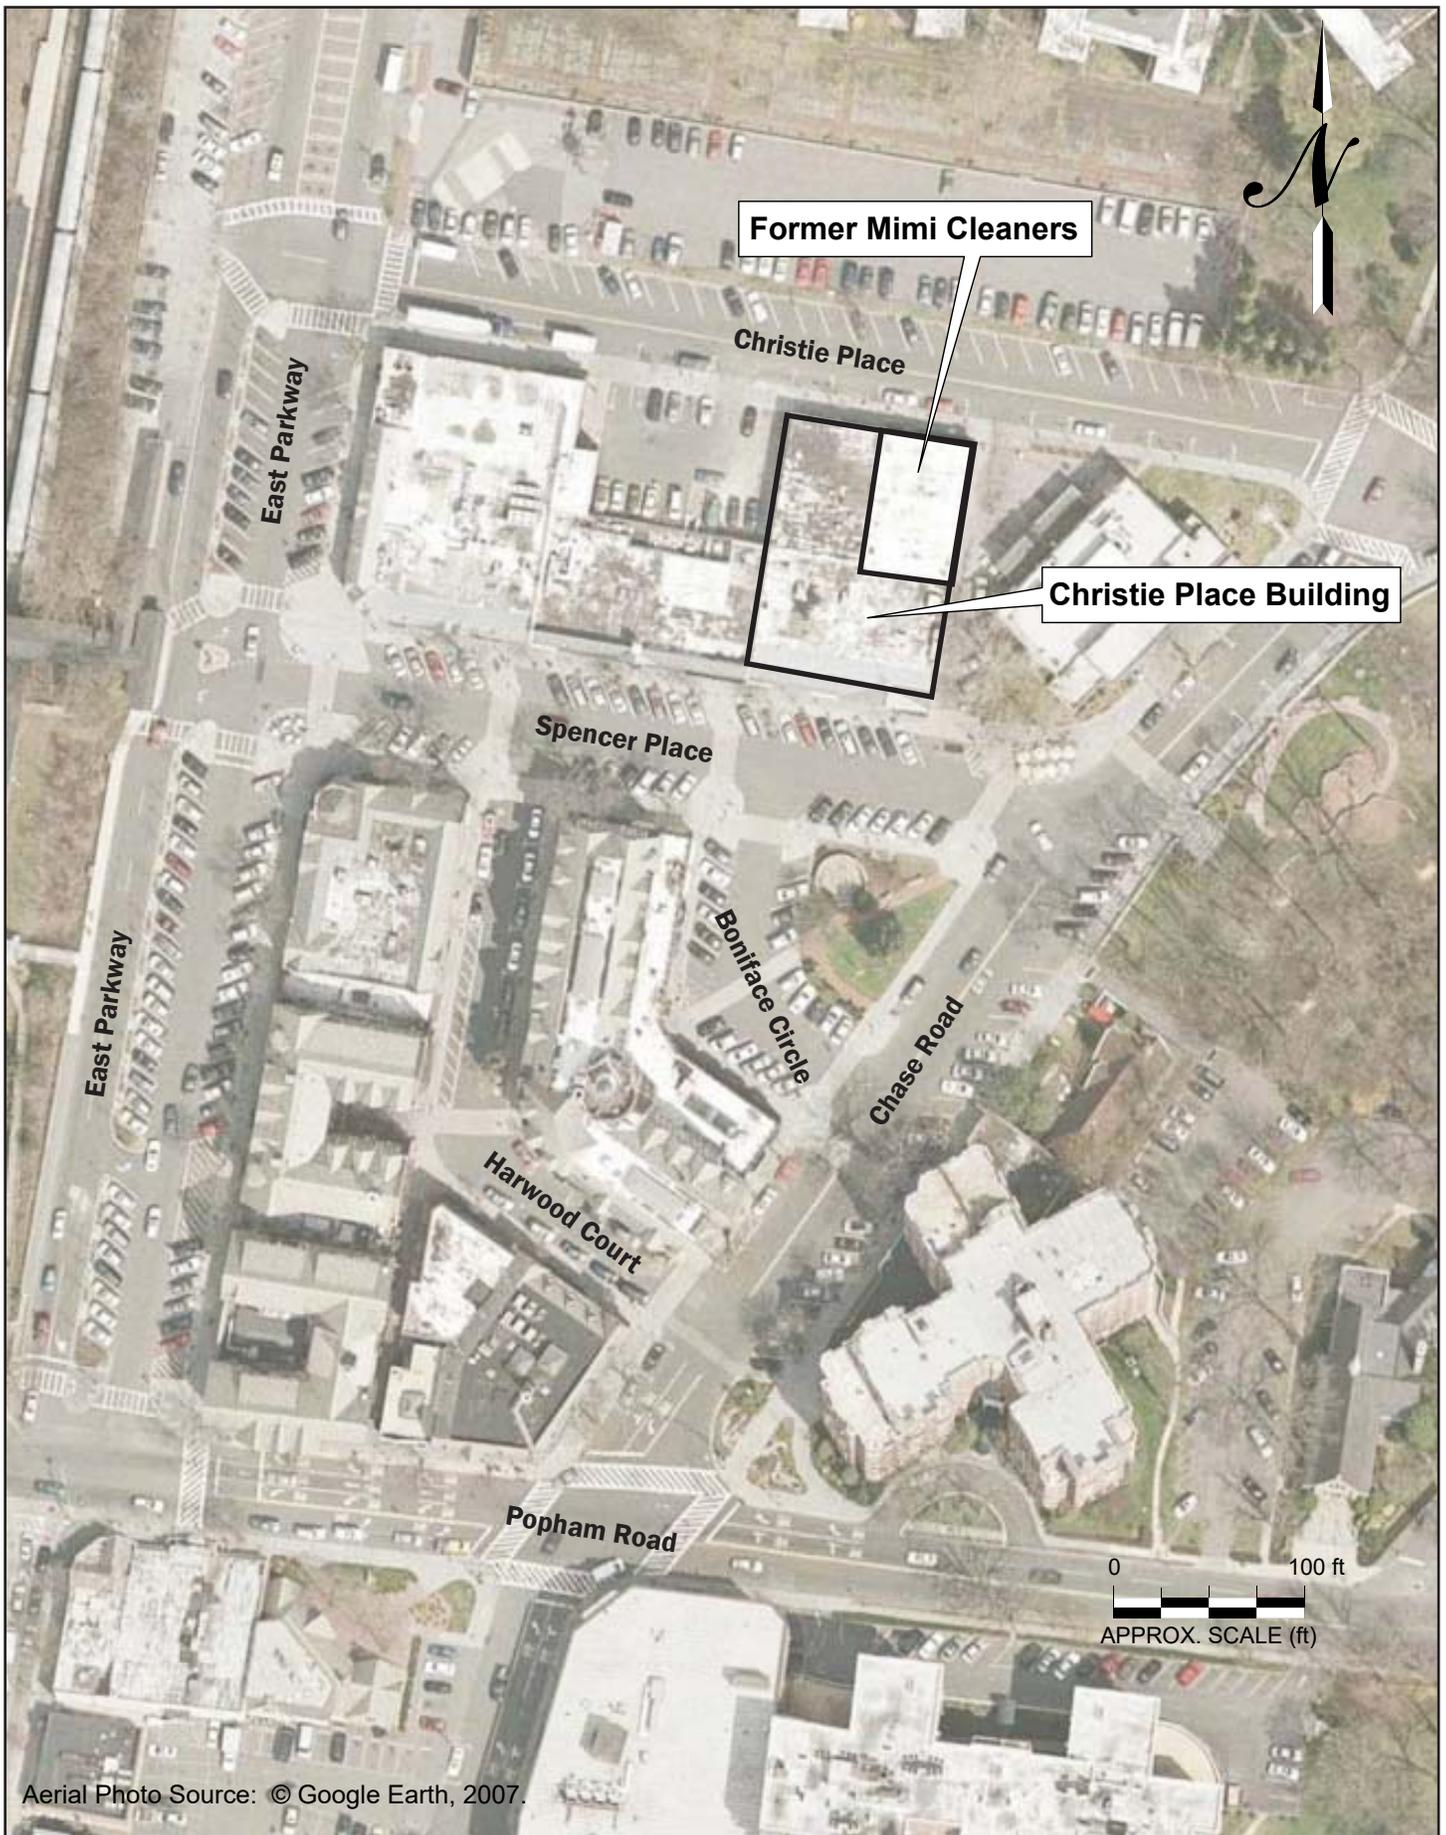
Figure 2  
Location of Former Mimi Cleaners  
Former Mimi Dry Cleaners  
Scarsdale, NY

The site is located in the Village of Scarsdale, Westchester County, New York and is identified in the VCA as the northeast corner of the Christie Place Building (CPB). The CPB is designated as Section 2, Block 5, Lots 11 and 12 on the Tax Map, covering approximately 0.3098 acres, of which the site comprises approximately 0.06 acres. CPB is bounded by Christie Place to the north, Spencer Place to the south, the Scarsdale Post Office to the east, and a parking lot and the Spencer Place Building to the west (see **Figure 2**). The boundaries of the CPB site are more fully described in Appendix A of the Site Management Plan (SMP).

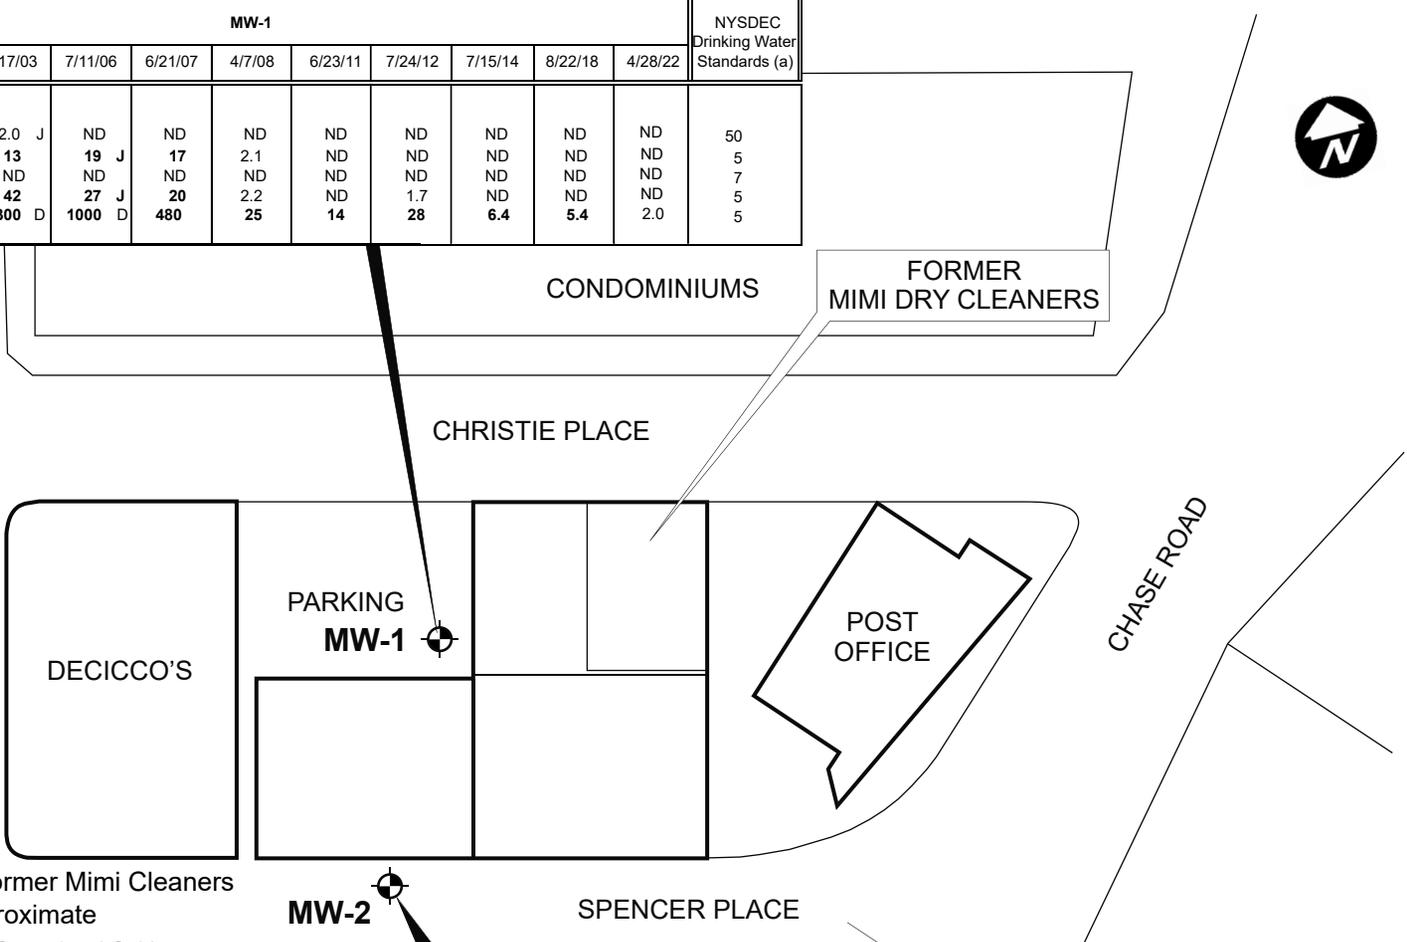
Groundwater results from the monitoring program are provided in **Table 1; Figure 3** provides a summary of the detected compounds in the monitoring wells since the sampling program was initiated. The results of the April 2022 sampling event indicate no VOCs were detected in the sample from MW-2 except for acetone at a concentration of 11 mcg/l. It should be noted that acetone is not typically detected in the groundwater samples at this project location and is not considered a chemical of concern for the site. Acetone was also detected in the trip blank at a concentration of 9.0 mcg/l, indicating its detection in the MW-2 sample was likely a laboratory contaminant issue and was not representative of the groundwater conditions. MW-1 contained no VOCs except for PCE at a concentration of 2.0 mcg/l. This was the first groundwater sampling event since the monitoring wells were installed in 2003 where the VOCs in both wells were below the New York State drinking water standard.

⊕ Monitoring well location, former Mimi Cleaners  
**NOTE:** Locations are approximate

In April 2022, during the most recent groundwater sampling event, HDR purged and sampled the two monitoring wells. MW-1 is located in the adjacent parking lot west of the CPB and MW-2 is located on the north side of Spencer Place adjacent to the sidewalk (see **Figure 3**). It should be noted that the curb box enclosure for MW-2 was paved over by the Village of Scarsdale prior to the 2022 sampling event when the road was resurfaced. HDR was given permission from the Village to remove the asphalt covering the monitoring well curb box to provide access to the well. There was a 3-to-4-inch layer of asphalt on top of the curb box. After the sample was collected from MW-2, the curb box was closed, and asphalt patch was used to patch the hole so it would not be a potential trip hazard for the public.

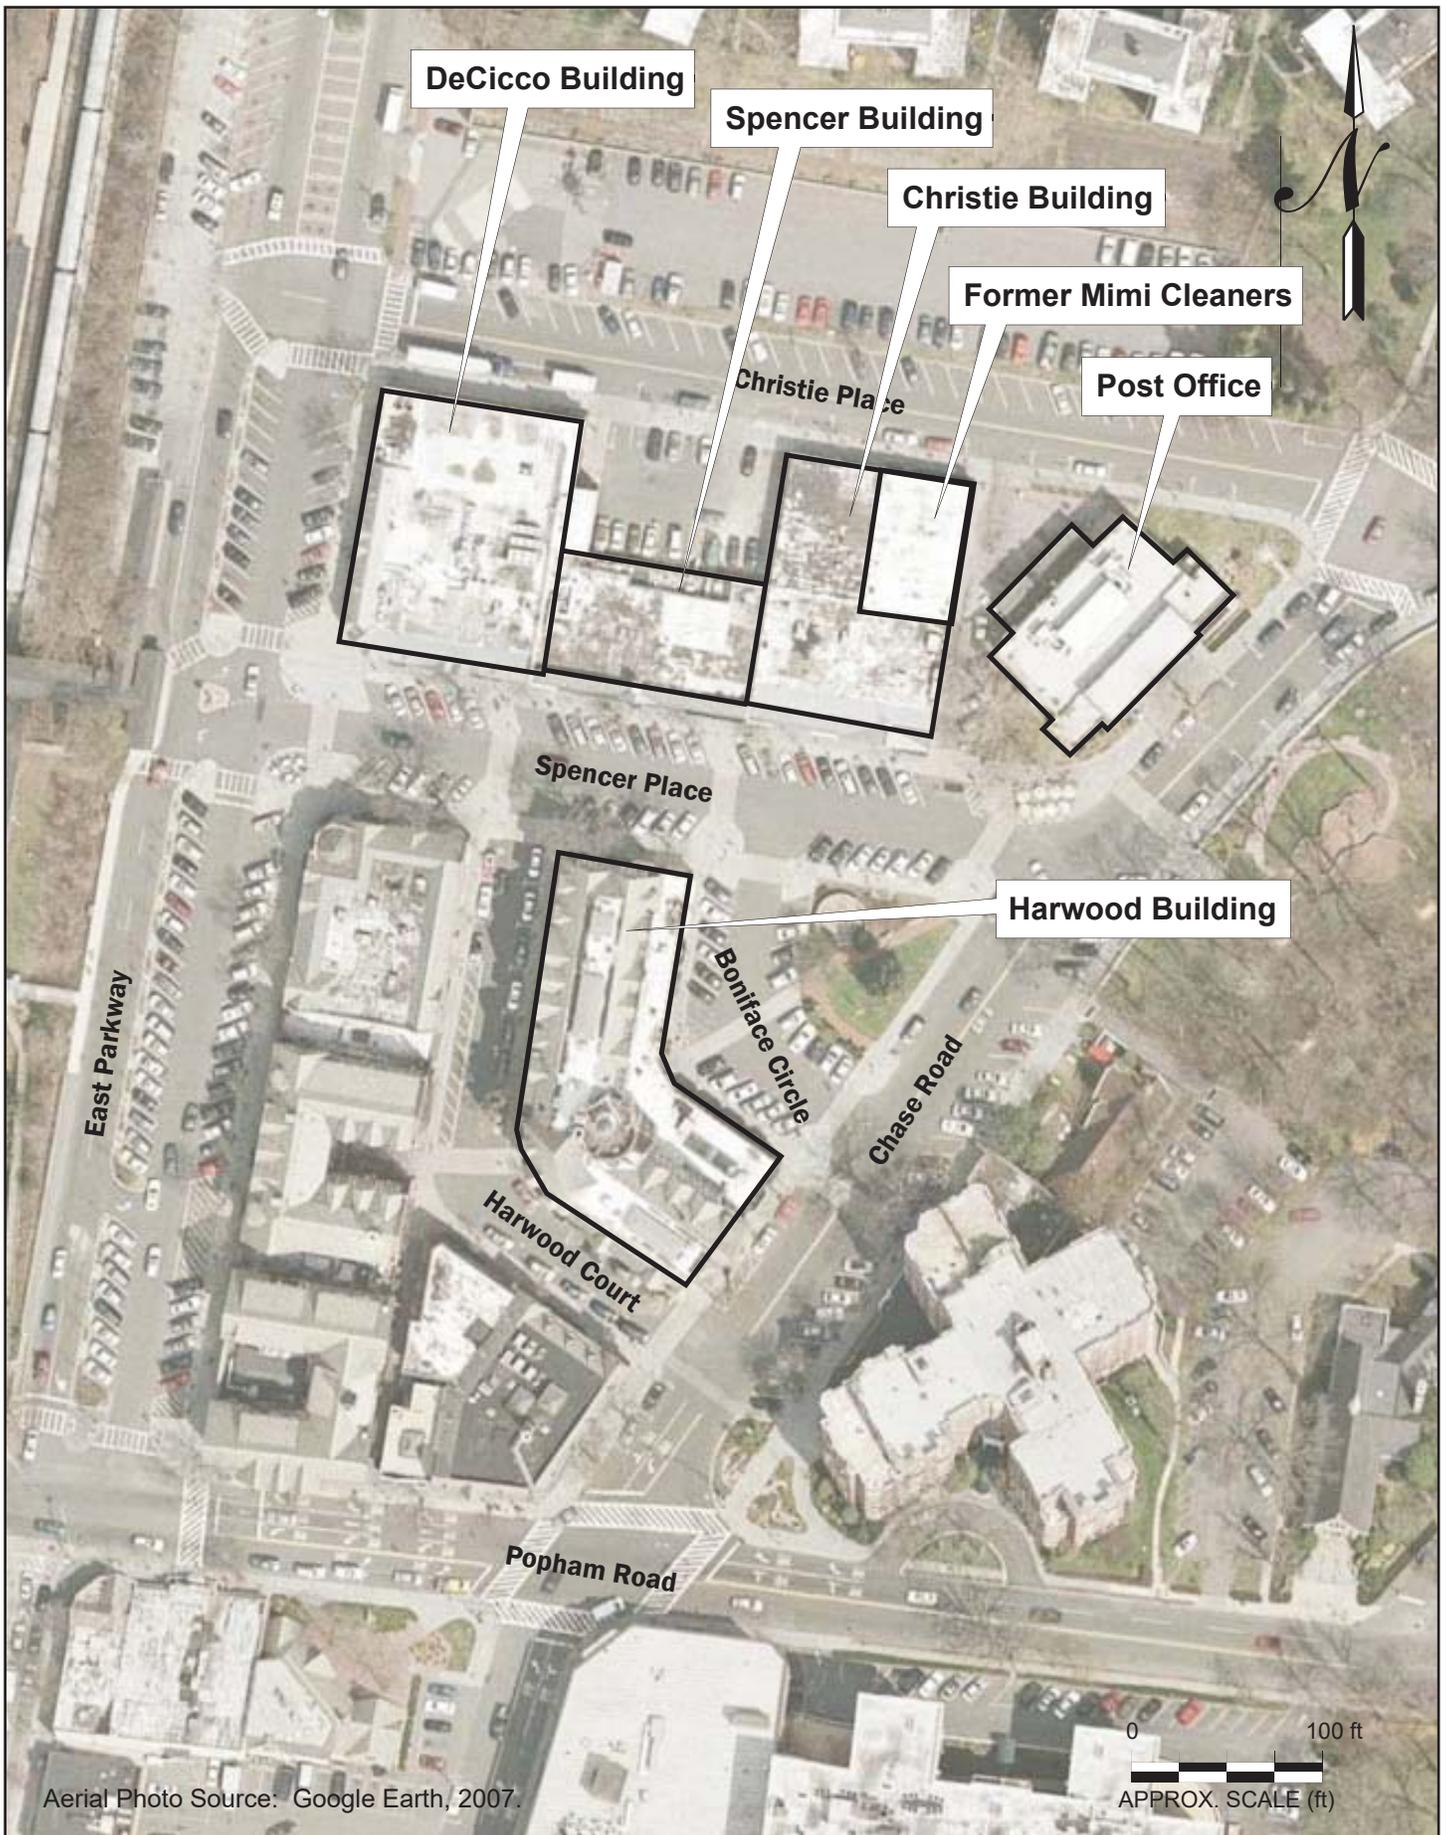
Figure 6

At the request of NYSDEC and NYSDOH, SSDSs were installed beneath five nearby offsite buildings at the request of NYSDEC/NYSDOH, shown on **Figure 6**: the Scarsdale Post Office Building at 29 Chase Road, the DeCicco Building at 58 East Parkway, the Harwood Building at 14 Harwood Court, and the southern portion of the East Parkway Building at 18-32 East Parkway. After documenting acceptable reductions in CVOC contaminants of concern and in accordance with permission from the NYSDEC and NYSDOH granted in June 2014, the SSDSs in these five nearby buildings have been shut down and removed. Annual inspections are no longer required in these off-site buildings since the SSDS equipment has been permanently removed, extraction points removed, and the slab penetrations sealed (some sections of the SSDS lateral piping were capped and left in place instead of being removed as approved by the building owners).

**Buildings Where SSDs Were Installed**

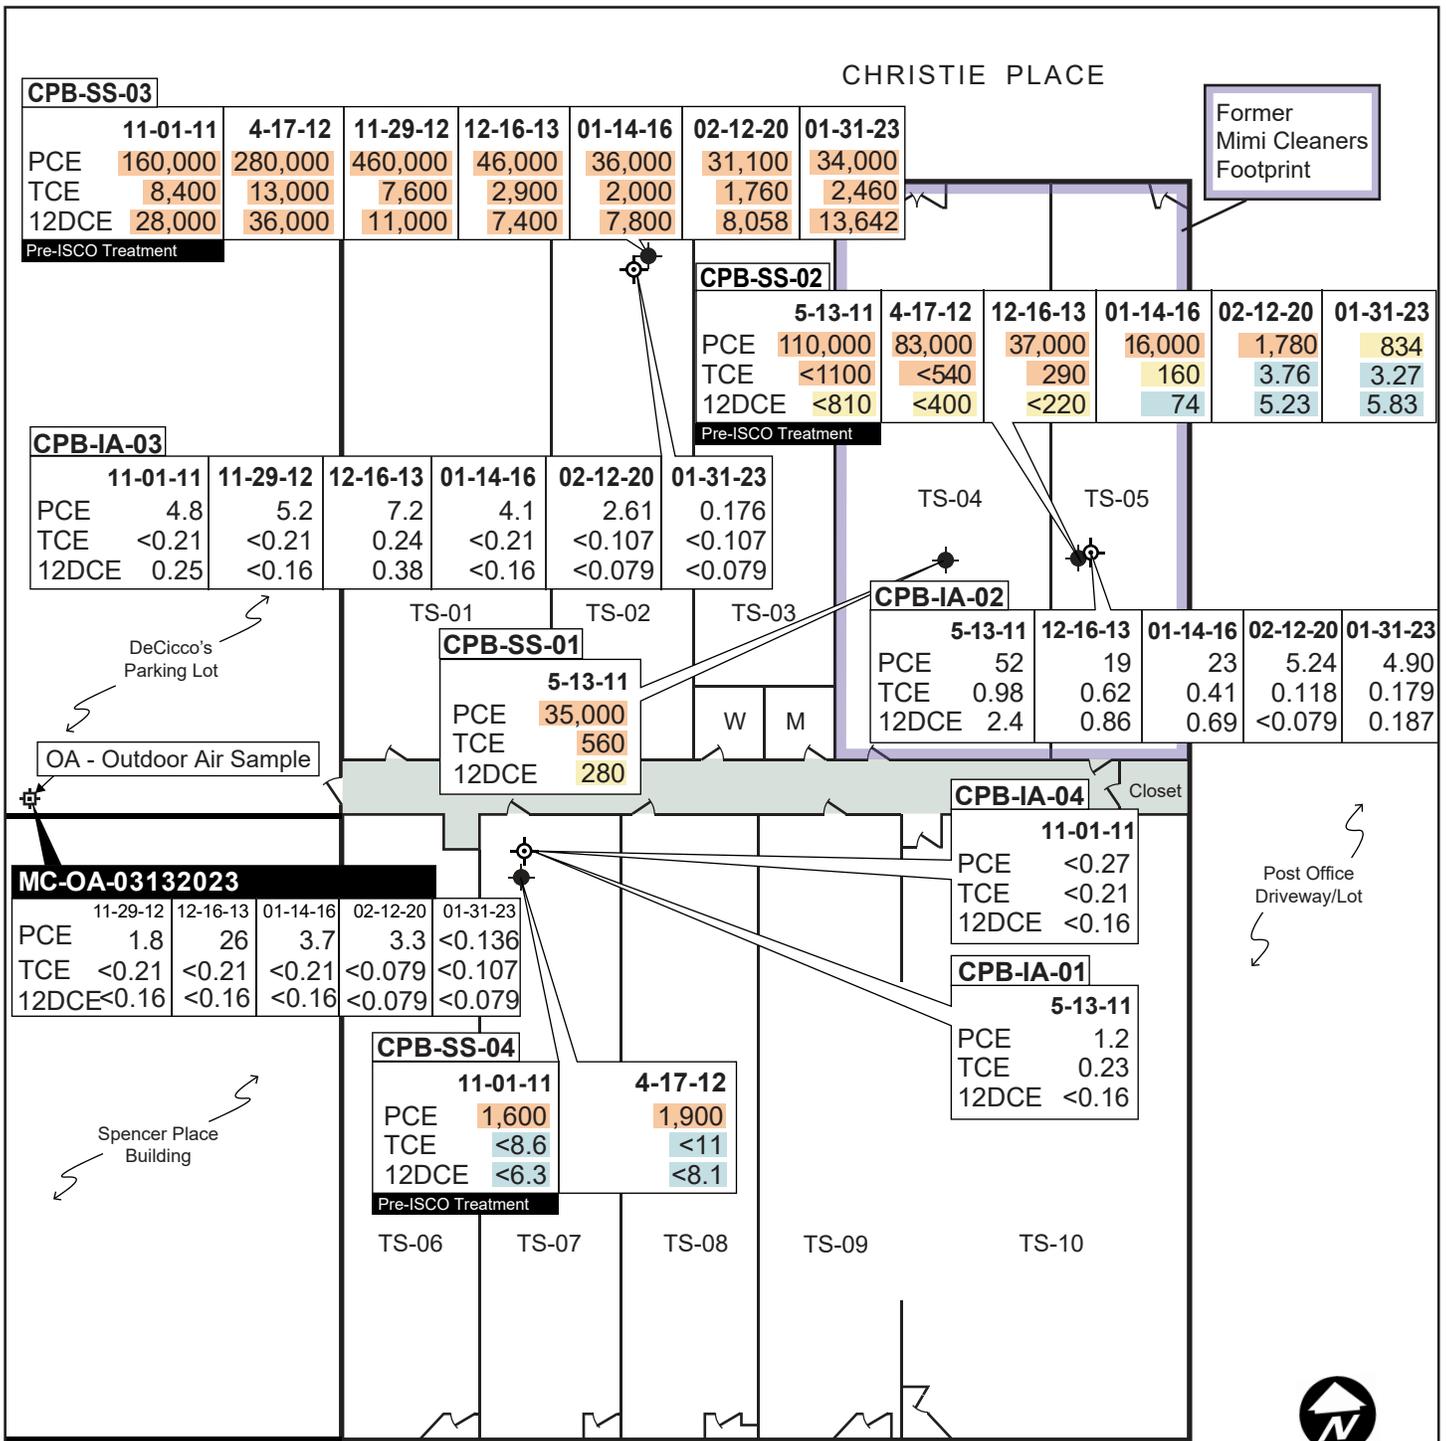
Sub-slab vapor and indoor air testing conducted at CPB between 2011 and 2020 revealed concentrations of PCE and TCE at which NYSDOH guidance recommended mitigation.. The results of the most recent sub-slab vapor and indoor air sampling event conducted in the CPB in January 2023 indicate that sub-slab concentrations of PCE have dropped below the level at which the NYSDOH guidance recommends mitigation, but remain within the range for which monitoring is recommended. The 2023 sampling results are further discussed in Section 5.2 of this report.

- Sub-slab vapor sample location
- Indoor air sample location
- Common hallway
- PCE Tetrachloroethylene
- TCE Trichloroethylene
- 12DCE 1,2-Dichloroethene

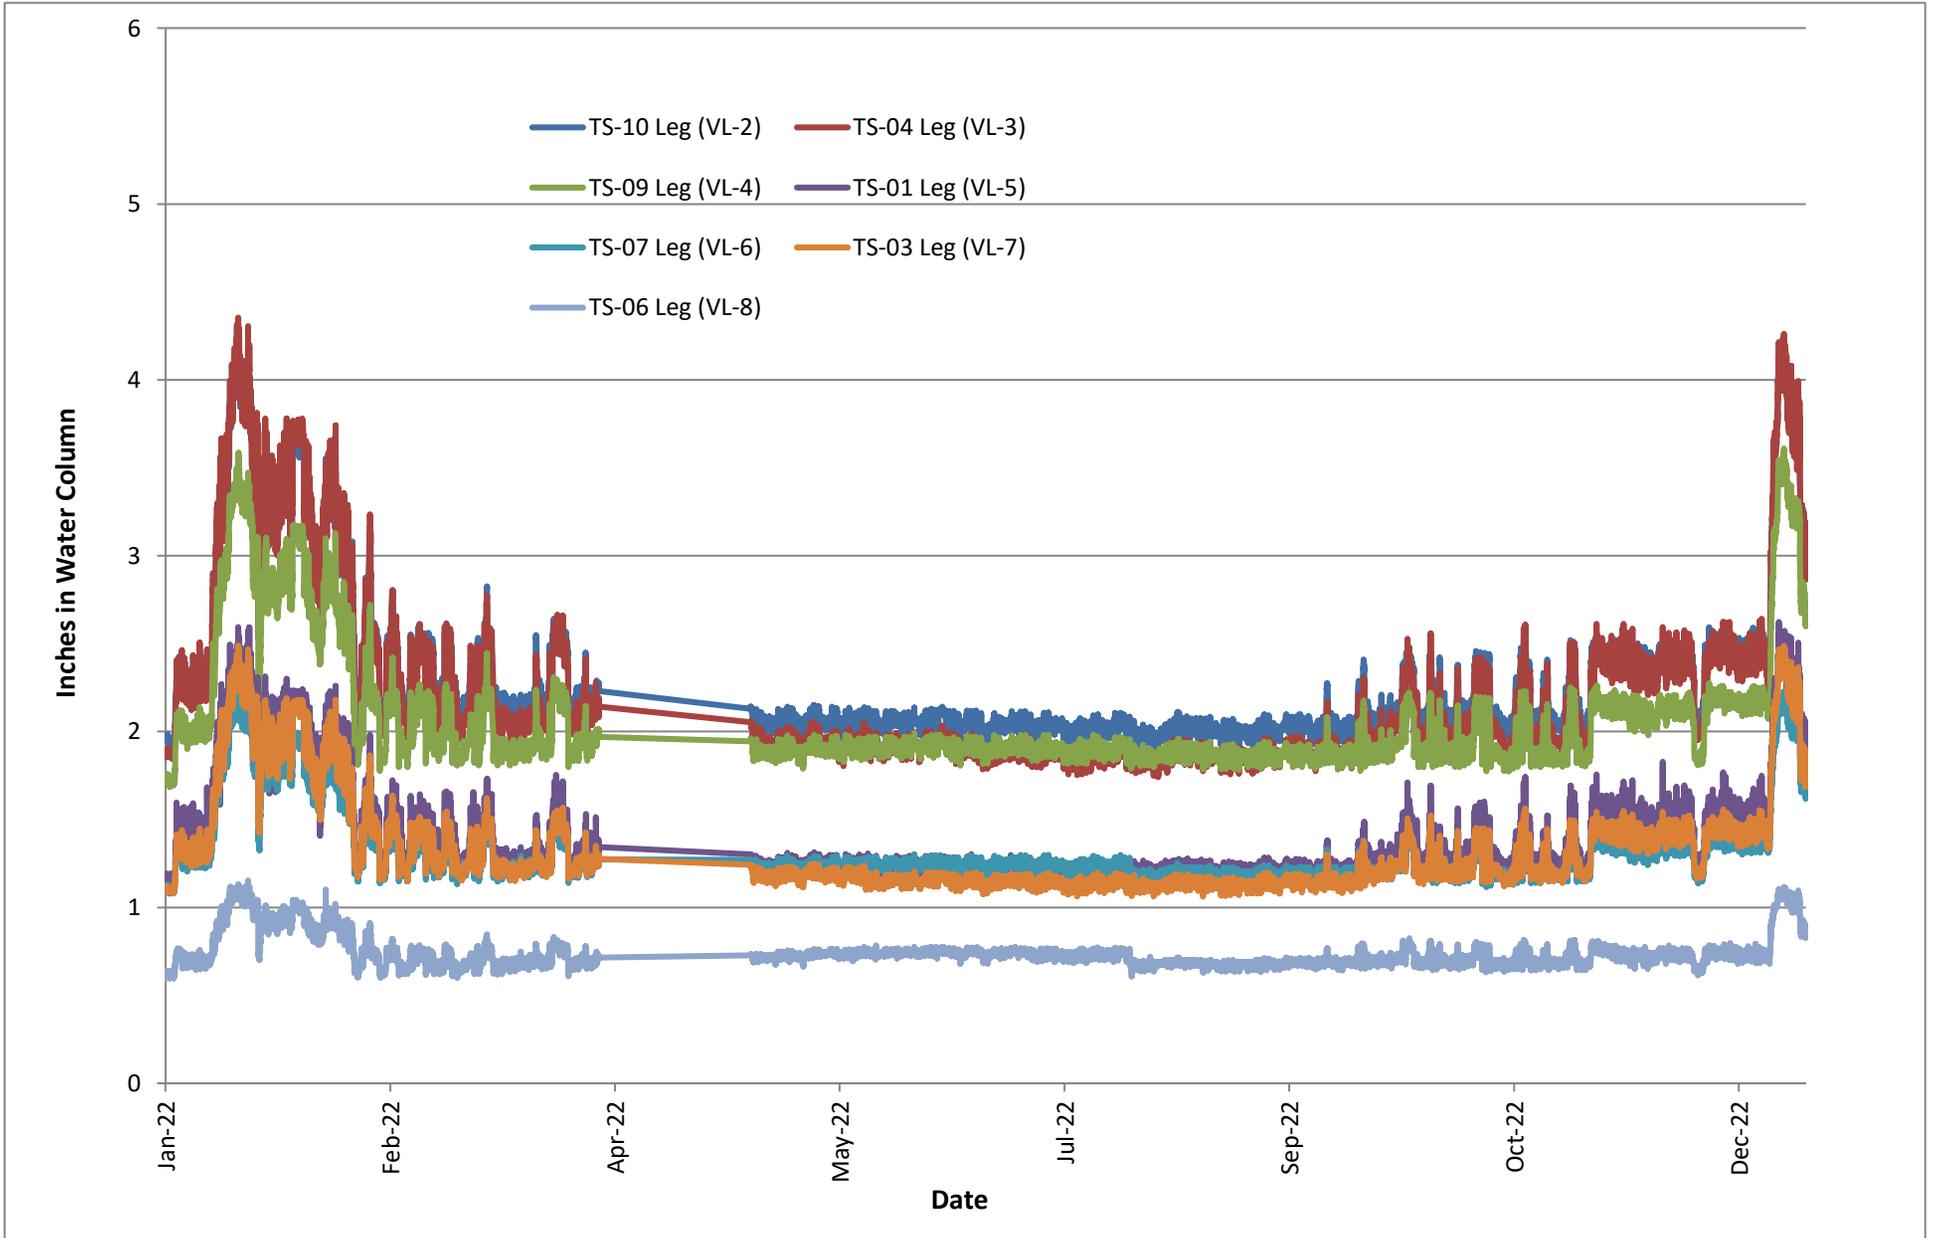
Former Mimi Cleaners - Christie Place Building  
Sub-Slab Depressurization System - Lateral Suction Leg Vacuum Data  
(January - December 2022)

The quarterly inspections at the CPB include recording the vacuums on the seven main extraction legs of the system, the vacuums on the moisture accumulator, and the dilution (bypass) bleed pressure on the blower exhaust. As stated previously, the SSDS at the CPB runs on a continuous basis. The differential pressure measurements are entered onto the field data sheets that are then transferred to an electronic spreadsheet (see **Table 3**). Differential pressure readings are collected from the sample ports in the floor to document that the sub-slab maintains an overall negative pressure under the building slab to remove a potential vapor intrusion pathway into the building. Inspection-to-inspection measurements are compared to identify possible degradation in system vacuum or the sub-slab vacuums.
