RE: Monthly Progress Report – December 2010
Greif, Inc. Facility – Tonawanda, New York
NYSDEC VCP Number V00334-9

TITLE SAMPLE AND MEASUREMENT LOCATIONS GREIF FACILITY-TONAWANDA, NEW YORK NYSDEC VCP NUMBER V00334-9		
PREPARED FOR SONOCO PRODUCTS COMPANY

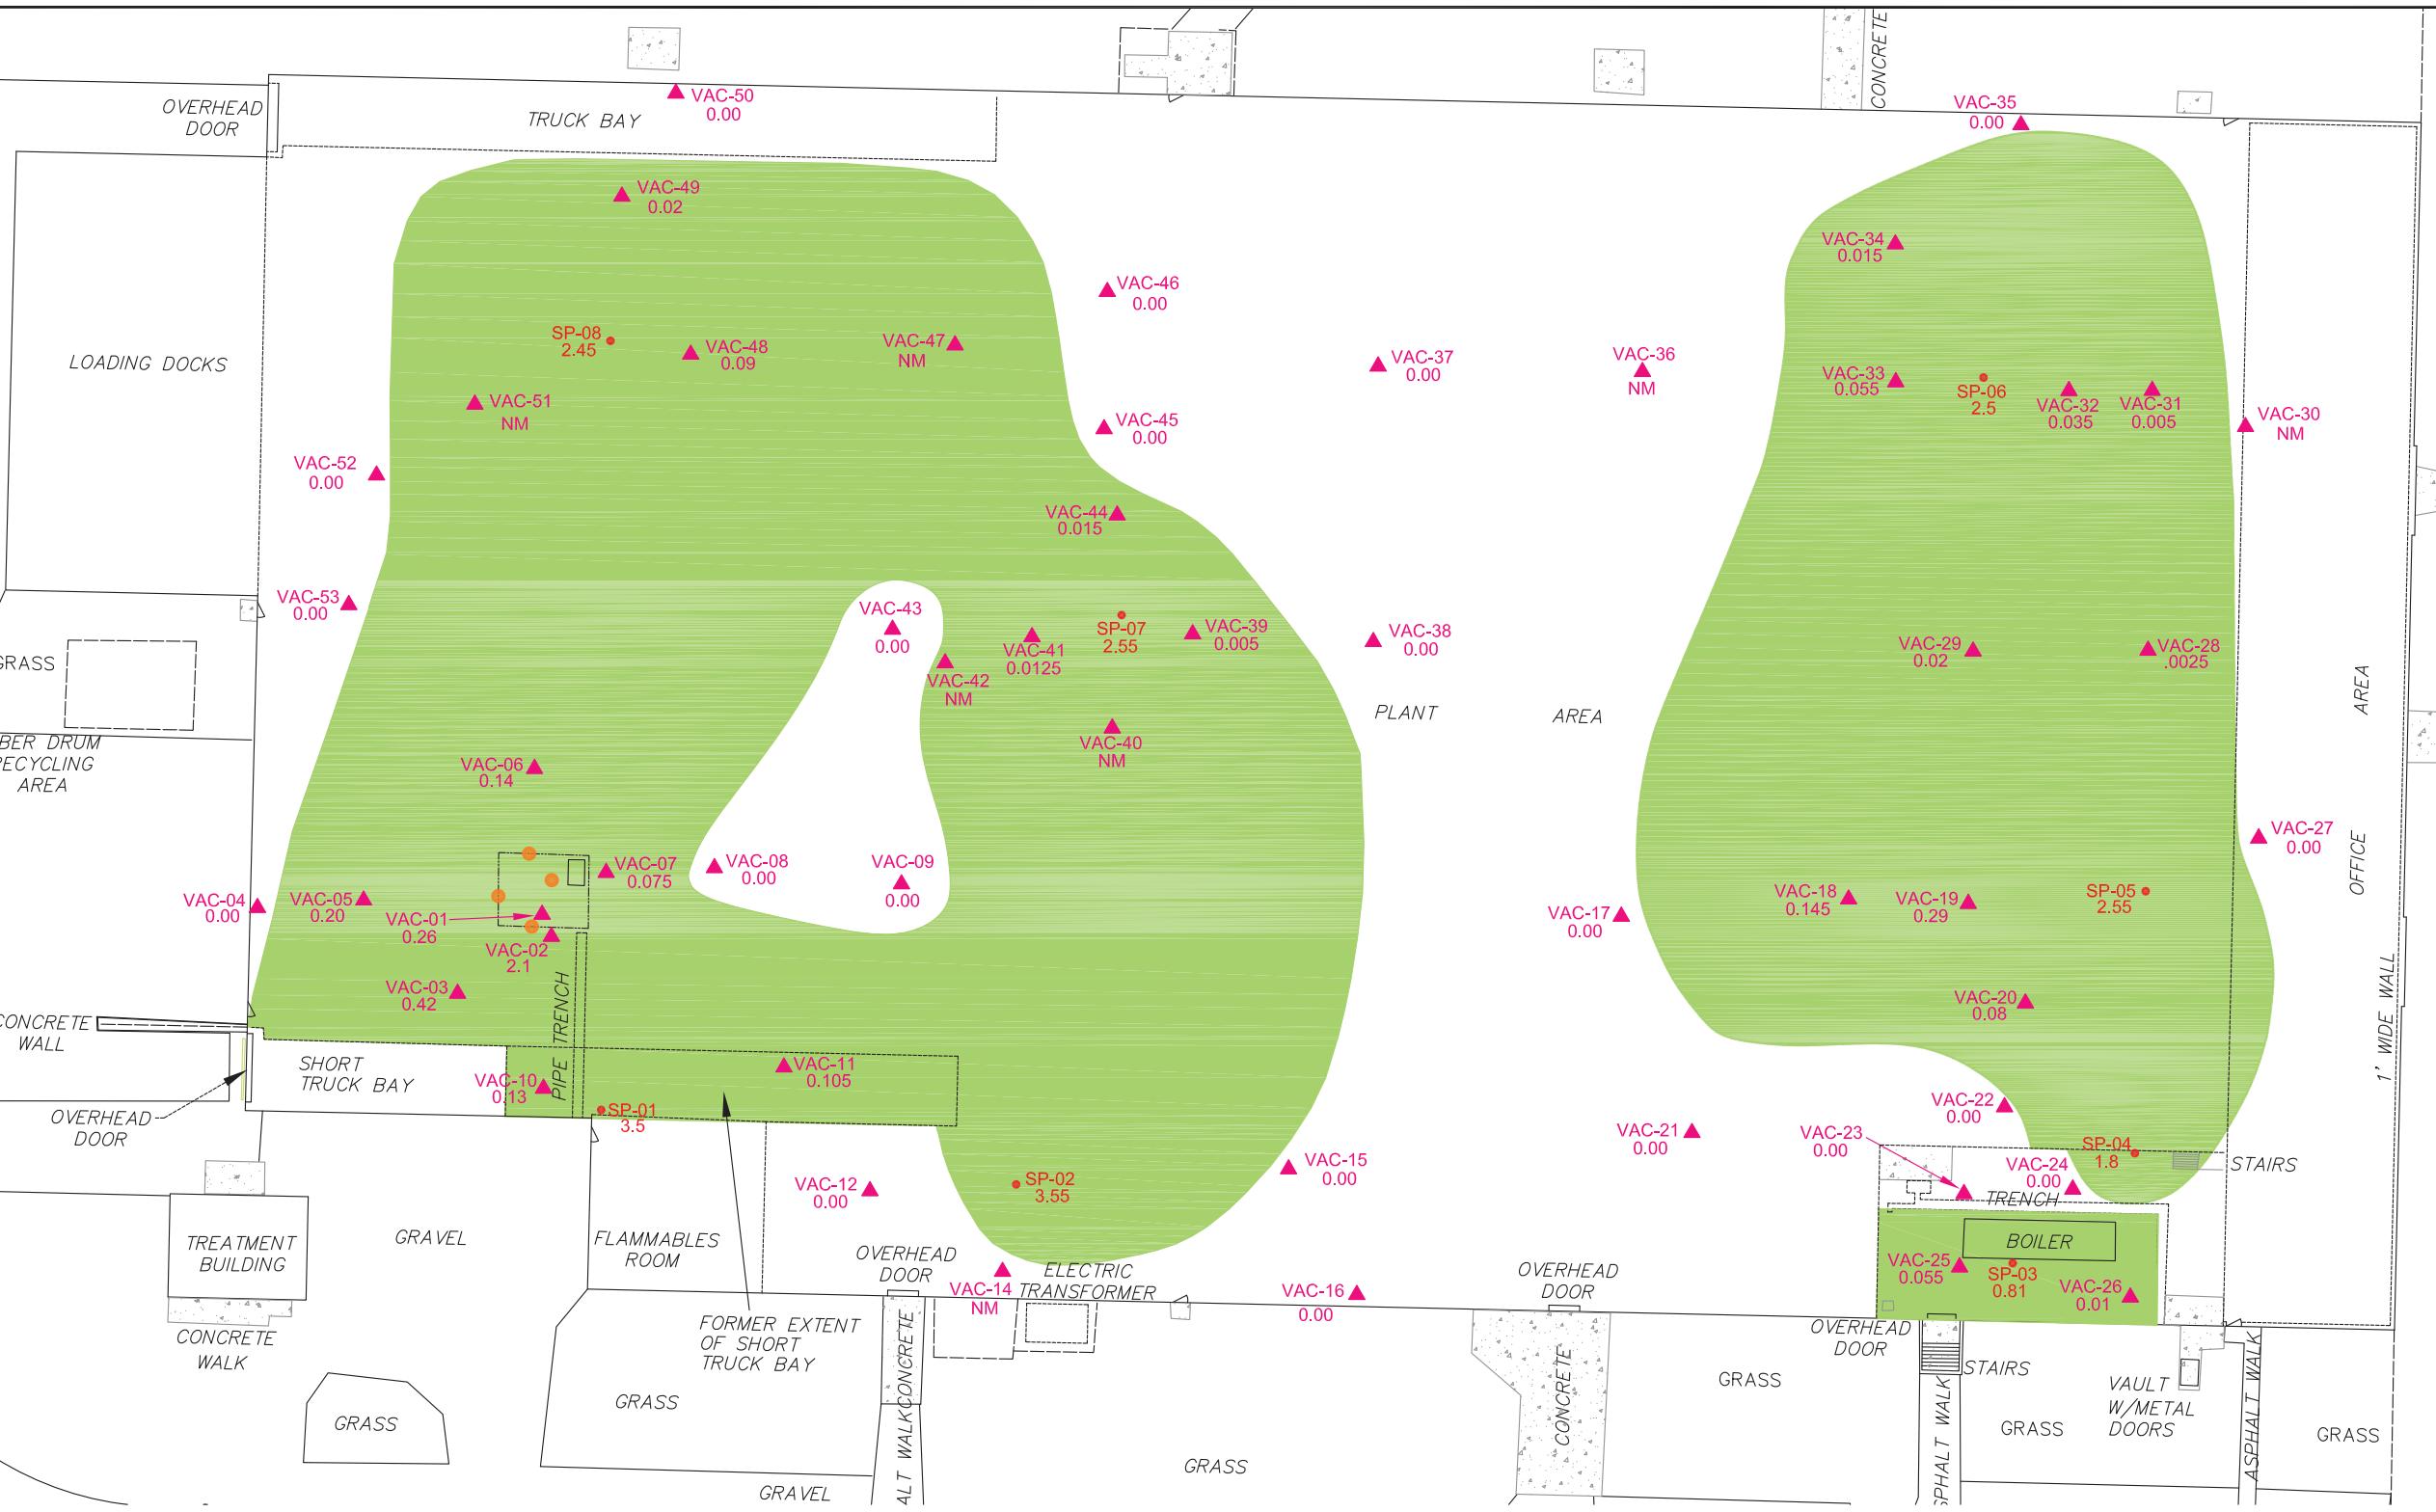
FIGURE
2

- Performed routine operations and maintenance (O&M) on the Pilot Sub-Slab Depressurization (SSD) system and dense, non-aqueous phase liquid (DNAPL) recovery equipment. Collected and recorded relevant data. Data collected included liquid level measurements in selected Site wells and monitoring points (Table 1), vacuum readings in vacuum monitoring points (Table 2), and treatment system operational data (Table 3). The locations of wells and other monitoring points are presented in Figure 1. A map showing the estimated distribution of vacuum in the sub-slab at the facility on 16 December 2010 is presented in Figure 2.

TITLE
SUBSURFACE VACUUM DISTRIBUTION
12 DECEMBER 2010
GREIF FACILITY-TONAWANDA, NEW YORK
