RE: Monthly Progress Report – January 2011
Greif, Inc. Facility – Tonawanda, New York
NYSDEC VCP Number V00334-9

**SAMPLE AND MEASUREMENT LOCATIONS
GREIF FACILITY-TONAWANDA, NEW YORK
NYSDEC VCP NUMBER V00334-9**

TITLE
SUBSURFACE VACUUM DISTRIBUTION
19 JANUARY 2011
GREIF FACILITY-TONAWANDA, NEW YORK

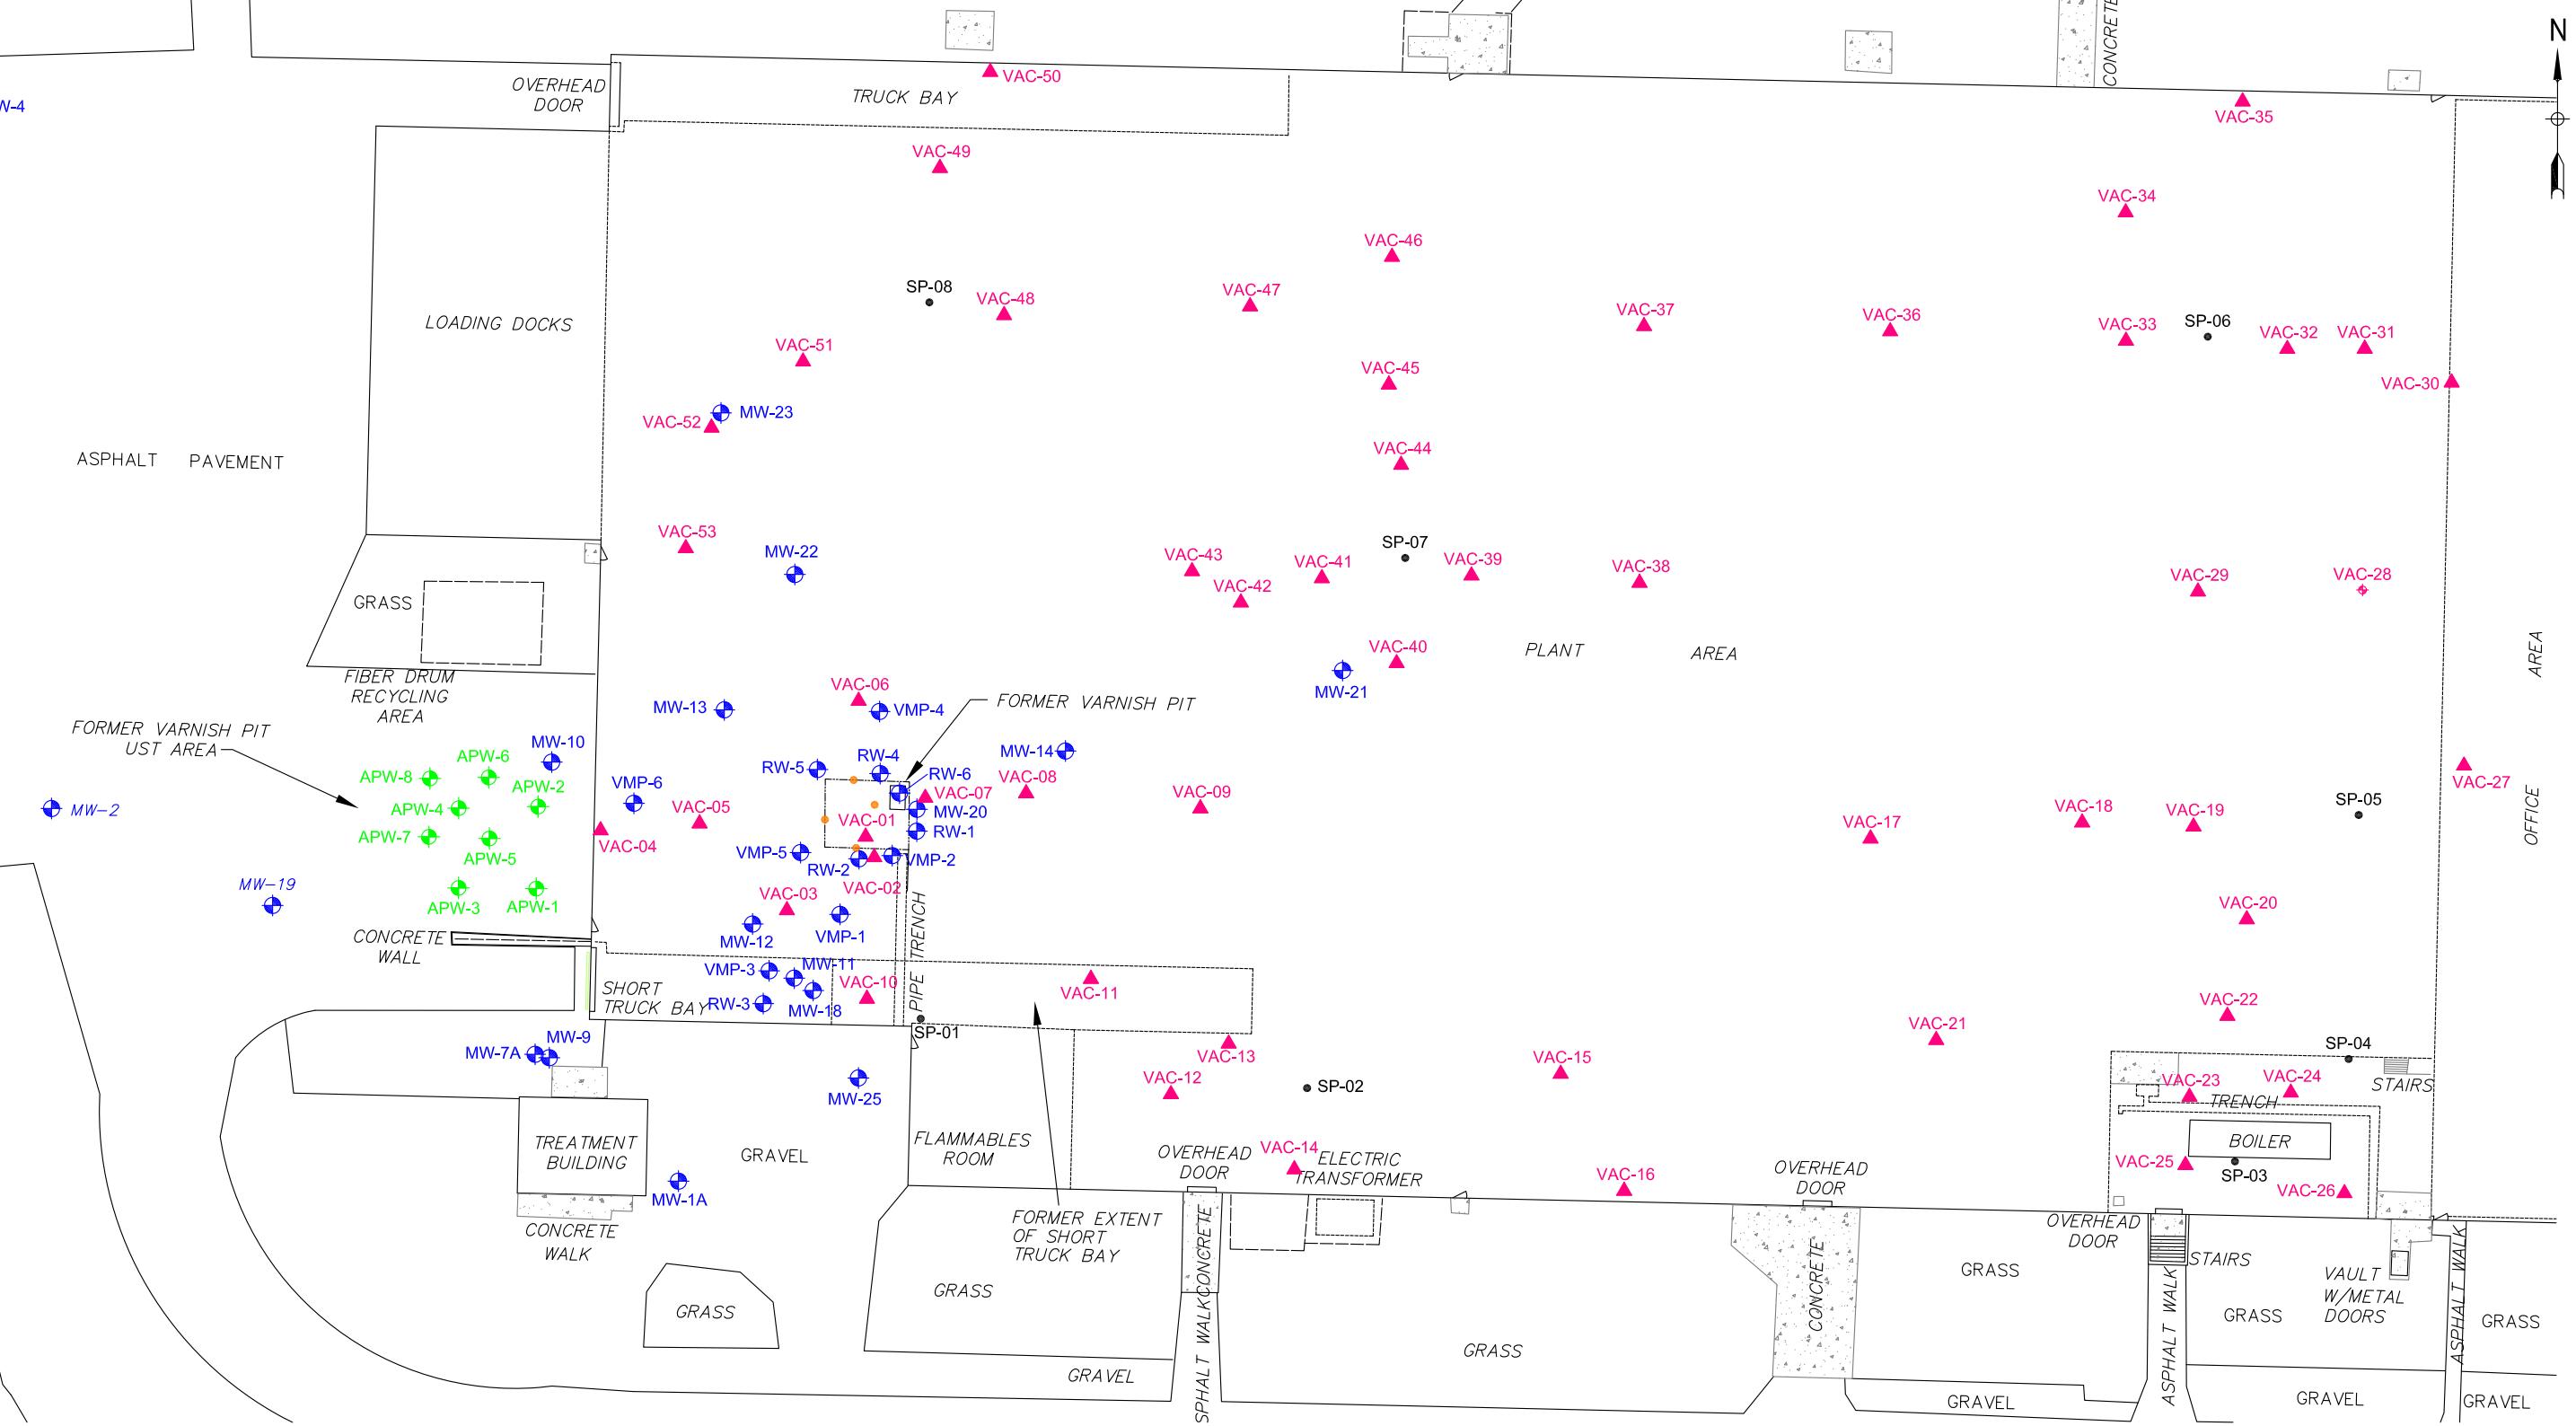
- ▲ Vacuum Monitoring Point Location
 - Monitoring or Recovery Well Location
 - ◆ Antenna Placement Well
 - Suction Point Location
 - Horizontal Suction Point Location

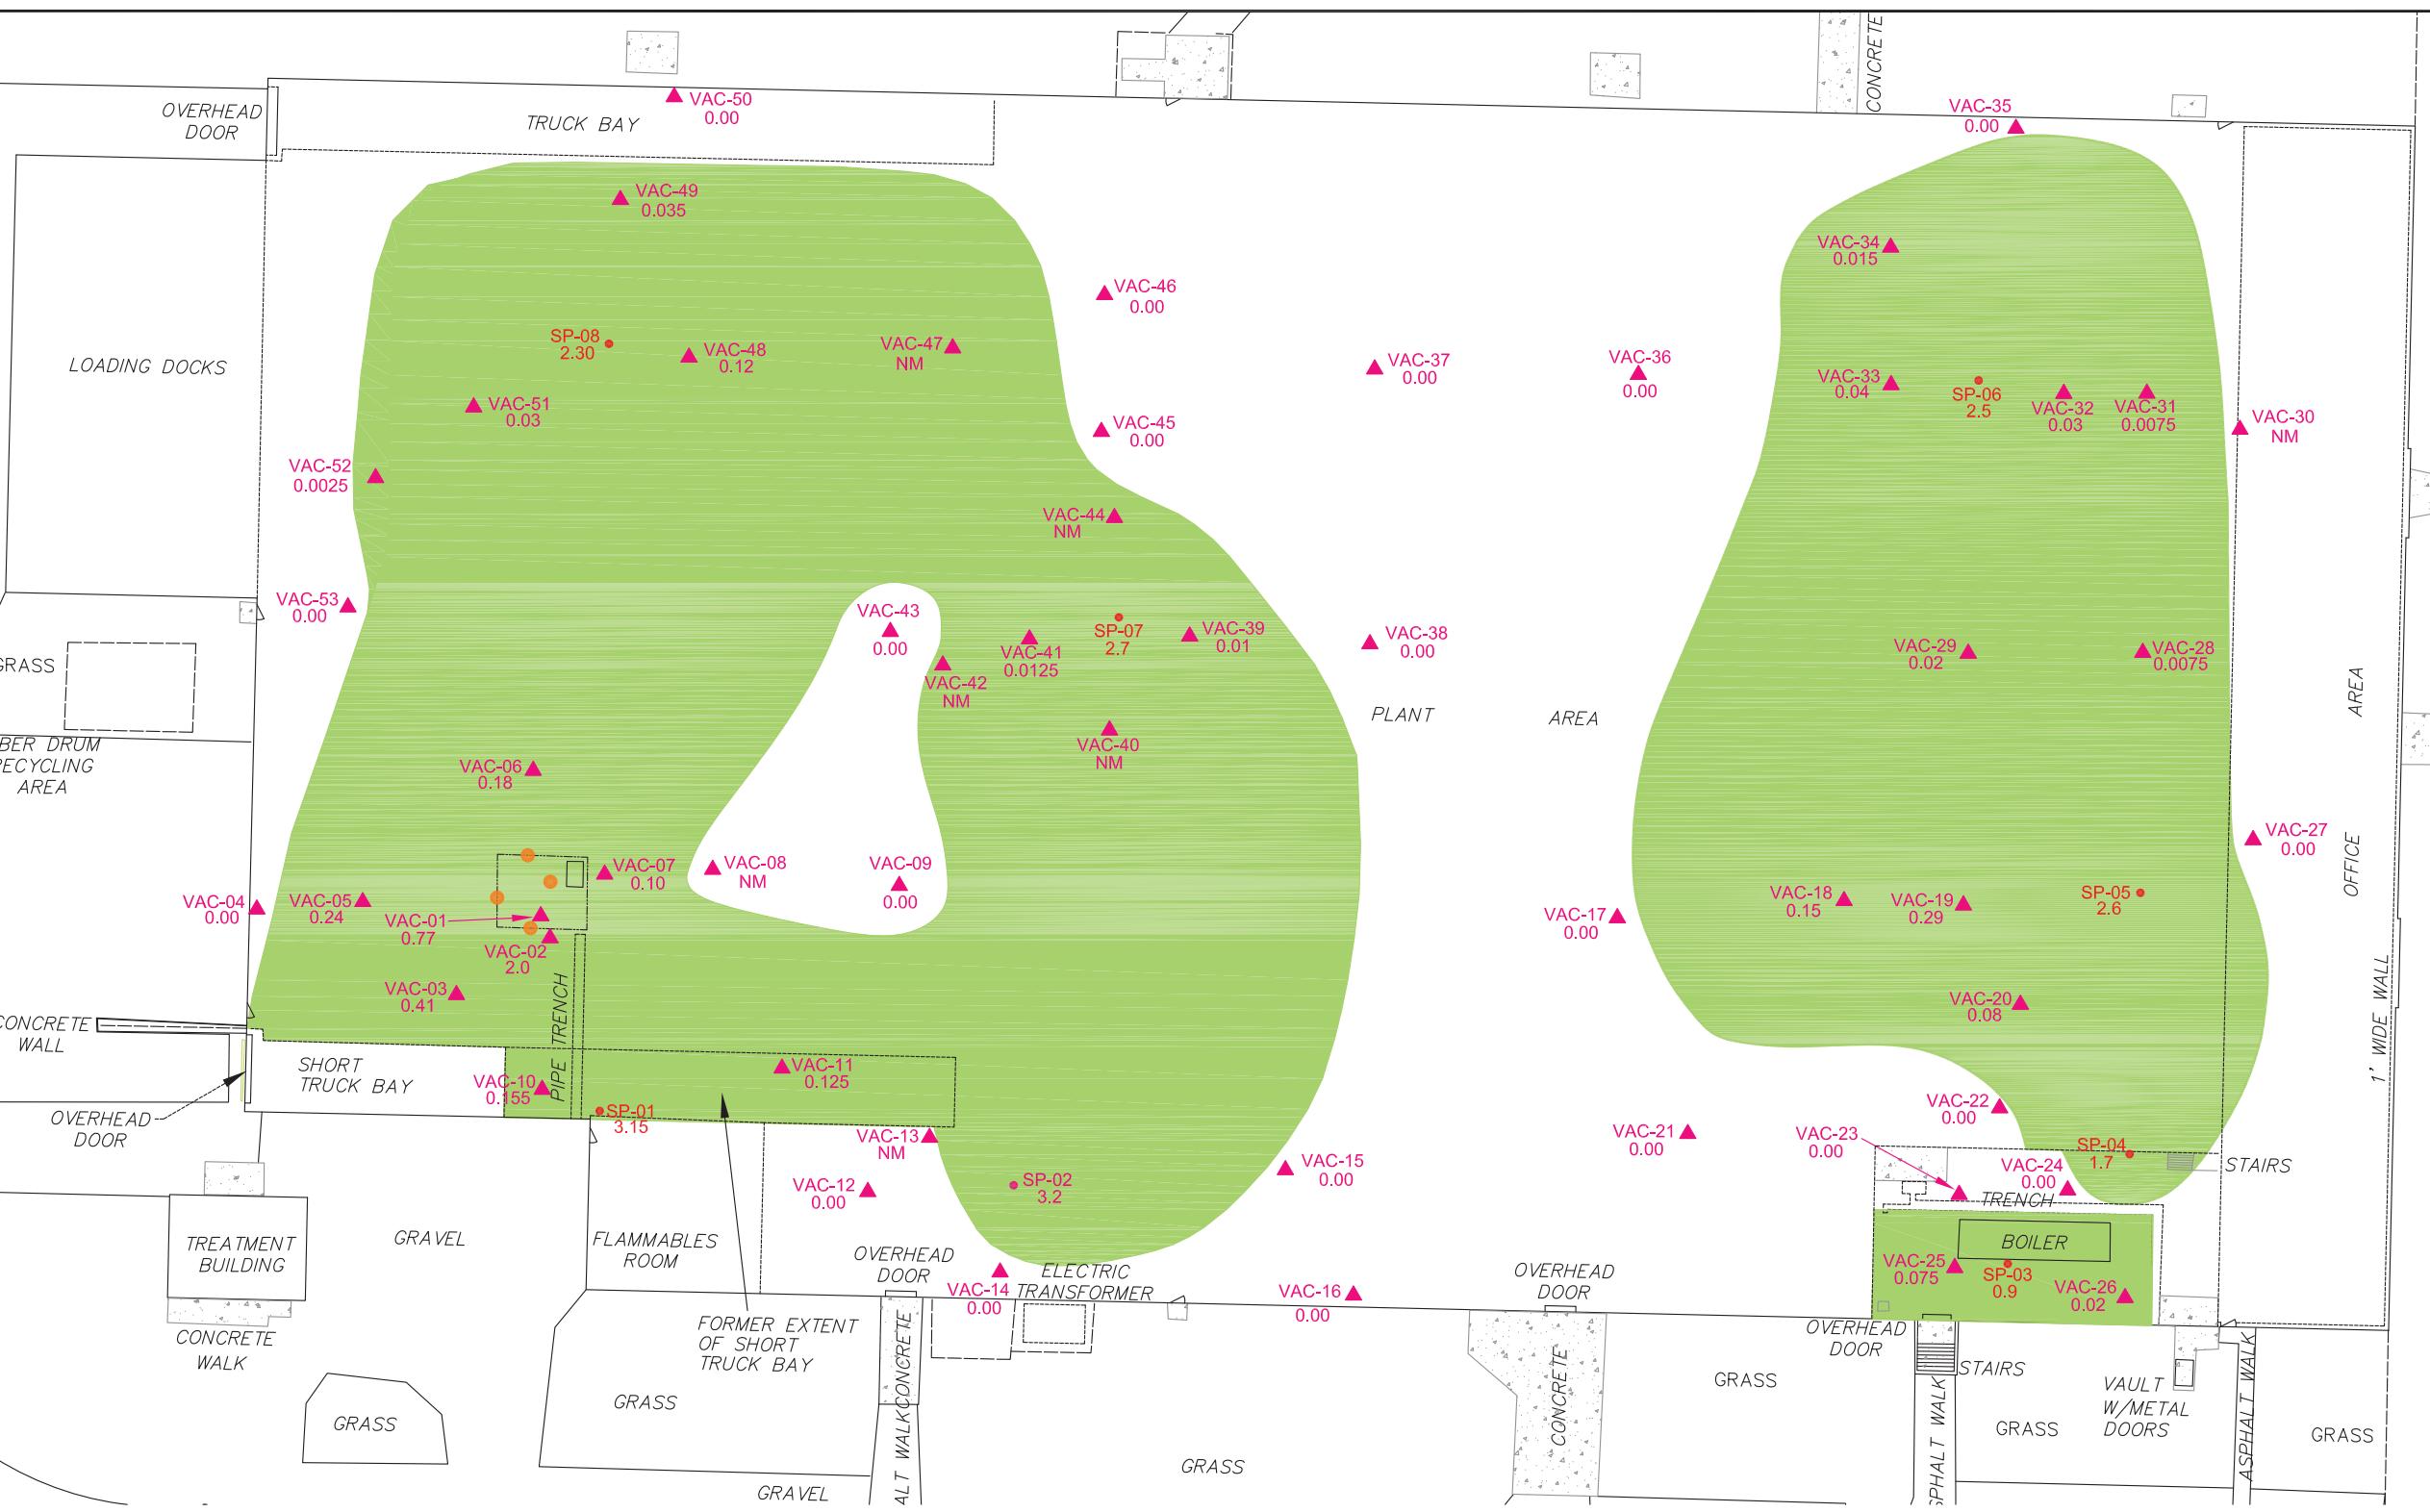
FIGURE
2

- Performed routine operations and maintenance (O&M) on the Pilot Sub-Slab Depressurization (SSD) system and dense, non-aqueous phase liquid (DNAPL) recovery equipment. Collected and recorded relevant data. Data collected included liquid level measurements in selected Site wells and monitoring points (Table 1), vacuum readings in vacuum monitoring points (Table 2), and treatment system operational data (Table 3). The locations of wells and other monitoring points are presented in Figure 1. A map showing the estimated distribution of vacuum in the sub-slab at the facility on 19 January 2011 is presented in Figure 2.

- Horizontal Suction Point Location
- Vertical Suction Point Location
- ▲ Vacuum Monitoring Point Location (vacuum in " H₂O)
- 0.125
- NM Not Measured
- Estimated Extent of Sub-Floor Vacuum
