2024 Periodic Review Report Corning Family YMCA Closed VCA Site Number V00357

WSP USA Inc.

01/23/2025

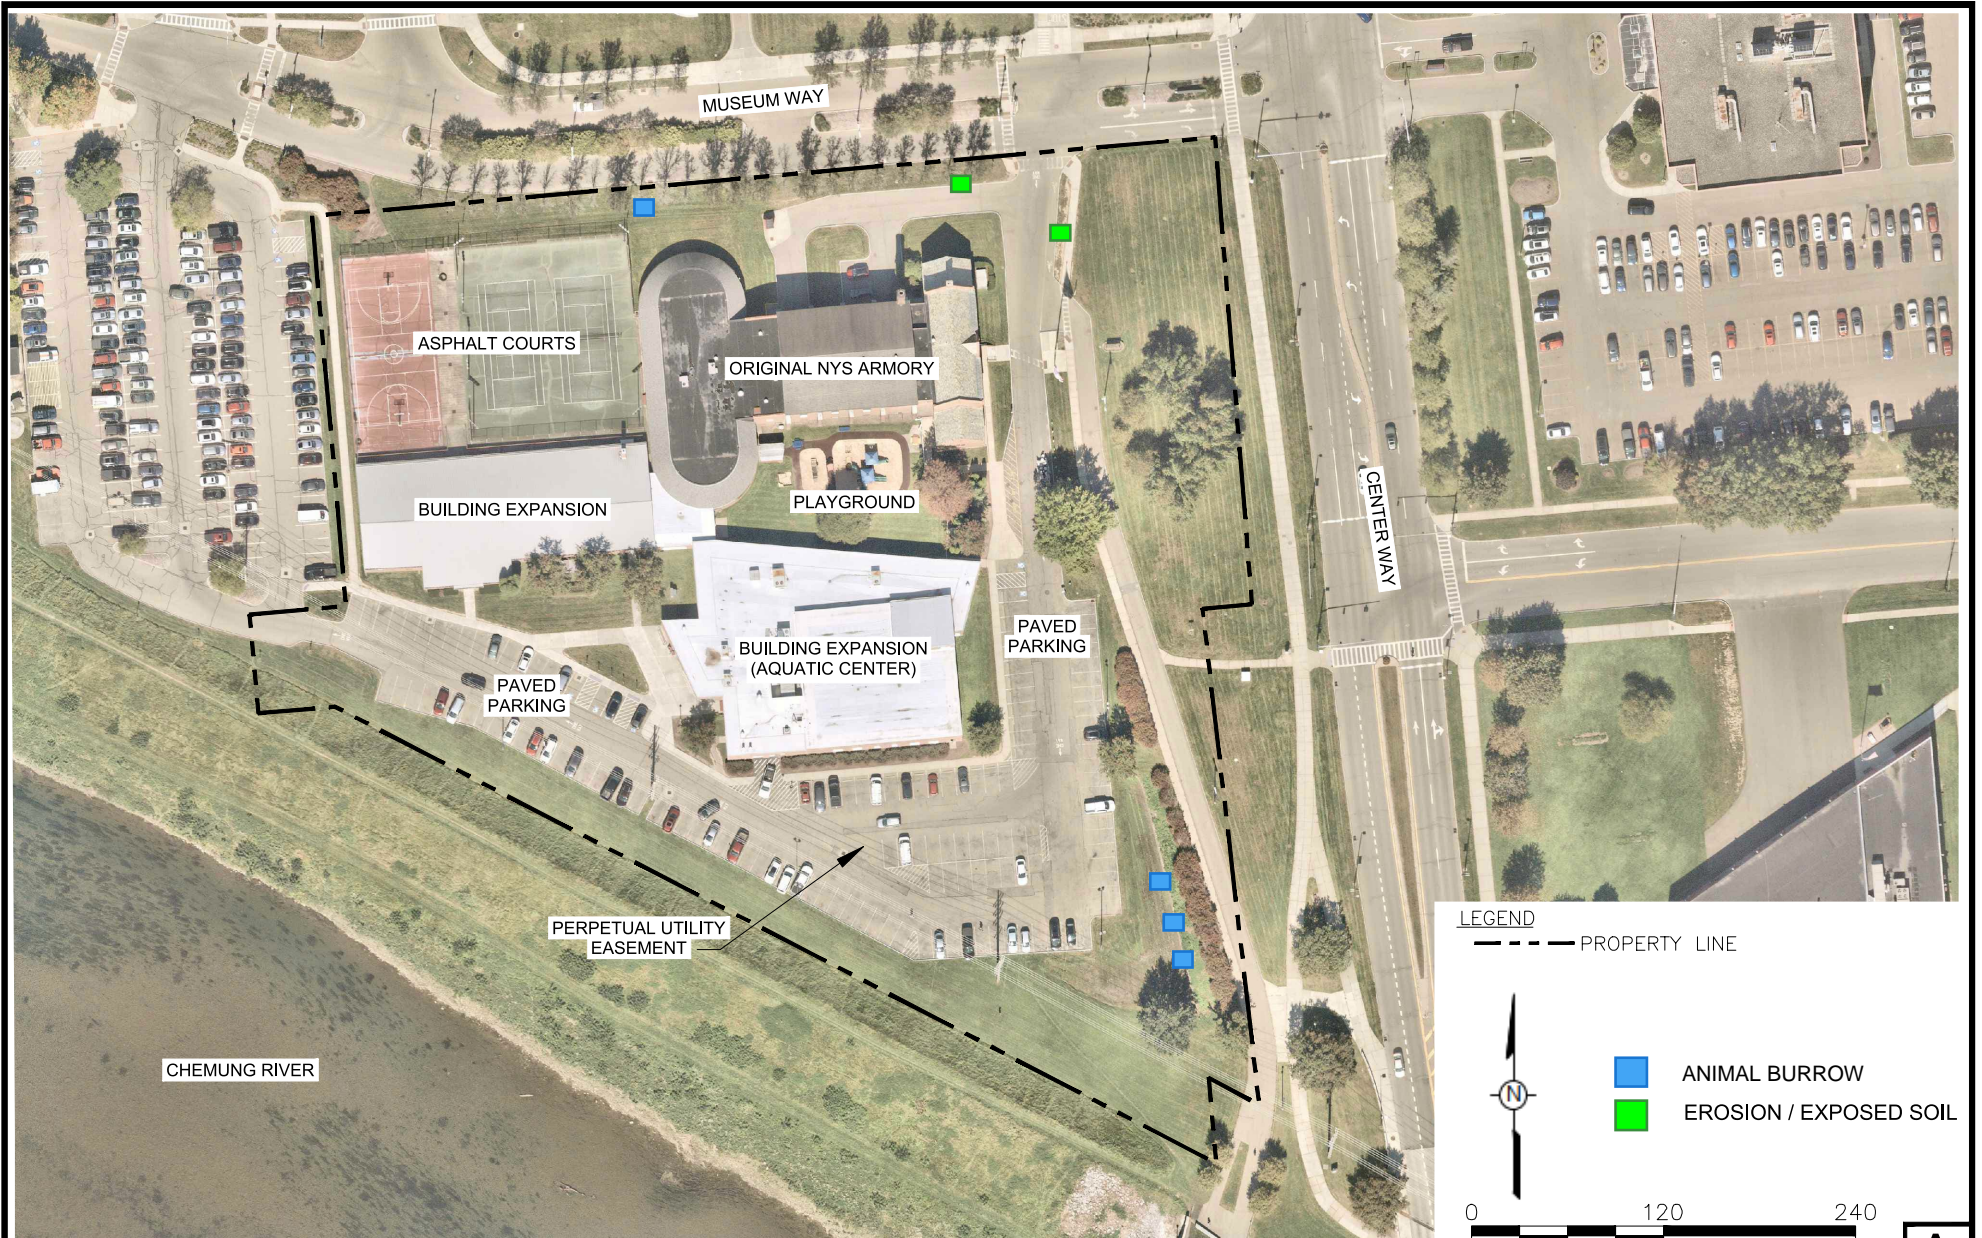
FIGURE 2

SITE PLAN

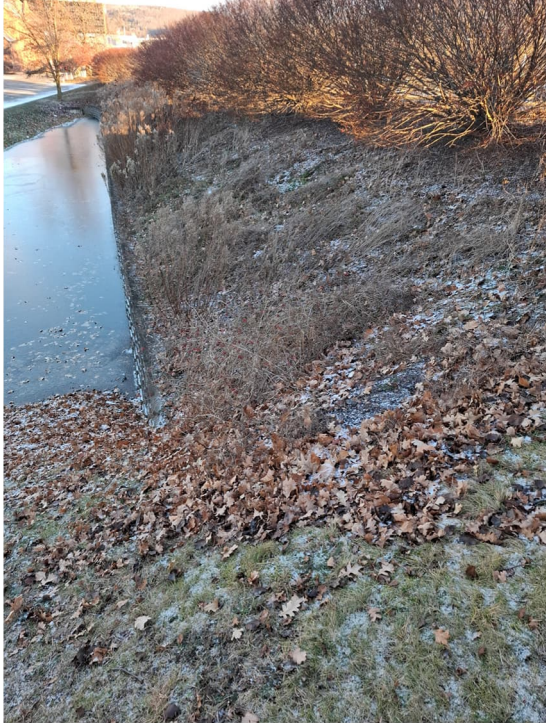
Photo No. 1	Date December 12, 2024

Bank of stormwater feature basin, facing north

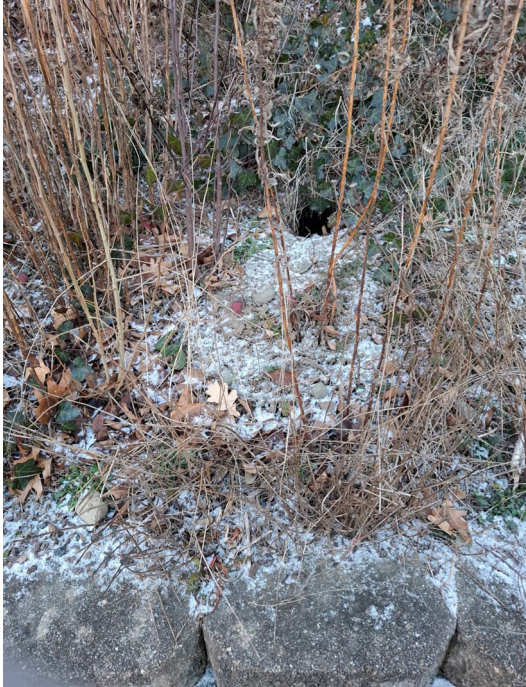
Photo No. 3	Date December 12, 2024

Animal burrow near the upper edge (West) of the stormwater feature, facing west.

1. Repair the areas of minor soil erosion
 - a. Seed the bare areas along the access ways where vegetative cover is limited when weather permits
2. Repair the animal burrows
 - a. Containerize, characterize, and dispose of ash-fill impacted material generated during repairs to the cover systems consistent with the means and methods previously utilized when weather permits

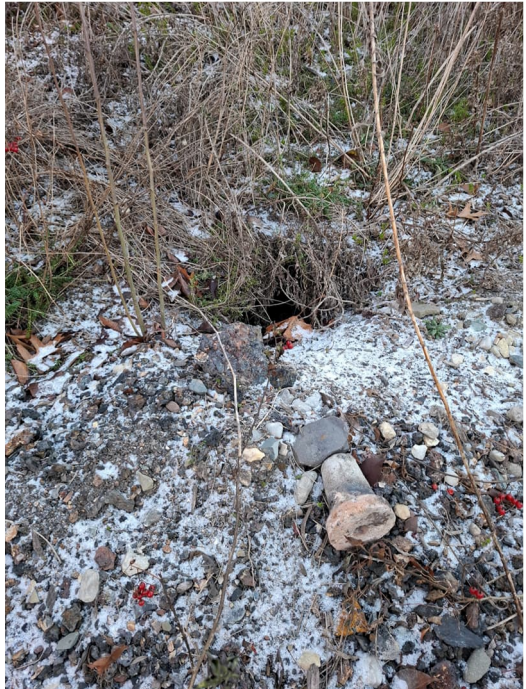
Photo No. 4	Date December 12, 2024

- Three animal burrows, consisting of two-burrows each, were identified along the upper edge of the east retaining wall of the stormwater feature (basin)
- Suspect exposed ash, brick, and glass material associated with animal burrows along the east retaining wall of the stormwater feature (basin).
- Two animal burrows were observed north of the asphalt sports court.
- Minor soil erosion around the stormwater feature (basin) slope.
- Limited vegetation near some paved areas.

Suspected ash, brick, and glass material associated with the animal burrows along the upper edge (West) of the stormwater feature.

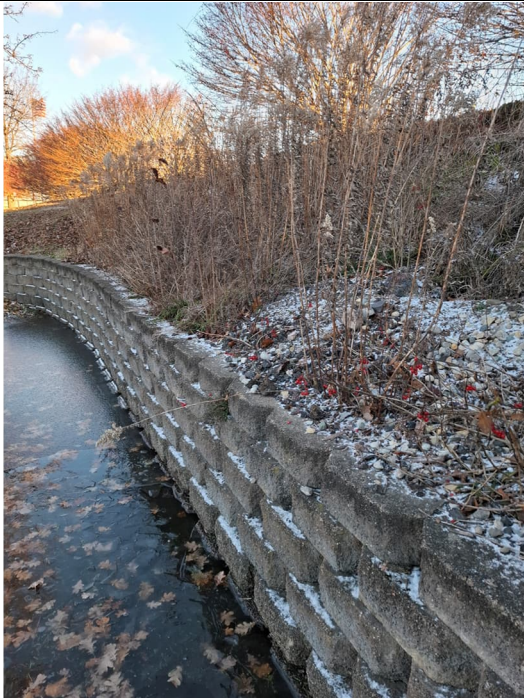
Photo No. 5	Date December 12, 2024

Suspected ash, brick, and glass material associated with the animal burrows along the upper edge (West) of the stormwater feature.

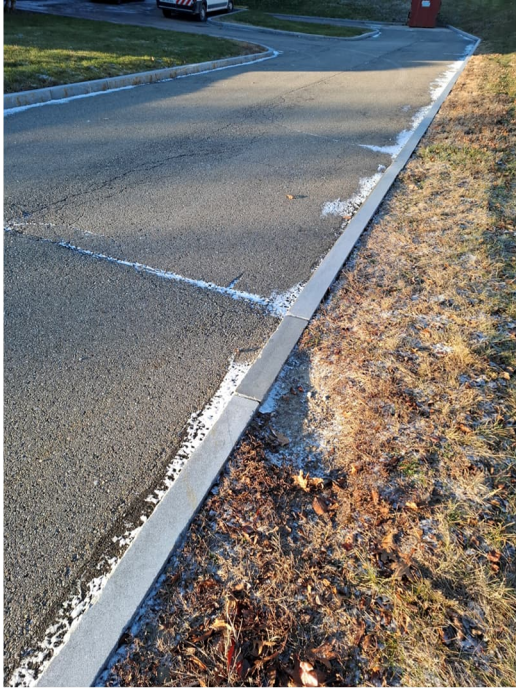
Photo No. 7	Date December 12, 2024

Soil depression along the roadway with limited vegetative cover, facing west.
