Re: Completion Report for Phase IV, Interim Remedial Measure at RG&E's
East Station Former MGP Site, Rochester, New York.
VCA Index #: B8-0535-98-07 Site #: V000358-8

**PHASE IV INTERIM REMEDIAL
MEASURE IMPLEMENTATION REPORT
EAST STATION FORMER MGP SITE
ROCHESTER, NEW YORK**

This Implementation Report provides details of the construction activities completed for the Phase IV ISS IRM at RG&E's East Station Former MGP Site in Rochester, New York. The ISS IRM involved excavation and off-site disposal of cyanide-impacted soils; installation of three rows of ISS columns incorporating impacted soils containing NAPL; a cement-bentonite slurry wall on the east side of the ISS columns for controlling potential non-aqueous phase liquid (NAPL) flow in the weathered bedrock underneath the ISS columns; and installation of a NAPL collection trench to the east side of the cement-bentonite wall on the land side. As required by NYSDEC, monitoring and NAPL recovery wells were installed for performance monitoring of the IRM. After the construction work was completed, the disturbed areas were restored by backfilling, grading and hydro seeding activities.

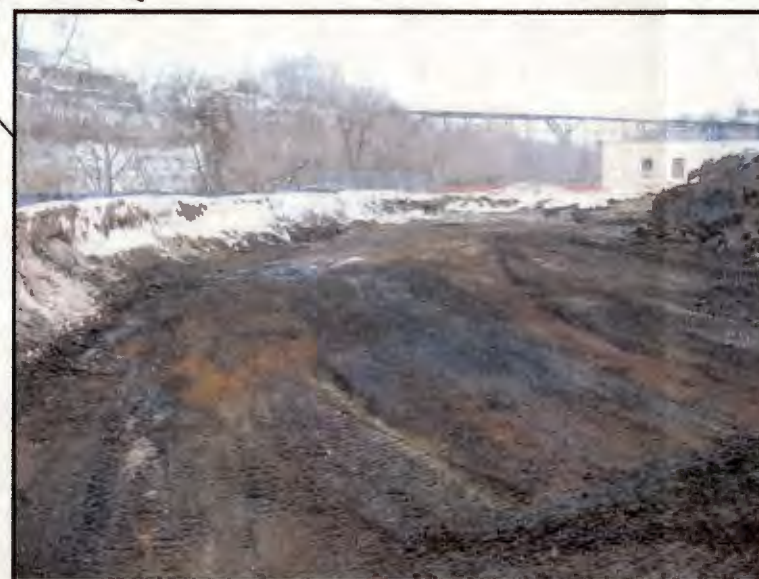
EXCAVATION BOTTOM (392') ON 12-07-07

Cyanide impacted soil was still observed in Area 1 on the excavation floor. Therefore, additional material was removed from the floor of Area 1 to an approximate elevation of 390 to 391 feet msl. Figure 2-4 provides the excavation area and depth information as of December 14, 2007. Photographs provided on Figure 2-4 document the excavation floor before and after the removal of the additional material. Standing water can be seen in the area where material was removed below the water table.

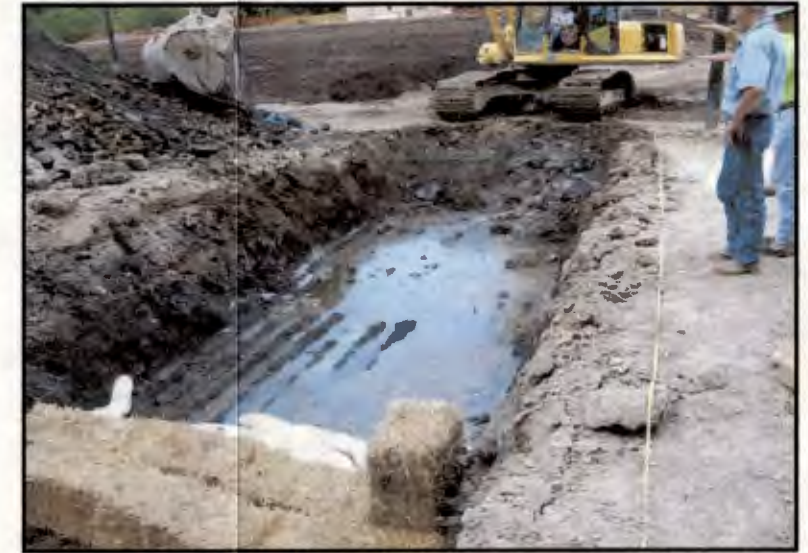
Groundwater Flow at 392' Elevation in Northern Channel

The northern swale was the first one constructed. An approximate 45 to 55 feet long by 15 feet wide by 8 feet deep channel was excavated in the ISS barrier. The bottom of the channel elevation was approximately 392 feet in elevation. Approximately 1 foot of cobblestone was placed on the bottom of the channel, covered with geotextile fabric and then backfilled to the original grade with the excavated stabilized material. Groundwater flow was observed passing through the channel at the constructed elevation.

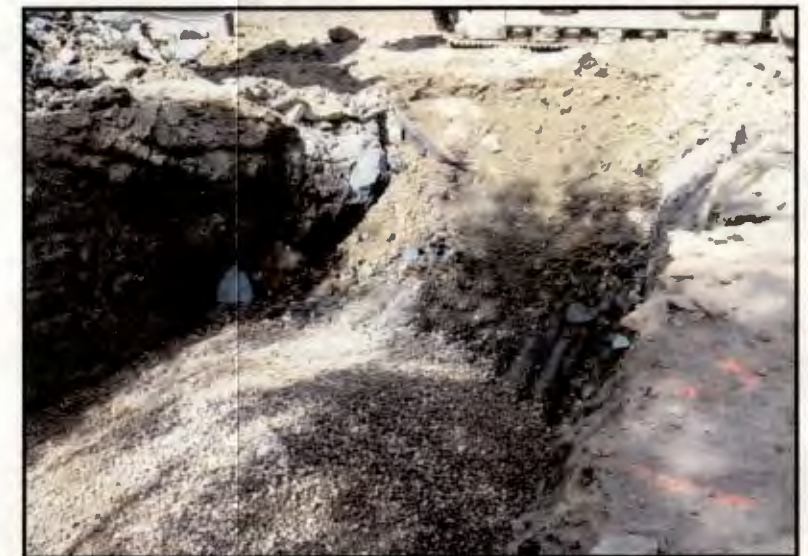
No Water Infiltration at Southern Channel at 392' Elevation

The second channel, completed in Area 2, was approximately 25 feet long by 18 feet wide and 5 feet deep. The same bottom elevation and construction details were utilized for the second channel although no groundwater flow was observed at the time of construction.

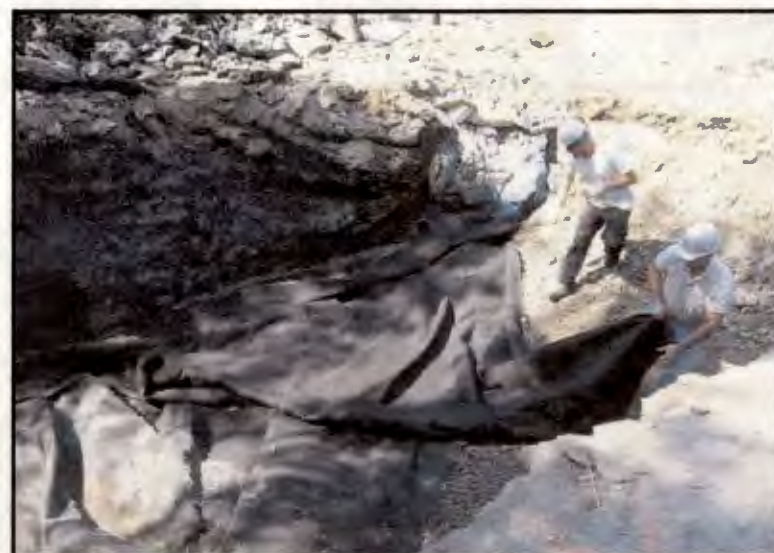
Geotextile Over Pea Gravel in Southern Channe

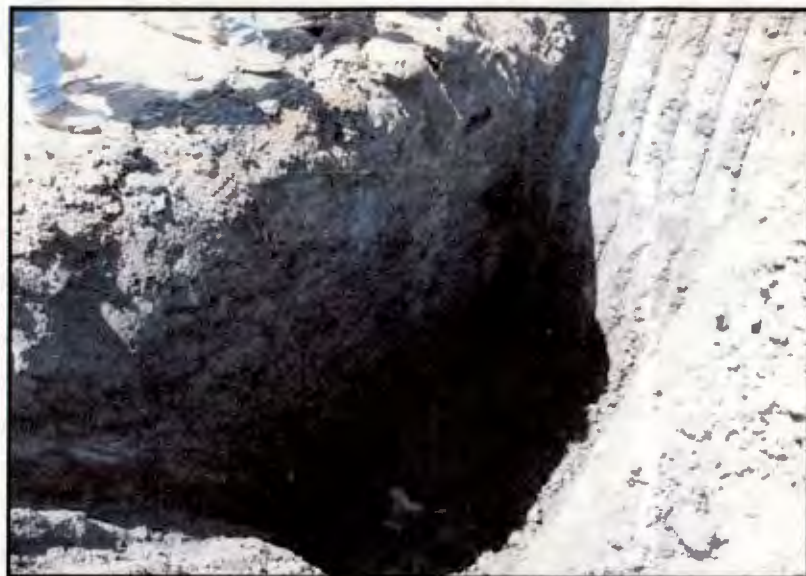
Test Pit at Columns B-6, B-7 and B-8 (5-28-08)

Test Pit in
ISS Column

video recordings are included in Appendix I. The test pits were excavated down the center columns (B-row) of the primary barrier with an excavator. Each test pit was excavated down to the hard bedrock beneath the columns. The stabilized material was hard and difficult for the excavator to penetrate. Following completion of the test pits, the previously stabilized material was remixed with grout for re-solidification as it was being replaced into the pit.

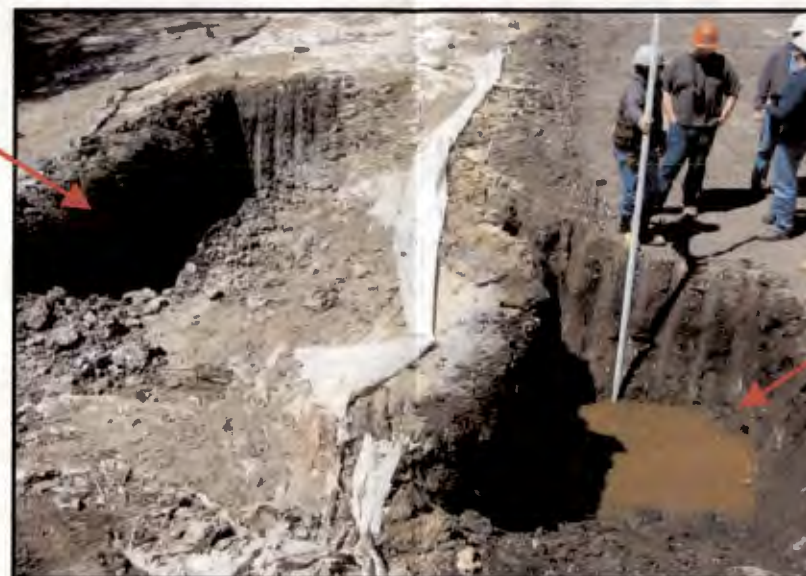
Test Pit at Columns B-6, B-7 and B-8 (5-28-08)
Showing Water Level East of ISS Barrier

Test Pit to
the East of
ISS Column

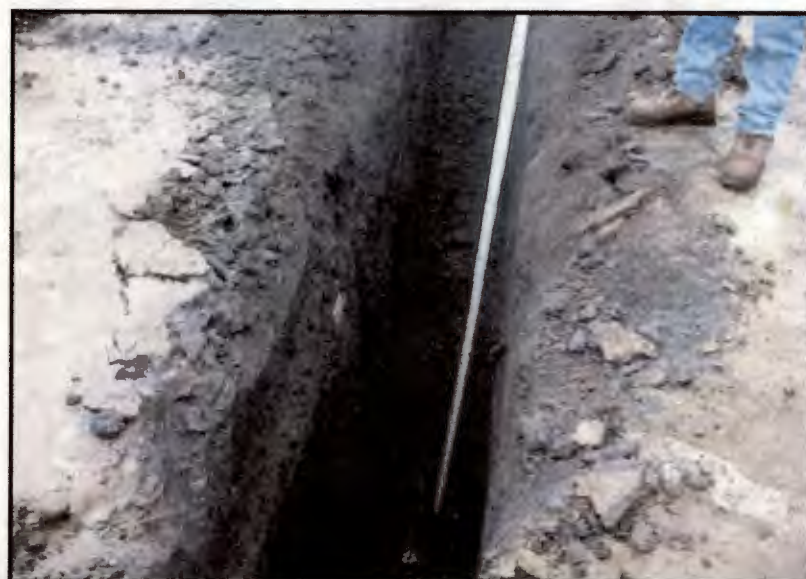
Test Pit at Columns B-24, B-25 and B-26 (6-4-08)

The second test pit was excavated through columns B-24, B-25 and B-26 in Area 2. This test pit was also dry down to 11.5 feet bgs where the bedrock layer was encountered. The bedrock layer was scraped and penetrated with the excavator rock bucket and water infiltration began entering from the bottom at the ISS interface after the bedrock was breached. NAPL was not encountered in this test pit.

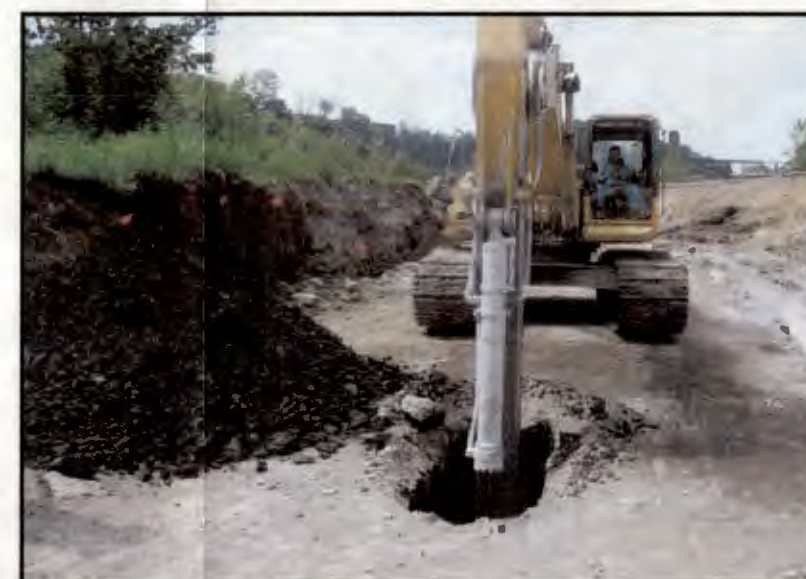
Test Pit at Columns B-111, B-112 and B-113 (6-26-08)

The third test pit was excavated through columns B-111, B-112 and B-113 in Area 3 to a depth of approximately 10 feet bgs. The bedrock was encountered and no free water or NAPL was observed in the stabilized mass.

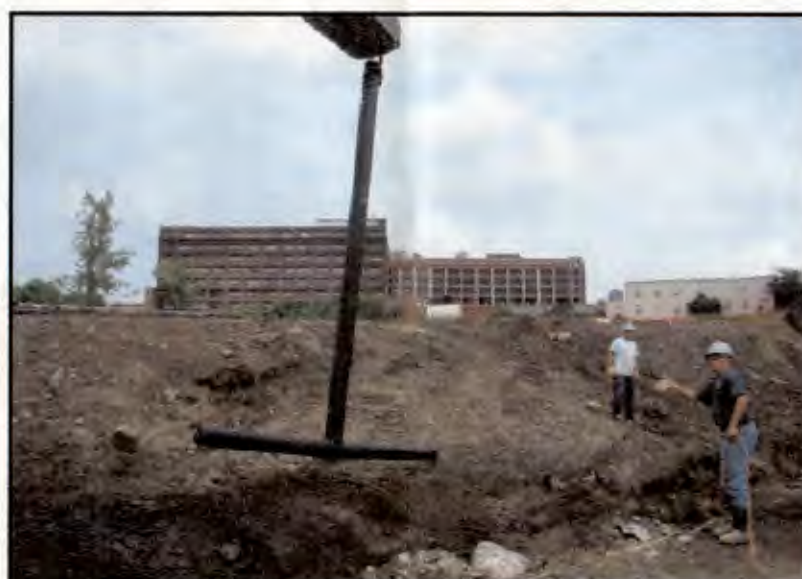
Vertical Recovery Point Construction and Placement

Provisions for the monitoring and removal of NAPL that may accumulate within the trench were made through the installation of 20 NAPL monitoring/recovery points. The design of the points incorporated features of both the vertical points and lateral pipes described in the Implementation Plan, and targeted locations of potential NAPL occurrence and bedrock conditions amenable to NAPL collection.

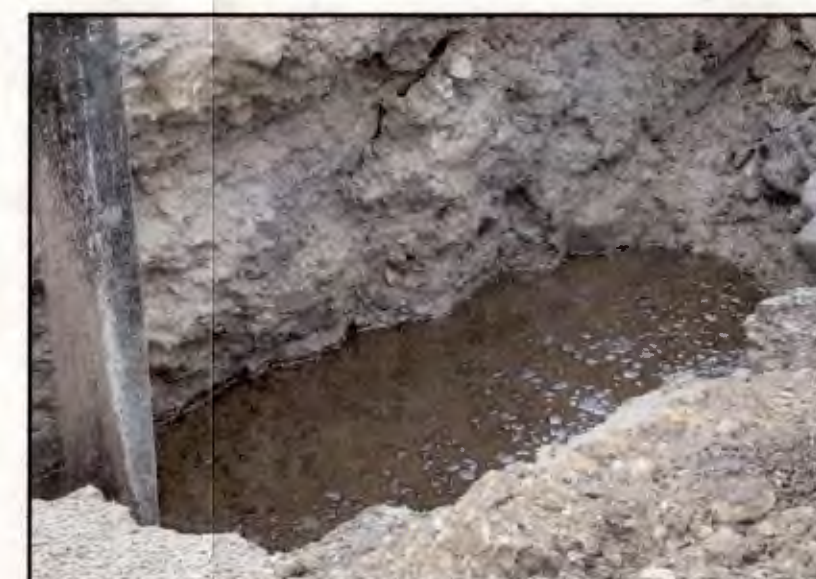
Water In Collection Trench
