**COMBINED PHASE I & PHASE II**

**SITE ASSESSMENT**

**ESI File Number: GY99143.21**

**Greyston Foundation  
21 Park Avenue  
Yonkers, NY 10701**

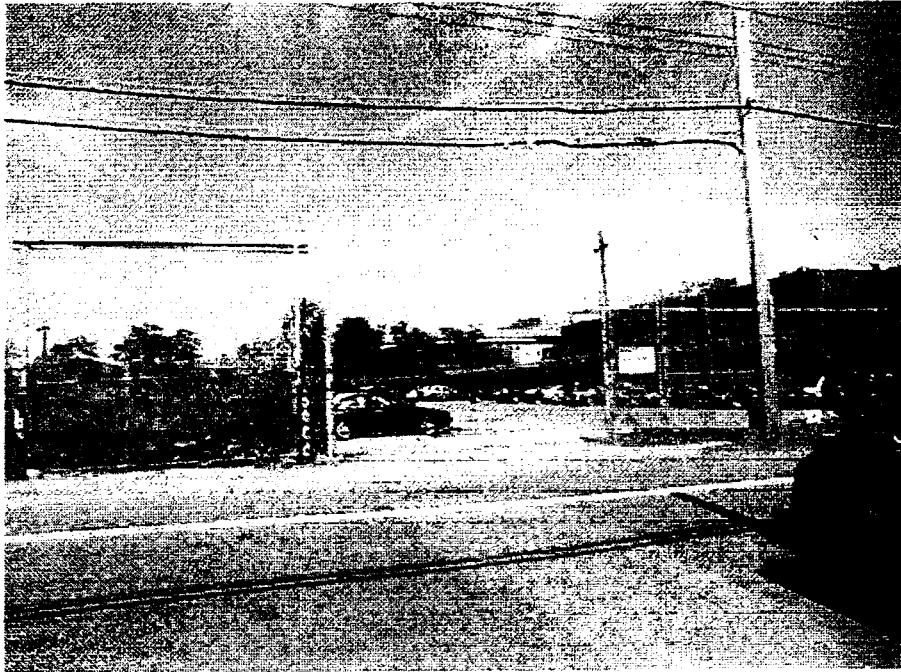
1. Representative view of subject property, facing north. Metro-North sub-station is pictured to the right.

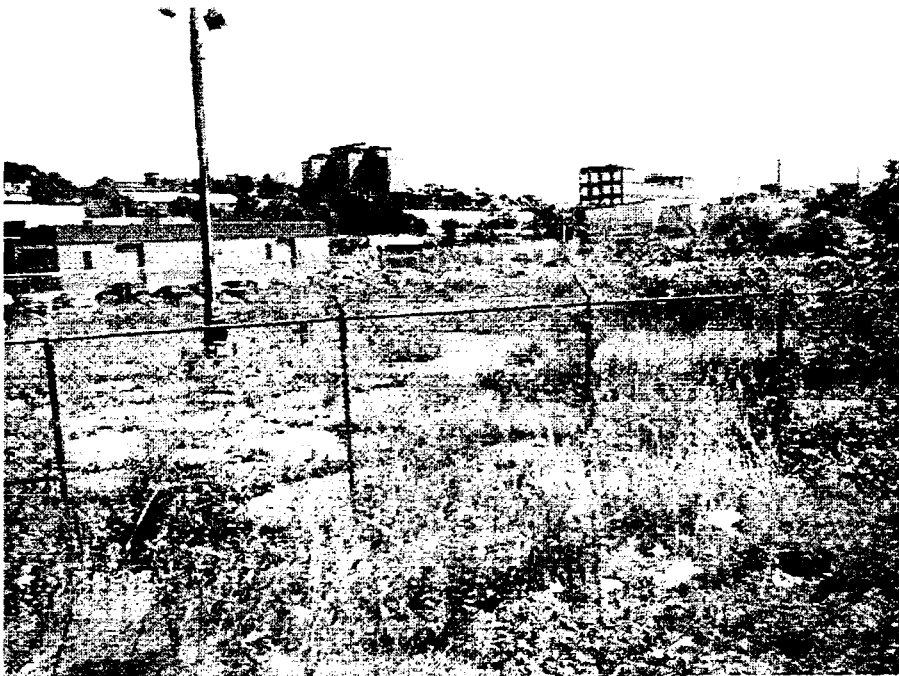
2. Representative view of subject property, facing east. Metro-North sub-station is pictured to the left.

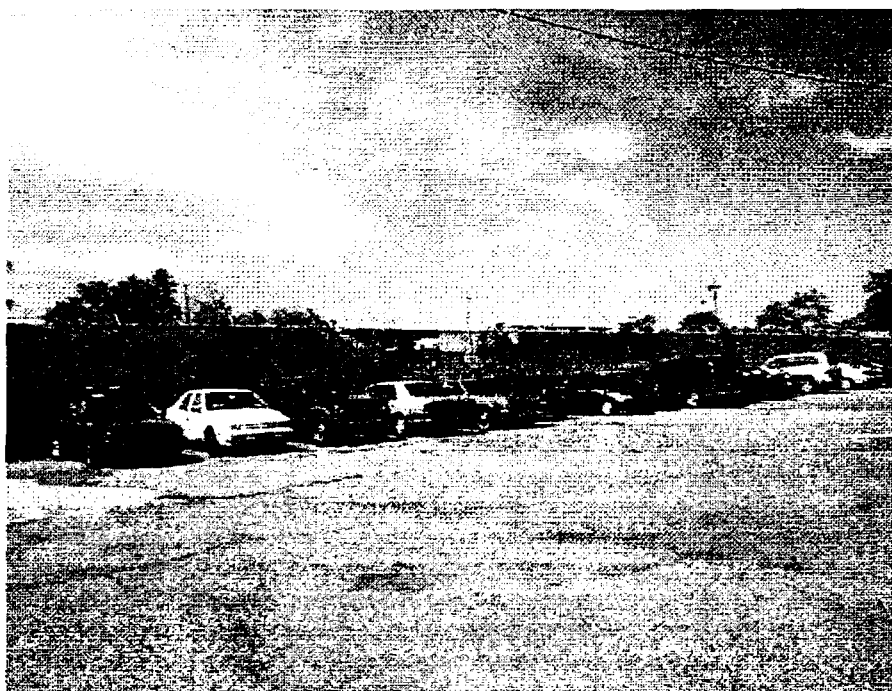
3. View of parking lot in central portion of subject property.
