Re: Letter Report of Dense Non-Aqueous Phase Liquid (DNAPL) Recovery System Evaluation at the Greyston Bakery Site, located at 104 Alexander Street  
City of Yonkers, Westchester County, New York  
NYSDEC VCP ID: V00361; ESI File: GY99143.74

This Letter Report of DNAPL Recovery System Evaluation (Letter Report) summarizes the results of the rehabilitation work and investigation performed by Ecosystems Strategies, Inc. (ESI) in August and September 2015 at the Greyston Bakery Site (the Site).

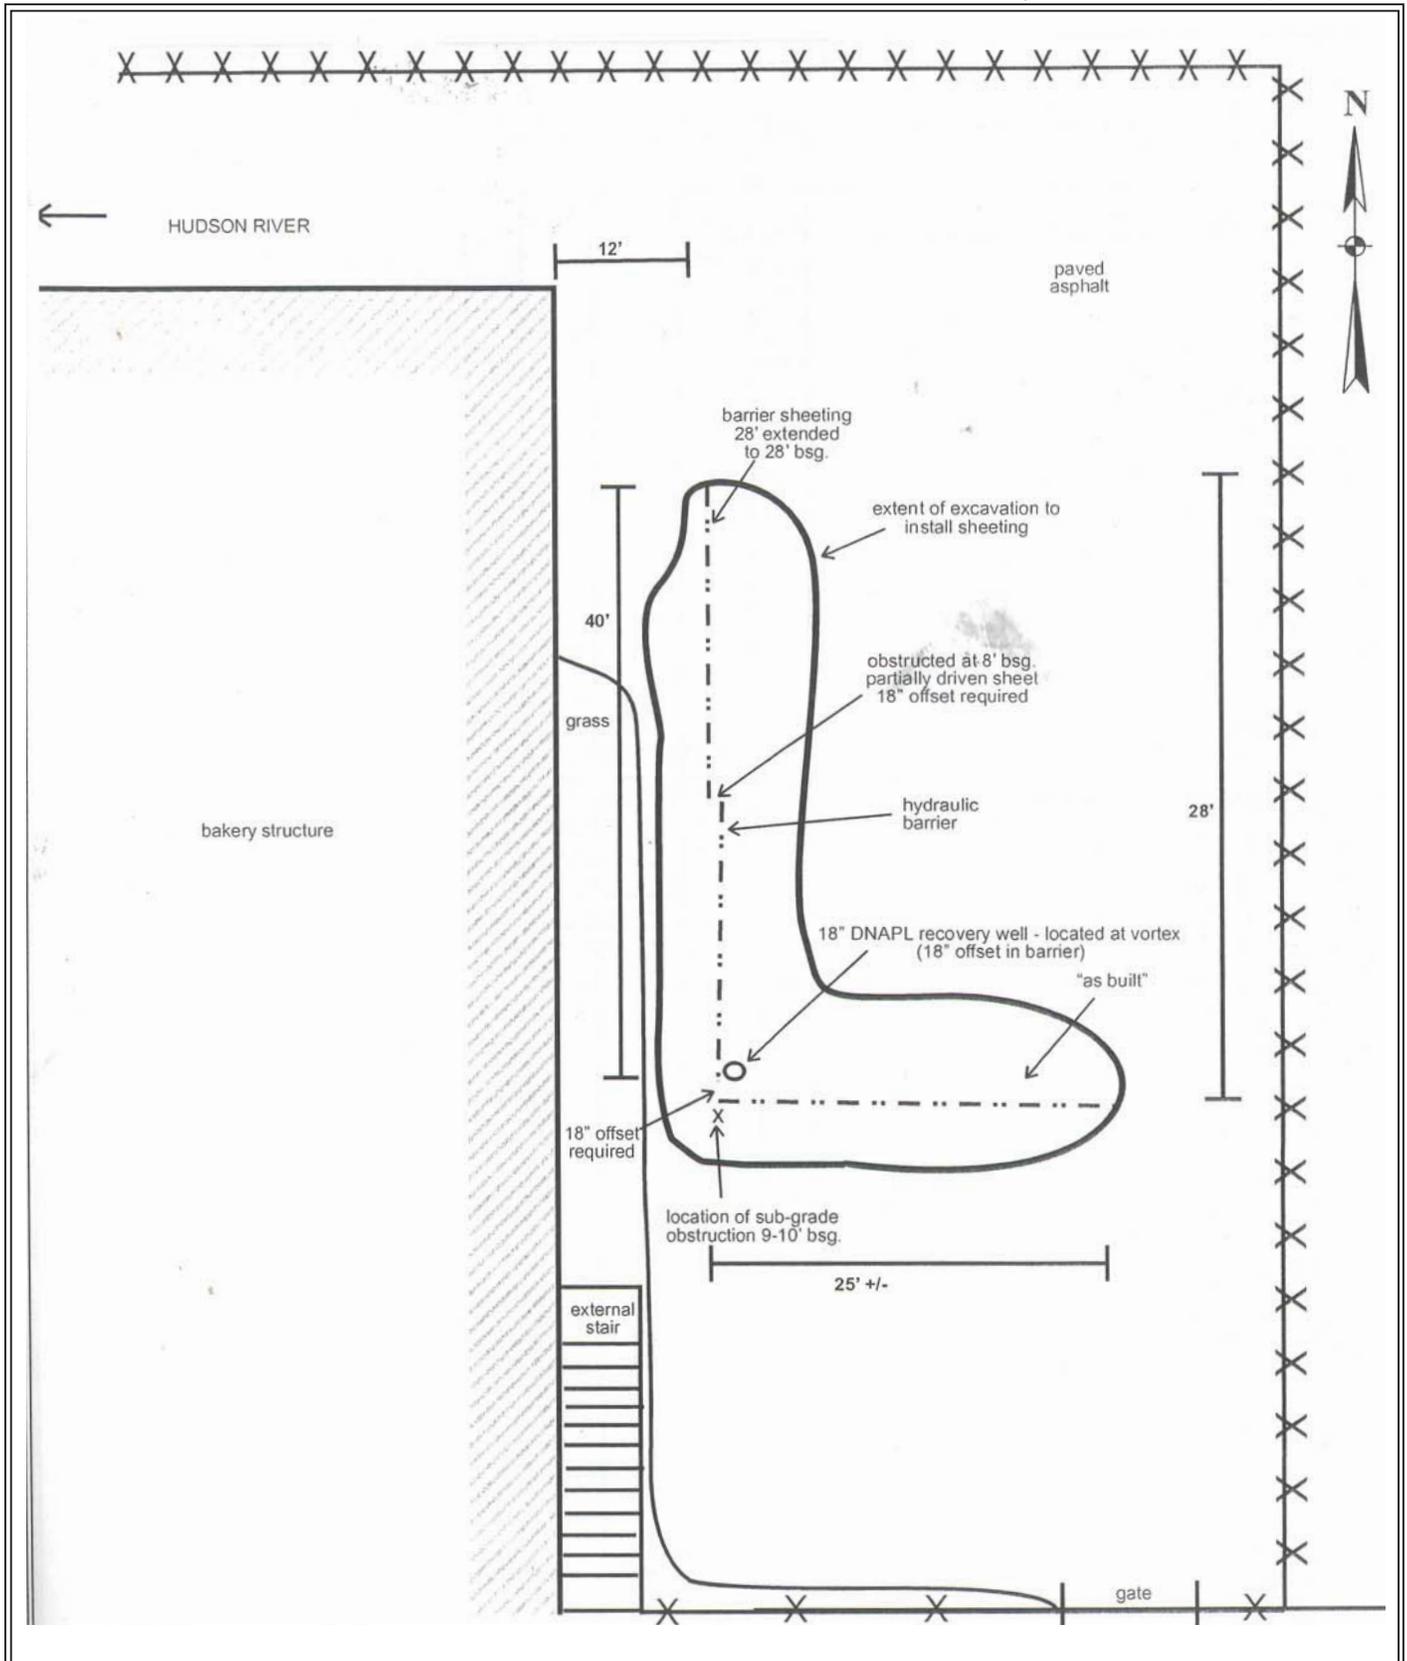
**Figure 2: "As Built" Drawing  
Funnel & Gate System**

The DNAPL recovery system was installed as part of the remedial activities outlined in the NYSDEC-approved Work Plan for Site Closure Activities (Work Plan, ESI, October 2000) for the Site. The DNAPL recovery system, installed between April 2002 and July 2003, is located in the east-central portion of the Site. The system consists of a “funnel and gate” sub-grade hydraulic barrier, directing DNAPL to a collection chamber. A Selected Site Features Map depicting the location of the DNAPL recovery system is presented as Figure 1, Attachment A. As built drawings of the DNAPL recovery system are presented as Figures 2 and 3, Attachment A.

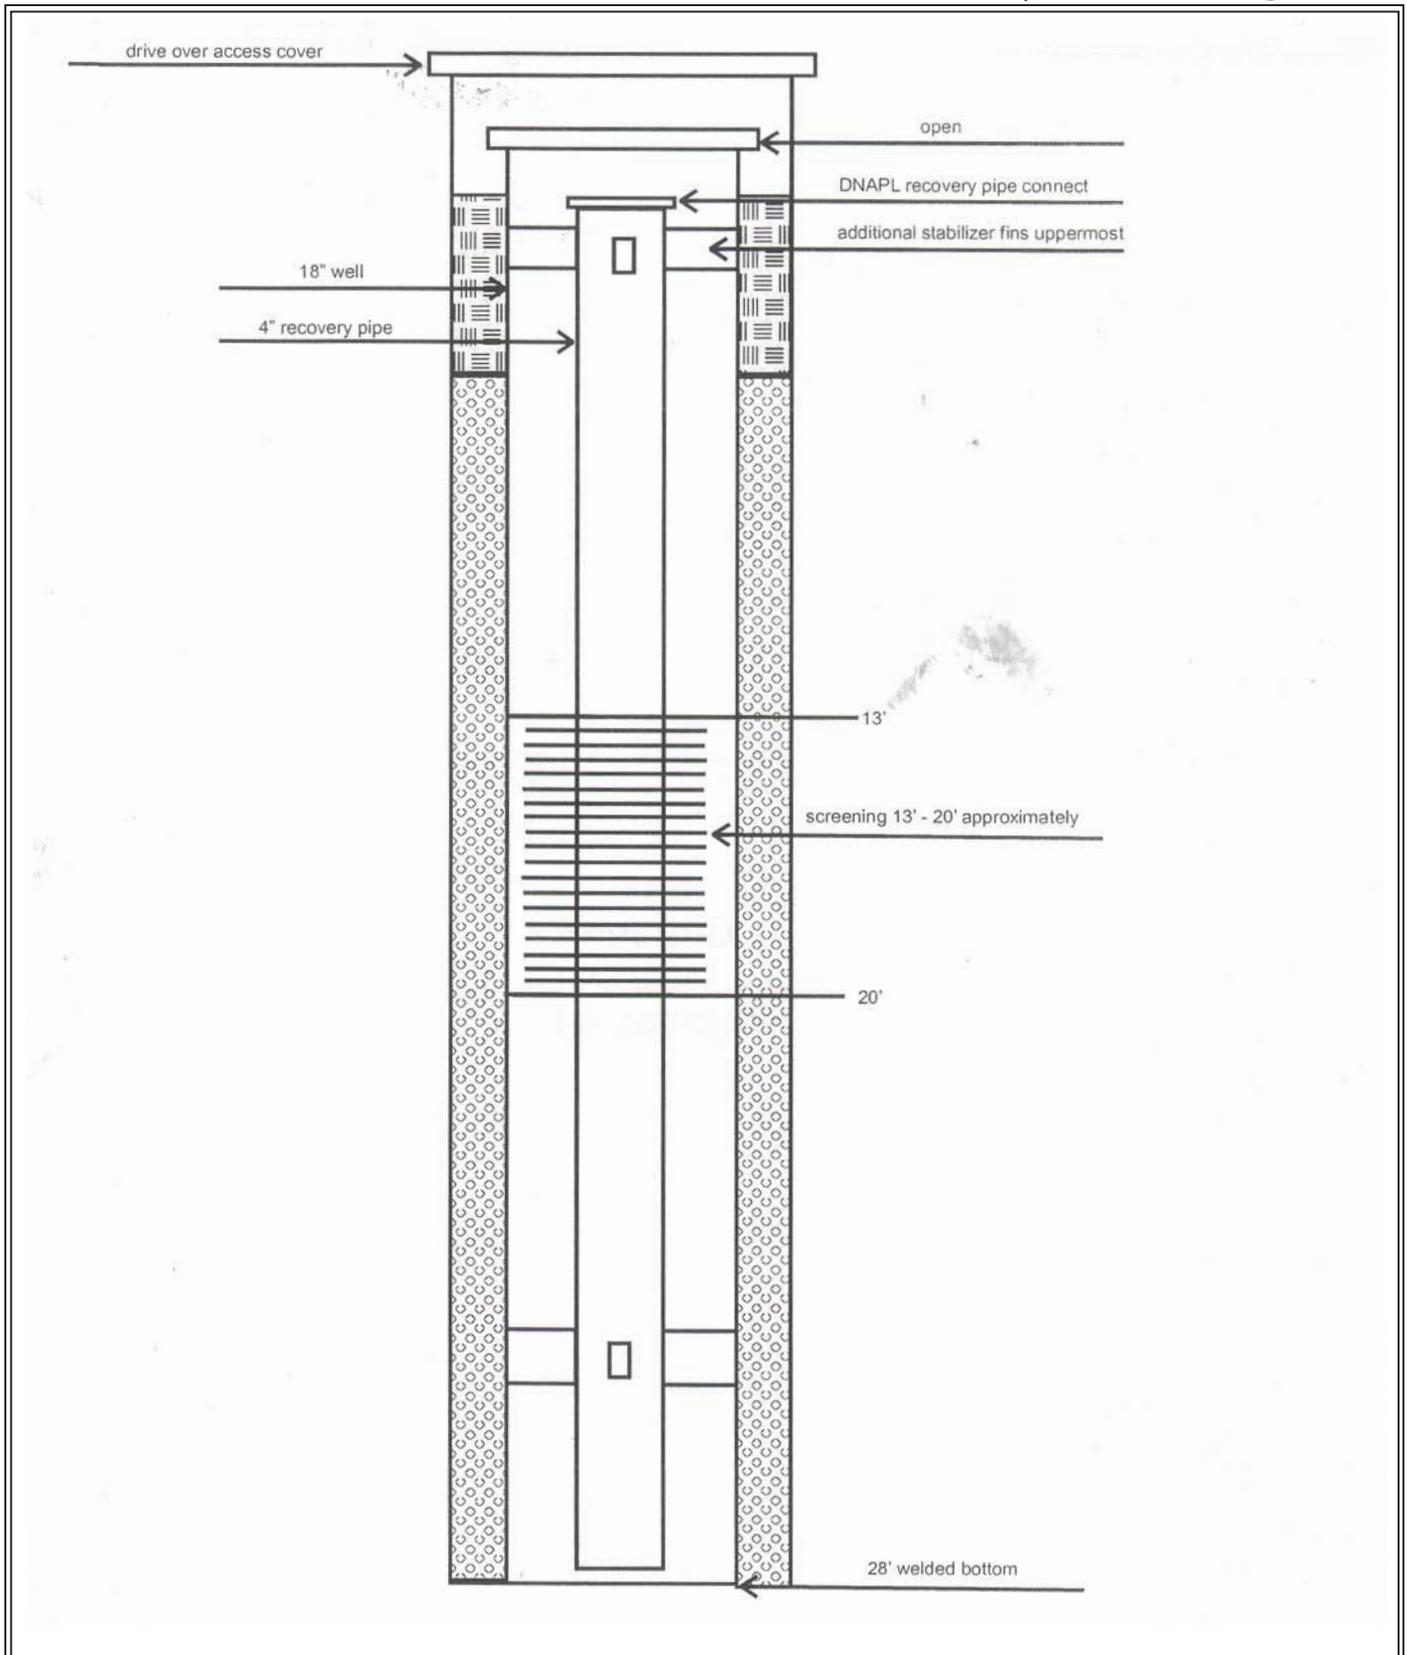
**Figure 3: "As Built" Drawing  
DNAPL Recovery System Detail**

gravel pack 1"

bentonite seal 12" typical

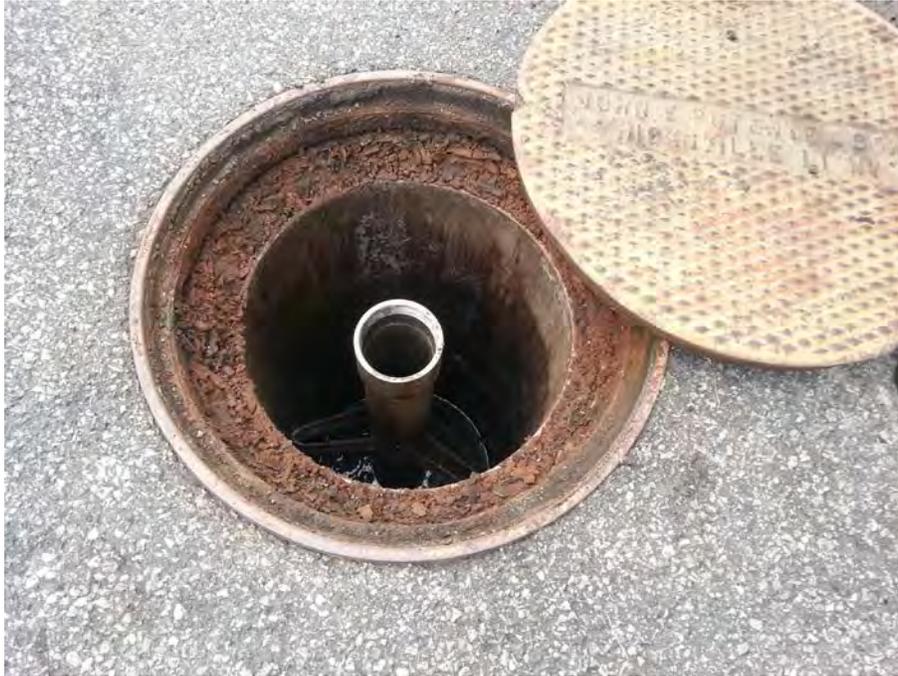
1. DNAPL recovery well prior to rehabilitation work.

Rehabilitation activities at the Site were conducted by Enviro Waste Oil Recovery, LLC under the oversight of ESI on August 18, 2015. Rehabilitation activities consisted of the removal of particles adhered to the well screen utilizing a pressure washer. The watertable inside the well was depressed in order to gain access to the well screen (approximately 13 to 20 feet below surface grade) by removing groundwater via a vacuum truck. A pressure washer wand was then extended to reach and clean the screen. Approximately 1,750 gallons of groundwater inside the recovery well were removed during rehabilitation activities. A waste manifest documenting the removal of groundwater is presented as Attachment B.

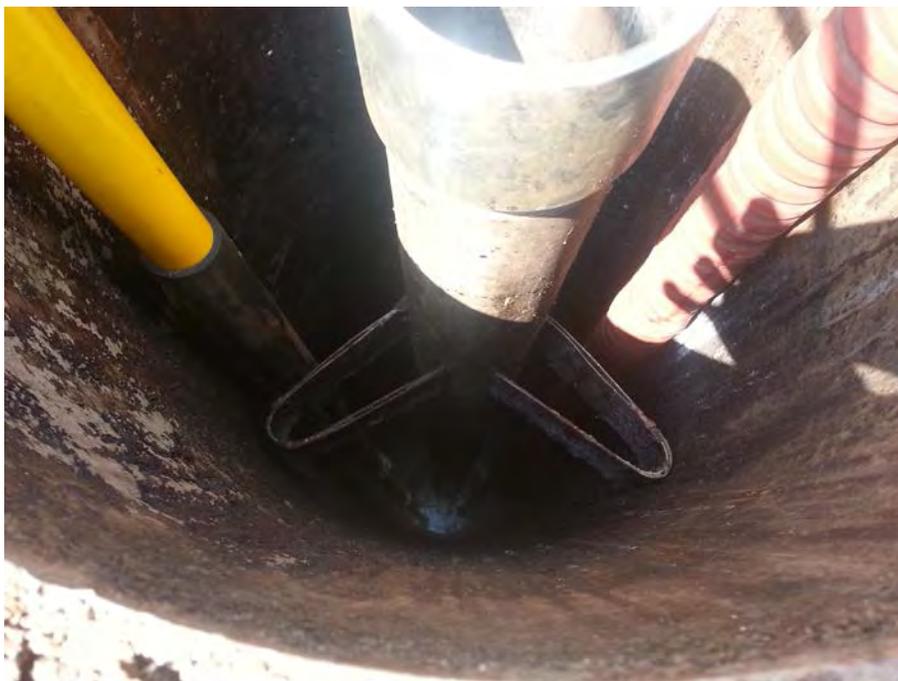
No DNAPL was measured in the recovery well before or after well rehabilitation activities. A moderate sheen was observed on the standing water in the recovery well. Moderate petroleum odors were noticed during well rehabilitation activities.

2. DNAPL recovery well during rehabilitation work (pressure washer wand left and vacuum truck hose right).
