**Off-Site Remedial Action Work Plan  
Coral Graphics Site  
840 Broadway  
Hicksville, New York  
Site # V00383-1**

**September 2011**

Re: **Off-Site Remedial Action Work Plan  
Coral Graphics Site, 840 Broadway  
Hicksville, New York  
Revision 3  
Site # V00383-1**

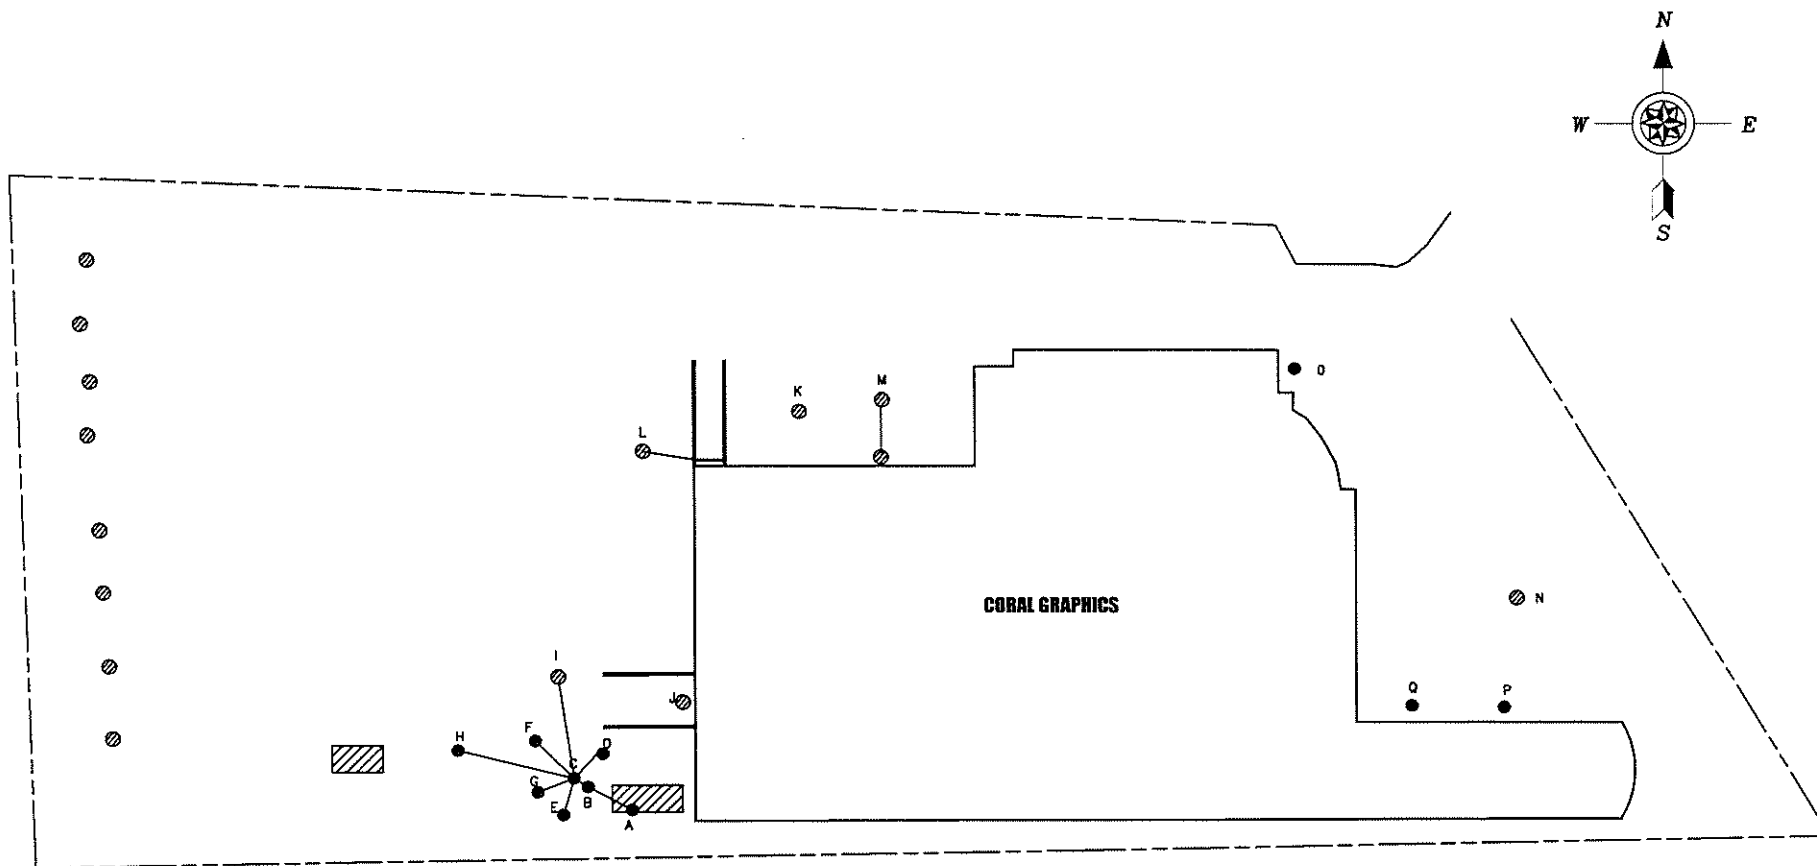
The suspect source areas at the Coral Graphics Site consisted of a former waste storage area, 11 former sanitary cesspools and six active storm water drains. The contaminants of concern were detected in three general areas of the property as illustrated on Figure 2.

**Existing Storm Water Drains** – A total of six active storm drains were sampled as part of on-site Voluntary Investigation (Ref. 8). These drains are labeled with the designations I, J, L, K, M and N. A clean out of the bottom of all of these drains was conducted. The contaminants of concerns in these drains were VOCs, SVOCs, and – to a lesser extent – copper and zinc. These drains have been properly remediated (Ref. 9).

**Former Waste Storage Area** – A former waste storage area existed in the rear of the plant. The contaminants of concern at this location consisted of VOCs. This soil contamination was also remediated as documented in Final Engineering Report – Part A (Ref. 9).

**Cesspools** - A total of 11 former sanitary cesspools that exist at this property were sampled as well. Three, E, F, and H, of the 11 former sanitary cesspools required a clean out. This was performed as part of the “Part – A” Report (Ref. 9). All the former sanitary cesspools were backfilled to grade. The building is currently sewered.

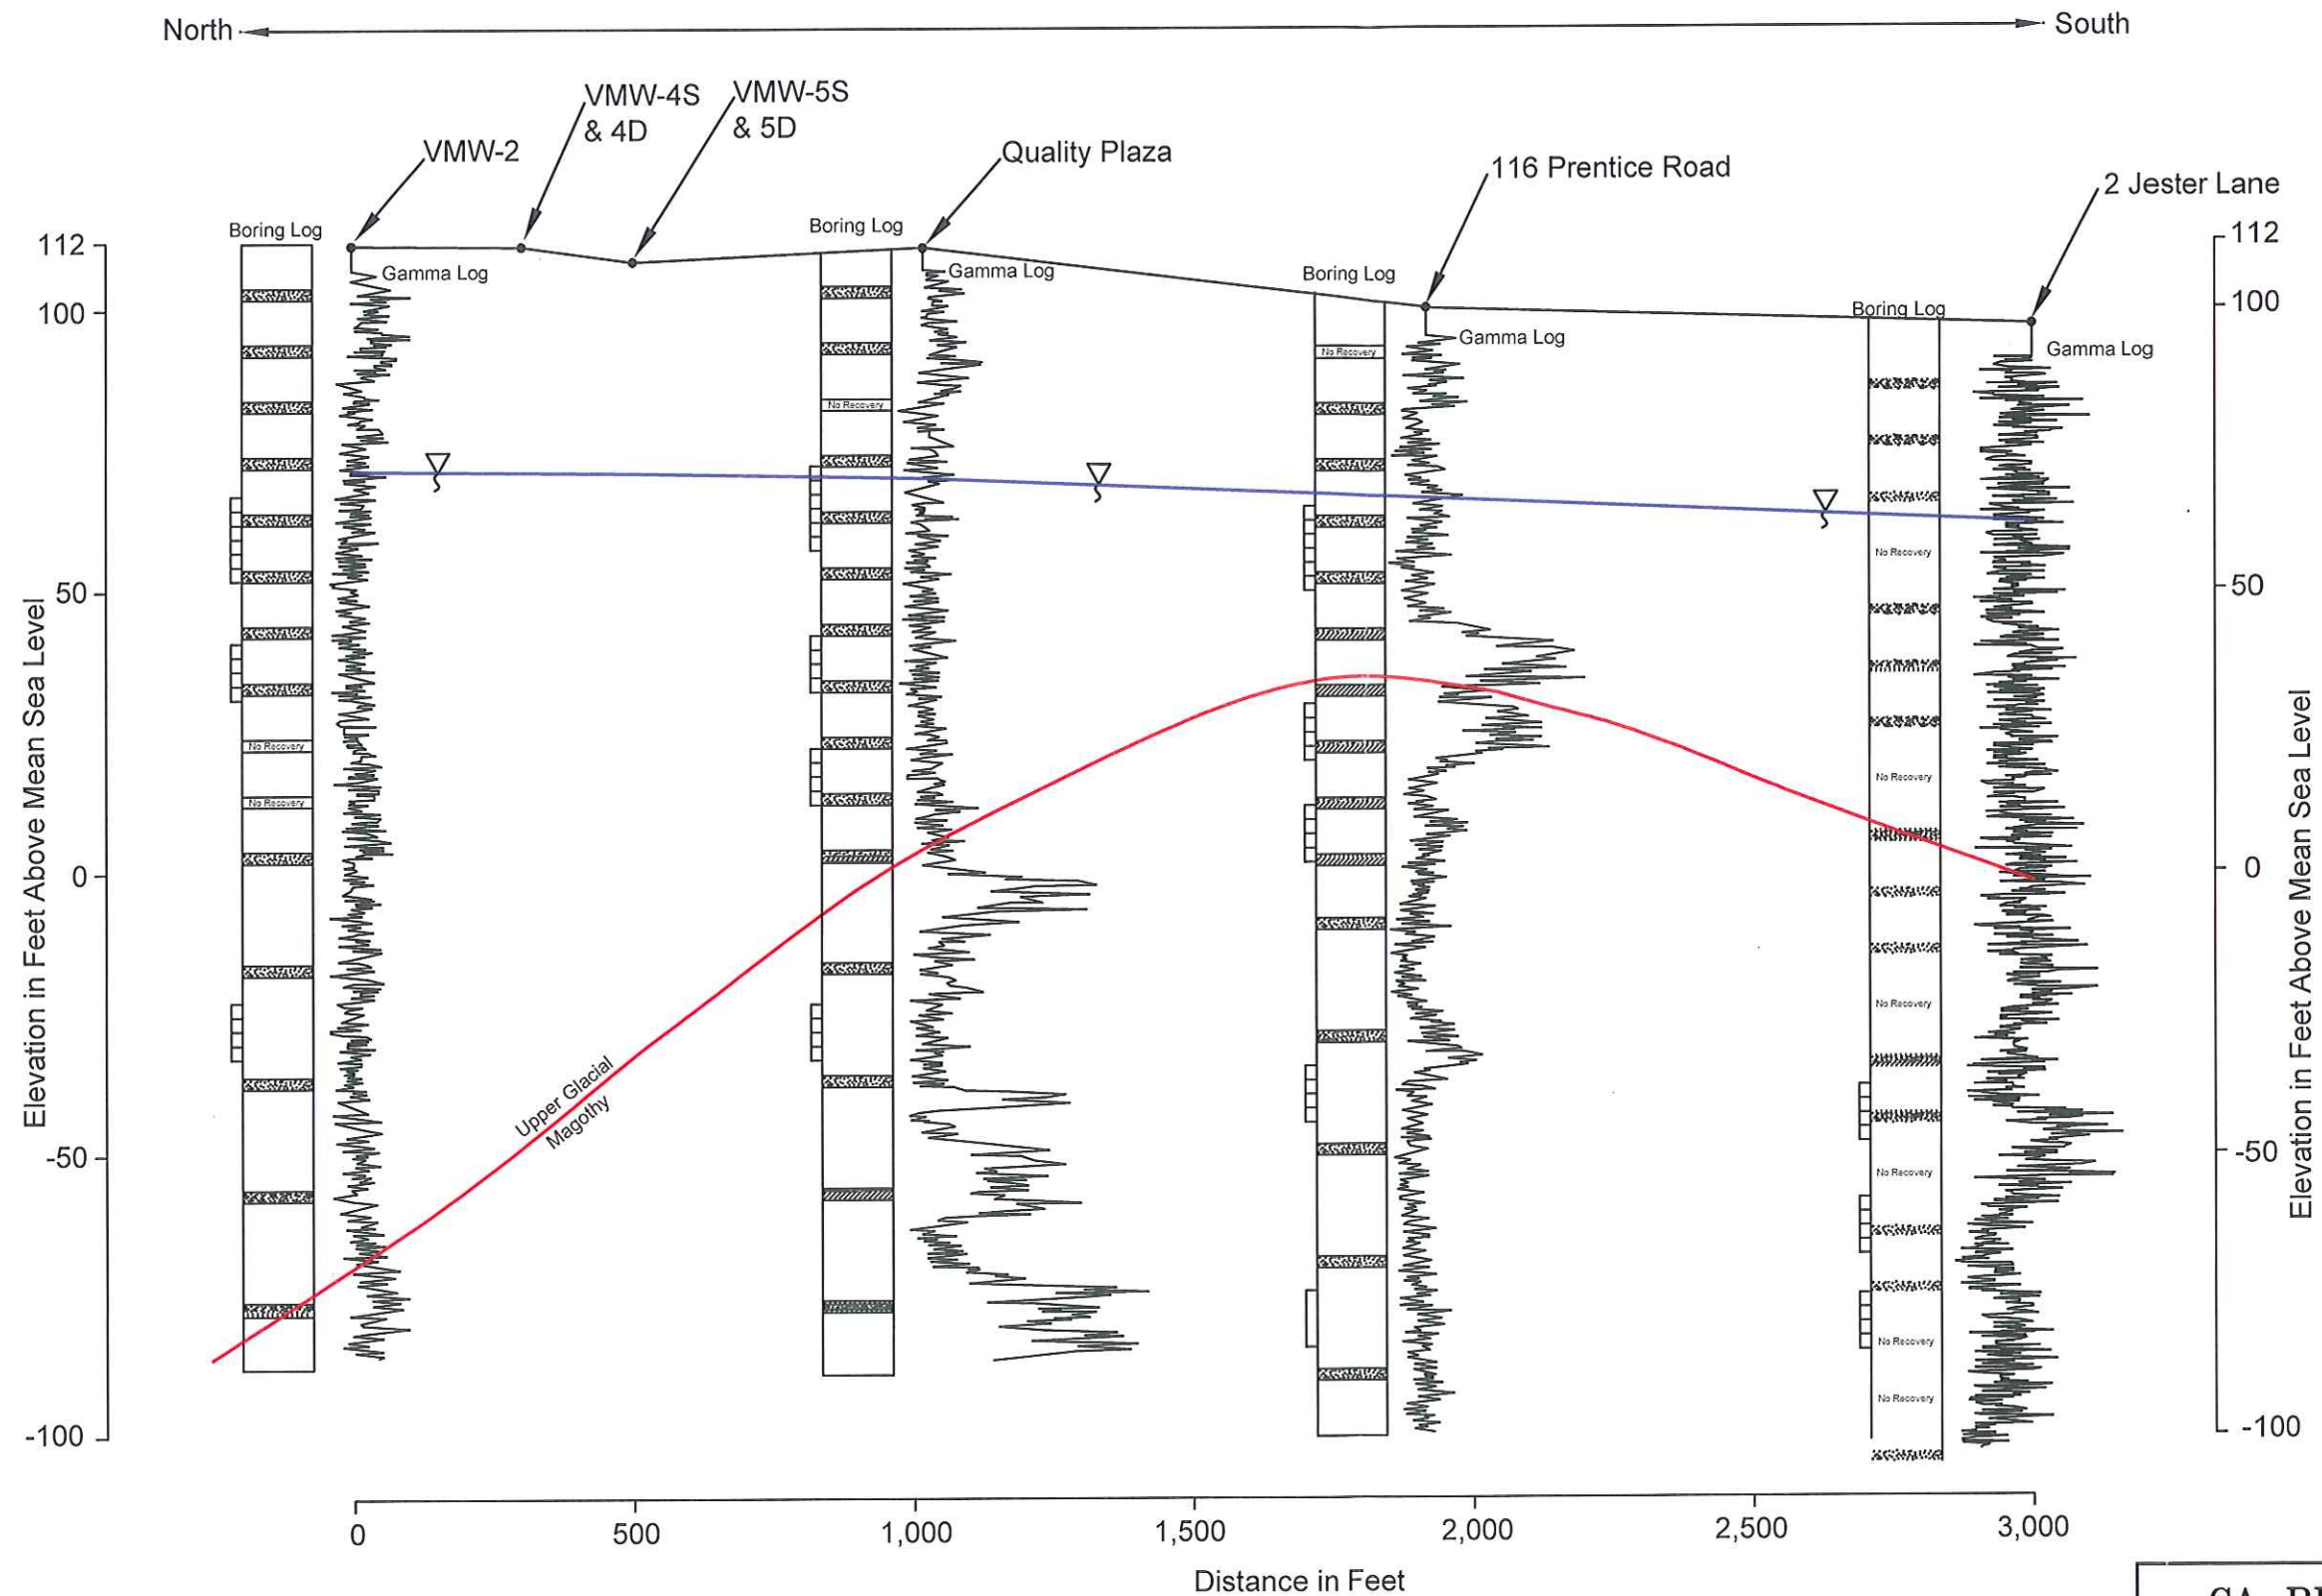
Note:  
The geologic and gamma logs for each monitoring well location were collected during drilling activities. Wells VMW-2, Quality Plaza, and 116 Prentice Road logs were collected during hypunch activities and were identified as VMW-2HP, Quality Plaza-HP, and Prentice Road-HP. Boring and gamma logs for monitoring well 2 Jester were collected during drilling activities and conducted in April 2009.

The Upper Glacial Formation, according to the USGS, is approximately 120 feet thick (Ref. 5) and is underlain by the Magothy Formation, the principal water supply aquifer for most of Nassau County. The contact between the Upper Glacial Formation and the Magothy Formation is plotted on Figure 3 of this Report. The Magothy Formation consists of material deposited in marine and fluvial or deltaic environments during the Cretaceous Period. These deposits consist of beds and lenses of sandy clay, clayey sand, silt, and sand and gravel; the coarsest sediments generally being within the basal portion of the unit (Ref. 5). The Magothy Formation is, in turn, underlain by the Raritan Formation. The Raritan Formation is composed of the upper Raritan Clay, a regional confining layer, followed by the more permeable Lloyd Sand. The Lloyd Sand lies directly upon crystalline bedrock.
