ITEM NO. 22

Submittal Package for Borrowed Fill Material

**PROJECT
ELMHURST GAS TANK PARK II
Q492-107M**

NY DIRT PORTFOLIO

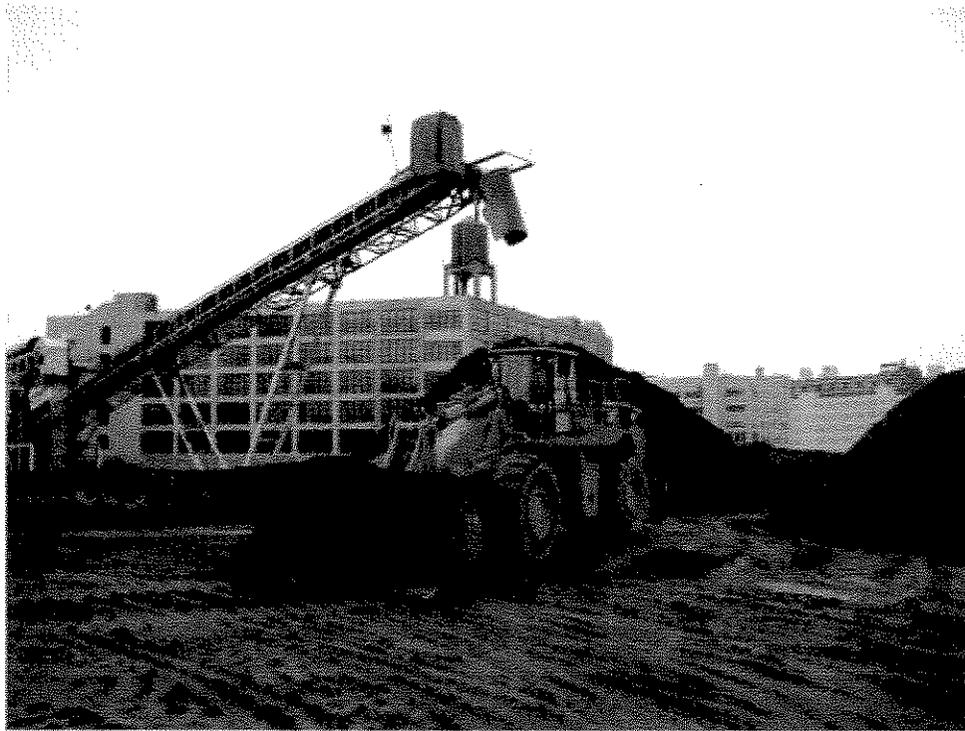
This is the excavation tunnel in the Long Island City East Side Access Tunnel. Point of entry is represented by the train tracks which extends 2 miles into the earth. The material is drilled or dynamited and brought out through this tunnel. Pulverized material is in the form of soil with varying silt sizes. Silt and chemical analysis is in the enclosed document. Soil material and large boulders metamorphic stones are also available for coastal bulkheads and jetties to protect against shoreline erosion.

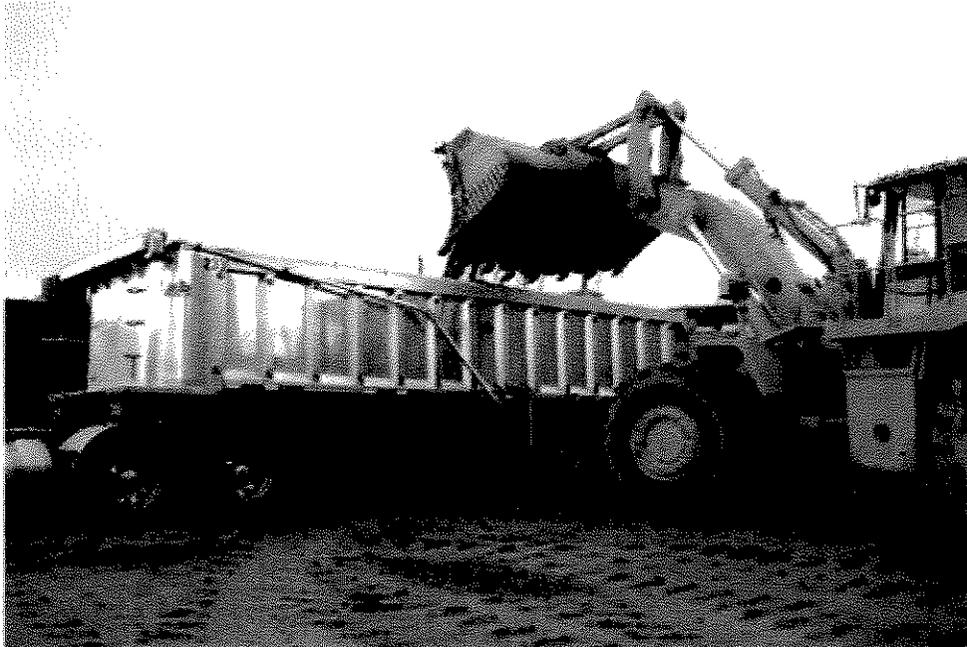
Material is transported over from the access tunnel and stored on Queens Street, 450 yards from the East Side Access Tunnel.

Soil material and large boulderous metamorphic stones are also available for coastal bulkheads and jetties to protect against shoreline erosion. Material is taken from the pile and then trucked to any location in the 5 Boroughs.

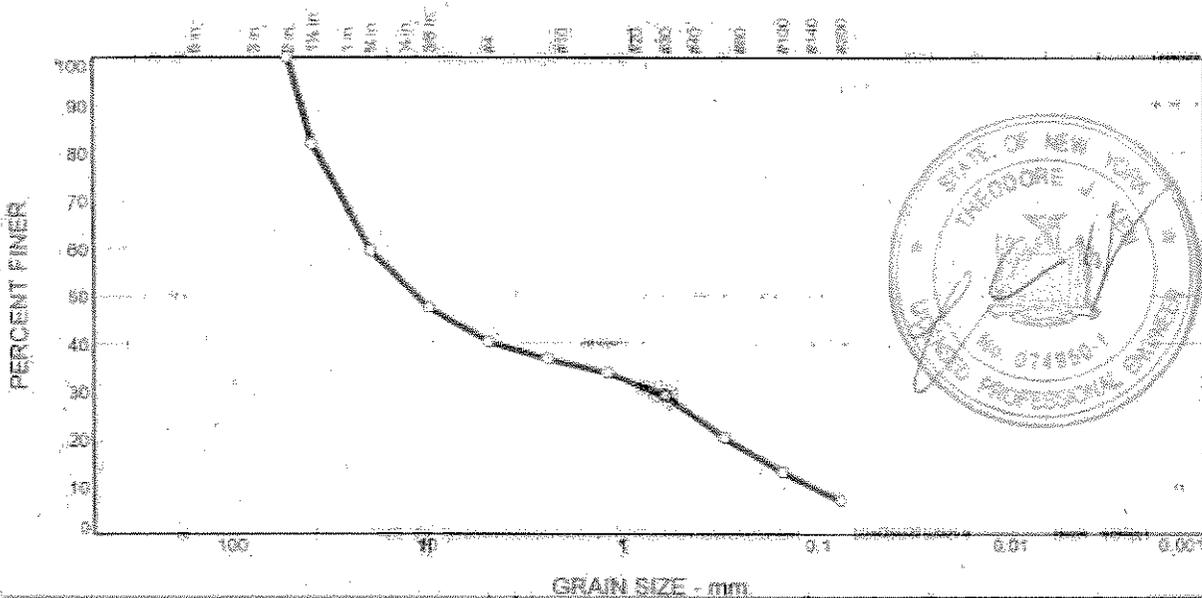
Figure

% Cobbles	% Gravel		% Sand			% Fines	
	Coarse	Fine	Coarse	Medium	Fine	Silt	Clay
0.0	40.5	19.2	4.3	11.4	17.7	6.9

SIEVE SIZE	PERCENT FINER	SPEC. PERCENT	PASS? (X=NO)
2	100.0		
1.5	81.7		
3/4	59.5		
3/8	47.4		
#4	40.3		
#8	36.7		
#16	33.8		
#30	29.0		
#50	20.2		
#100	12.9		
#200	6.9

Material Description		
PL=	Atterberg Limits LL=	PI=
D ₈₅ = 40.1104	Coefficients: D ₆₀ = 19.3716	D ₅₀ = 11.0531
D ₃₀ = 0.6930	D ₁₅ = 0.1833	D ₁₀ = 0.1075
C _u = 180.24	C _c = 0.23	
USCS=	Classification AASHTO=	
Remarks
