Re: **SUBMITTAL OF REQUESTED INFORMATION**
ELMHURST PARK, QUEENS BOROUGH

Submittal Package for Borrowed Fill Material

**PROJECT
ELMHURST GAS TANK PARK II
Q492-107M**

**East
Side
Access
Tunnel
Long
Island
City
Queens**

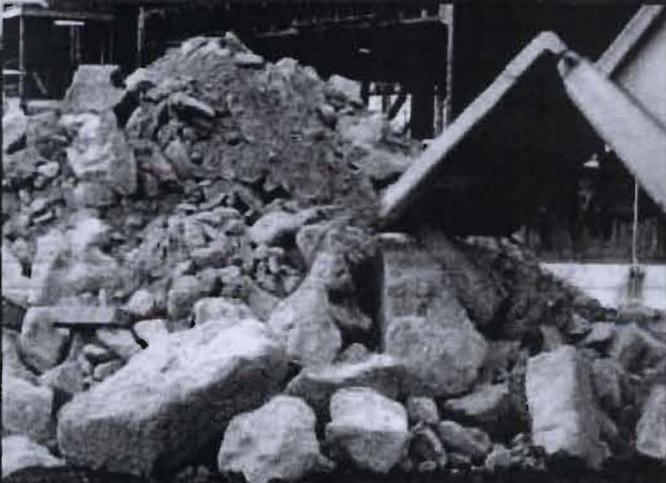
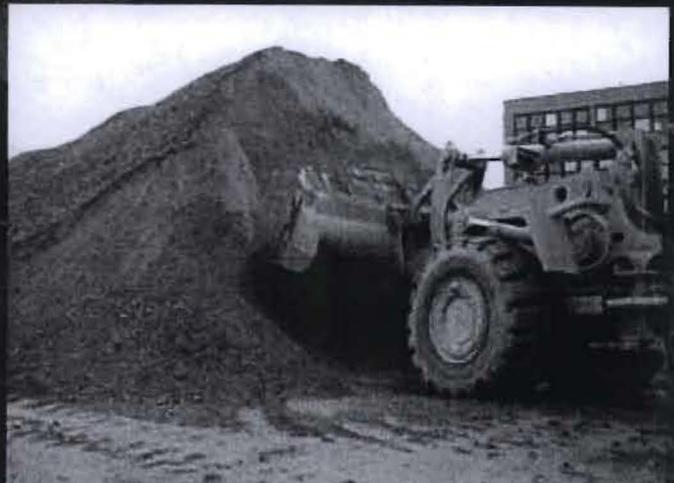
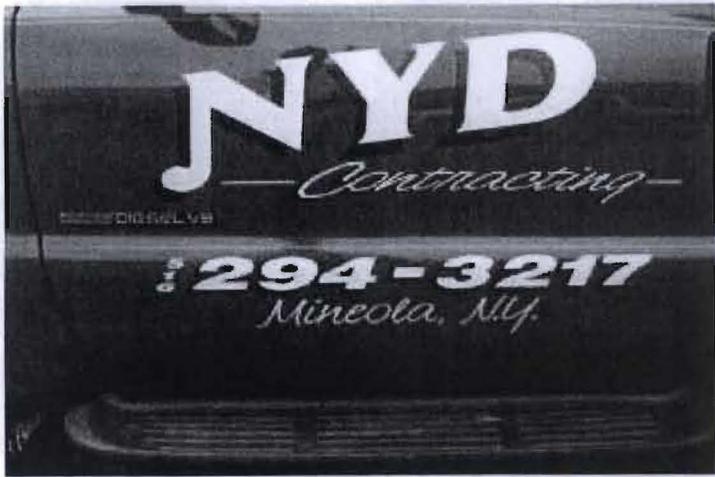
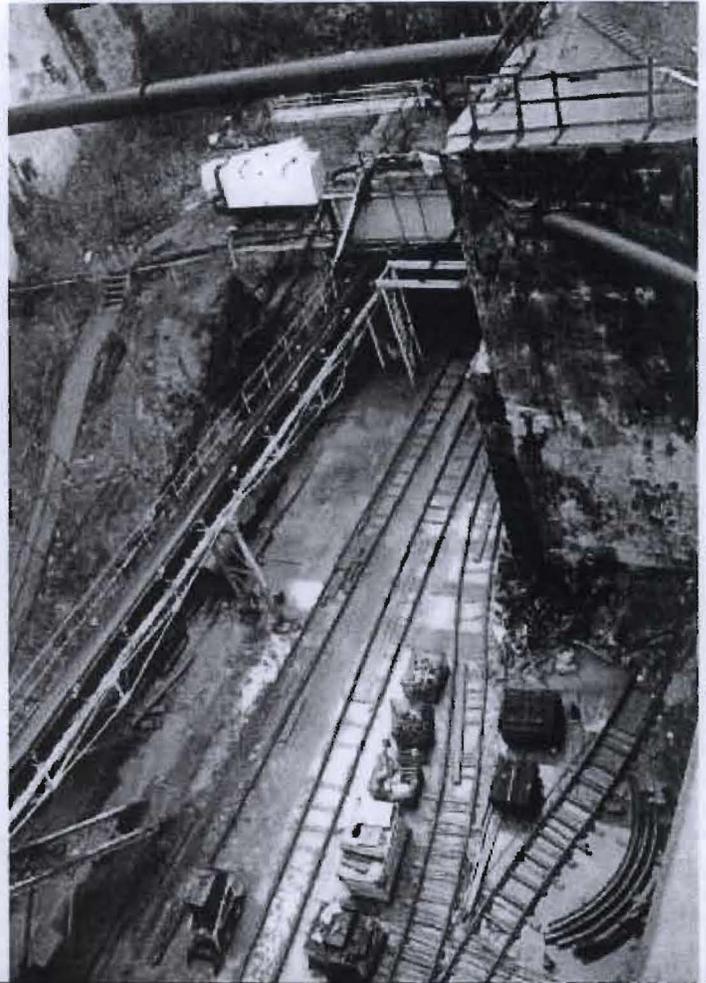
This is the excavation tunnel in the Long Island City East Side Access Tunnel. Point of entry is represented by the train tracks which extends 2 miles into the earth. The material is drilled or dynamited and brought out through this tunnel. Pulverized material is in the form of soil with varying sive sizes. Sive and chemical analysis is in the enclosed document. Soil material and large boulderous metamorphic stones are also available for coastal bulkheads and jetties to protect against shoreline erosion.

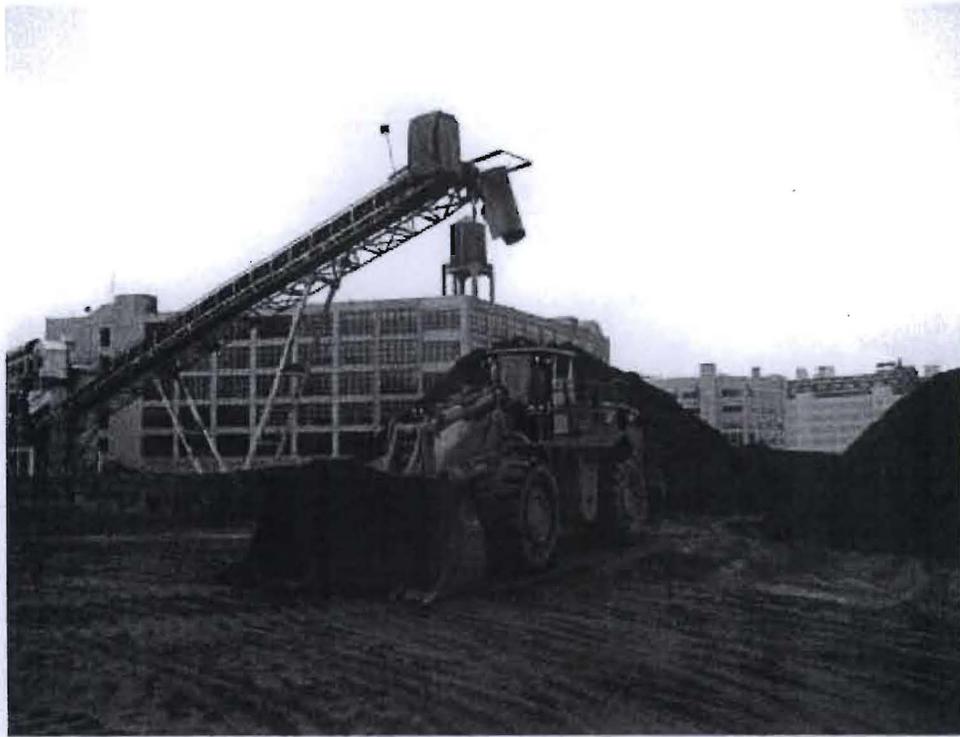
Material is transported over from the access tunnel and stored on Queens Street, 450 yards from the East Side Access Tunnel.

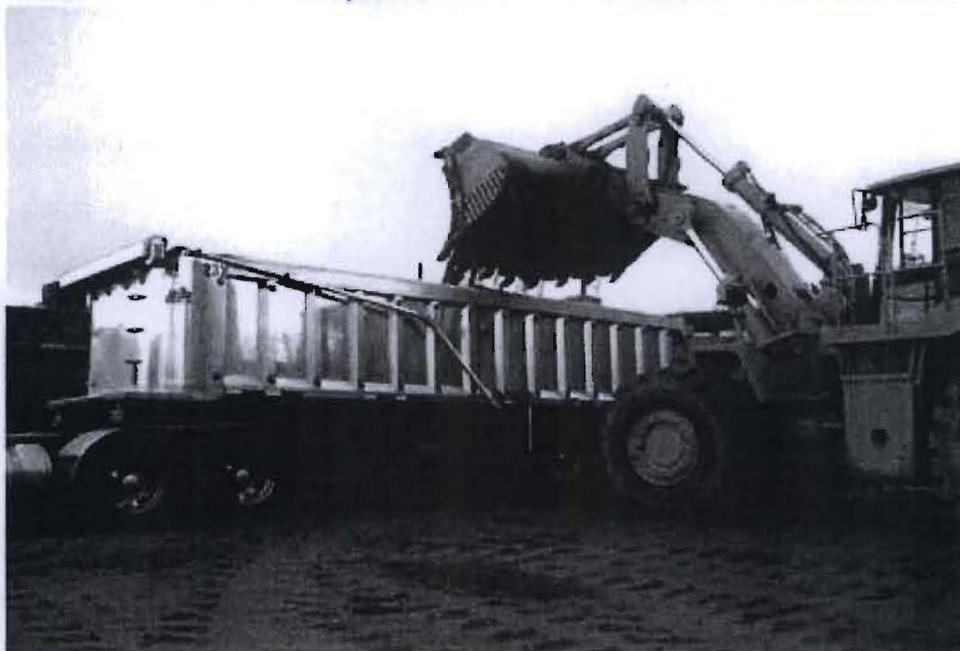
Soil material and large boulderous metamorphic stones are also available for coastal bulkheads and jetties to protect against shoreline erosion. Material is taken from the pile and then trucked to any location in the 5 Boroughs.

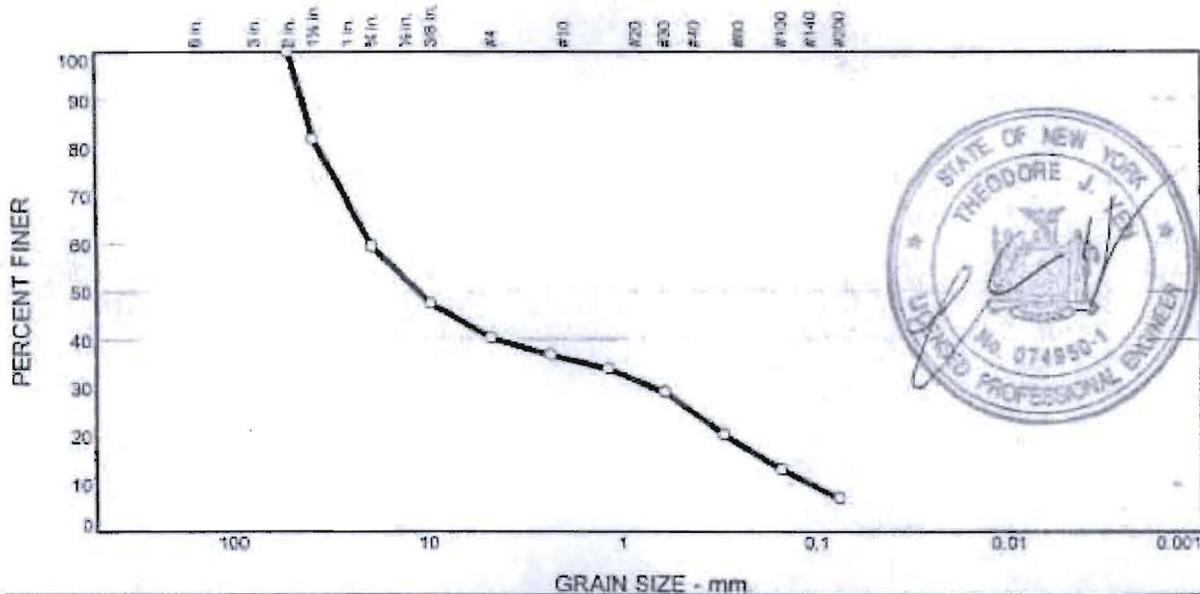
SOIL WASH SIEVE ANALYSIS REPORT

% Cobbles	% Gravel		% Sand			% Fines	
	Coarse	Fine	Coarse	Medium	Fine	Silt	Clay
0.0	40.5	19.2	4.3	11.4	17.7	6.9

SIEVE SIZE	PERCENT FINER	SPEC.* PERCENT	PASS? (X=NO)
2	100.0		
1.5	81.7		
3/4	59.5		
3/8	47.4		
#4	40.3		
#8	36.7		
#16	33.8		
#30	29.0		
#50	20.2		
#100	12.9		
#200	6.9

Material Description		
PL=	<u>Atterberg Limits</u> LL=	PI=
D ₈₅ = 40.1104	Coefficients D ₆₀ = 19.3716	D ₅₀ = 11.0551
D ₃₀ = 0.6930	D ₁₅ = 0.1833	D ₁₀ = 0.1075
C _u = 180.24	C _c = 0.23	
USCS=	<u>Classification</u> AASHTO=	
Remarks
