Periodic Review Report

(July 7, 2023 through July 7, 2024)

Former Dowell Facility

3311 Walden Avenue, Depew, New York

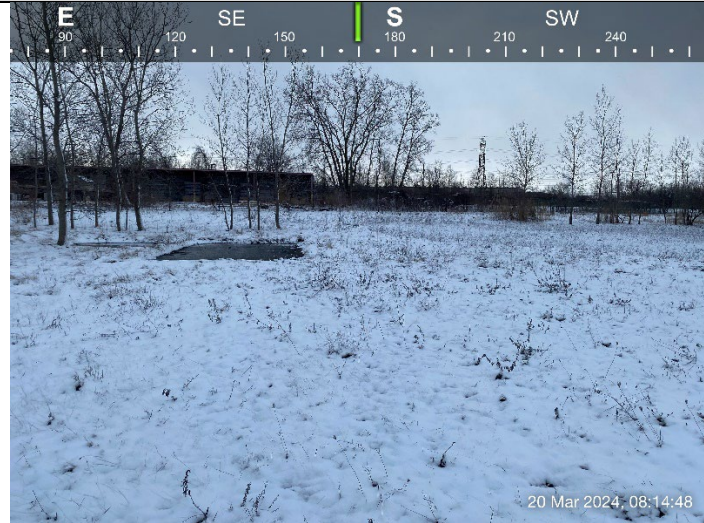
Site Inspection – March 2024	
Photographs	
<p>Photograph Number: 1</p> <p>Subject/Description: Photograph taken from site entrance area facing south</p>

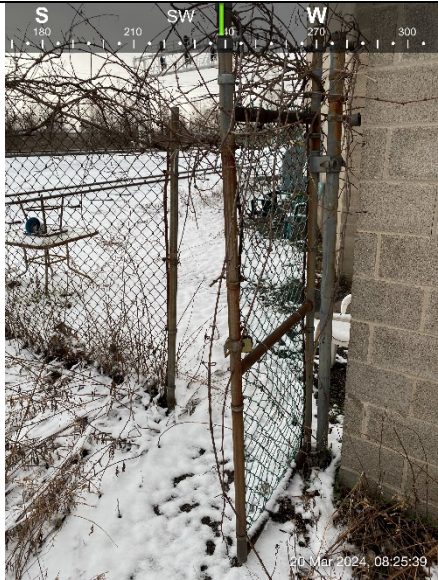
<p>Photograph Number: 8</p> <p>Subject/Description: Photograph taken from southern corner gate area (unlocked and open upon arrival) facing southwest</p>

- The extent of the soil cover consisting of graded native soil and the extent of the soil cover consisting of graded crusher run stone were in good condition.
- There were no visible signs of cracks, depressions, or animal burrows.
- Vegetation around the site was not stressed.
- The main entrance gate was secured and locked upon arrival. However, the man gate in the southwestern corner of the site was open upon arrival. It appeared that the chain-link fencing was cut to allow the gate to be opened. The chain-link fencing was repositioned, and the gate locked with a combination lock.

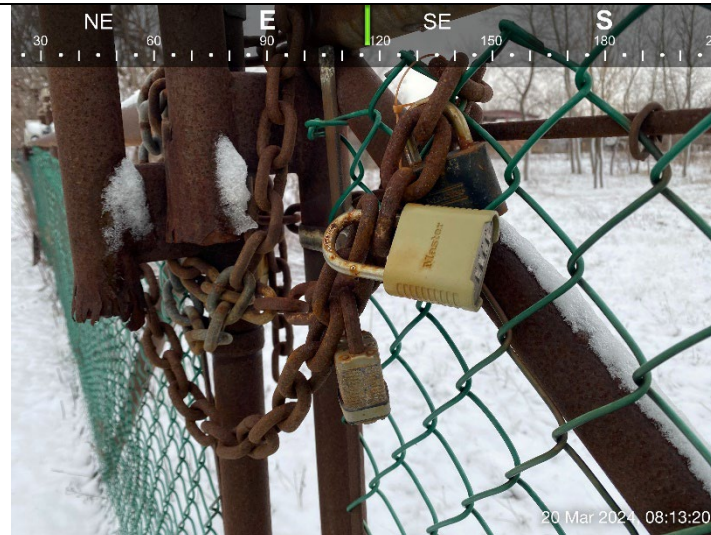
Photograph Number: 12

Subject/Description: Photograph taken of main entrance gate (locked) facing east-southeast

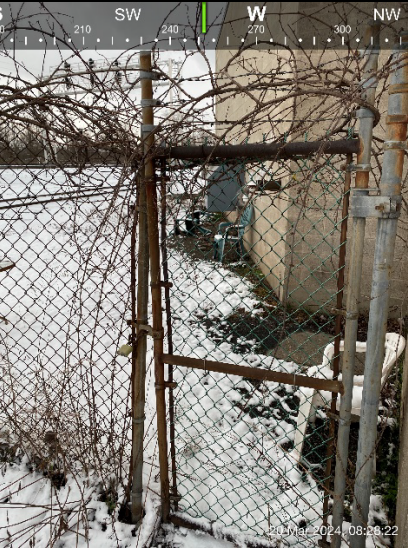
Photographs	
<p>Photograph Number: 13</p> <p>Subject/Description: Photograph taken from southern corner gate area (locked before departing) facing west</p>

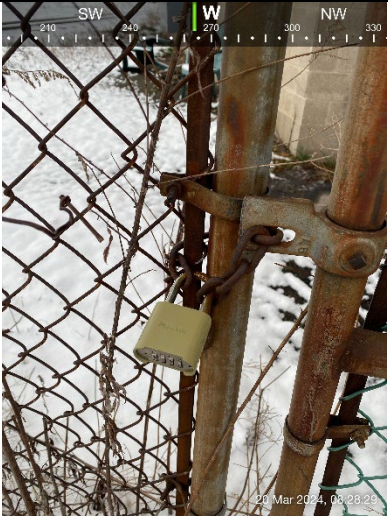
<p>Photograph Number: 14</p> <p>Subject/Description: Photograph taken of southern corner gate (locked) facing west</p>
