Hunts Point Food Distribution Center Redevelopment Plan

Investigative Report for the Operating Unit Portion of Parcel C, Bronx, NY

**Prepared by: Lawler, Matusky &
Skelly Engineers LLP November 1999**

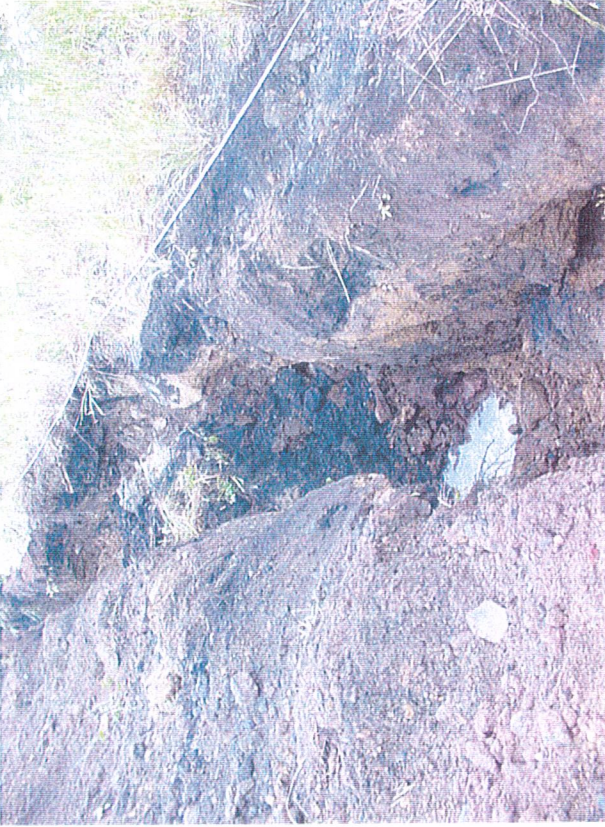
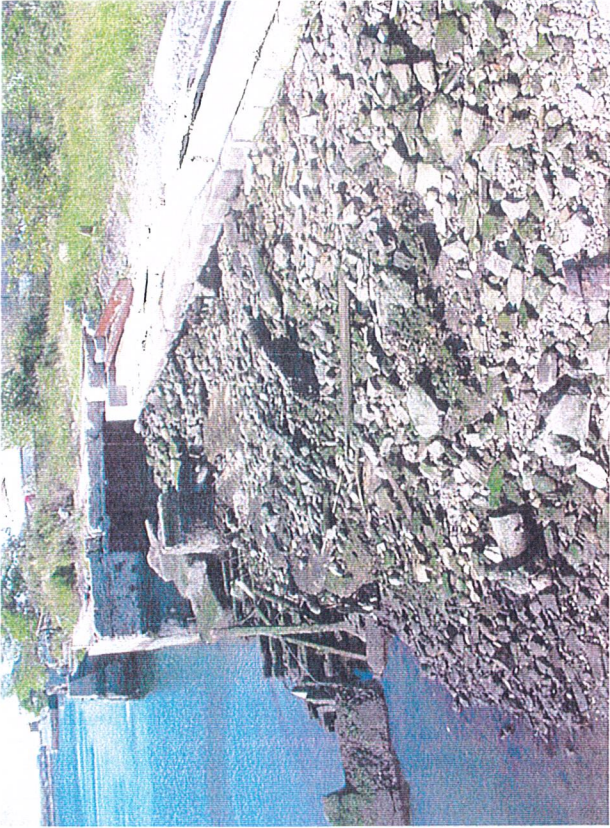
Bulkhead facing south

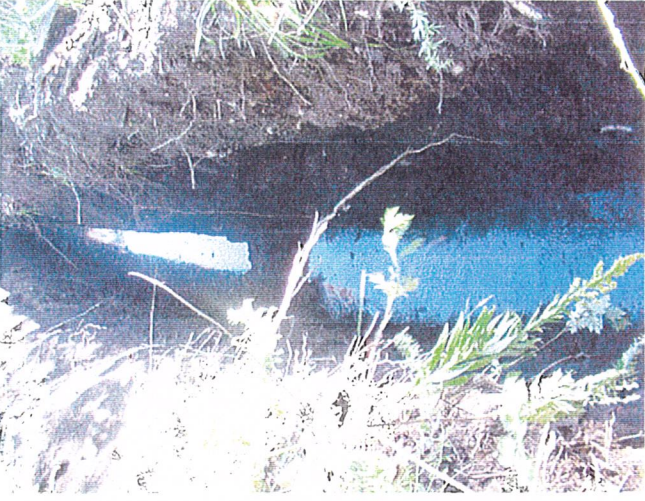
Trench 3

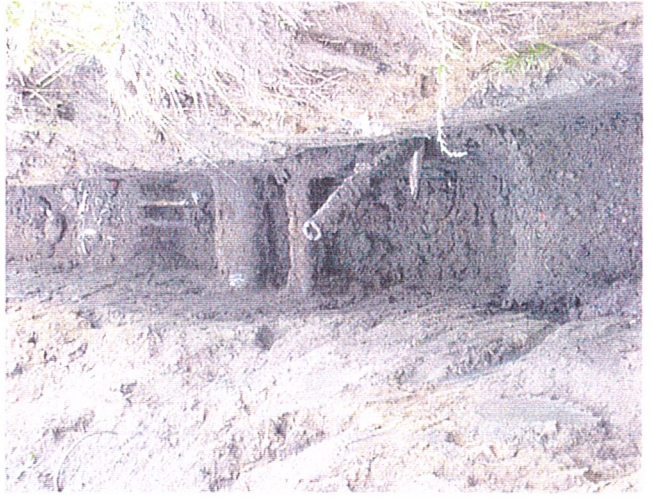
Trench 2
showing buried
pipes

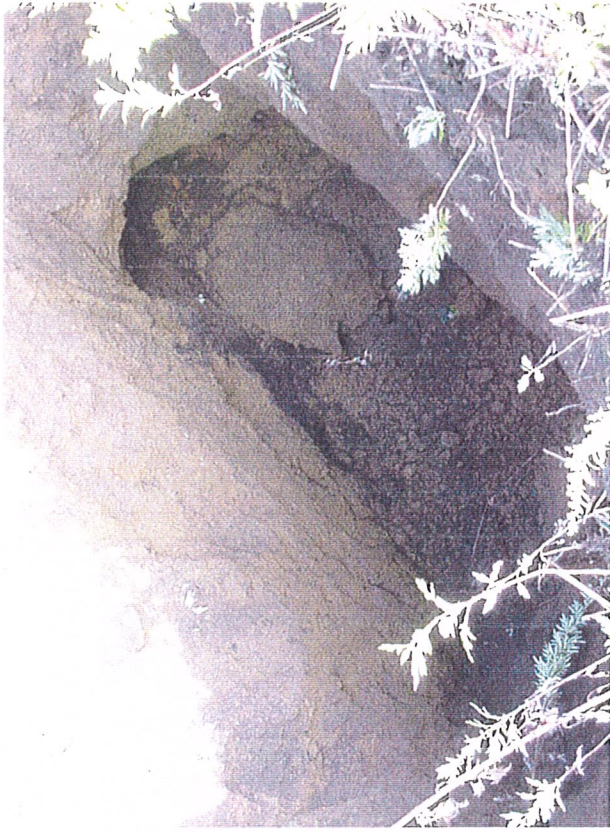
Test Pit 1

Test pit CTP1 was advanced approximately 220 feet from the south end of the site to a depth of approximately 8.5 feet below ground surface. The material encountered in this test pit included mostly sand with some concrete and brick. A 3-inch diameter pipe was encountered, but it did not contain any fluids. A small seam of black tar was also encountered. The sample identified as CTPSA was collected from this test pit.

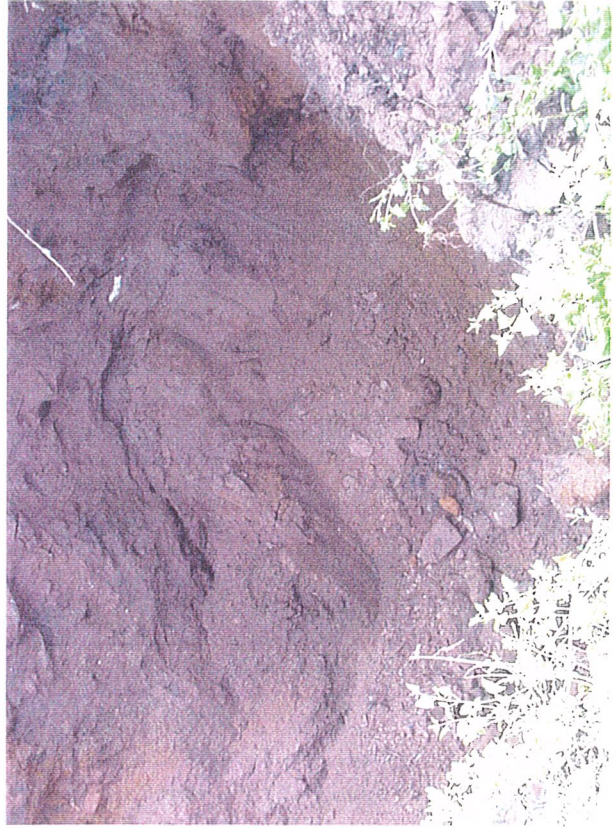
Test Pit 3 was advanced approximately 495 feet from the south end of the site to a depth of approximately 7.5 feet bgs. The test pit was advanced to the east of an old railroad bed. The material encountered in the test pit was mainly reddish brown fine sand. Concrete was observed at the west wall and floor of the excavation. A piece of weathered metal resembling an old container was removed from this excavation. The container was approximately 2 feet long and 1 foot in diameter. No samples were collected from this test pit for chemical analysis.

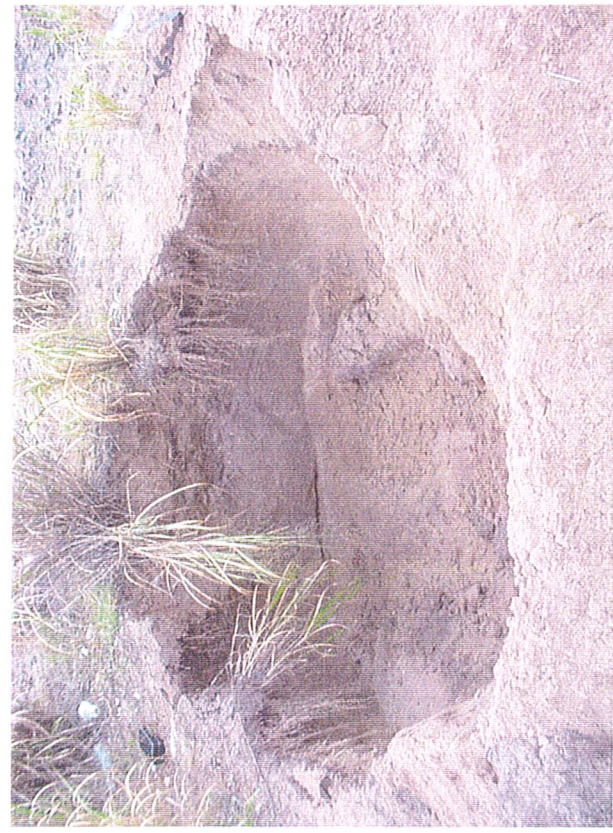
Test Pit 4 was the northernmost test pit advanced along the east side of the site. It was advanced approximately 720 feet from the south end of the site, to a depth of approximately 6.5 feet bgs. The material excavated from this test pit included orange to brown, fine to medium sands that appear to have been used as fill from dredged material. No samples for chemical analysis were collected from this test pit.
