CORAL GRAPHIC SERVICES, INC.

Phase II Environmental Site Assessment

**840 S. Broadway
Hicksville, NY**

**327 New South Road
Hicksville, NY**

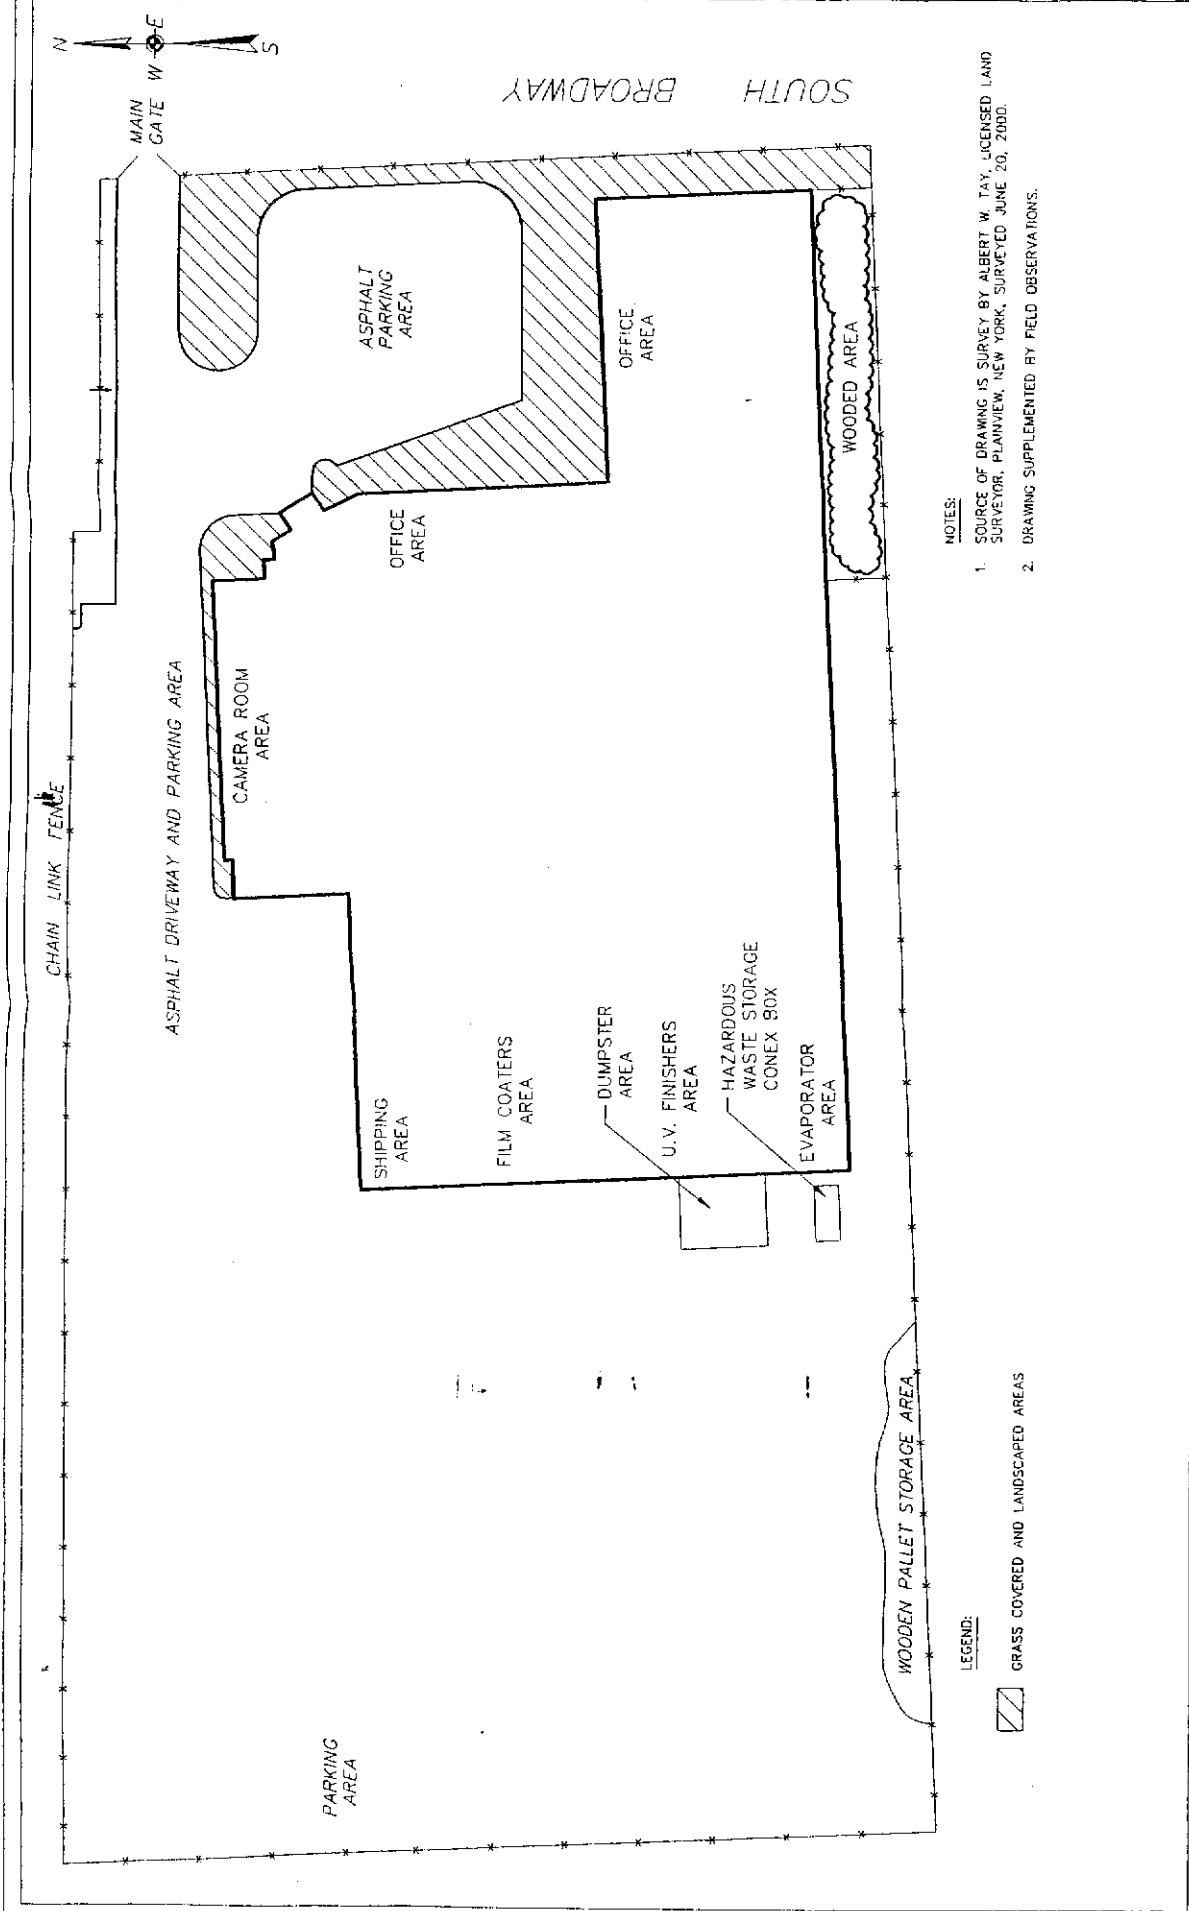
FIGURE 3

The Company's 15,000-sf warehouse facility (Figure 3) is located on a 42,900-sf tract of land ½-mile northwest of the production facility. The exact date of building construction was not determined, however, the building was constructed between 1953 and 1966. Prior occupants of the property include South Nassau Control Corporation, and Busada Manufacturing Corporation. South Nassau Control Corporation is a division of Oceanside Launderers and reportedly occupied the site for seven years. Busada Manufacturing occupied the building for at least 10 years. The property is situated in a primarily industrial area with residential units to the west.

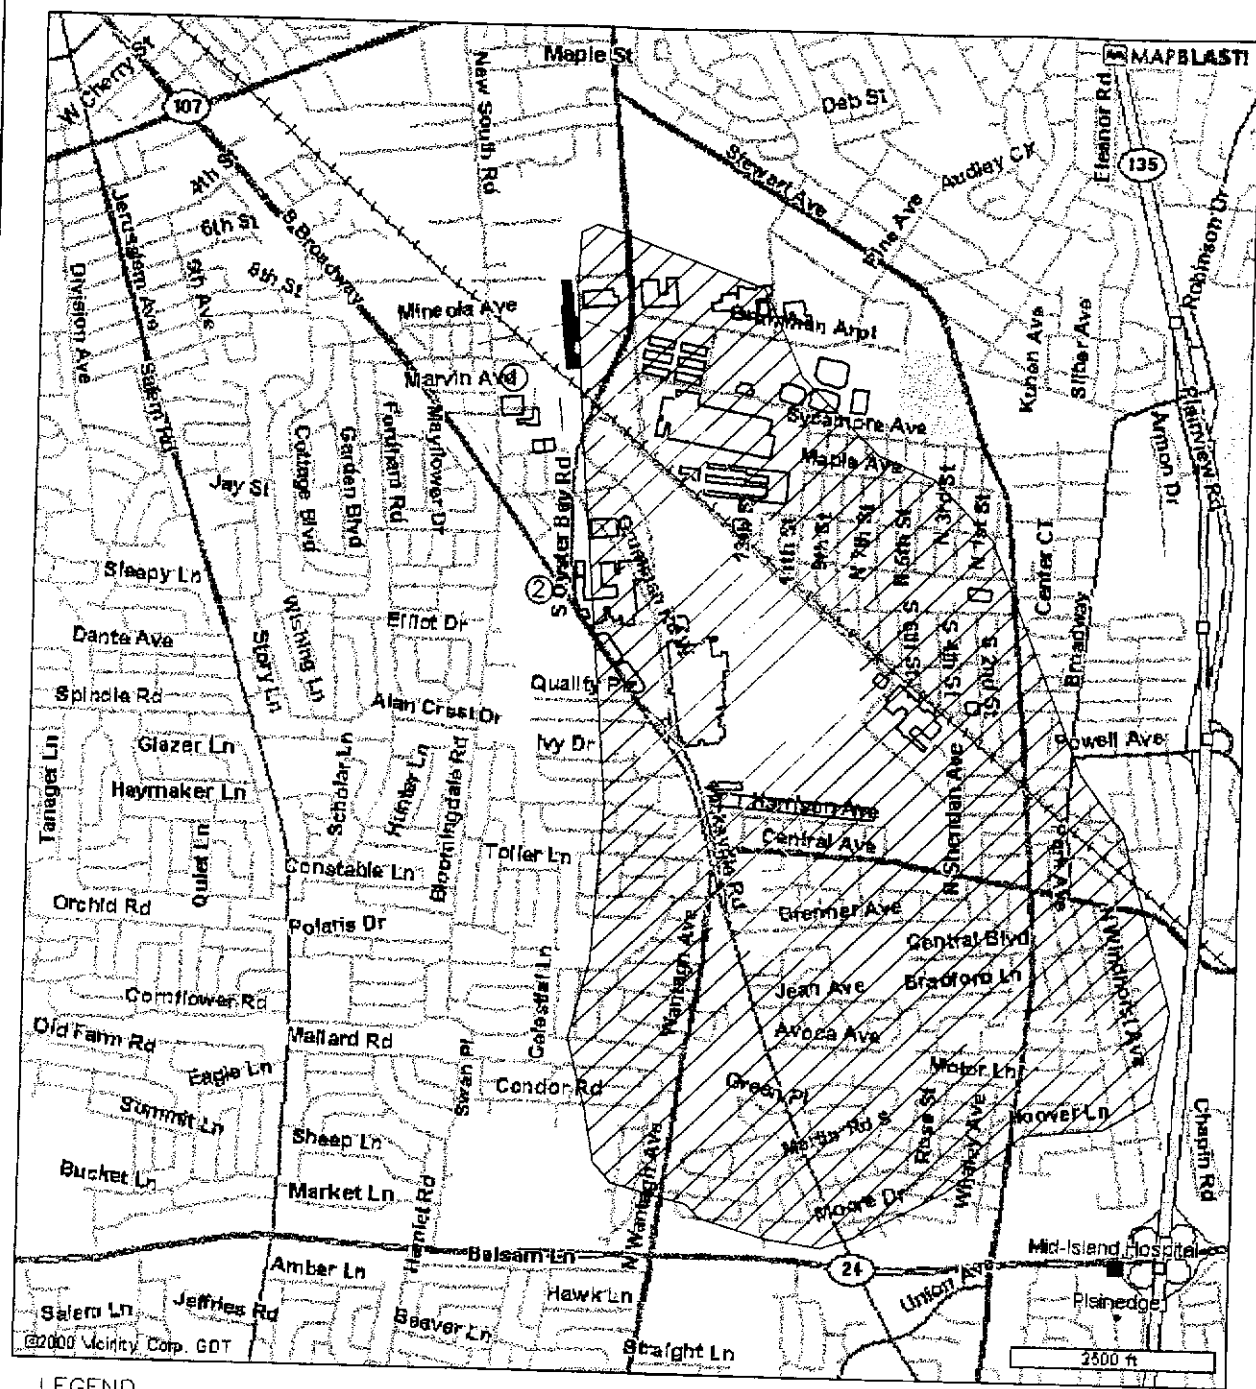
FIGURE 4

The 840 S. Broadway property is located approximately 500 feet west of the TVOC plume (Figure 4). According to the plume map presented in *First Quarter 1999 Hydraulic and Groundwater Quality Monitoring Report* and used to generate Figure 4, the western boundary of the plume is either non-detect or at very low concentrations for TCE and PCE (AG&M 1999). According to the limits of the plume delineated in Figure 4, the plume does not encroach upon the subject property. However, the western boundary of the plume does not appear to be adequately defined to rule out possible migration of the plume onto the 840 S. Broadway property.

The 327 New South Road facility is approximately 1,000 feet west of the TVOC groundwater plume (Figure 4). This plume likely does not impact the property. However, the facility is in the vicinity of an area of contamination discussed in the *Remedial Investigation Report* (G&M 1994) along the Northrop/Grumman and Hooker/Ruco site borders (near Plant 37) (Figure 4). It is likely that the 327 New South Road property is impacted by the contaminants identified in this upgradient area. The contaminants consist of TCE; PCE; 1,1,1-TCA; 1,1-DCE; and VC (G&M 1994).

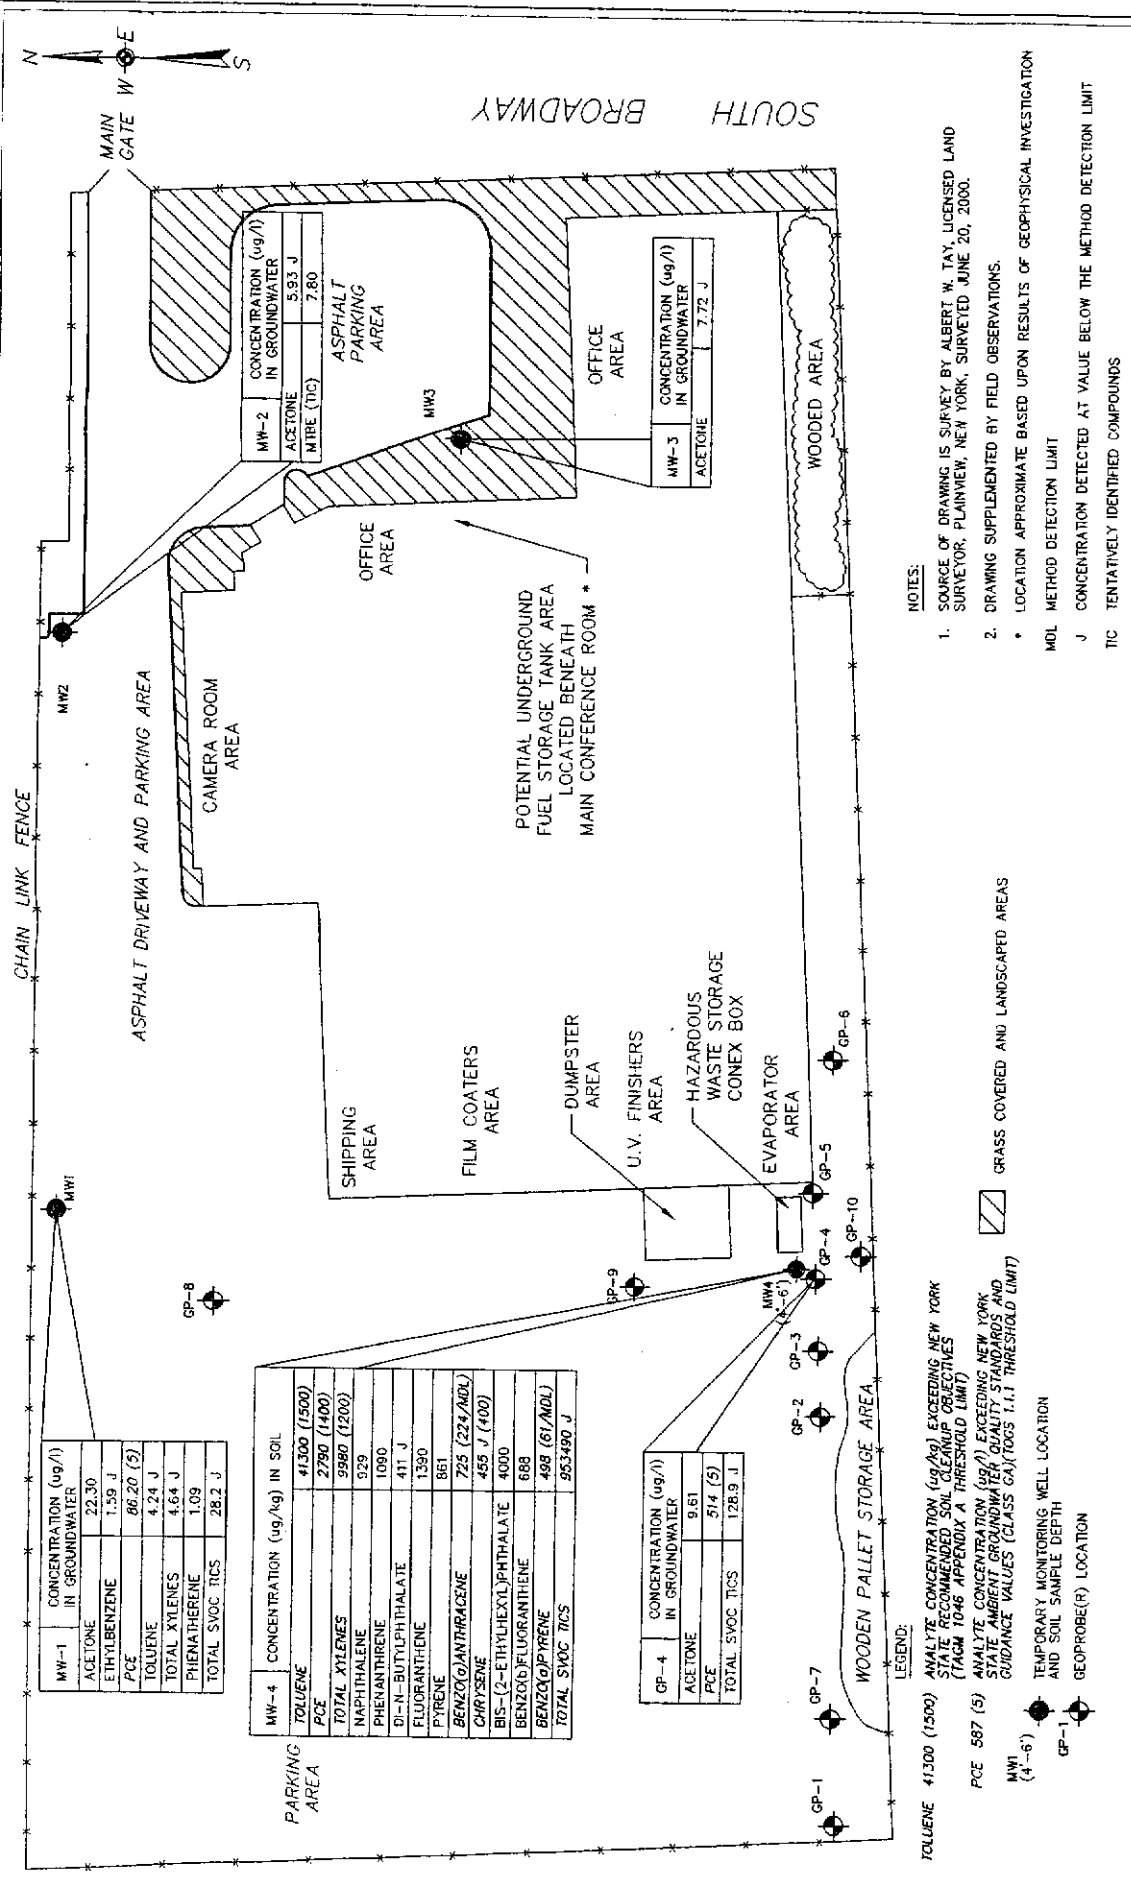
ANALYTE CONCENTRATIONS
WITHIN SOILS AND GROUNDWATER

Toluene, PCE and total Xylenes were detected above analytical method detection limits (MDLs) at concentrations of 41300 µg/Kg, 2790 µg/Kg and 9980 µg/Kg respectively within the soil sample collected at sample location MW-4. Concentrations of these VOCs exceed New York State recommended soil clean-up objectives (TAGM 4046) and are displayed in italicized text on Figure 6. Benzo(a)anthracene and Benzo(a)pyrene were also detected above MDLs within the soil sample at concentrations of 725 µg/Kg and 498 µg/Kg, respectively. Concentrations of these semivolatile organic compounds

(SVOCs) exceed New York State recommended soil clean-up objectives (TAGM 4046) and are displayed in italicized text on Figure 6.

Chrysene and Di-n-Butylphthalate were detected at concentrations below MDLs within the soil sample from sample location MW-4 and are, therefore, displayed with a "J" in Figure 6 as estimated concentrations. Although Chrysene was detected at a concentrations lower than the MDL, its estimated concentration in the soil sample exceeds New York State recommended soil clean-up objectives and is also displayed in italicized text on Figure 6.

PCE was detected above the MDL at concentrations of 86.2 µg/L and 514 µg/L within groundwater samples collected from sample locations MW-1, and GP-4, respectively. Concentrations of this VOC in these samples were observed to exceed New York State Class GA Groundwater Quality Standards (T.O.G.S 1.1.1 threshold limits) and are displayed in italicized text on Figure 6.

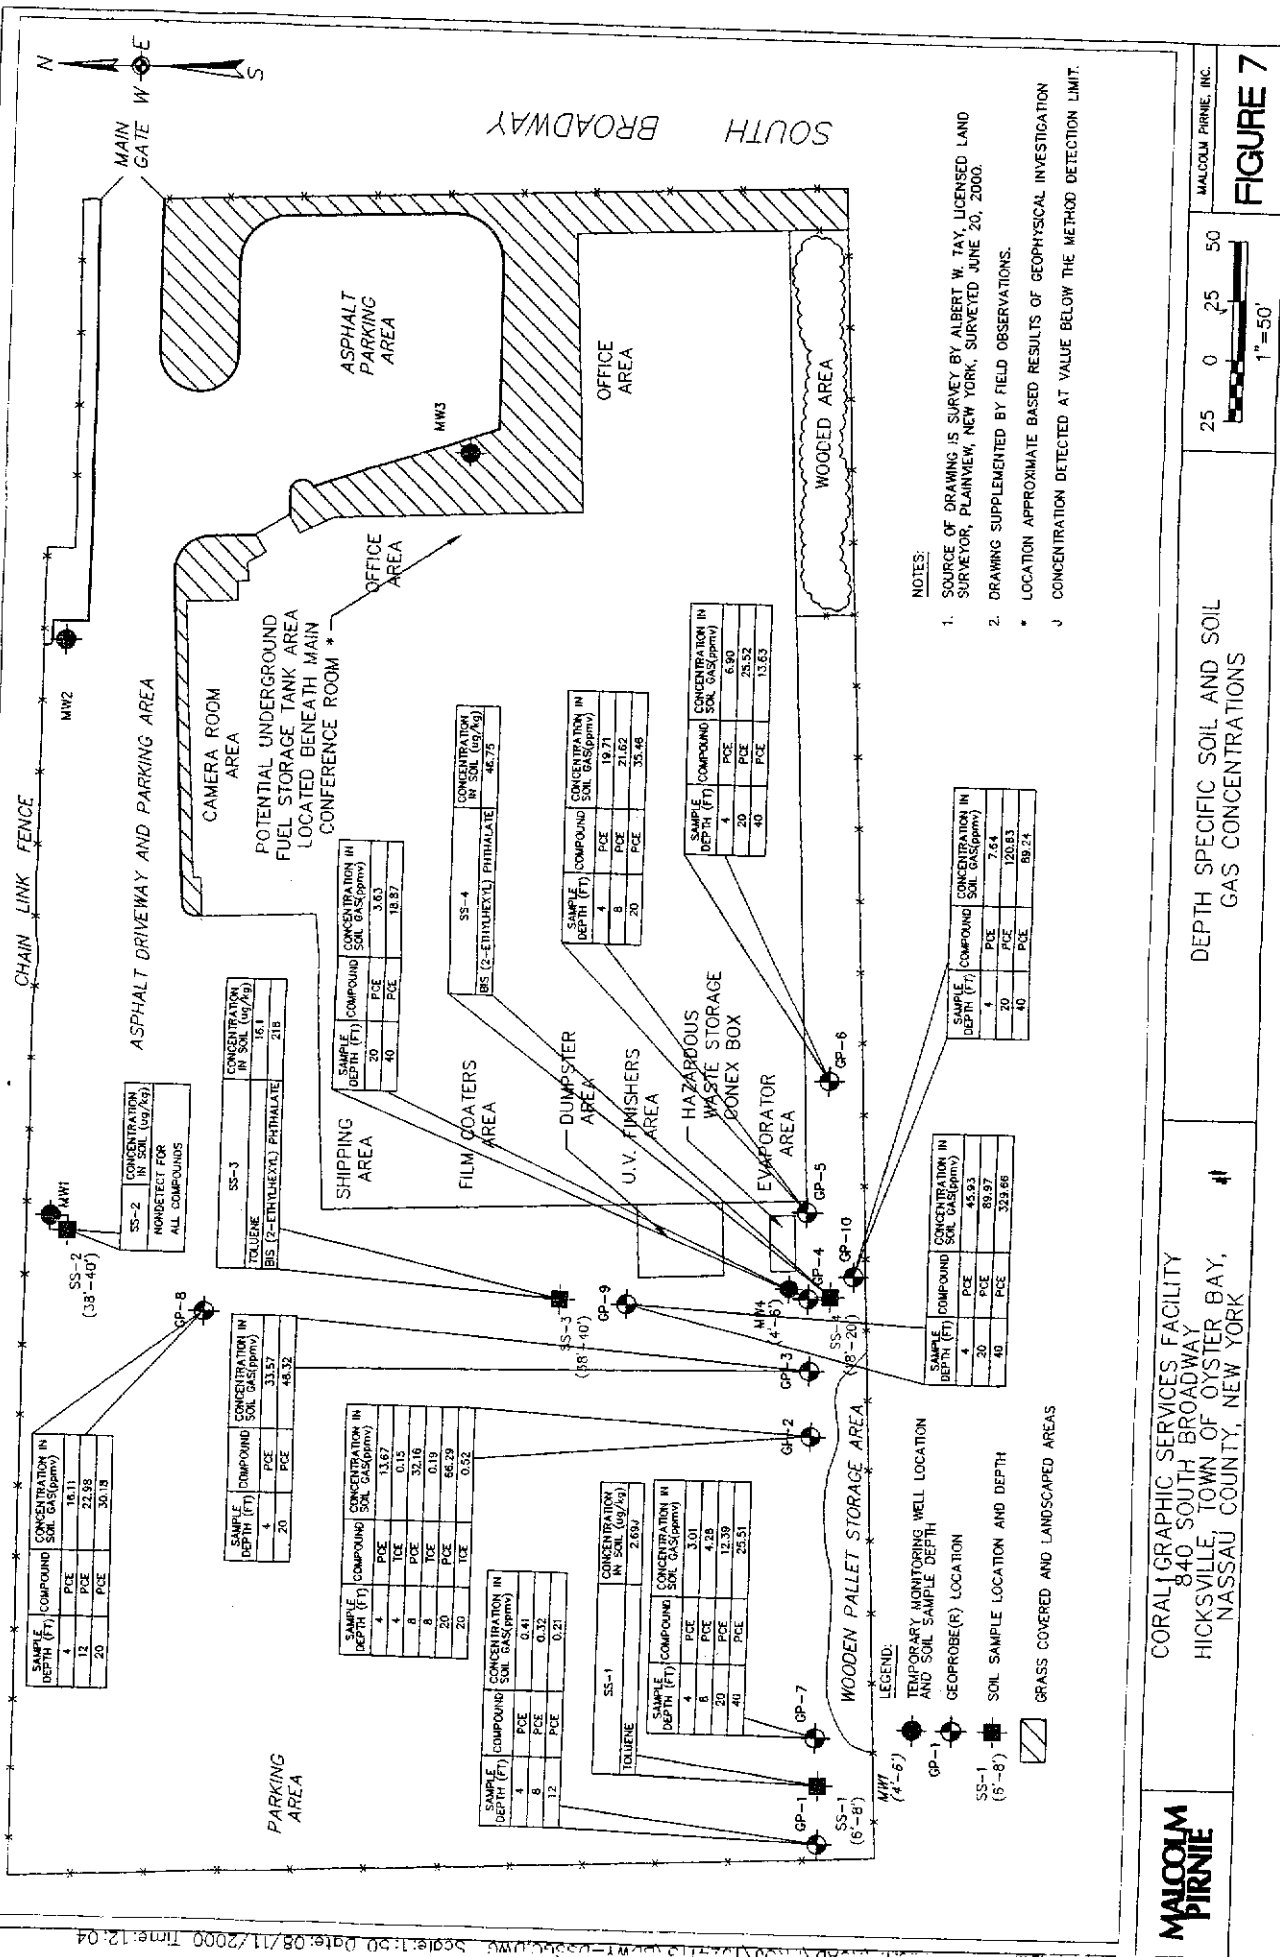
MALCOLM
PIRNIE, INC.
FIGURE 7

Results of PID field screening of split spoon soil samples collected during the advancement of soil borings at the 840 South Broadway property did not result in the detection of any total VOCs above background within soil borings constructed at sample locations MW-1, MW-2 and MW-3. As previously discussed, PID values in excess of 500 ppmv were observed in the breathing zone during the advancement of the soil boring at sample location MW-4. One subsurface soil sample was obtained at this sample location from a depth of 4 to 6 feet bgs. Four additional soil samples were also obtained from sample locations SS-1, SS-2, SS-3 and SS-4 during the expanded Phase II site investigation of the property. Sample locations and analytical results of the Phase II site investigation are displayed in Figure 6. Sample locations and analytical results of the expanded Phase II site investigation are displayed in Figure 7.

The results of the on-site analyses of depth-specific soil gas samples collected using Geoprobe® techniques during the expanded Phase II site investigation of the AOC west of the Hazardous Waste Storage CONEX box area displayed in Figure 7. Benzene and Ethylbenzene were detected in the soil gas sample collected at a depth of 4 feet bgs at concentrations of 0.06 parts per million by volume (ppmv) and 0.1 ppmv, respectively. TCE was detected in soil gas samples collected at depths of 4, 8 and 20 feet bgs at concentrations ranging from 0.15 to 0.52 ppmv.
