report.VCP.V00433.2001-09-14.In-Situ Bio Presentation

# ENVIRONMENTAL, INC.

## IN-SITU BIO-CHEMICAL REMEDIATION SERVICES PRESENTATION

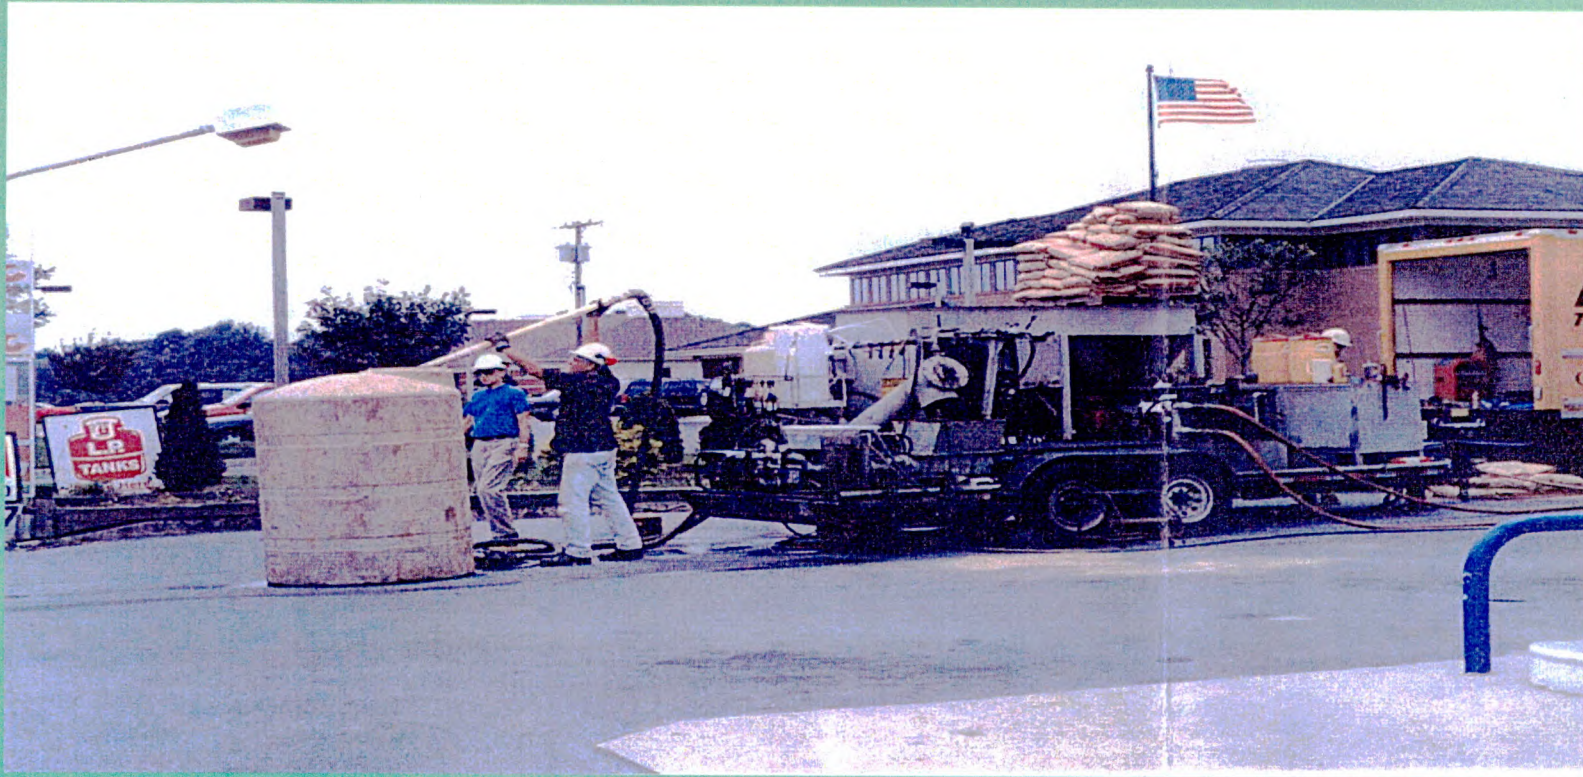
# In-Situ Bio-Chemical Remediation Fracturing Step

- Can advance up to 4 to 6 fractures/day.
- Fractures can be safely advanced in close proximity to utility lines (approximately 4' vertical distance)

- Determine the depths and locations of fractures required;
- Install injection wells to depth of desired fractures;
- Inject high pressure water/air to create and advance the fracture;
- Determine the extent of the fracture; and
- Prop the fracture.
