2011 Periodic Review Report

Hunts Point Food Distribution Center Parcel B

Site reconnaissance was conducted on January 13, 2012 by HDR. Photographs were taken during the site visit and are included as Appendix B.

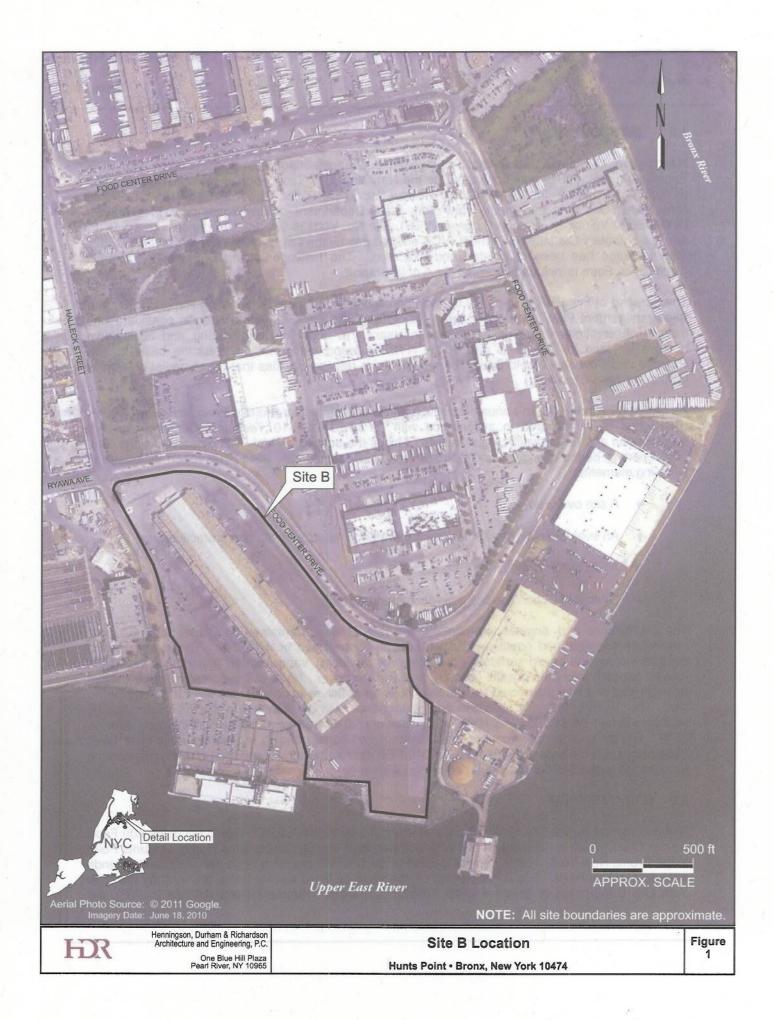
east by a New York City Department of Sanitation (DSNY) salt storage facility and abandoned waste transfer station, and the south by the Bronx River (Figure 1).

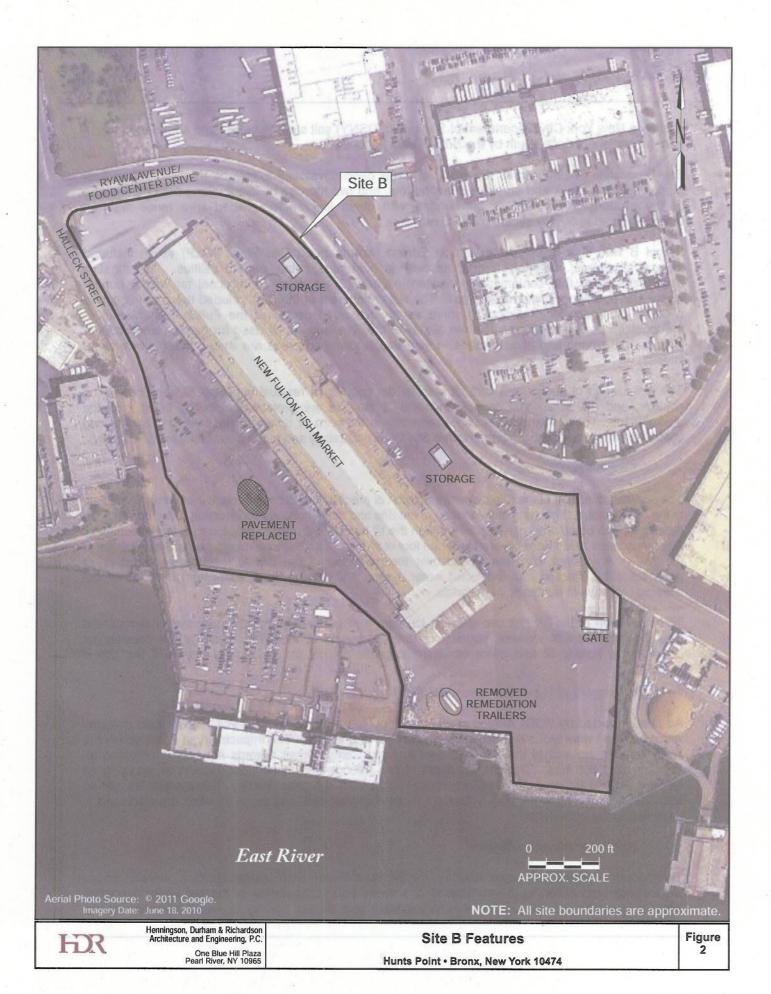
Site B consists of 29.04 acres (Figure 2) and has been developed to include the New Fulton Fish Market building, truck and employee parking lots, and two storage buildings along the eastern side of the property. The Site is surrounded with chain link and/or barbed wire fence with an attended/gated entryway securing Site B entirely.

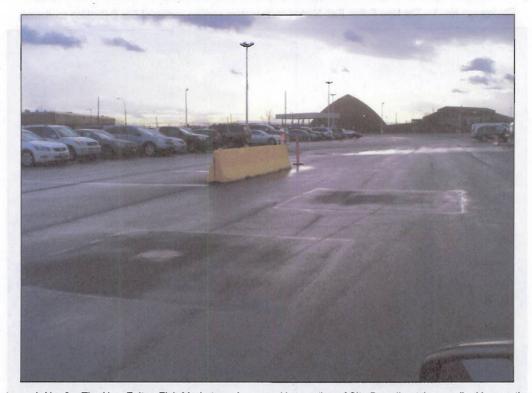
Photograph No. 6 - The New Fulton Fish Market employee parking portion of Site B, well patch seen (looking southeast)

Based on information in the May 26, 2009 letter, HDR determined that the system could be permanently shutdown and the above-ground components could be dismantled and removed. With NYSDEC approval, 30 wells related to the former AS/SVE remediation system located at Site B were decommissioned on September 9, 2010. This activity included all of the associated wells outside of the building footprint (with the exception of AS-A-4, which is located under an onsite storage structure and inaccessible). The process and procedure for closure consisted of the following: The well caps were removed and the wells were filled with a Portland and Bentonite grout mixture to approximately 0.5 to 1 foot below ground surface. A Portland cement concrete was then used to fill in the remaining void space, bringing the surface flush with the surrounding parking lot. Former well caps, were filled with concrete in during the September decommissioning and were further replaced with asphalt patches to allow for a smoother surface at grade during the Spring of 2011.

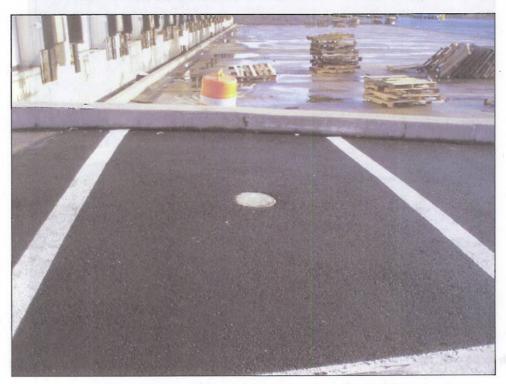
Photograph No. 8 - The New Fulton Fish Market monitoring well closures Site B

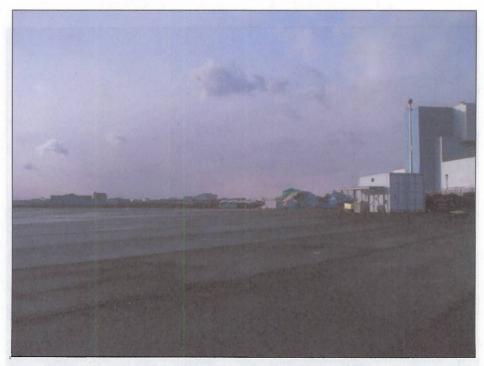
Photograph No. 9 - The New Fulton Fish Market south parking portion, Remediation Trailer Removal at Site B (looking south)

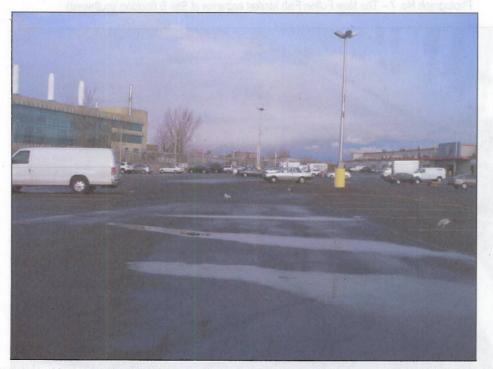
Photograph No. 10 - The New Fulton Fish Market western parking portion of Site B, degraded asphalt (looking north)

Subsurface utilities do exist in Site B. However, no maintenance or upgrades requiring subsurface intrusion have been performed on these structures within the past year. A Generic Worker/Department Notification plan has been created to provide notification, prior to the commencement of work, to the NYSDEC when intrusive activities are scheduled. This plan has been included as Appendix C. Catch Basins were repaved and new grates installed along the western portion of the patron parking areas but no subsurface intrusive work occurred during these upgrades and construction activities. Several potholes and one larger degraded asphalt area were repaved after excessive snow removal efforts during the 2011 winter months.

Direct contact exposure to residual subsurface contamination (i.e., on-site soil/fill/bedrock) is prevented by the surrounding asphalt parking lots and limited vegetation at the Site. No major maintenance of the barrier is required under normal conditions. However, several potholes and one larger degraded asphalt areas were repaved after excessive snow removal efforts during the 2011 winter months. No fill material was exposed in any of these areas and the cap remained fully functional.

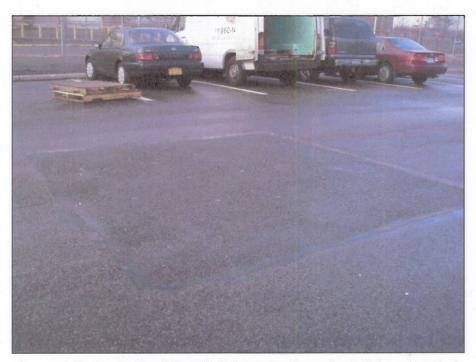
Photograph No. 11 - The New Fulton Fish Market west parking portion, pothole repair at Site B

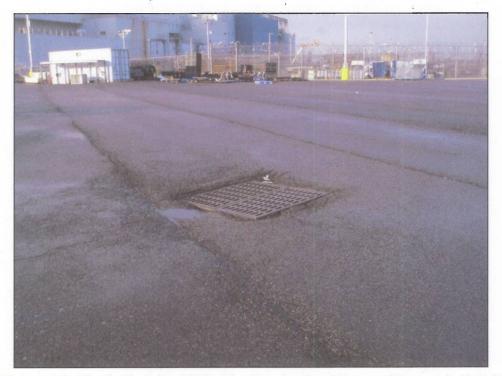
Photograph No. 12 - The New Fulton Fish Market southwest parking portion, one of the remaining Catch Basins for repair
