2019 Periodic Review Report

Hunts Point Parcel B

For the Property located at 800 Food Center Drive
Bronx, New York 10474
Former NYSDEC VCP Site No. V00436-2

Revised January 2020
GEI Project #: 1901379

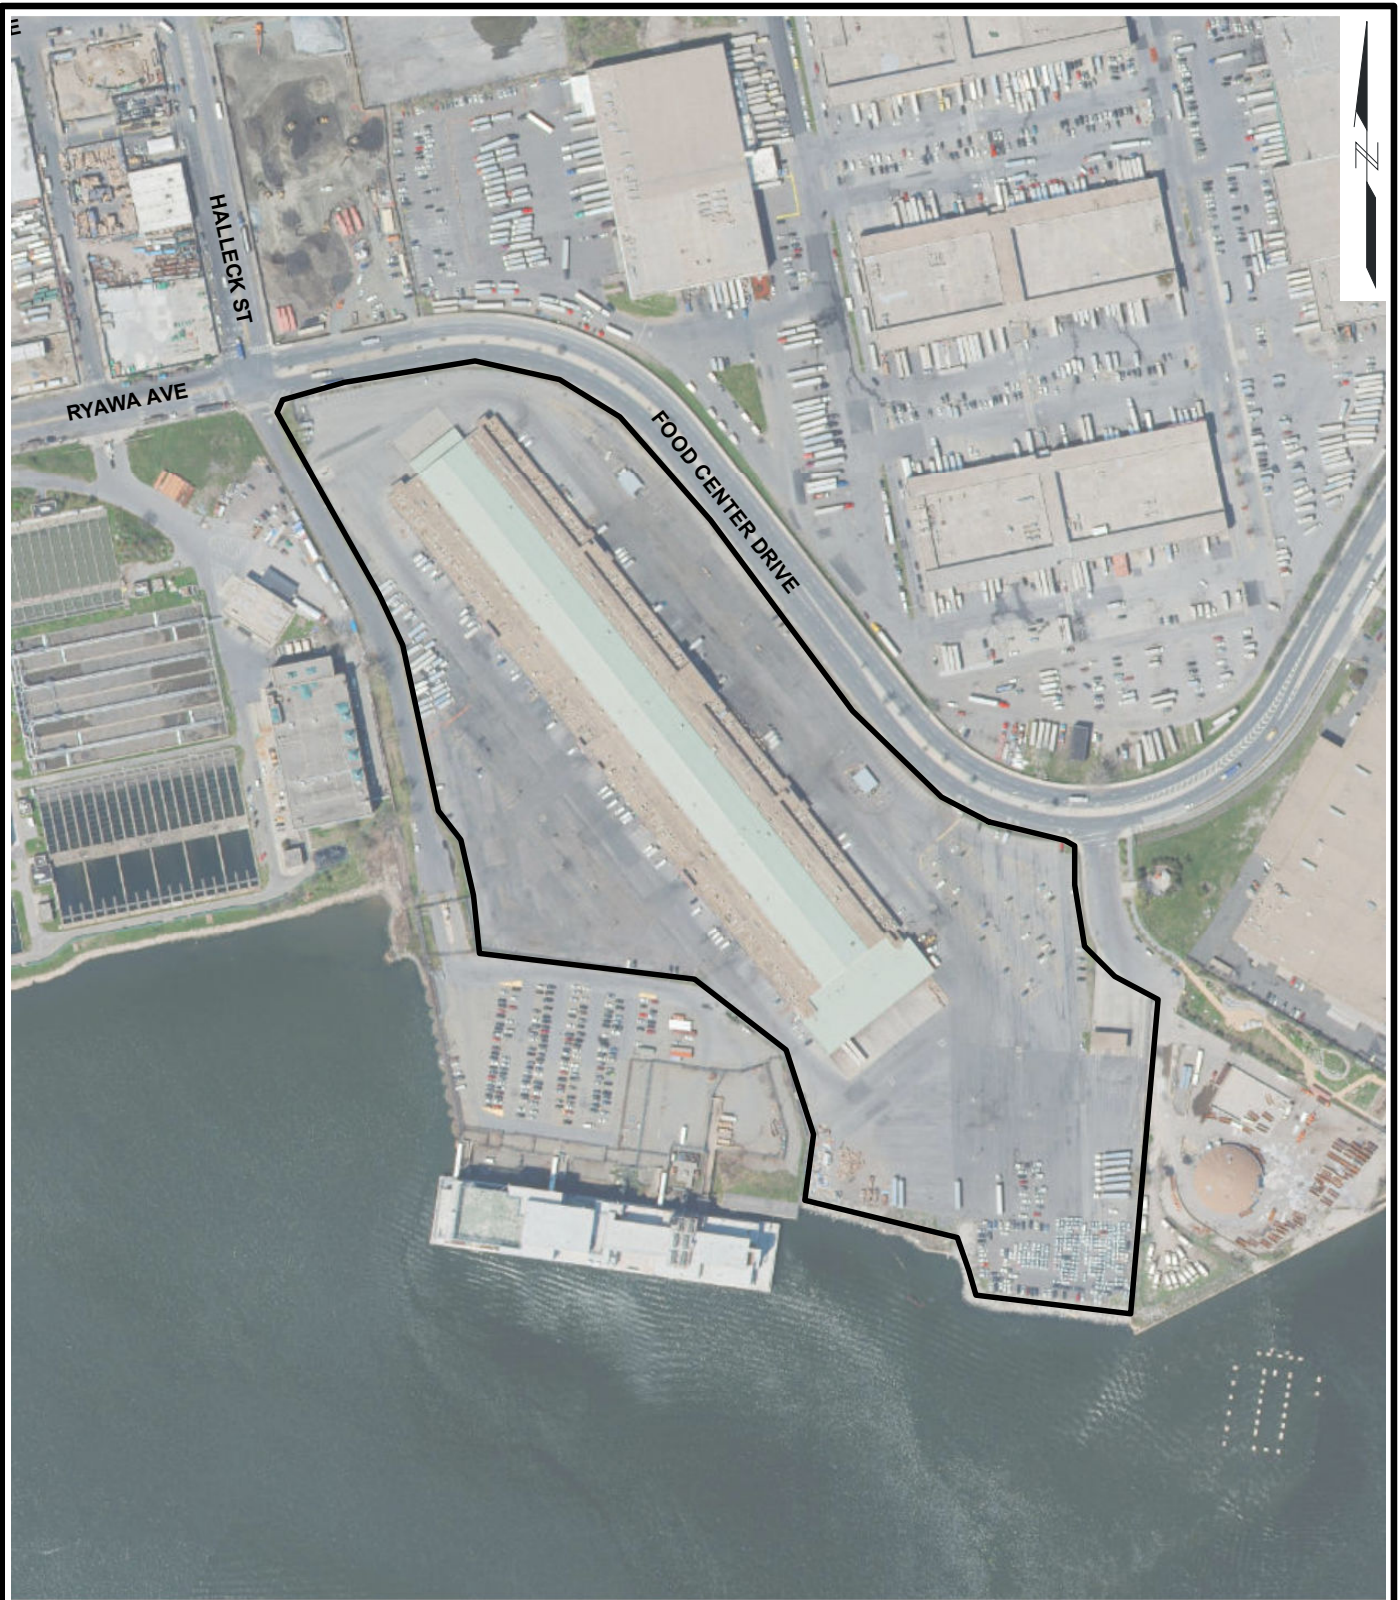
Fig. 2

SITE LAYOUT

Summer 2018 Storm Line Installation and Repaving
-

September 2018 Fence Installation
-

March 2019 Guard Shack Installation
-

March 2019 Storm Sewer Repair

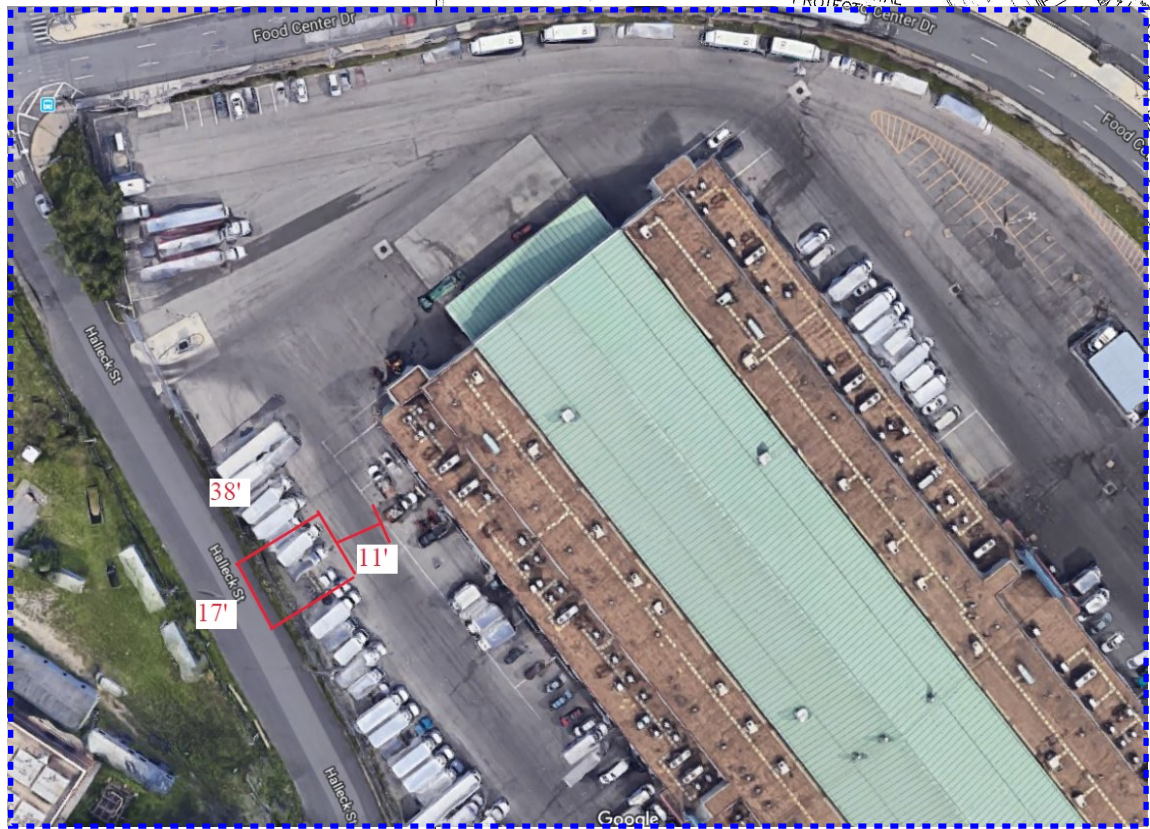
VCP Site #V00436-2 December 2019 Fig. 3

PORTIONS OF SIDEWALK / CURB TO BE REMOVED AND REPLACED, AND AS DIRECTED.
 1,000 FT. SIDEWALK / CURB.
 FENCE TO BE REPAIRED
 200 FT. MESH
 50 BRACES / POLES

SITE REPAIRS/IMPROVEMENTS
 2018 - 2019

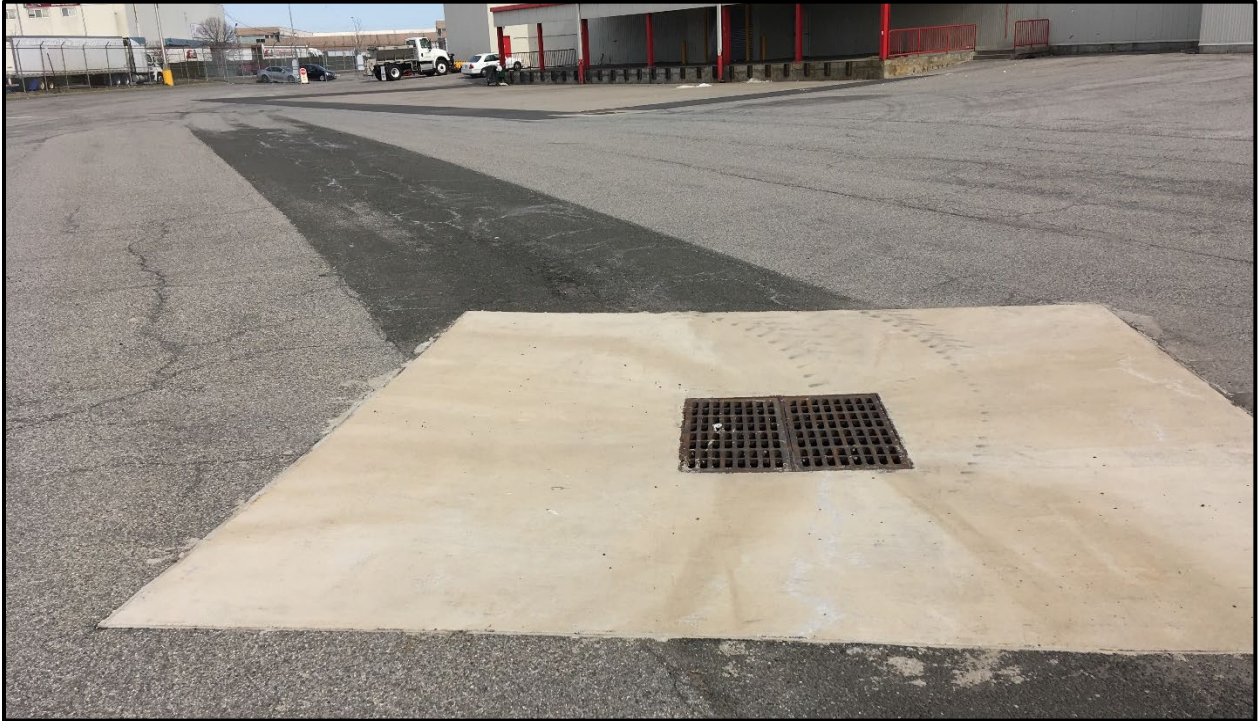
Photo 1: Facing east in the northwestern portion of Site; Storm sewer installation and re-paving/re-capping as performed by Verdugos General Contractors Corp. (mid-2018).

Based on a discussion with Gaston Verdugos (foreman) of Verdugos General Contractors Corp., in mid-2018, Verdugos milled a path of asphalt within the northern portion of the Fulton Fish Market parking lot to install a storm sewer. The milled asphalt was removed from the site and no soil was generated as part of the operations. The engineering control was restored once the areas of removed asphalt were re-paved. Photo documentation of the recently paved area is provided in **Photo 1**.

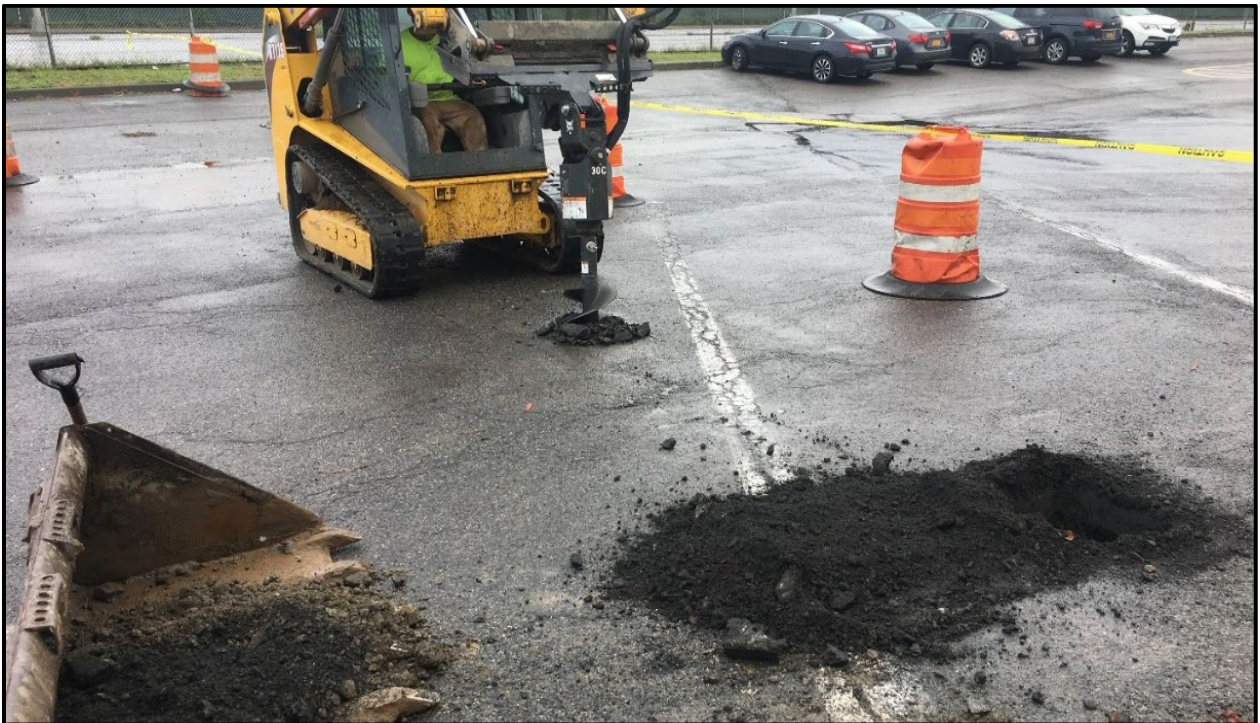
Photo 2: Facing northeast in the northeastern portion of Site; SH5 Construction Corp. augering holes for fencepost installation (September 2018).

GEI provided oversight during the installation of new fencing in the northern portion of the Fulton Fish Market as performed by SH5 Construction Corporation on September 26, 2018. Twenty (20) fence posts were installed, each requiring a post hole of approximately four-feet deep and one-foot in diameter. All soil (approximately 2-3 cubic yards) removed from the post holes was stockpiled and staged on-site. The holes were backfilled to grade with the metal fenceposts and concrete. Photo documentation of these activities are provided in **Photos 2 and 3**. Continuous air monitoring was performed during all ground intrusive and concrete pouring activities for dust, volatile organic compounds (VOCs), hydrogen cyanide (HCN) and hydrogen sulfide (H₂S). No exceedances were noted by the field representative during the fence installation activities. While continuous air monitoring was performed, the data logging function on the instrument was not initiated.

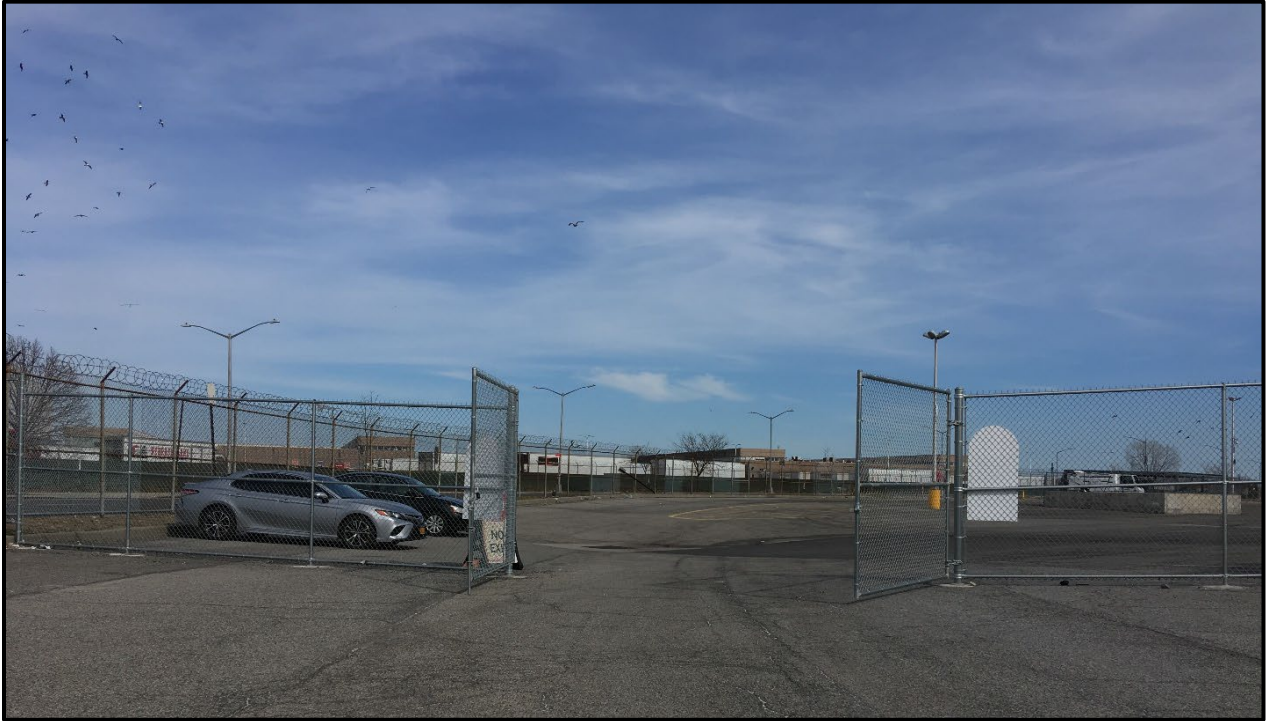
Photo 3: Facing east in the northeastern portion of Site; newly installed fencing and gated entryway completed by SH5 Construction Corp. (September 2018).

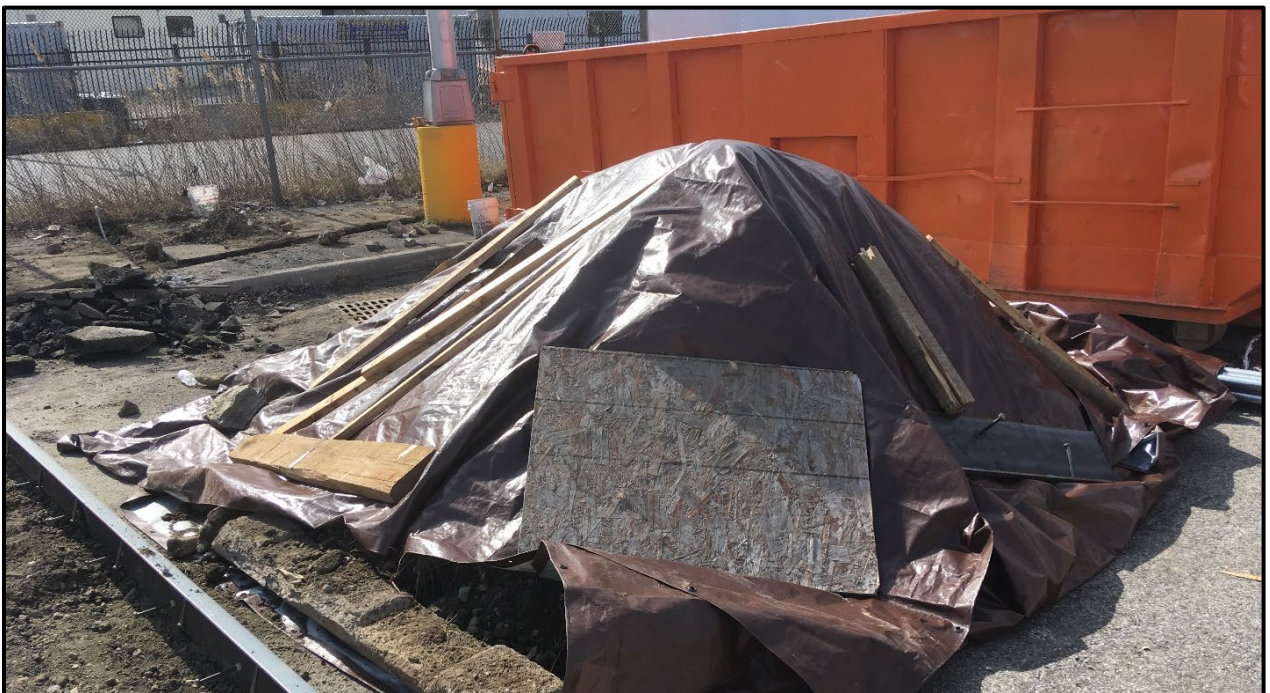
Photo 4: Facing northwest in the northwestern portion of Site; excavated soil on plastic sheeting and covered with a tarp to be sampled, characterized and disposed of at an appropriate facility (March 2019).

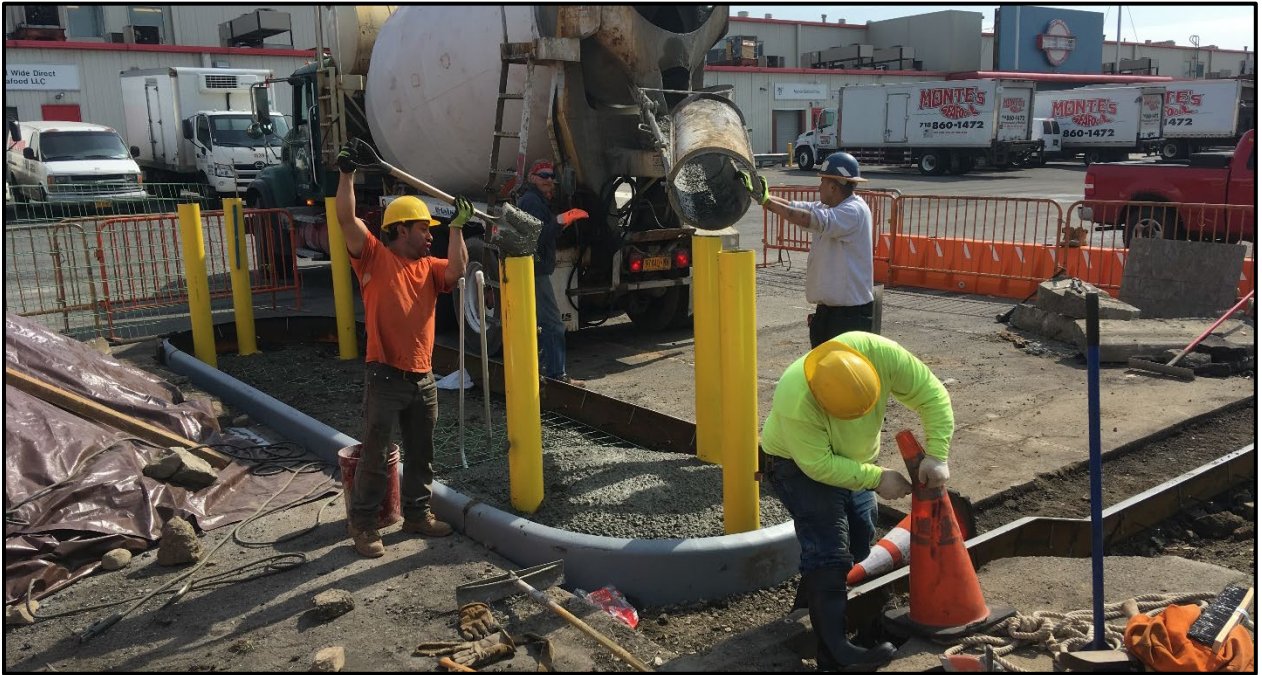
Photo 5: Facing east in the western portion of Site; Verdugos General Contractors Corp. pouring concrete for the guard shack foundation (March 2019).

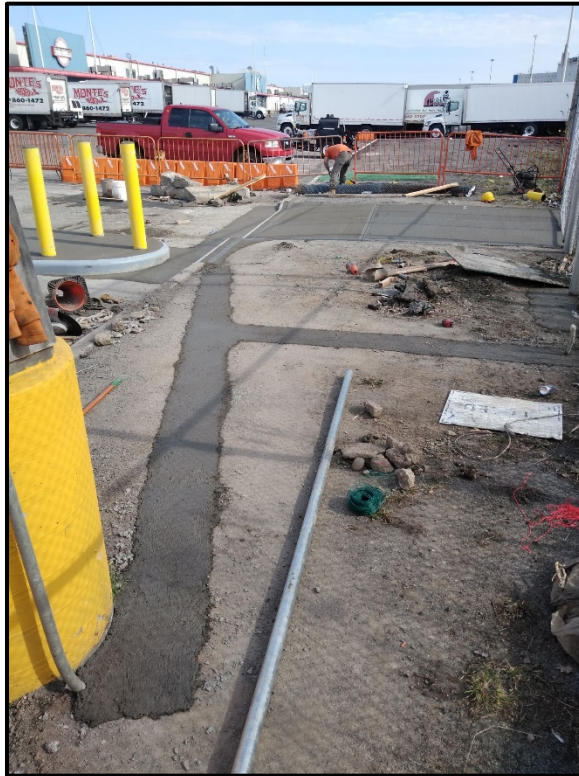
Photo 7: Facing south in the northwestern portion of Site; concrete poured over the electrical conduit trench, re-establishing the engineering cap (March 2019).

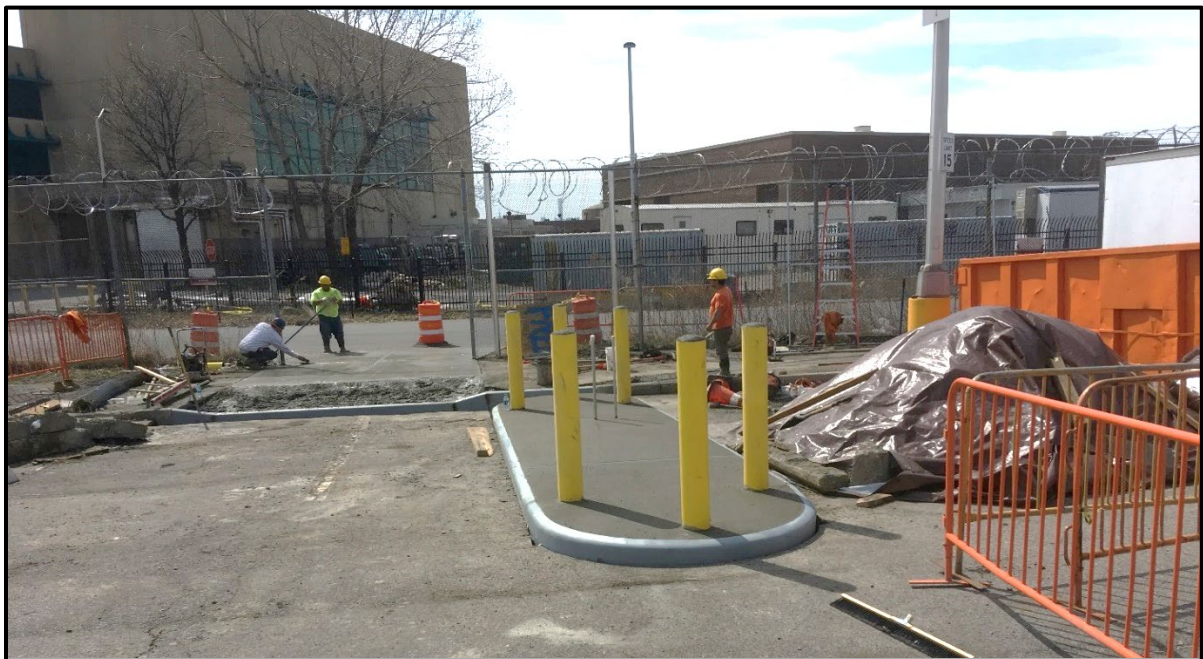
Photo 8: Facing west in the northwestern portion of Site; concrete poured over exposed subgrade material for the new guard shack foundation (March 2019).

the asphalt cap was a layer of RCA that remained undisturbed during the project. A second cut in the asphalt pavement was cut to the dimensions of 12 ft x 20.5 ft x 3 inches deep. Soil was found beneath the slab and approximately 29 tons of material was excavated to achieve pre-pour grade. The excavated soil was temporarily stockpiled on plastic sheeting and covered with a tarp until soil characterization and disposal arrangements were made. Verdugos General Contractors Corp. arranged for export and disposal of the Site generated material to Soil Safe, Inc. as non-hazardous soil on May 22, 2019 (**Appendix C**). Approximately 5-7 cubic yards of asphalt and approximately two (2) cubic yards of concrete were also generated and disposed of at a registered recycling facility in accordance with the SMP. Two separate cuts were made for electrical conduit, due northwest from the guard shack foundation. One cut/trench led to an existing light post and the second to the future location of a powered device. The dimensions of these cuts were approximately 15 ft x 1 ft x 8 inches deep, and the activity generated less than one (1) cubic yard of soil. Fabricated metal curbs were installed and concrete was poured over all exposed subgrade on March 30th, 2019, thus restoring the EC.

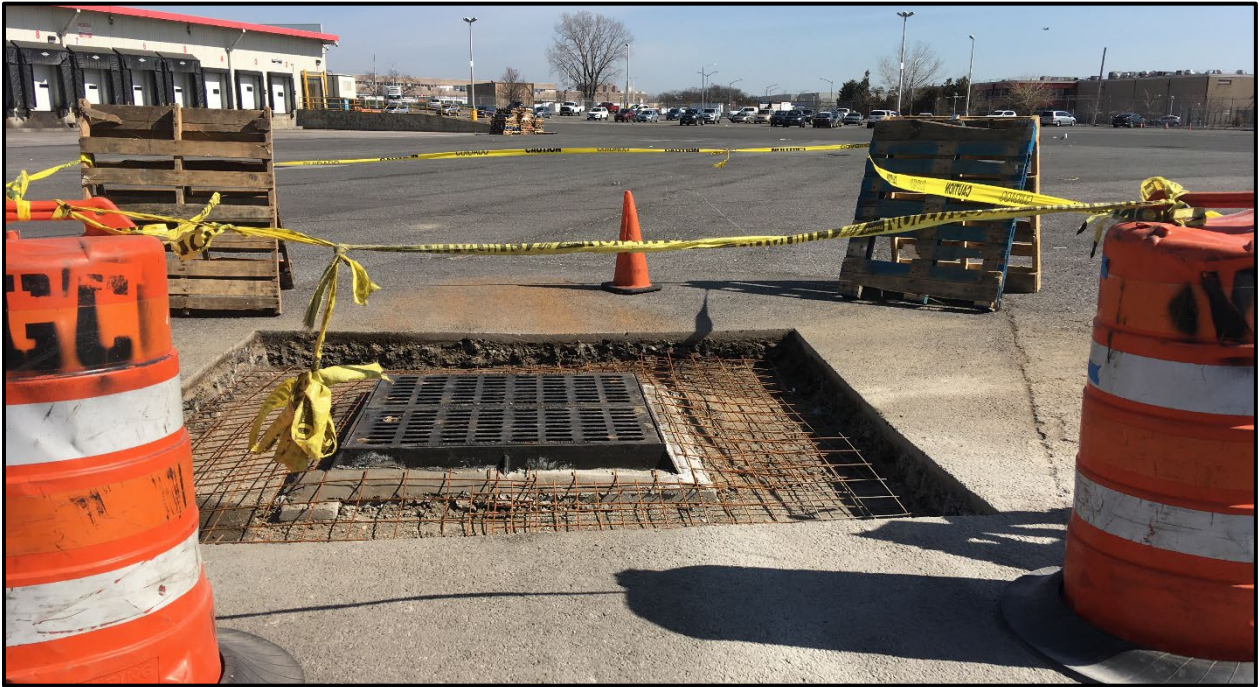
Photo 9: Facing east in the southern portion of Site; asphalt removed and subbase exposed for storm sewer drain repairs (March 2019).

During the week of March 25th, 2019, under the supervision of NYCEDC, contractors repaired a storm sewer drain in the southern portion of the Fish Market parking lot. The work required removal of asphalt and exposure of the subbase material. Concrete was poured over the exposed material and the EC was restored on March 29th, 2019 (**Photos 9 and 10**).

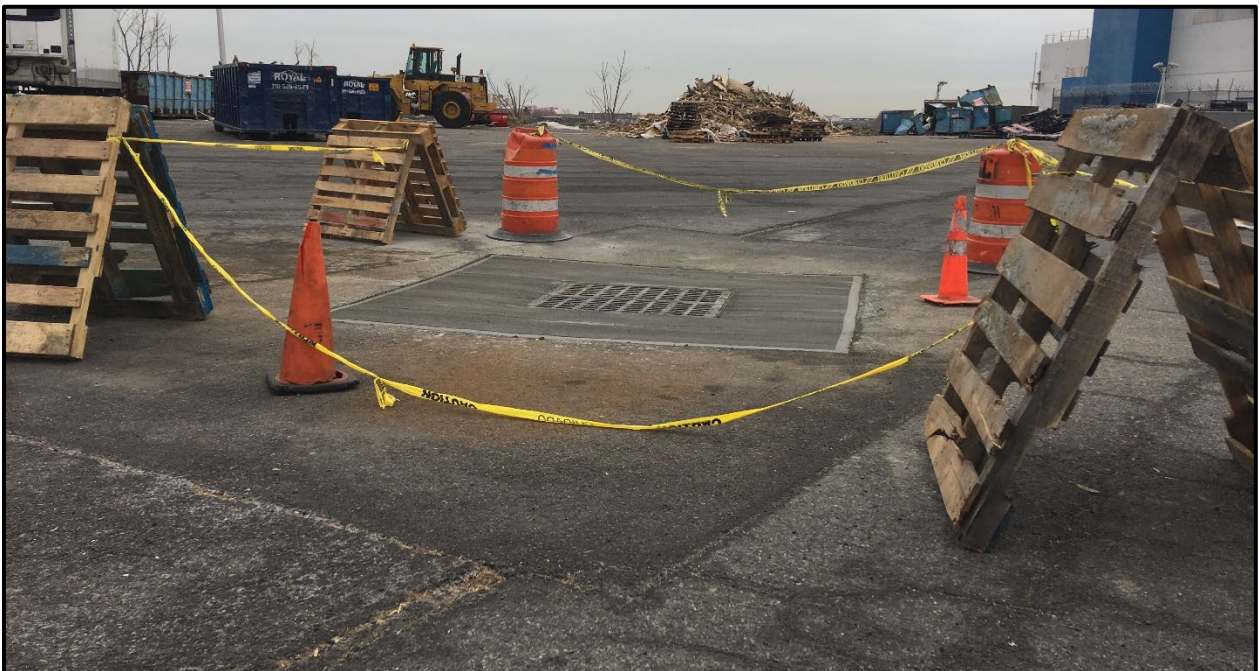
Photo 10: Facing west in the southern portion of Site; completed repairs on a storm sewer drain. Following the concrete pour, the EC was re-established (March 2019).

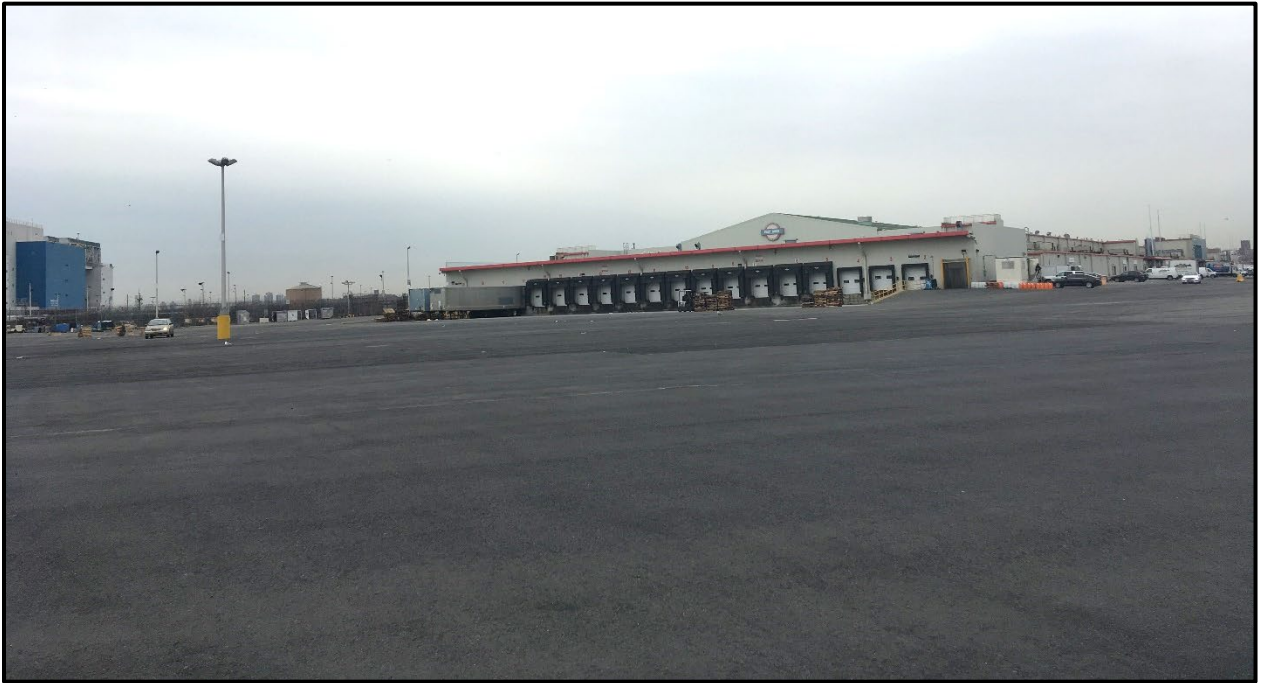
Photo 11: Facing north in the southern portion of Site; engineering controls are still in place. Normal wear from heavy truck traffic in the form of asphalt cracks and potholes of various sizes are present in the parking lot (March 2019).

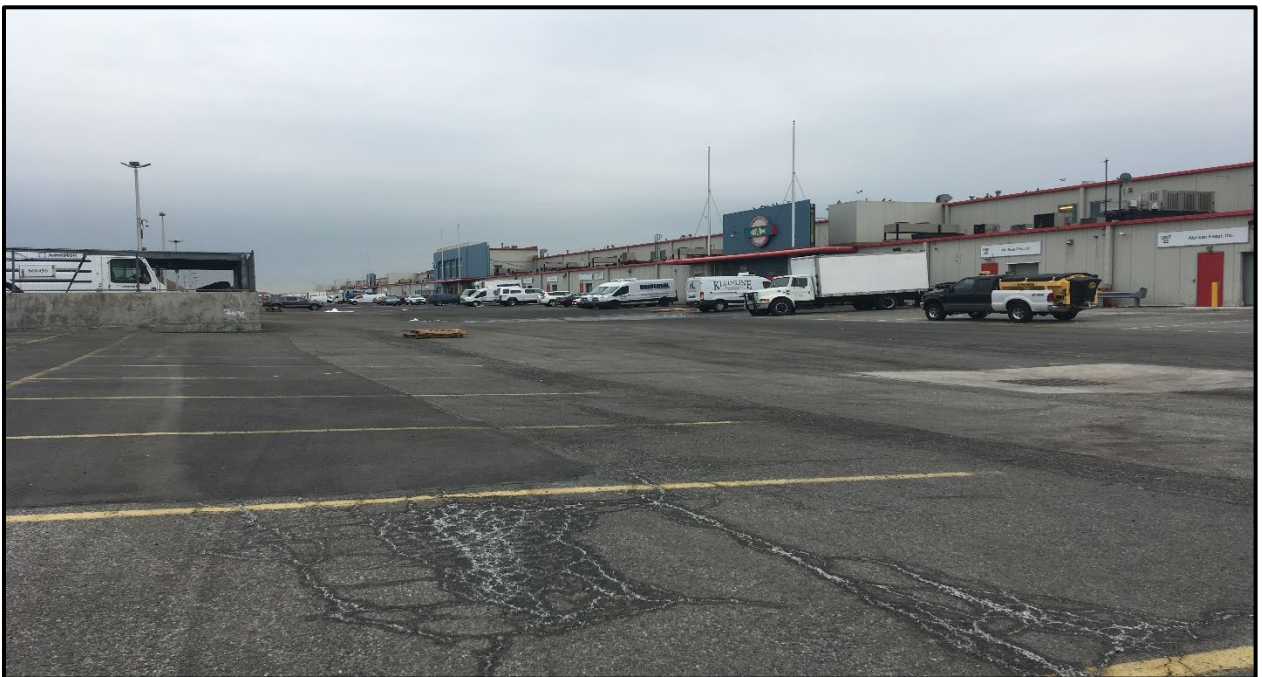
Photo 12: Facing south in the eastern portion of Site; engineering controls are still in place. Normal wear from heavy truck traffic in the form of asphalt cracks and potholes of various sizes are present in the parking lot (March 2019).

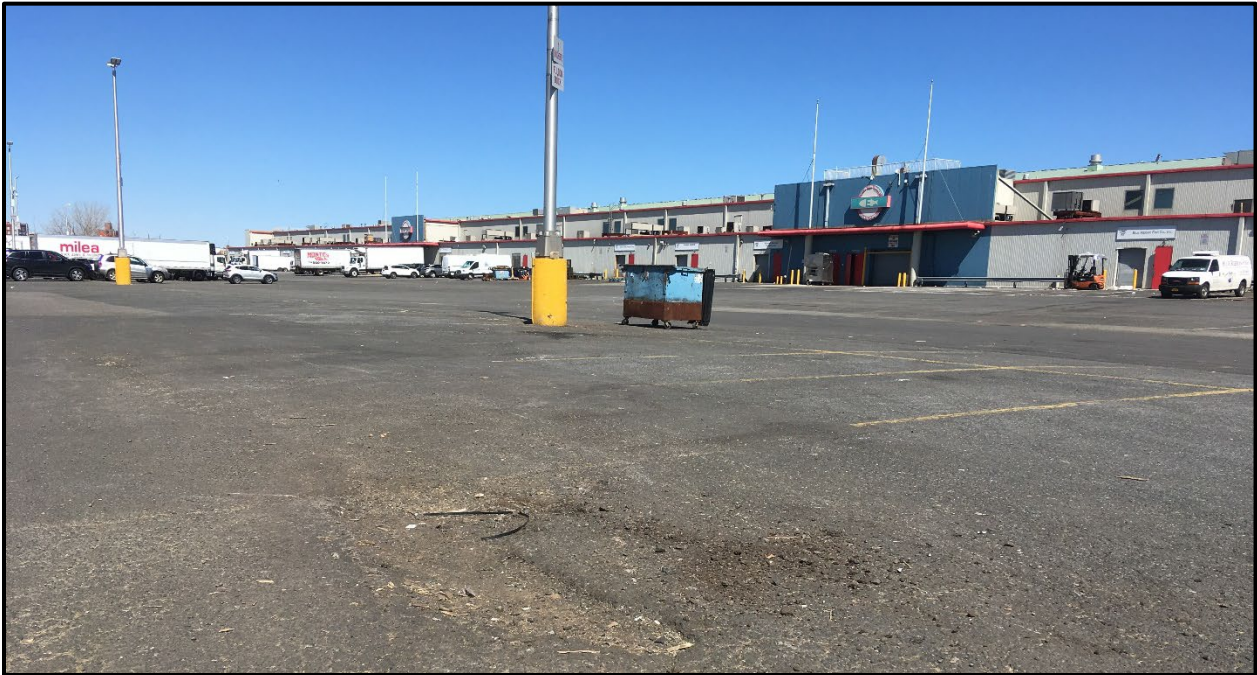
Photo 13: Facing northeast in the western portion of Site; engineering controls are still in place. Normal wear from heavy truck traffic in the form of asphalt cracks and potholes of various sizes are present in the parking lot (March 2019).

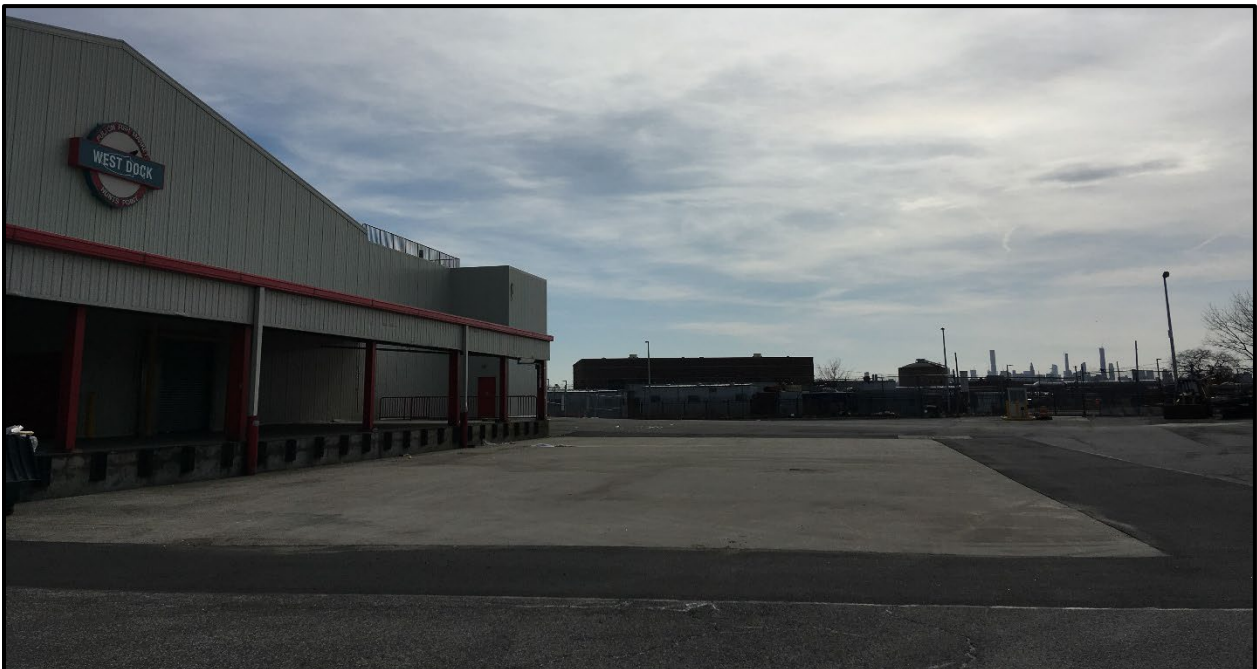
Photo 14: Facing west in the northern portion of Site; engineering controls are still in place and in good condition (March 2019).
