2021 Periodic Review Report

Hunts Point Parcel B

For the Property located at 800 Food Center Drive
Bronx, New York 10474
Former NYSDEC VCP Site No. V00436

January 2022
GEI Project #: 1901379

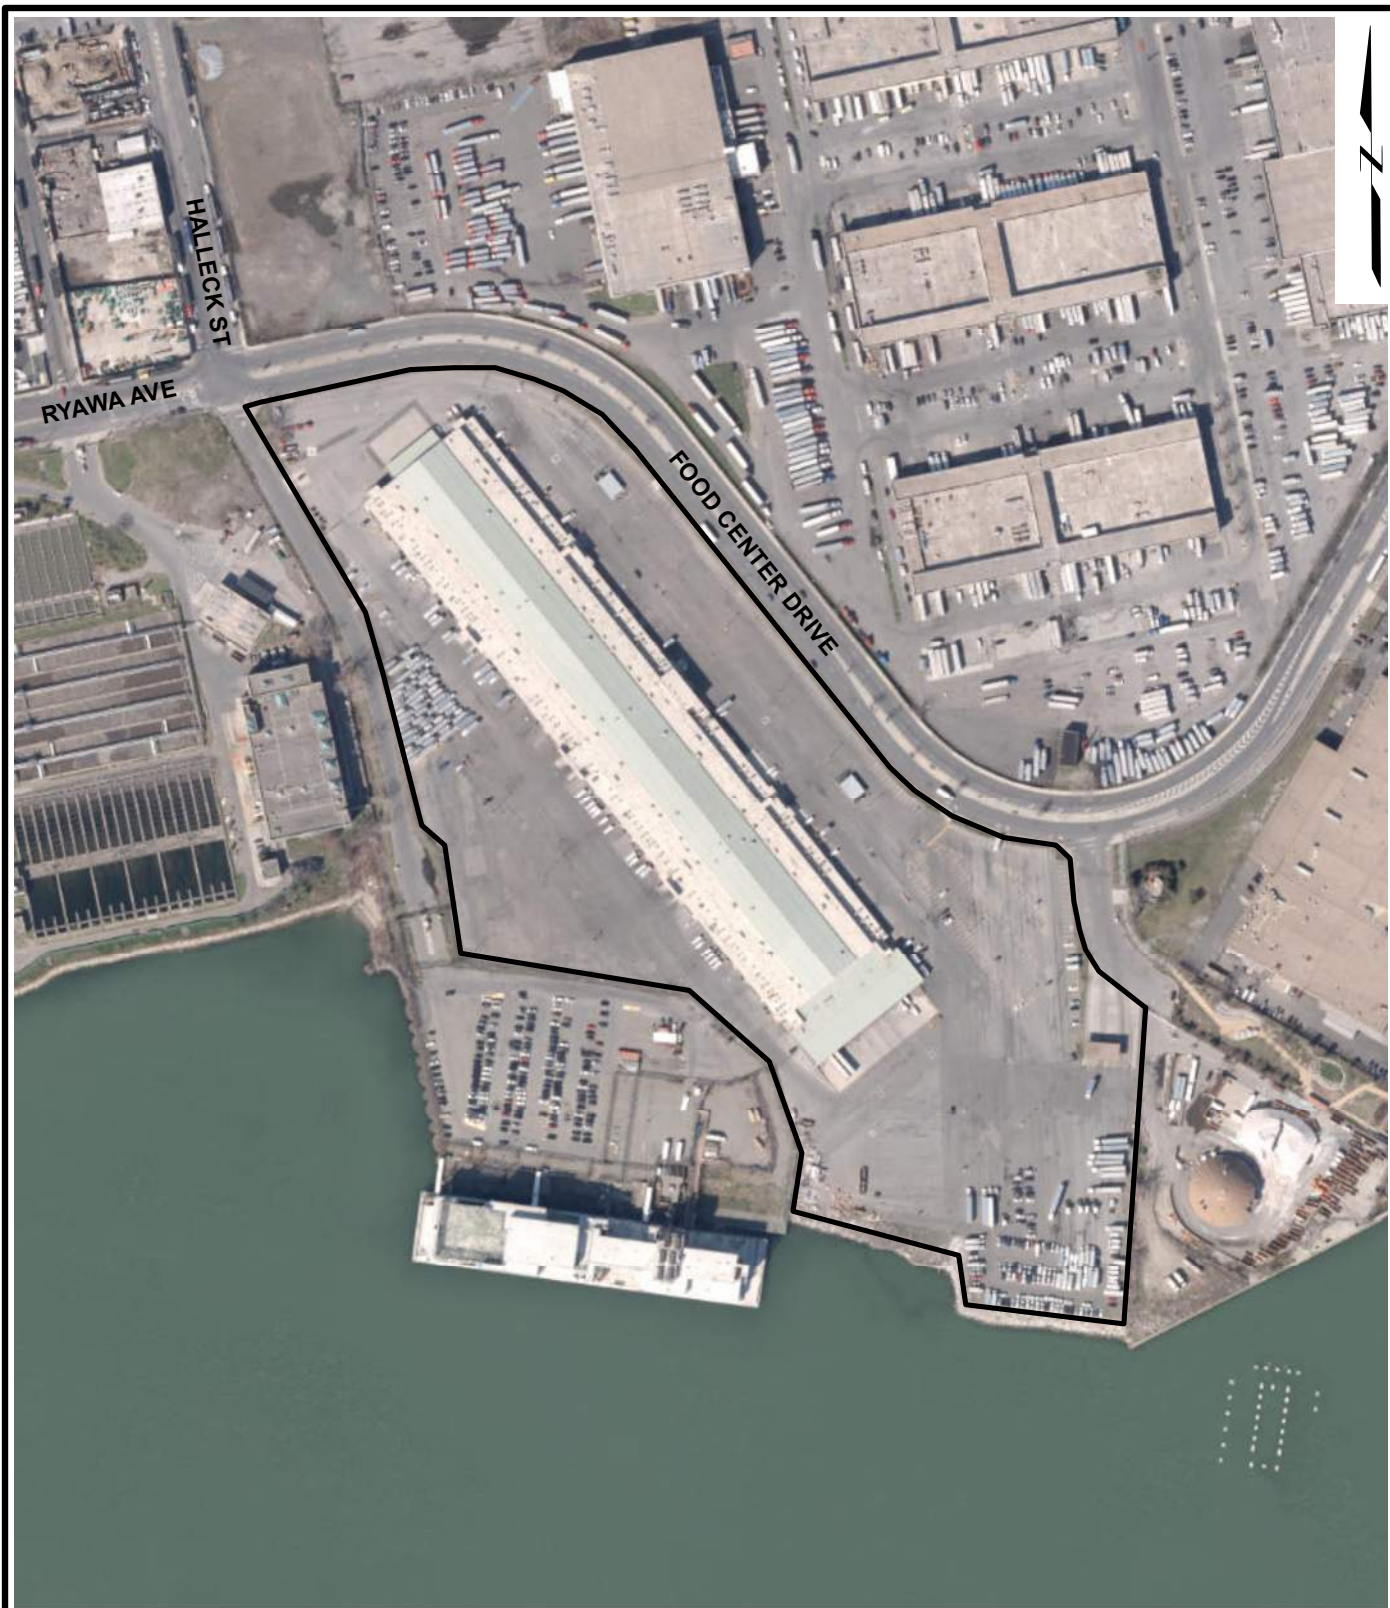
Fig. 2

SITE LAYOUT

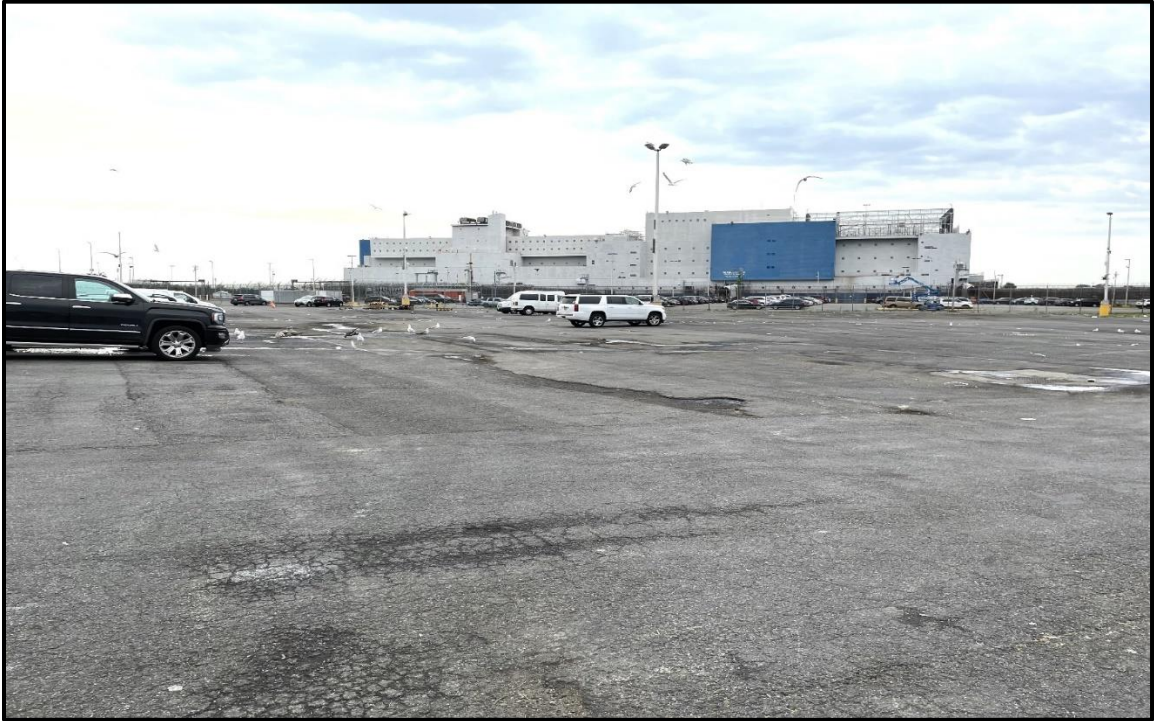
Photo 1: Facing south in the southern portion of Site. Minor cracking in the asphalt noted.

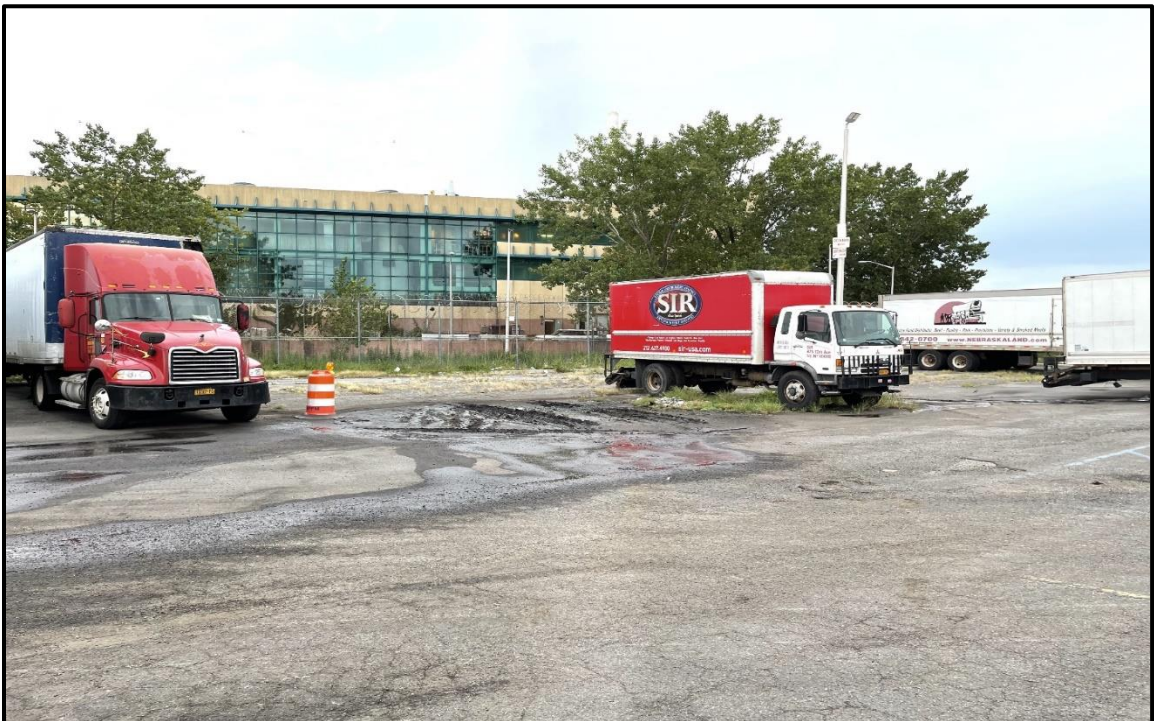
Photo 2: Facing west in the western portion of Site; low laying area with soil and debris accumulation. The engineering cap remains in place with some vegetation growing through cracks in the asphalt.

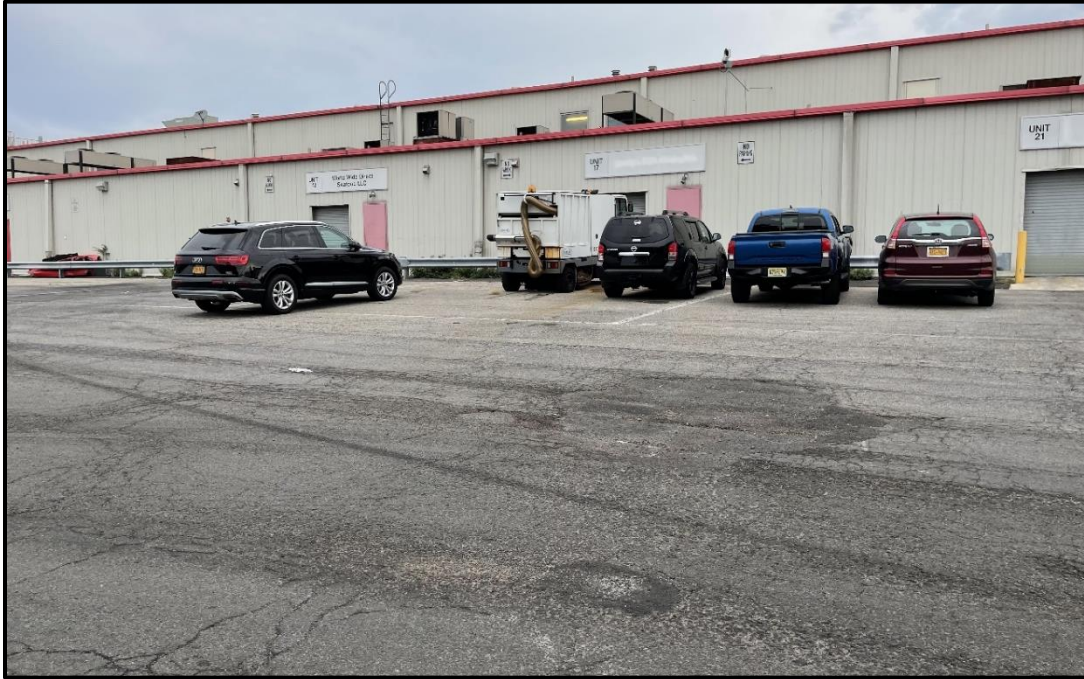
Photo 3: Facing east in the western portion of Site; areas of re-paving performed at an unknown date.

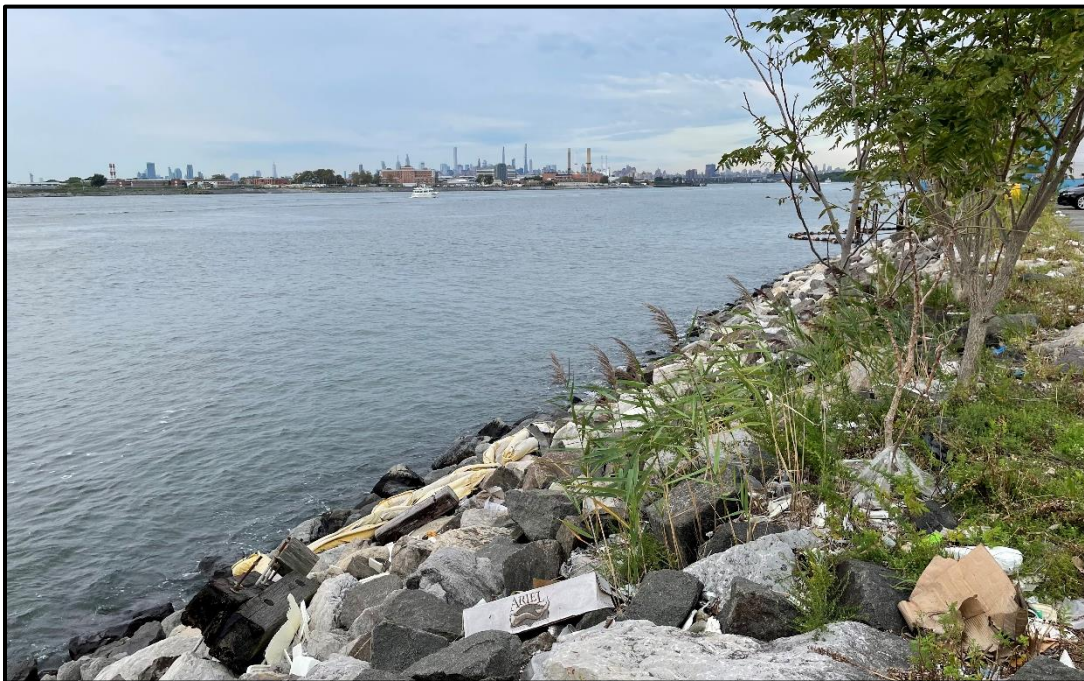
Photo 4: Facing west along the northwestern portion of Site; bulkhead along waterfront in good condition.

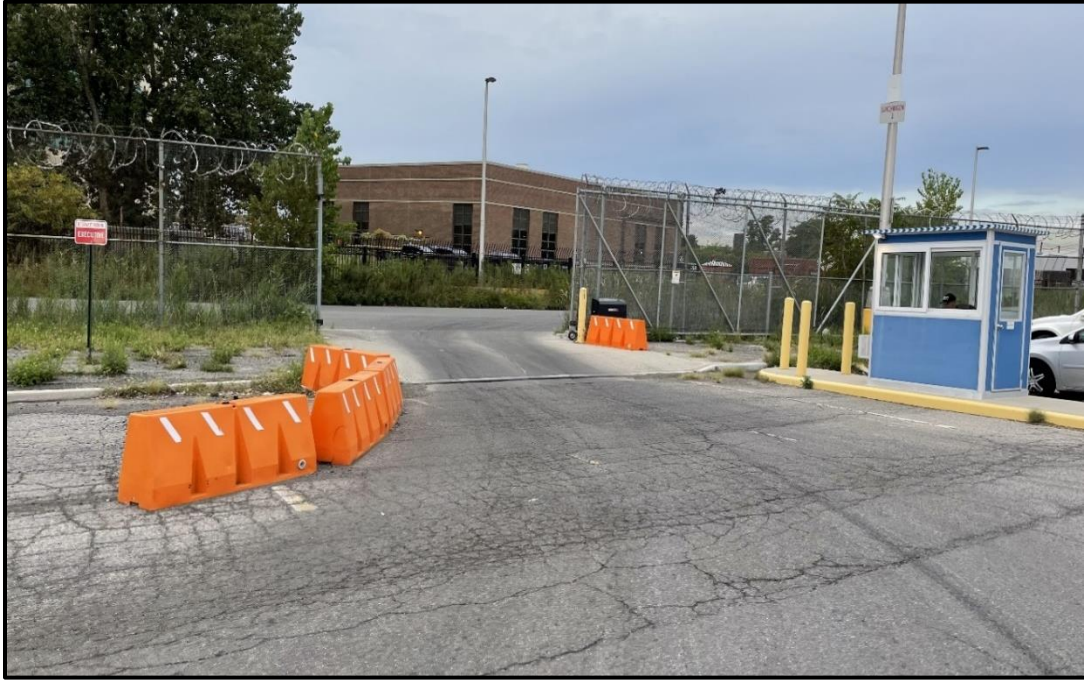
Photo 5: Facing west in the western portion of Site; location of guard shack installed in March 2019.

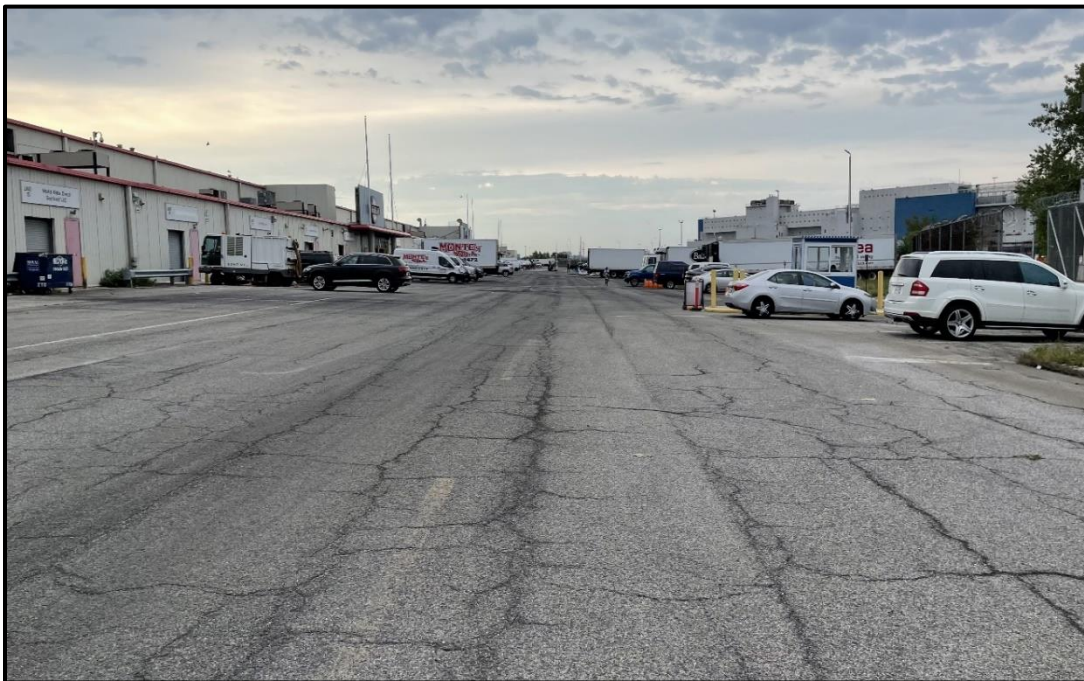
Photo 6: Facing south in the southwestern portion of Site; minor cracking present.

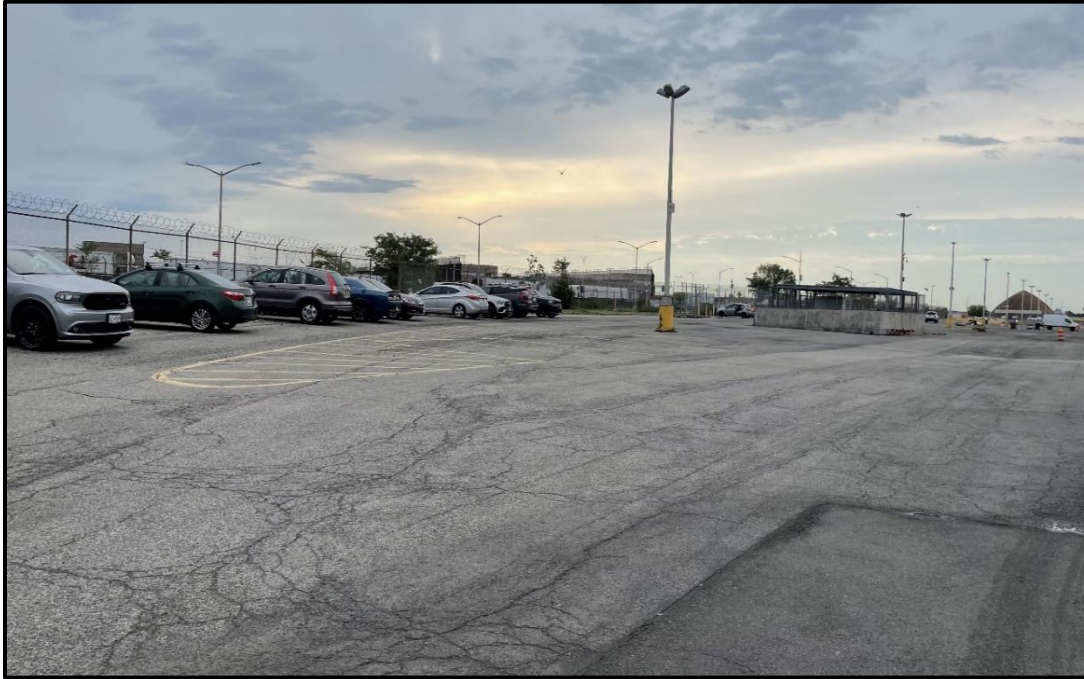
Photo 7: Facing south in the northeastern portion of Site; asphalt in good condition.

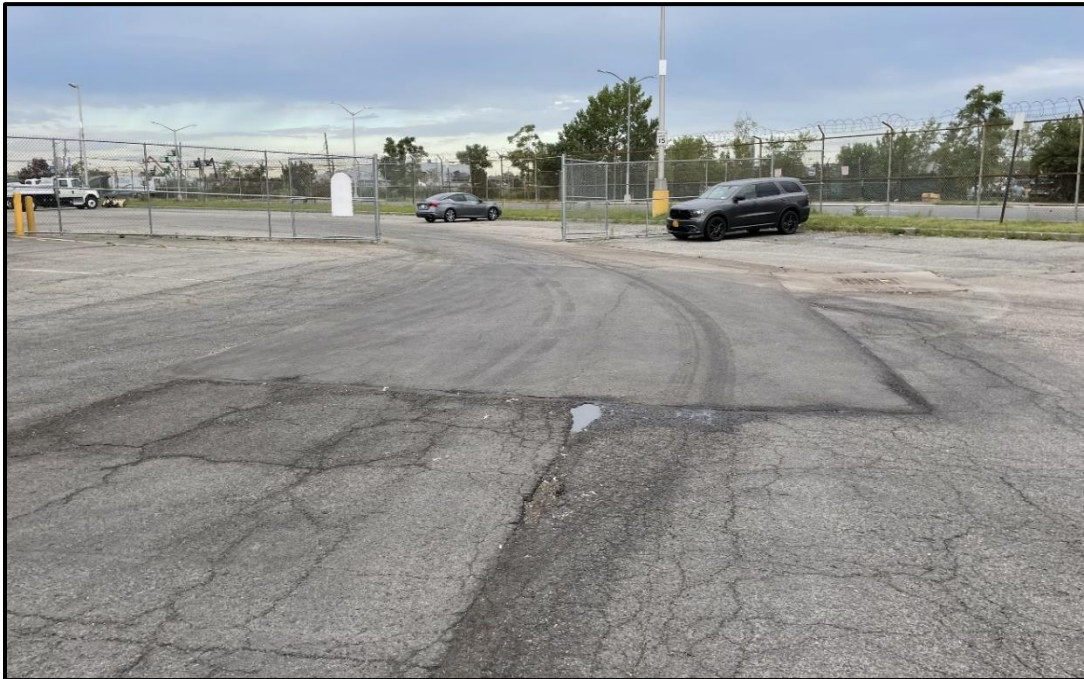
Photo 8: Facing north in the northern portion of Site; cracking and small potholes present.

As demonstrated in the attached photographs, there are areas present around the northern portion of the parking lot where significant cracking and potholes have developed particularly in the vicinity of the catch basins. This normal wear and tear should be addressed should conditions worsen in the future, however, no subgrade is currently present, therefore, the engineering cap is still in place.

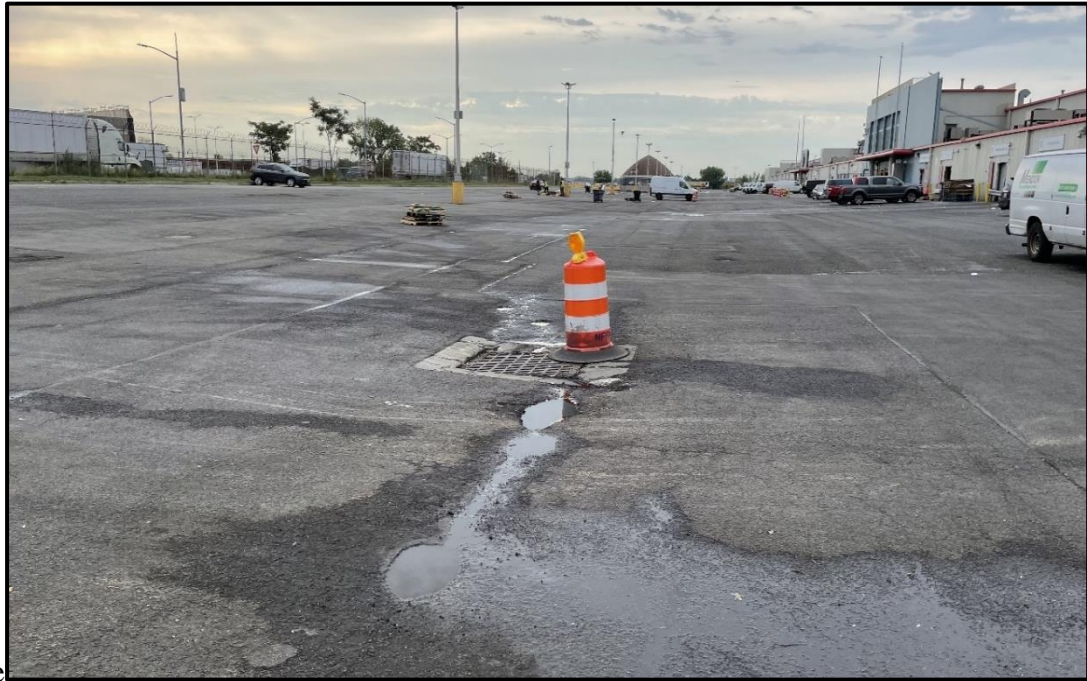
Photo 9: Facing southeast in the eastern portion of Site; potholes and cracking noted in the asphalt, particularly surrounding the catch basins.

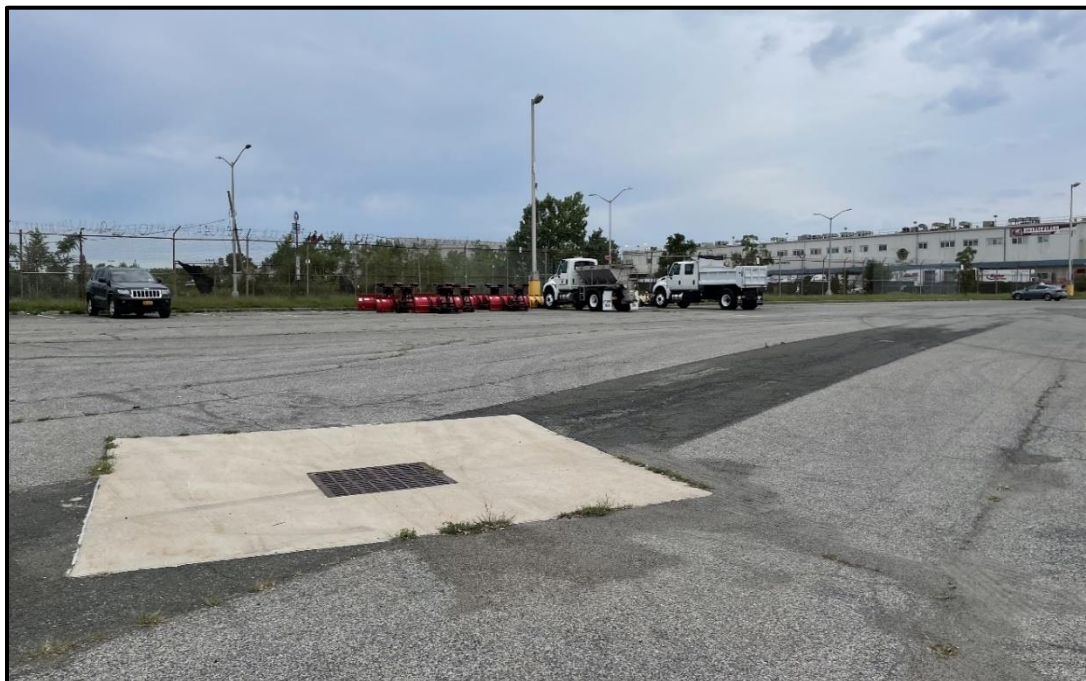
Photo 10: Facing west in the northern portion of Site; shows area of storm sewer drain repairs completed in March 2019. Asphalt and concrete in good condition.

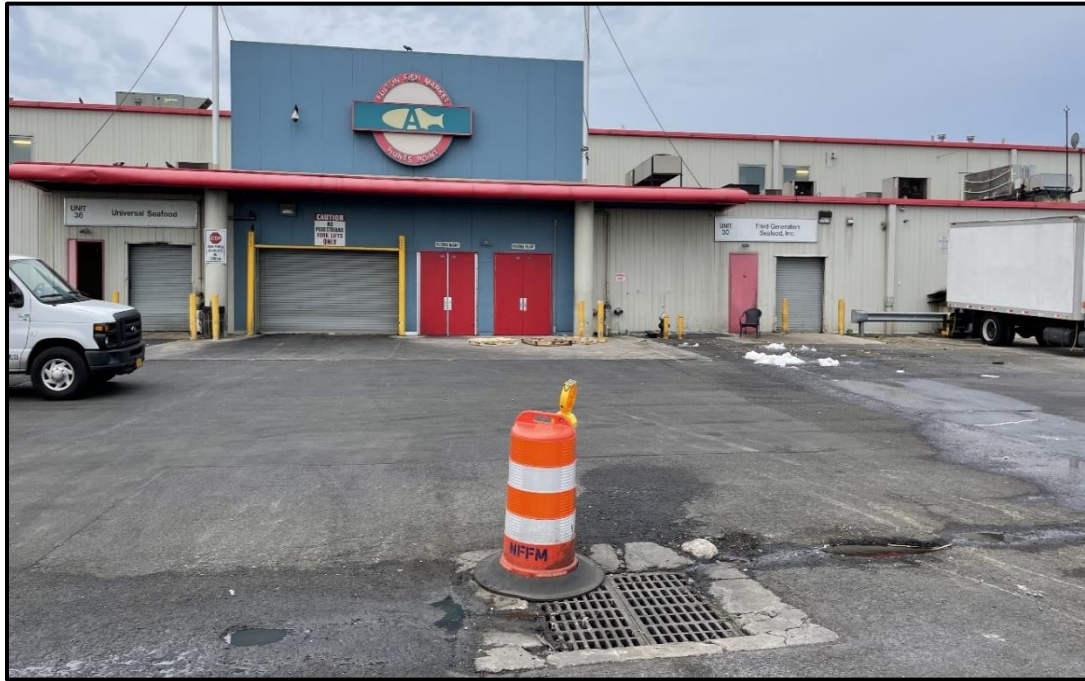
Photo 11: Facing west in the eastern portion of Site; engineering controls are still in place. Normal wear from heavy truck traffic in the form of asphalt cracks and potholes of are present in the parking lot, particularly around the catch basins. No subgrade exposed.

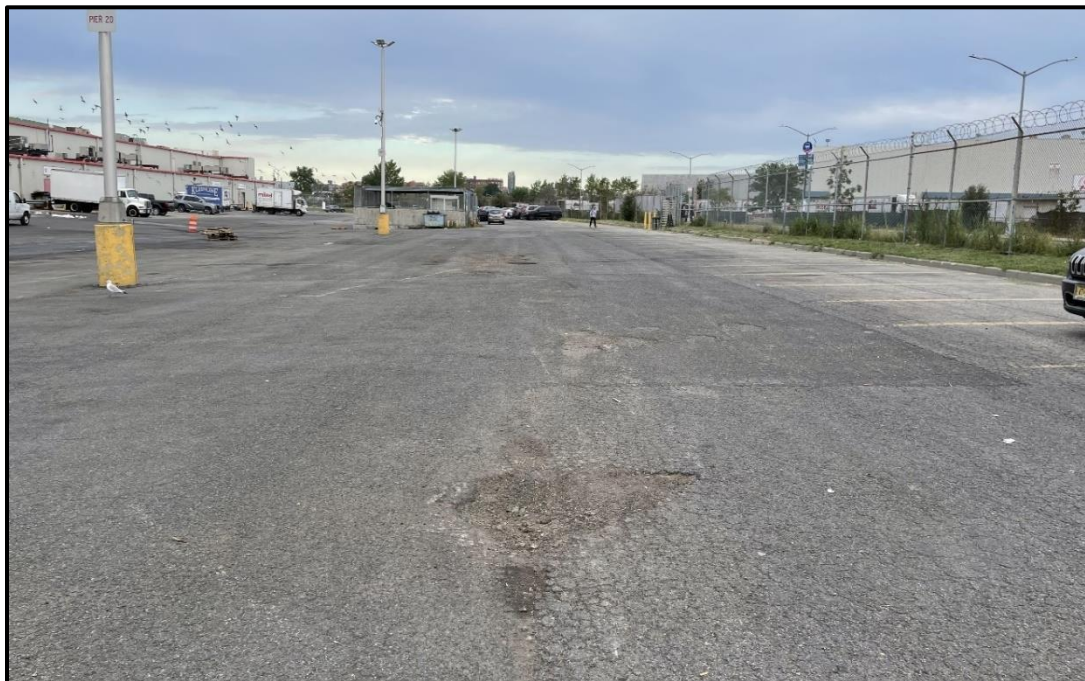
Photo 12: Facing north in the eastern portion of Site; engineering controls are still in place. Normal wear from heavy truck traffic in the form of asphalt cracks and potholes of various sizes are present in the parking lot.

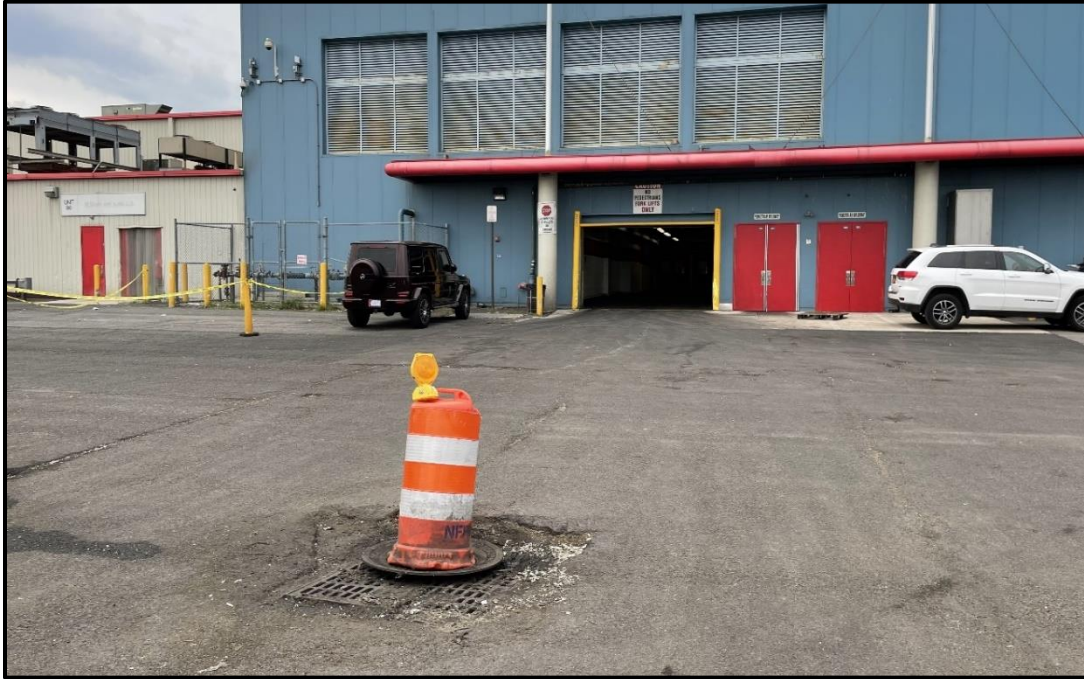
Photo 13: Facing west in the eastern portion of Site; engineering controls are still in place. Normal wear from heavy truck traffic in the form of asphalt cracks and potholes of various sizes are present in the parking lot, particularly around the catch basins. No subgrade exposed.

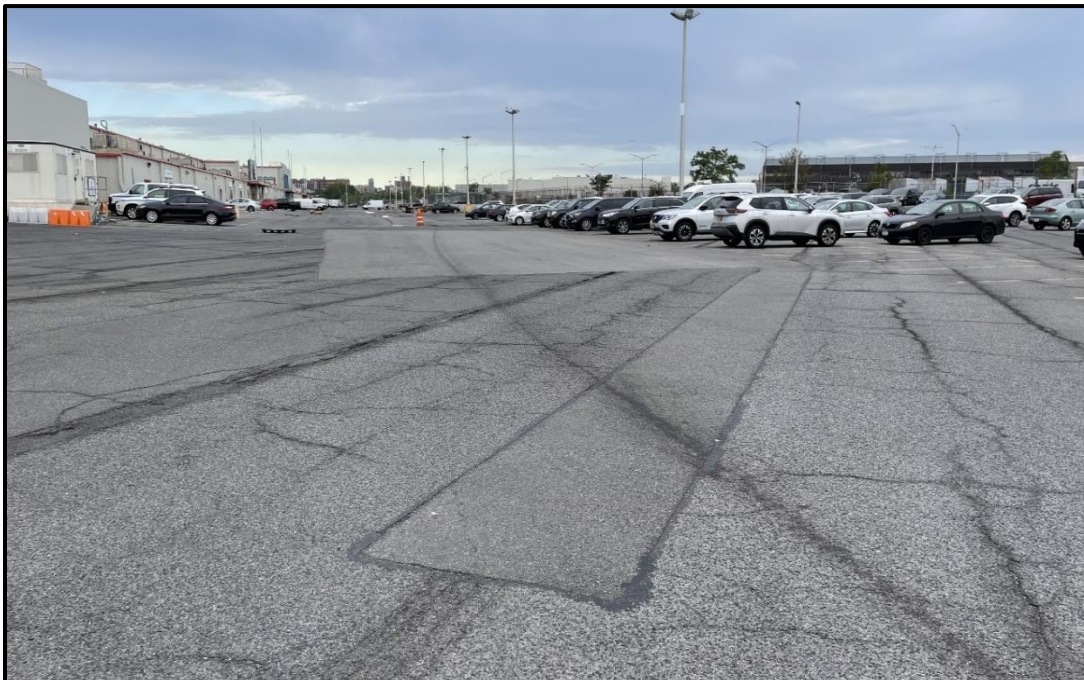
Photo 14: Facing northwest in the southern portion of Site; engineering controls are still in place and in good condition.
