2023 Periodic Review Report

Hunts Point Parcel B

For the Property located at 800 Food Center Drive
Bronx, New York 10474
Former NYSDEC VCP Site No. V00436

GEI Consultants, Inc., P. C.
530 7th Avenue, Suite 2007
New York, NY 10018
212-687-8282

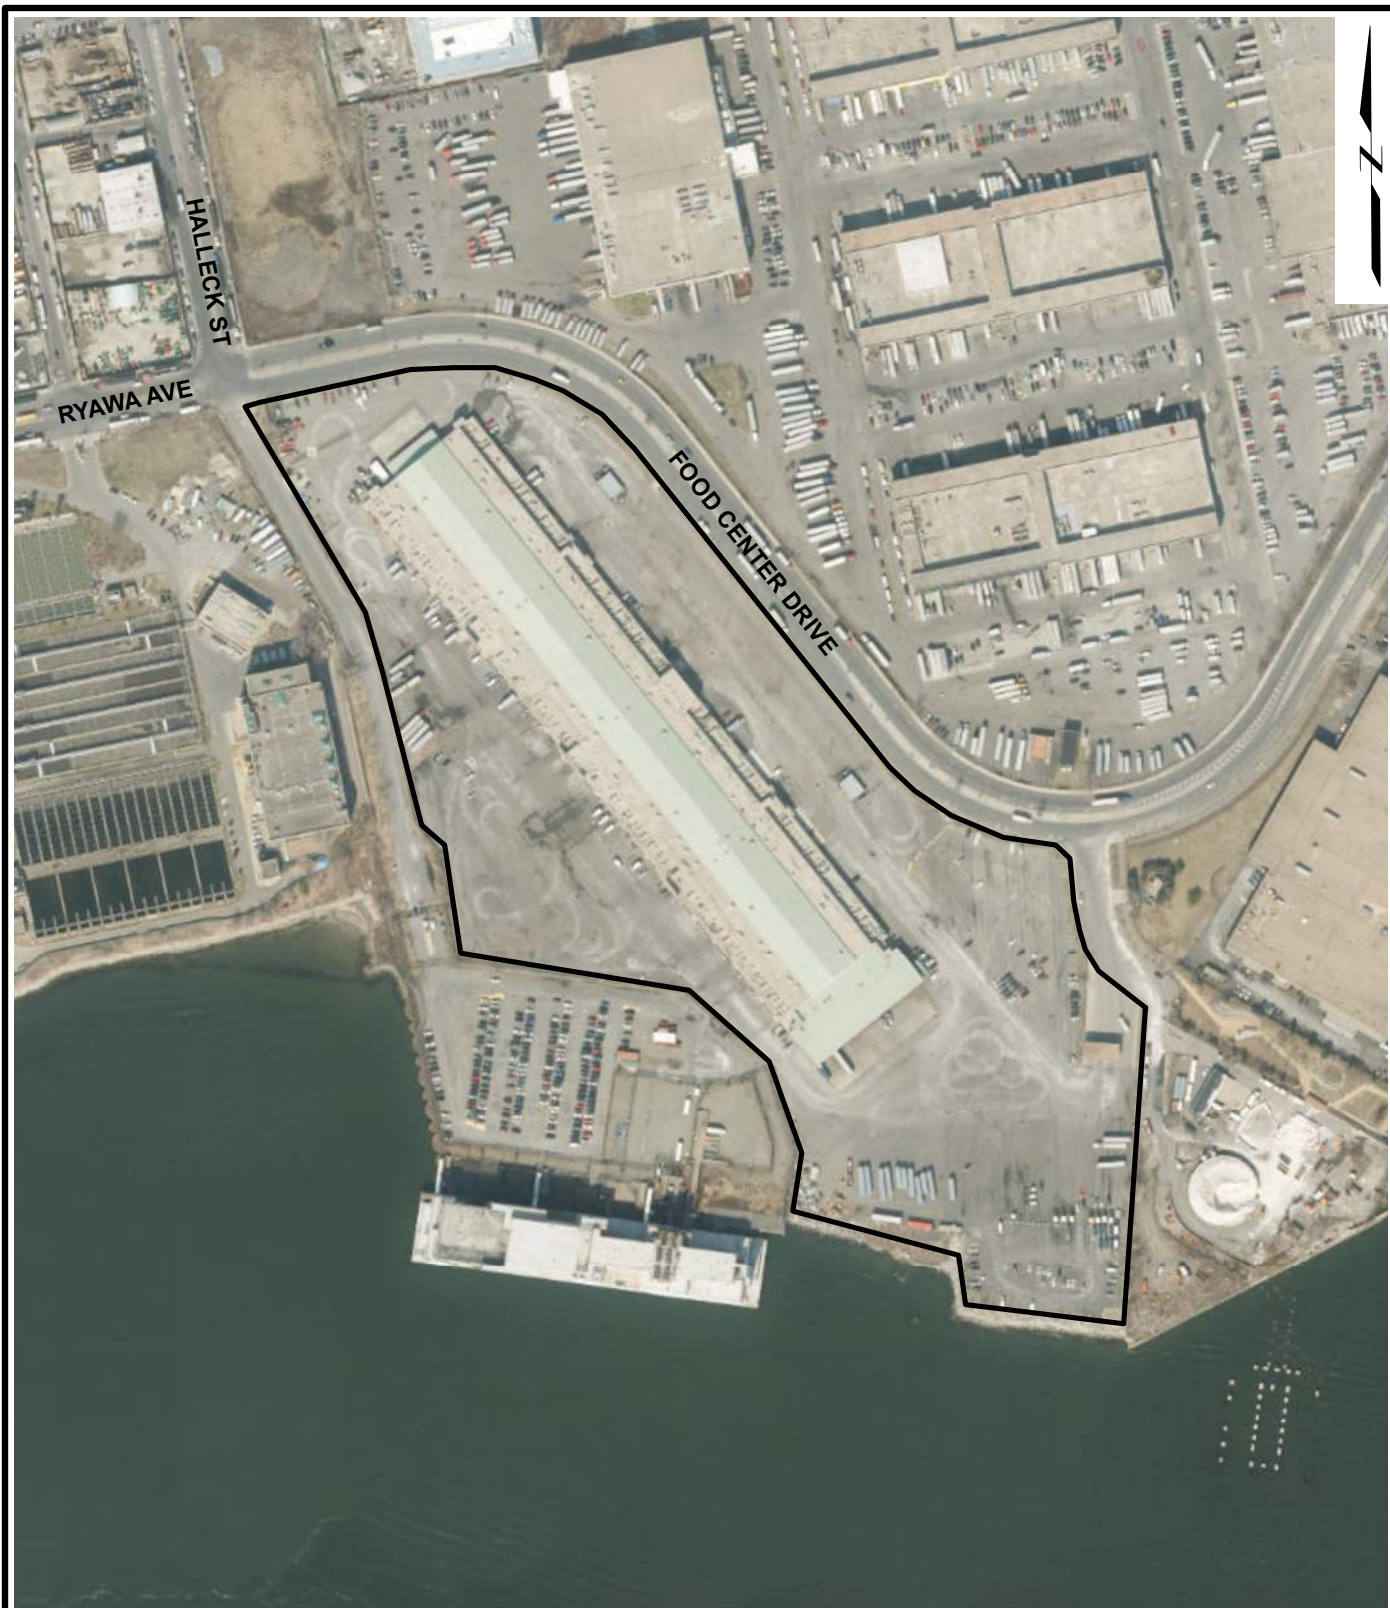
Fig. 2

SITE LAYOUT

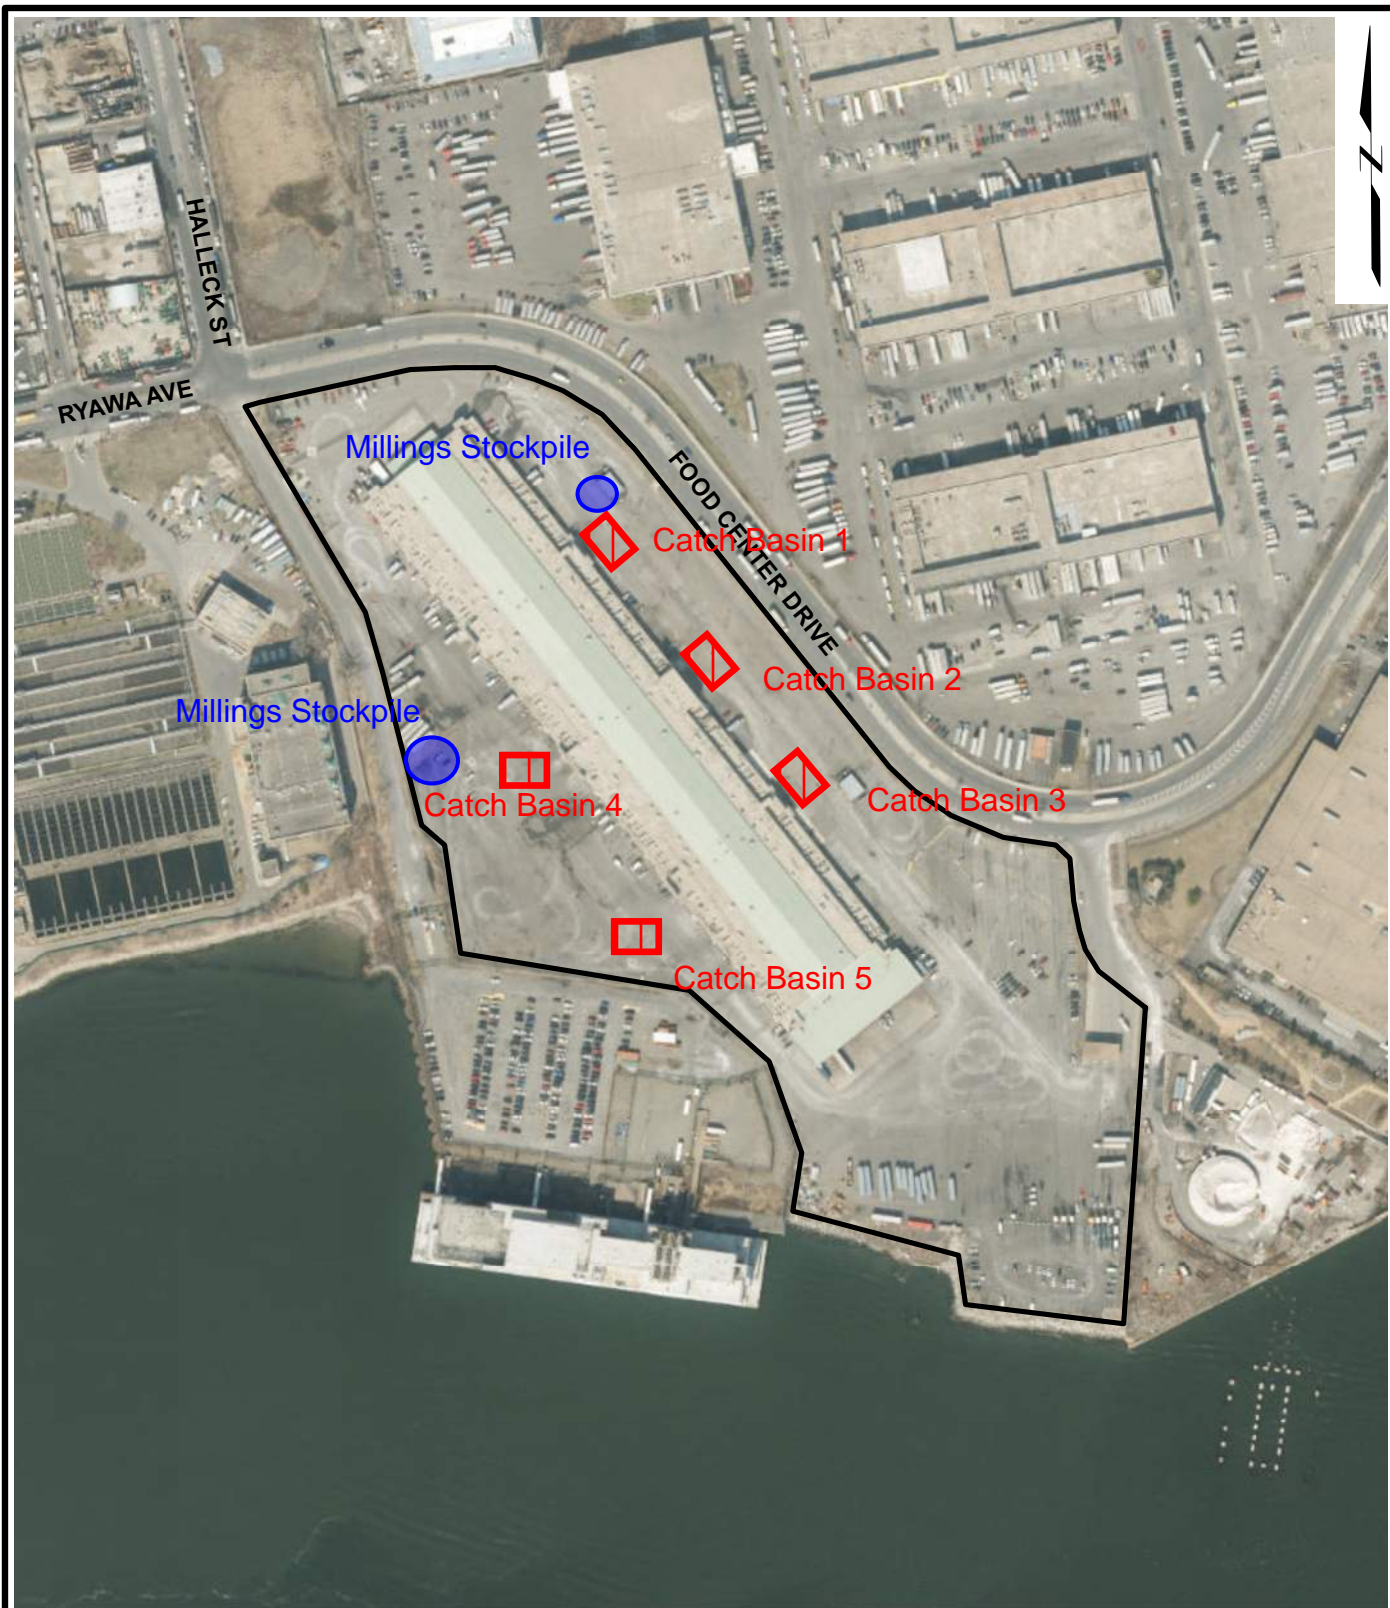
Fig. 3

**LOCATIONS OF JANUARY
2022 REPAIRS**

In January 2022, Cowboy Contracting and All Pro mobilized to Site to repair onsite drainage structures (catch basins). Due to settlement, Cowboy and All Pro were required to remove the pavement surrounding existing catch basins down to sub grade use of a skid-steer milling attachment (approximately 3 to 4 inches from top of asphalt), reset the catch basin to proper grade utilizing brick and concrete, and then repaving the area. During milling activities, dust control was constantly performed with a hydrant and hose. GEI performed air monitoring for dust/particulate matter with a DustTrak™ DRX Aerosol Monitor 8533 at each location for the duration of all surface disturbing activities. No exceedances of particulates were detected at any catch basin location. A Community Air Monitoring Summary is provided in **Table 1** below.

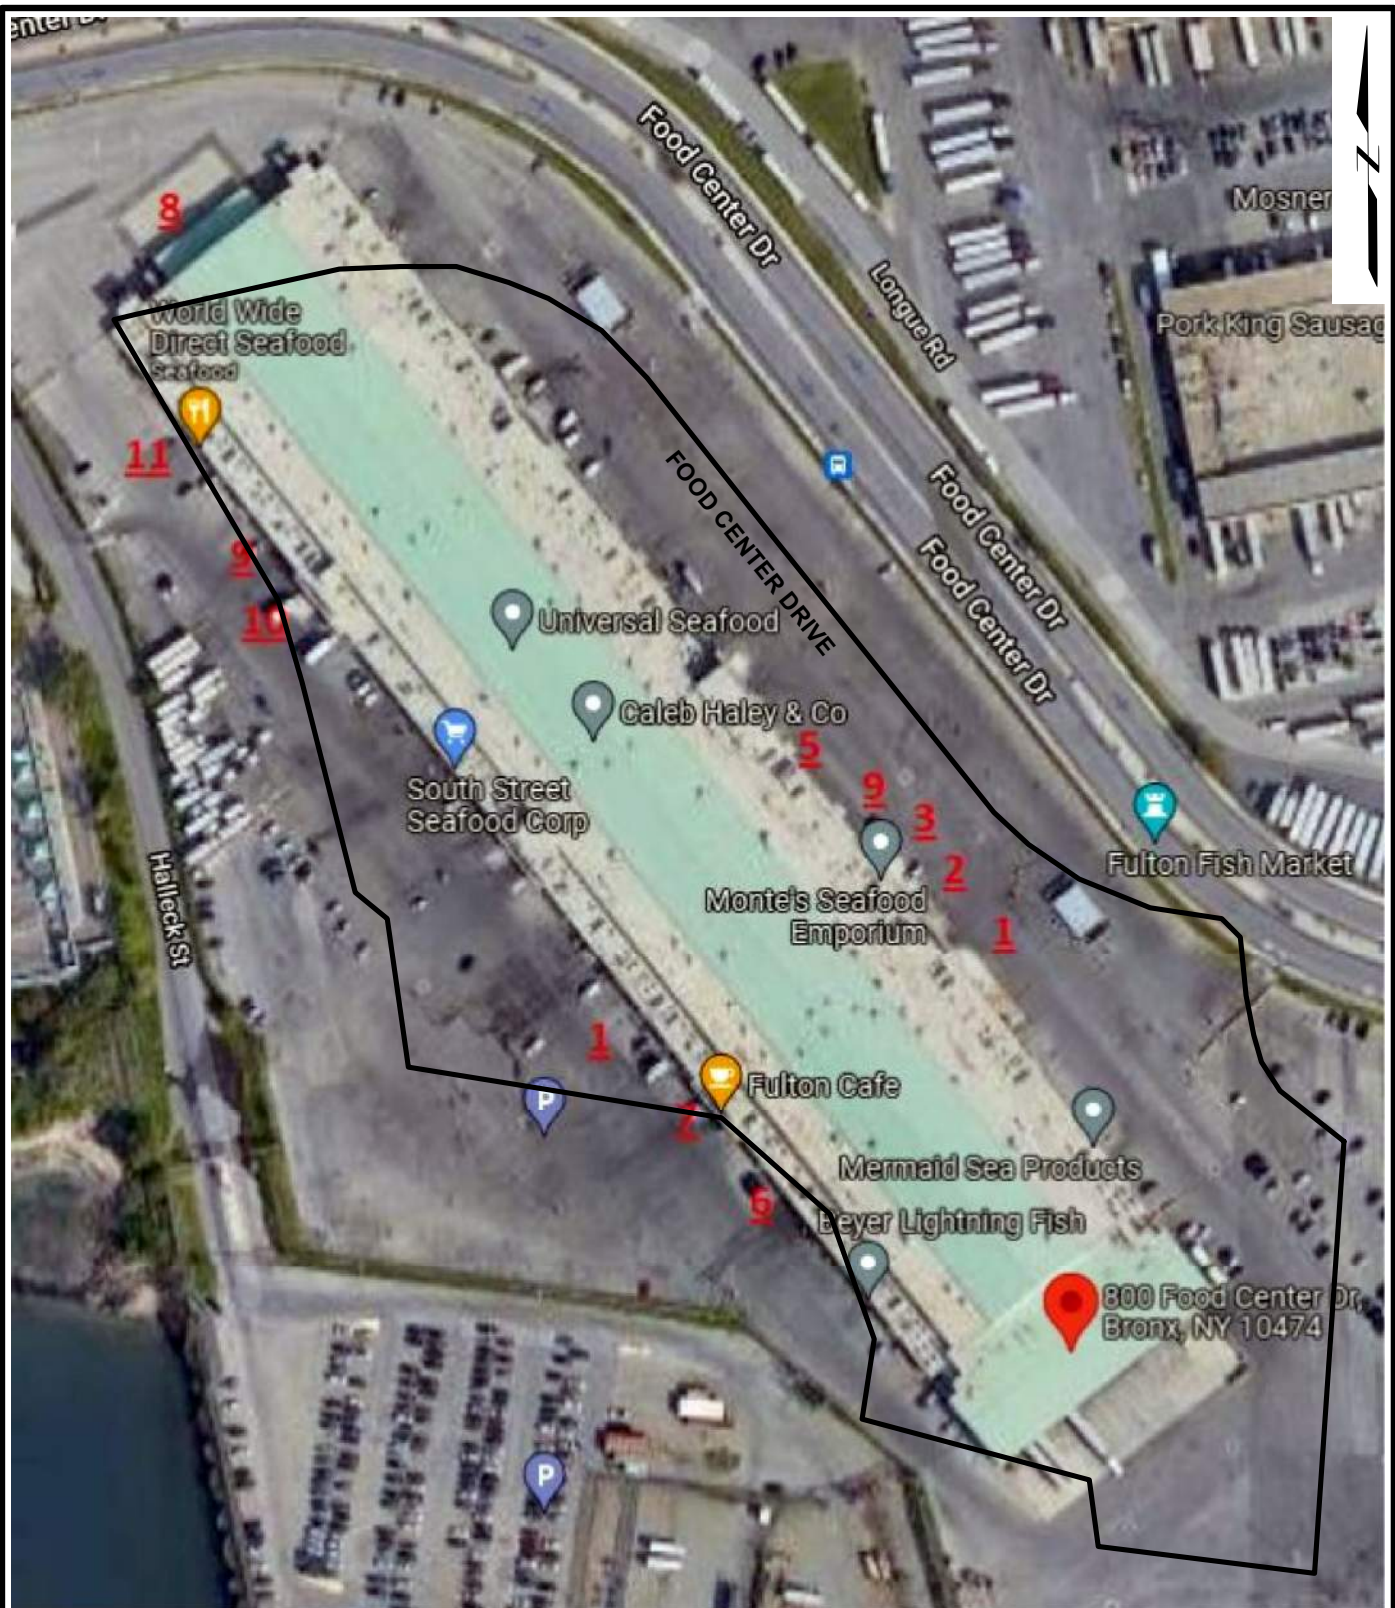
Fig. 4

**LOCATIONS OF AUGUST
2022 REPAIRS**

Cowbay Contracting and All Pro mobilized to Parcel B in August 2022 to repair potholes in the parking areas and internal roadways, repairs which included re-paving and use of a skid-steer milling attachment to grind and remove the top 3 to 4-inches of asphalt. The sub-base and soil beneath the pavement were not exposed or disturbed during this effort. During the asphalt repair effort, Cowbay implement dust suppression via a hydrant and hose. GEI performed air monitoring for dust/particulate matter with a DustTrak™ DRX Aerosol Monitor 8533. No exceedances of particulates were detected at any repair location. A Community Air Monitoring Summary is provided in **Table 2** below.

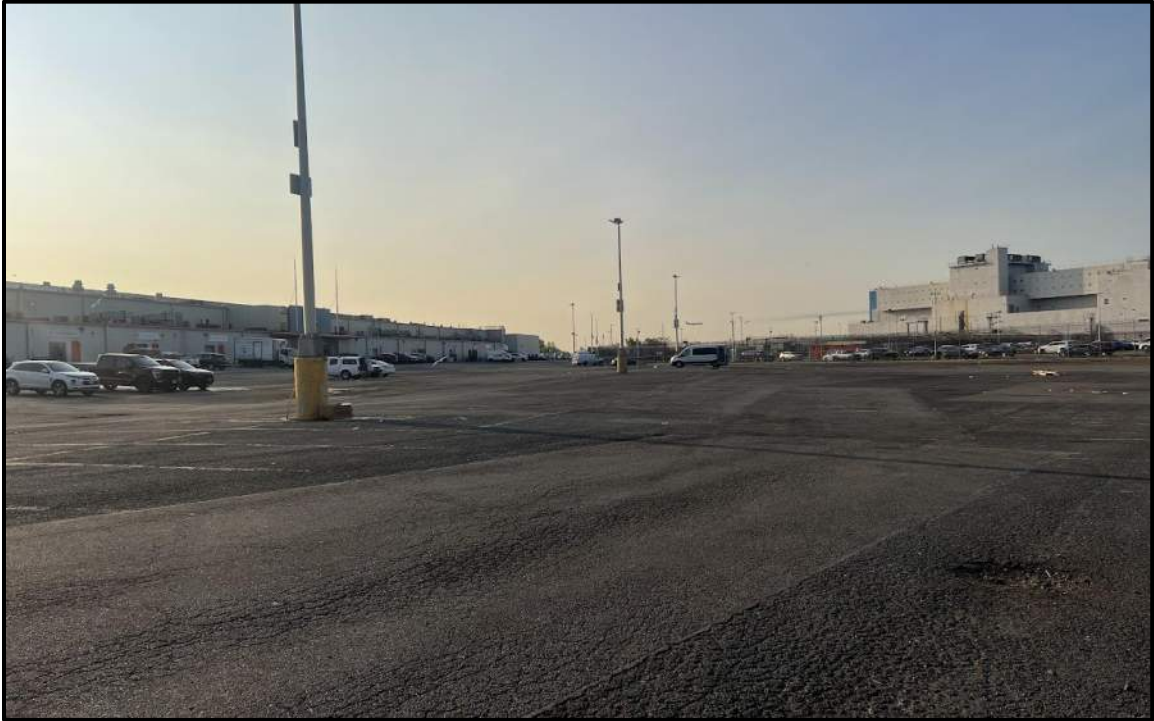
Photo 1: Facing south in the southern portion of Site; minor cracking in the asphalt noted.

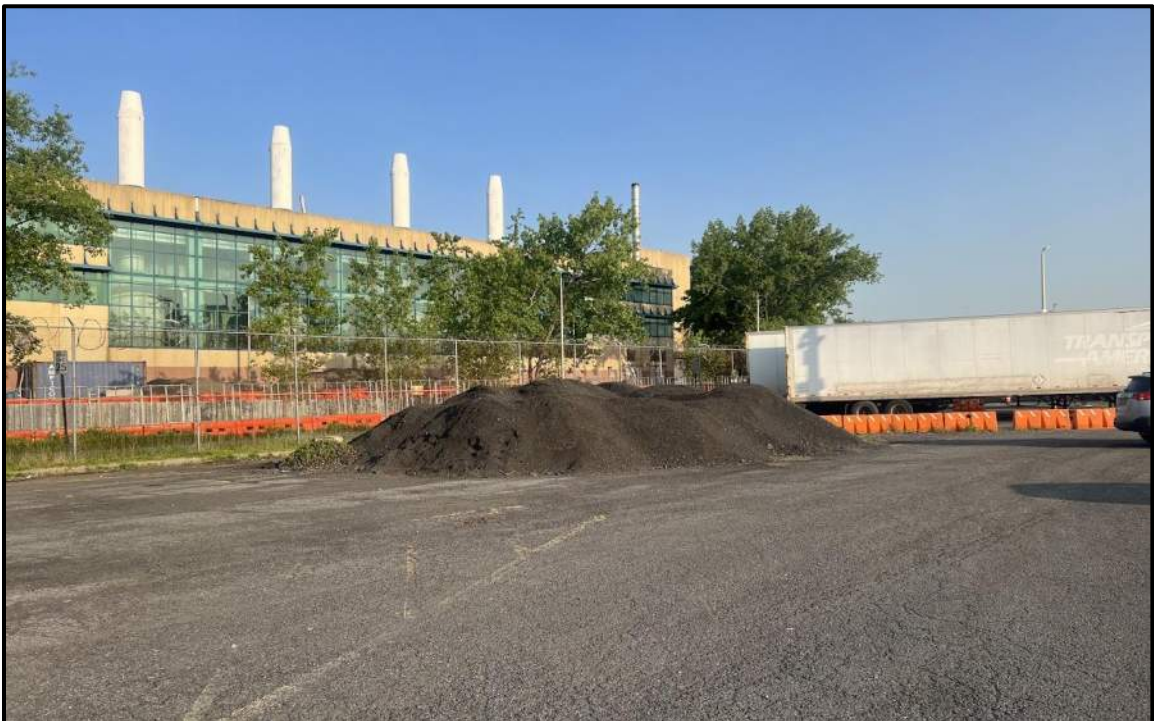
Photo 2: Facing west in the western portion of Site; stockpile of asphalt millings from onsite pavement and draining repairs.

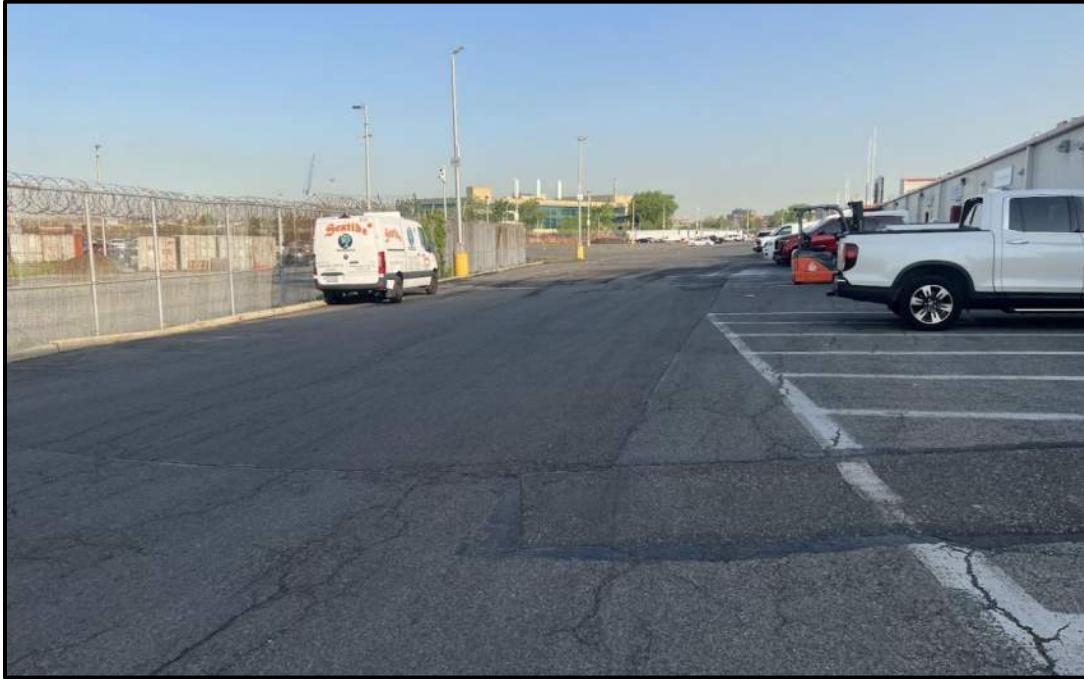
Photo 3: Facing northeast in the southwestern portion of Site; areas of re-paving performed in August 2022.

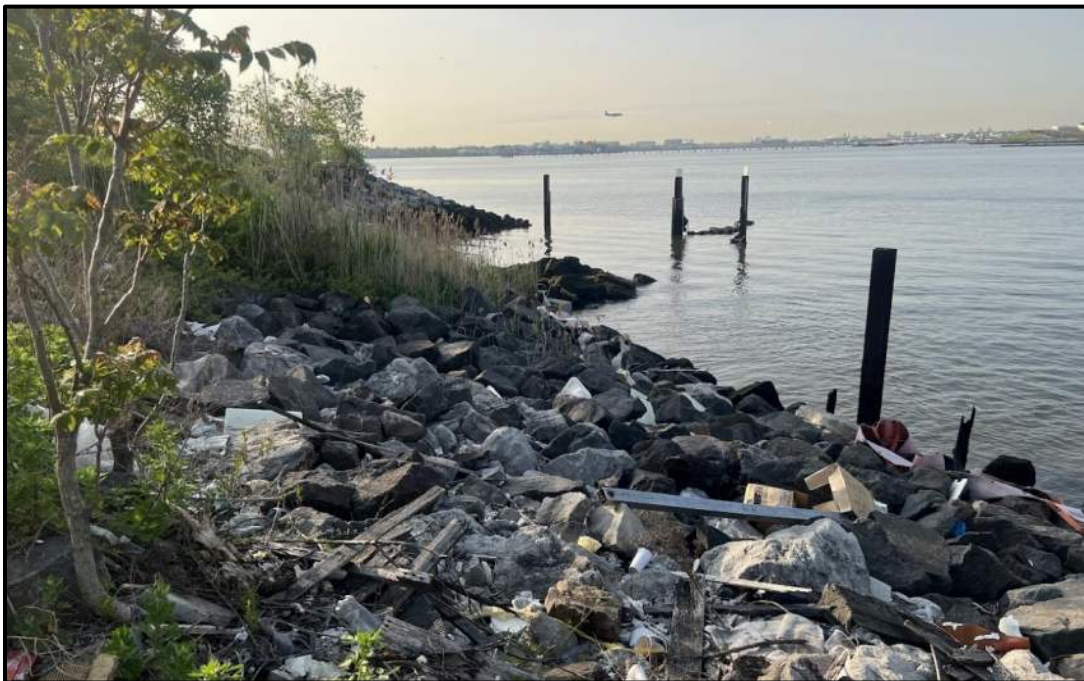
Photo 4: Facing south along the southeastern portion of Site; bulkhead along waterfront in good condition.

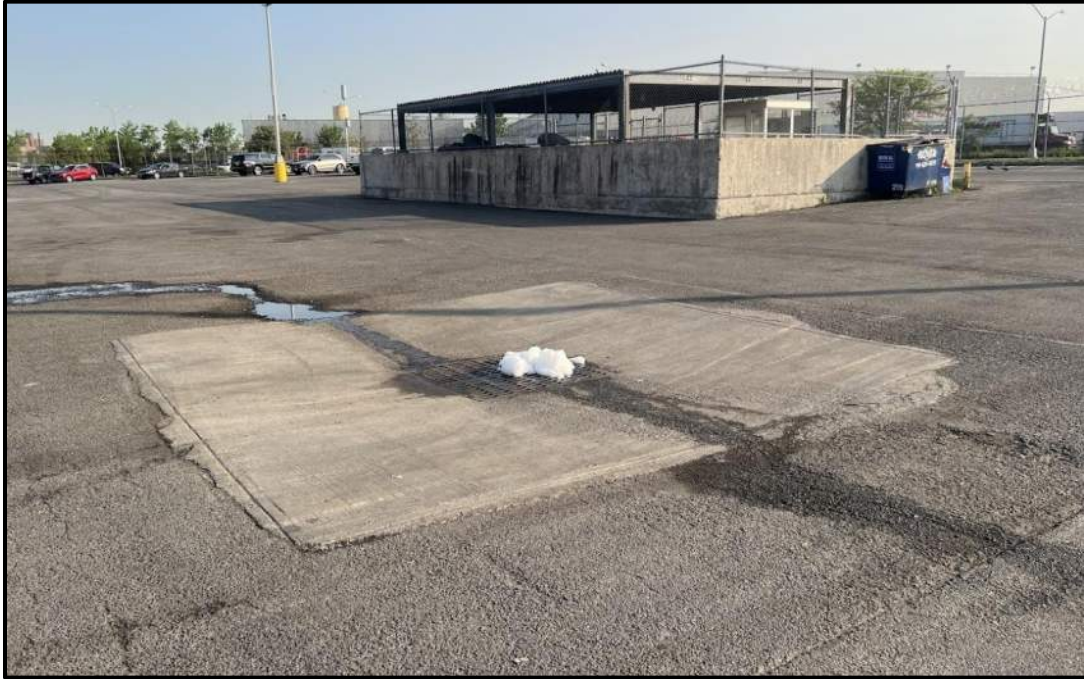
Photo 5: Facing northeast in the northeastern portion of Site; location of a catch basin repaired in January 2022.

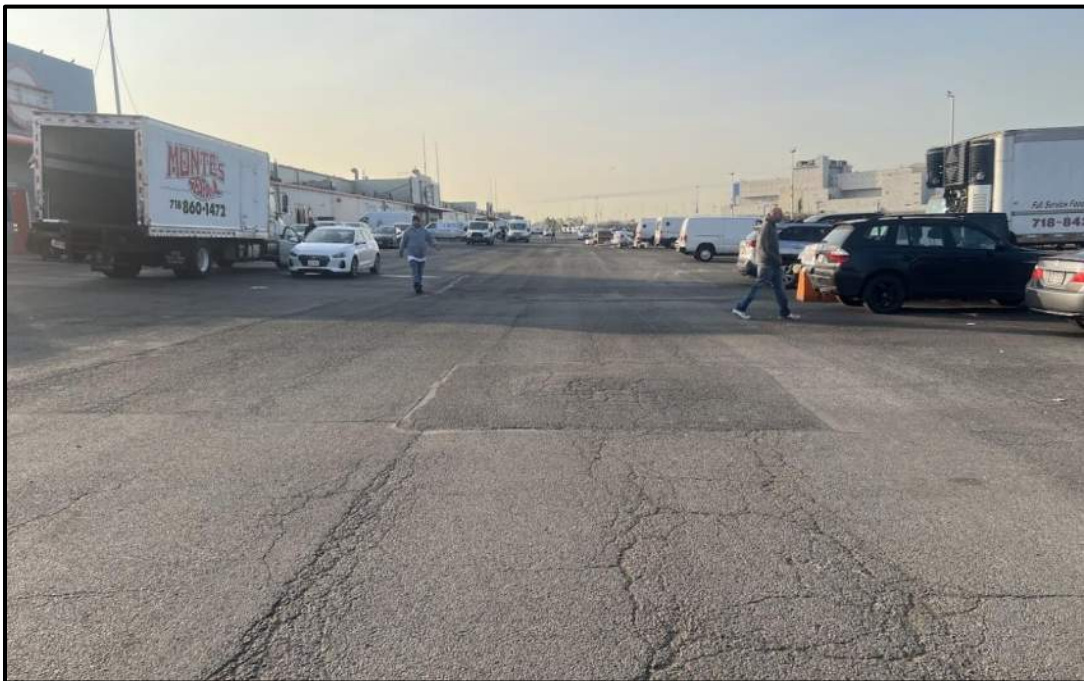
Photo 6: Facing south in the southwestern portion of Site; area of previous asphalt patching completed in August 2022. Minor cracking present.

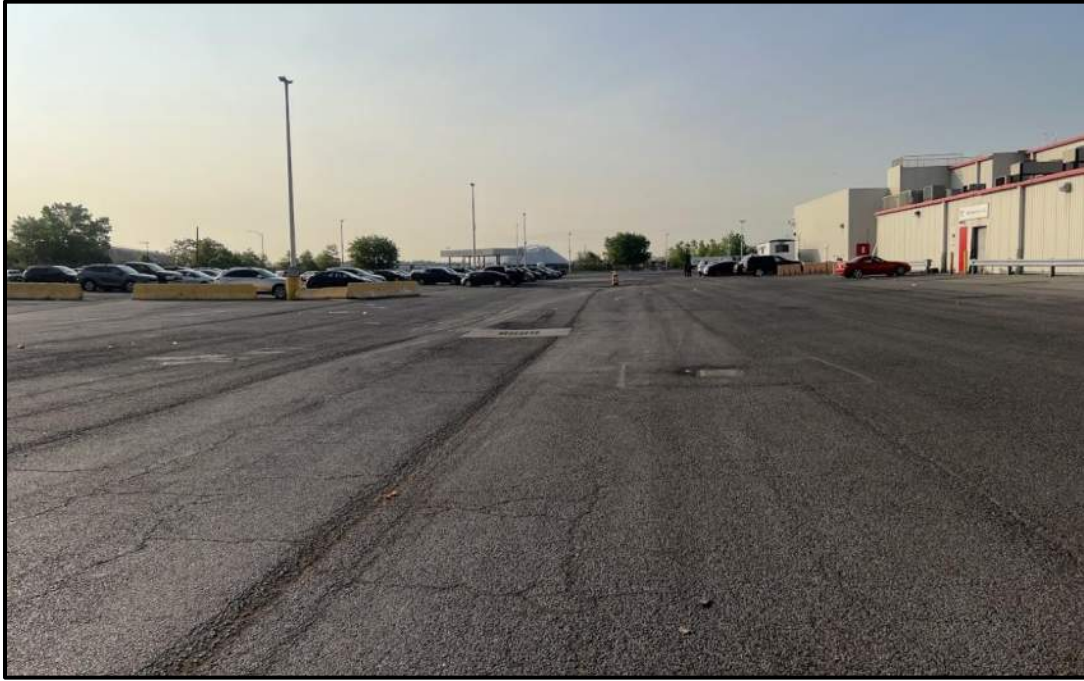
Photo 7: Facing southeast in the northeastern portion of Site; pavement in good condition with minor cracking. Previous utility repair in the background.

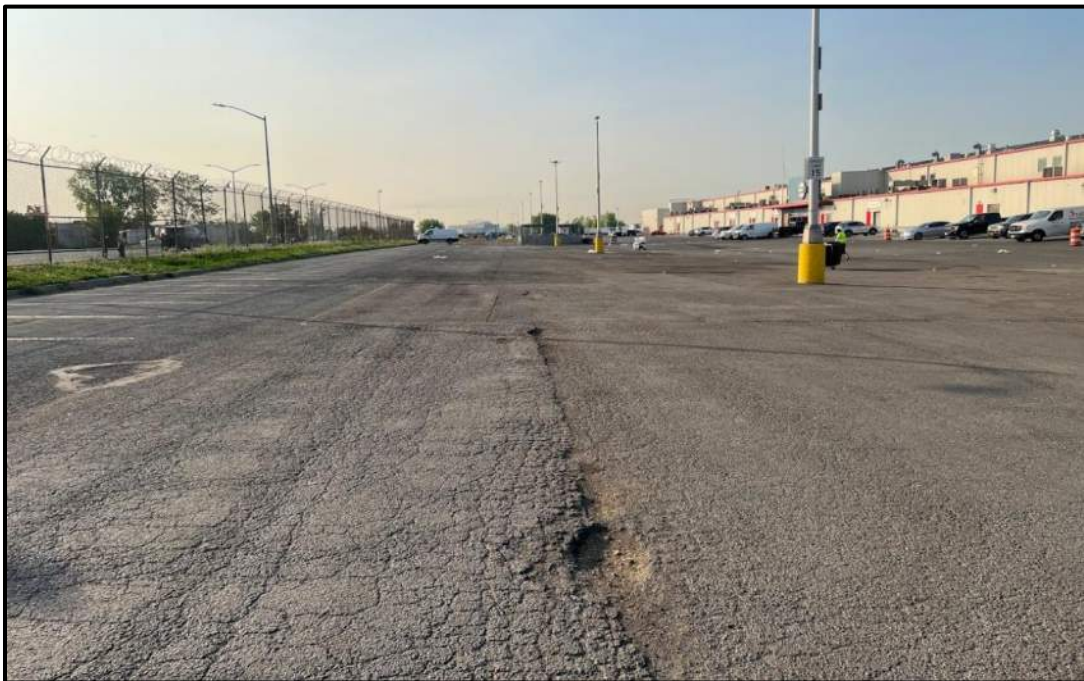
Photo 8: Facing southeast in the eastern portion of Site; cracking and small potholes present.

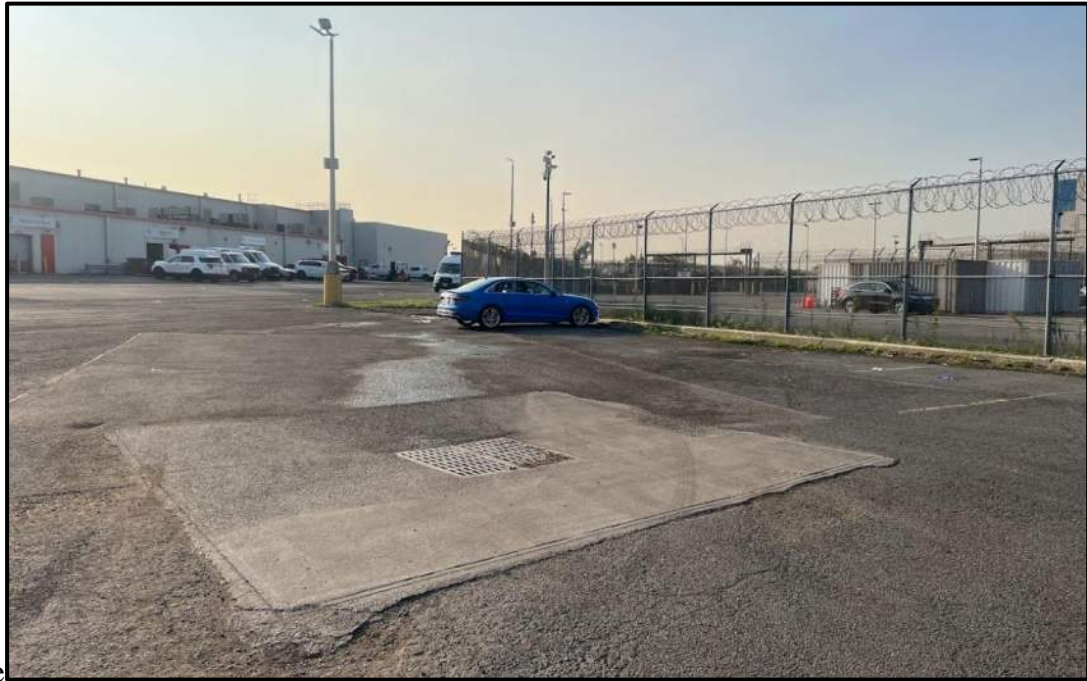
Photo 9: Facing southeast in the southern portion of Site; potholes and cracking noted in the asphalt surrounding catch basin (repaired in January 2022).

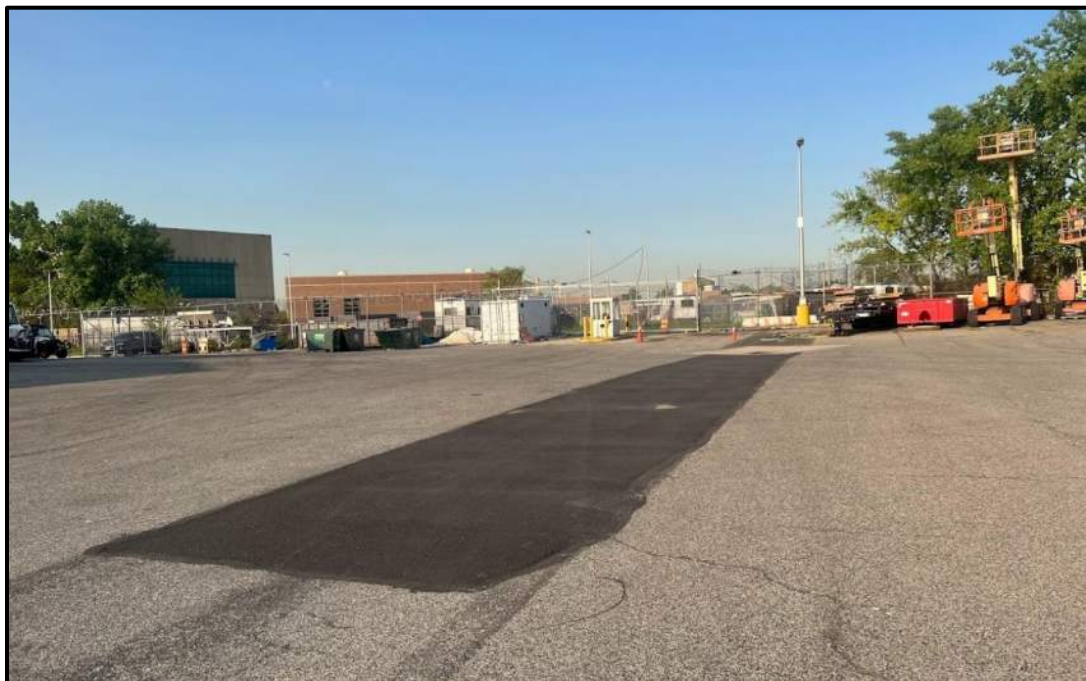
Photo 10: Facing west in the northern portion of Site; shows area asphalt repair completed in August 2022. Asphalt and concrete in good condition.

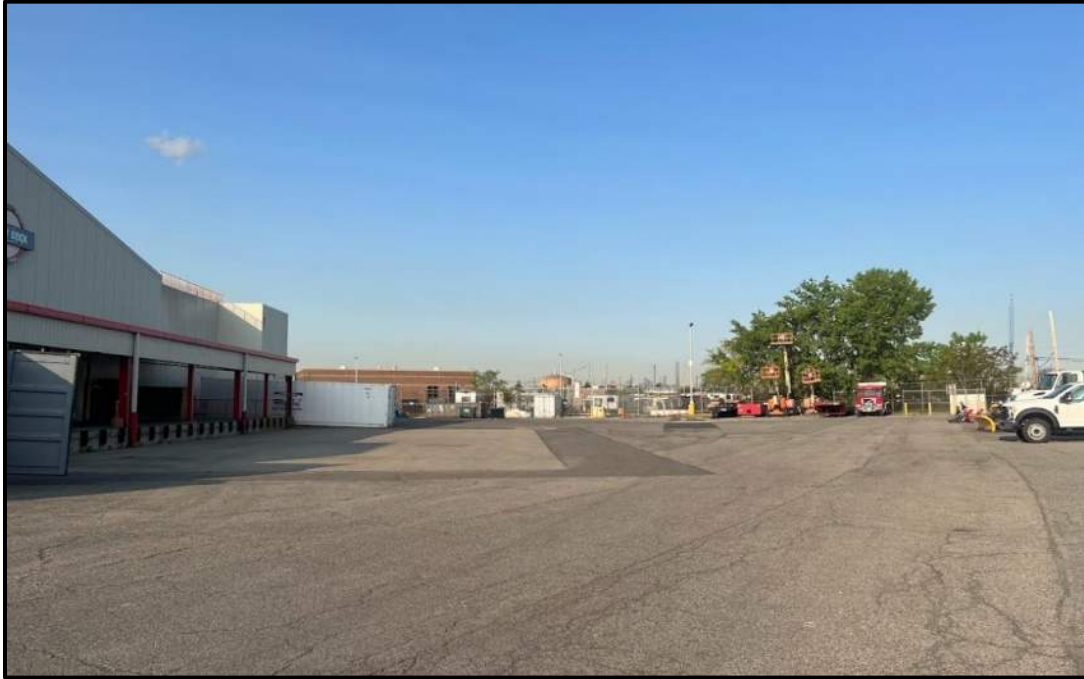
Photo 11: Facing southwest in the eastern portion of Site; engineering controls are still in place. Reinforced concrete pad and asphalt in good condition. Minor cracking in asphalt.

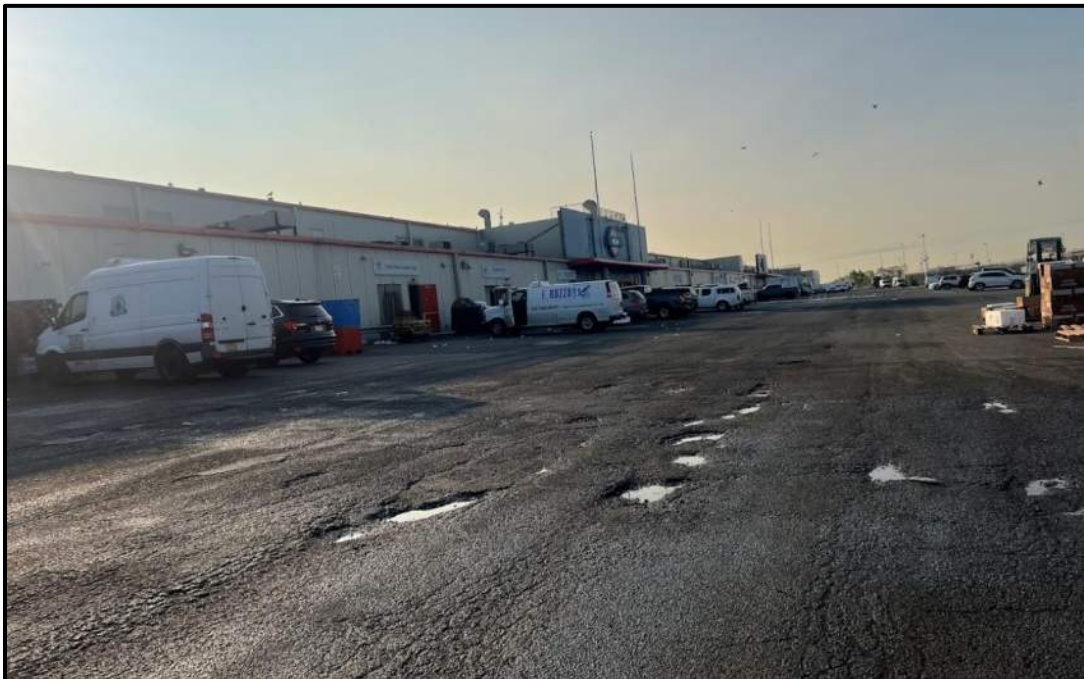
Photo 12: Facing south in the western portion of Site; engineering controls are still in place. Normal wear from heavy truck traffic in the form of asphalt cracks and potholes of various sizes are present in the parking lot.
