2024 Periodic Review Report

Hunts Point Parcel B

For the Property located at 800 Food Center Drive
Bronx, New York 10474
Former NYSDEC VCP Site No. V00436

July 2024
Project No. 1901379

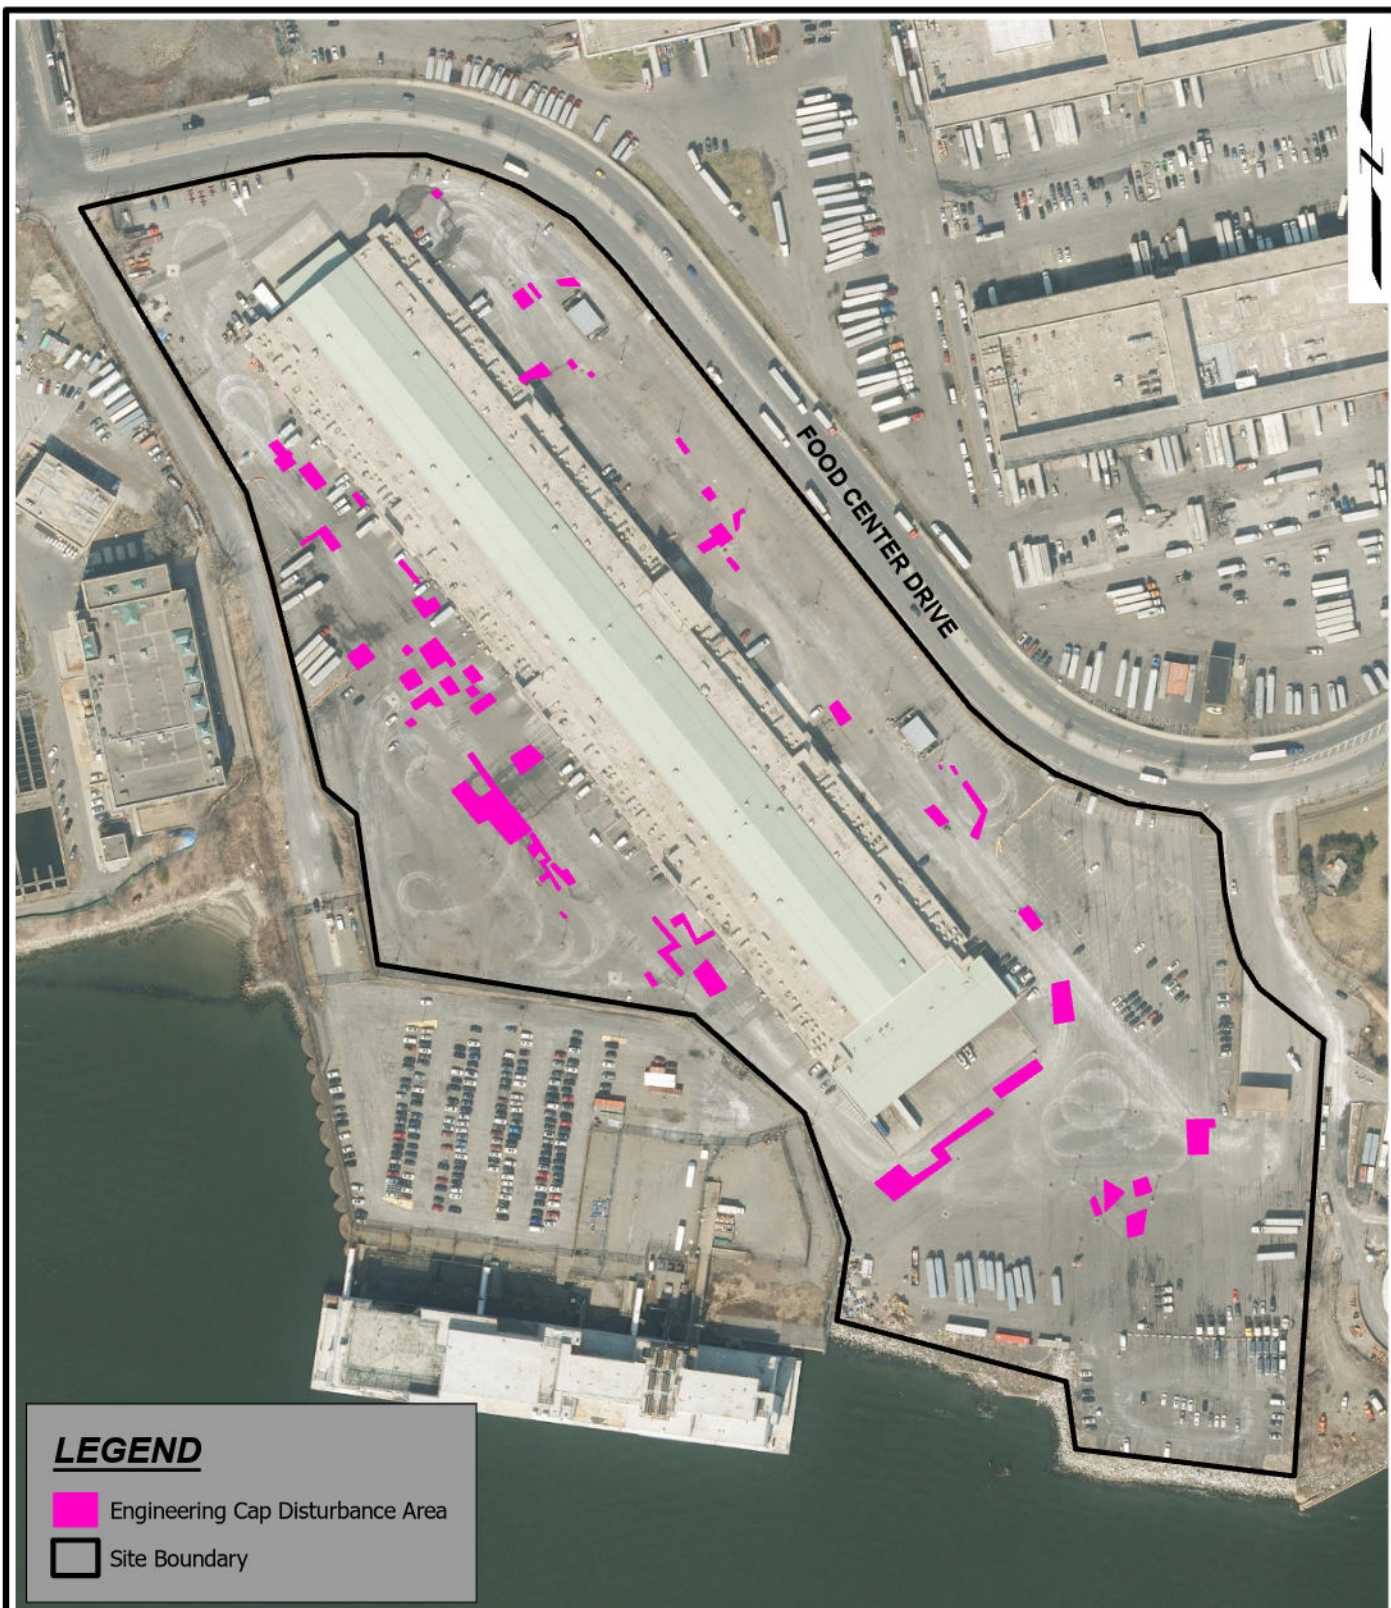
Fig. 3

In June 2023, All Pro mobilized to Site to repair potholes in the parking areas and internal roadways. Repairs included re-paving and use of a skid-steer milling attachment to grind and remove the top 3 to 4-inches of asphalt; repair locations are illustrated in **Figure 3**. The sub-base and soil beneath the pavement were not exposed or disturbed during this effort. During milling activities, dust control was constantly performed via a hydrant and hose, and a sweeper attachment. GEI performed air monitoring for dust/particulate matter with a DustTrak™ DRX Aerosol Monitor 8533 at each repair location for the duration of all surface disturbing activities. No exceedances of particulates were detected at any repair location. A Community Air Monitoring Summary is provided in Table 1 below.

In August 2023, All Pro mobilized to Site to repair additional potholes in the parking areas, loading docks, and internal roadways. Repairs consisted of utilizing a skid-steer milling attachment to grind and remove the top 3 to 4-inches and repaving the area with asphalt; repair locations are illustrated in **Figure 3**. The sub-base and soil beneath the pavement were not exposed or disturbed during this effort. During milling activities, dust suppression was performed via dampening with a hydrant and hose and using a sweeper attachment. GEI performed air monitoring for particulate matter with a DustTrak™ DRX Aerosol Monitor 8533 for the duration of all surface-disturbing activities at each repair location. No exceedances of dust were detected during the repair effort. A Community Air Monitoring Summary is provided in Table 3 below.

**SITE DISTURBANCE
LOCATIONS**

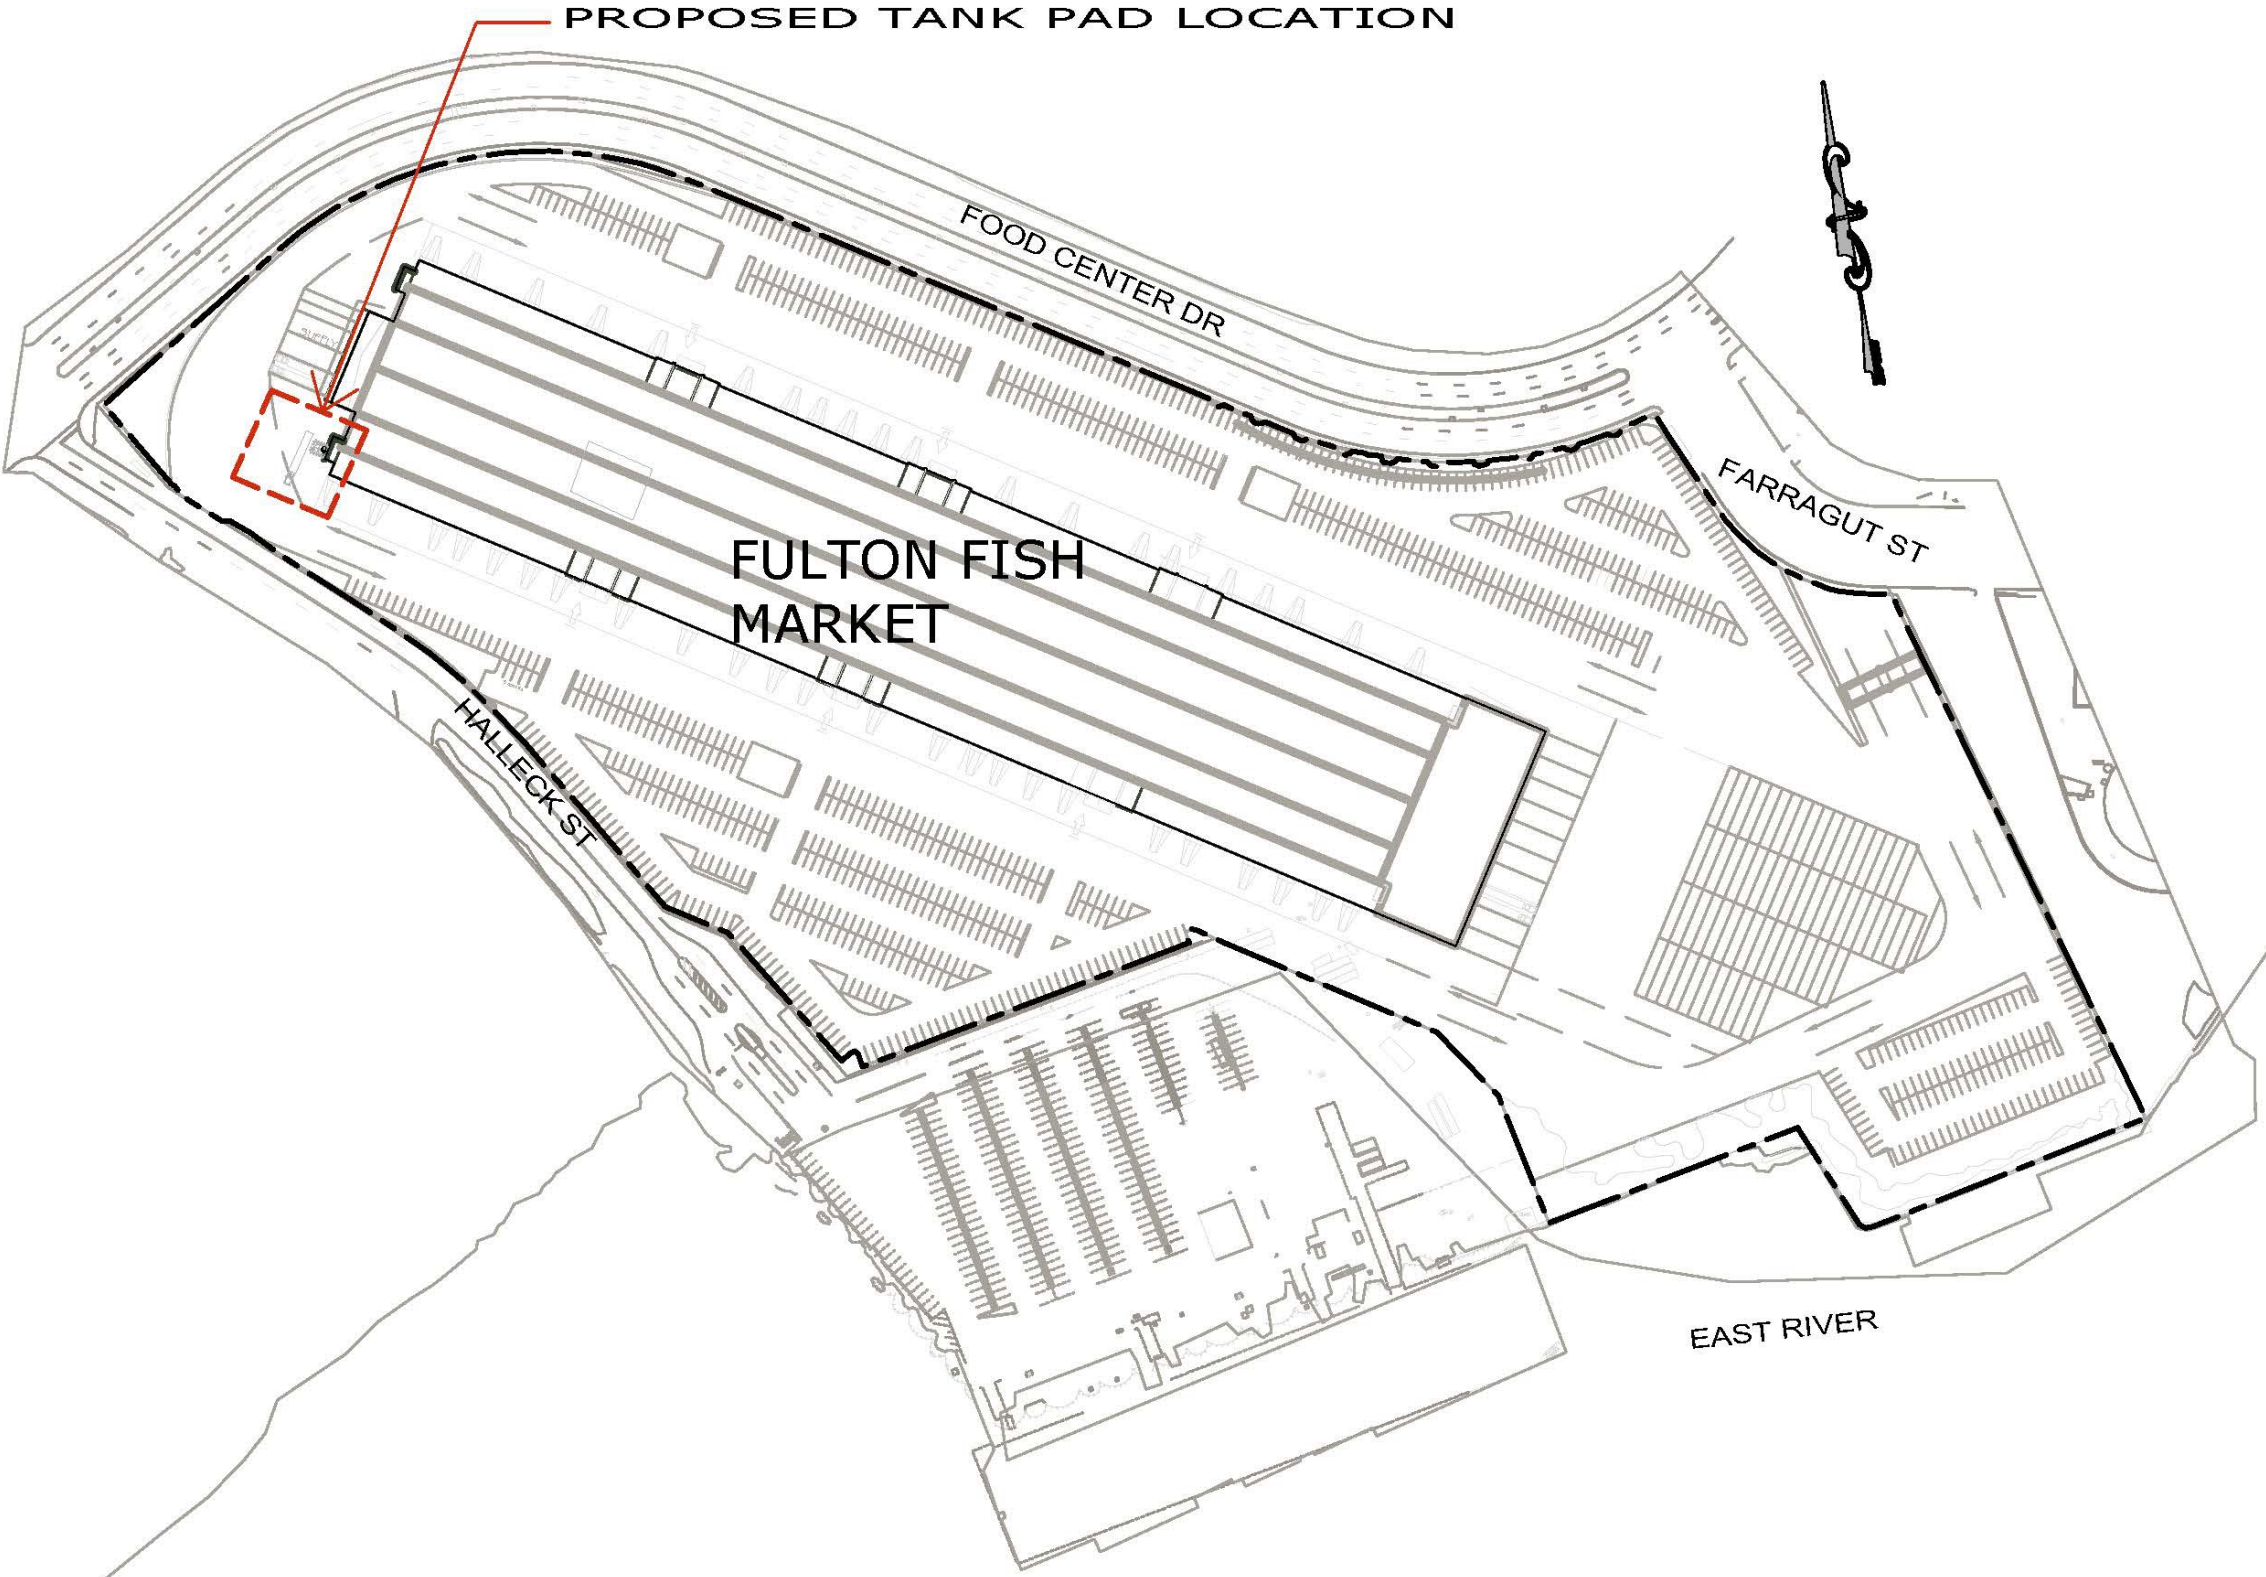
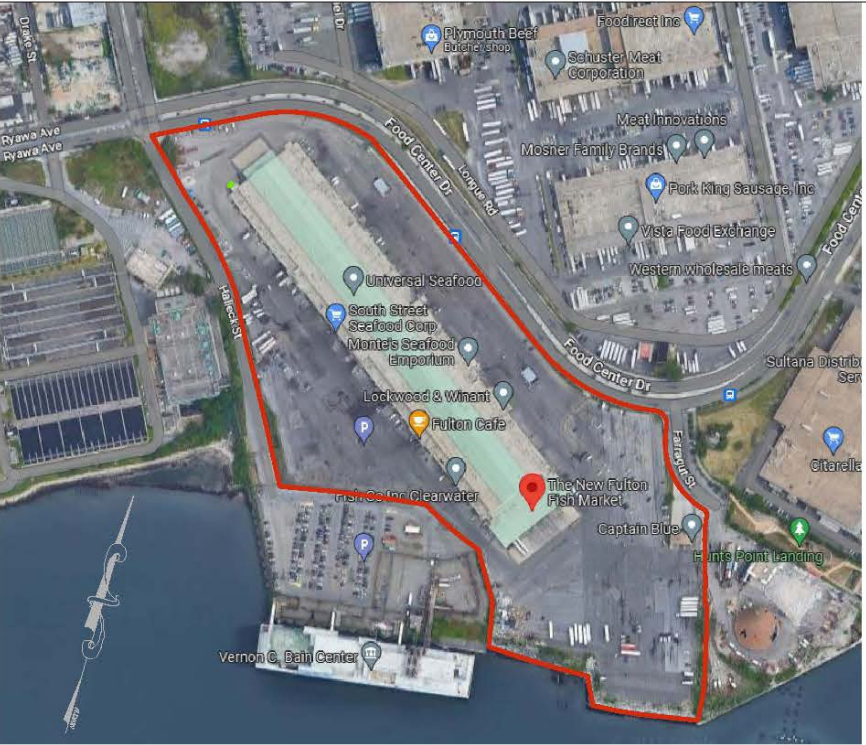
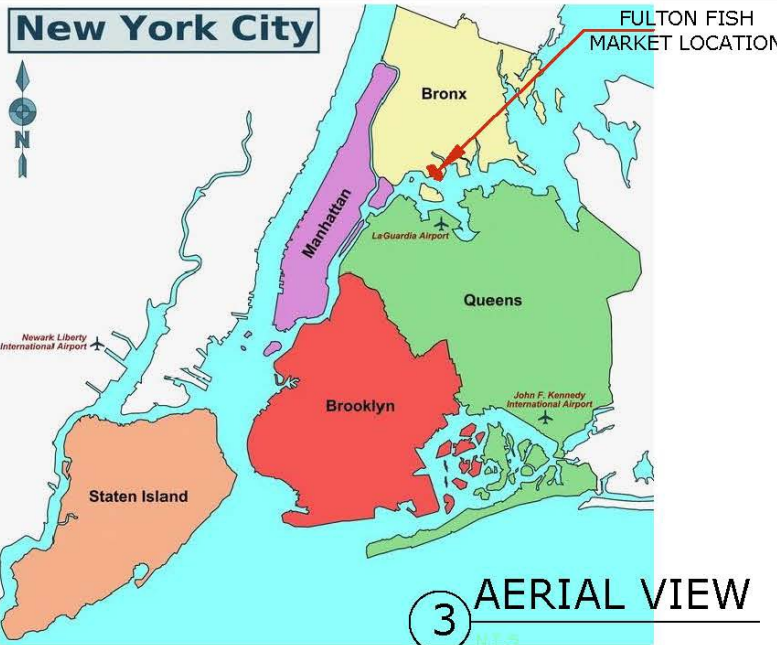
DRAWING NO.
Fig. 4
Nitrogen Tank Foundation
Location
1 Total 8

In July 2023, Eden General Construction Inc. (Eden) mobilized to site to install a concrete foundation slab (approximately 20 feet x 20 feet) for a proposed nitrogen tank to support facility processing and operations (**Figure 4**). Eden performed demolition and removal of the existing pavement, which was disposed of offsite at a recycling facility. Eden hand dug approximately 24 inches into the subsurface; no visual or olfactory impacts were noted in the shallow soils, which were staged onsite in a 20-cubic yard (cy) roll-off adjacent to the work area. The foundation footprint was lined with Sakrete ¾-inch gravel, which was purchased from a retailer (0.03 cubic yard bags), and a concrete slab poured with safety bollards installed around the slab. GEI performed air monitoring for dust/particulate matter and volatile organic compounds (VOCs) with a DustTrak™ DRX Aerosol Monitor 8533 and Honeywell RAE Systems

PROPOSED TANK PAD LOCATION

1 BUILDING SITE PLAN
N.T.S.

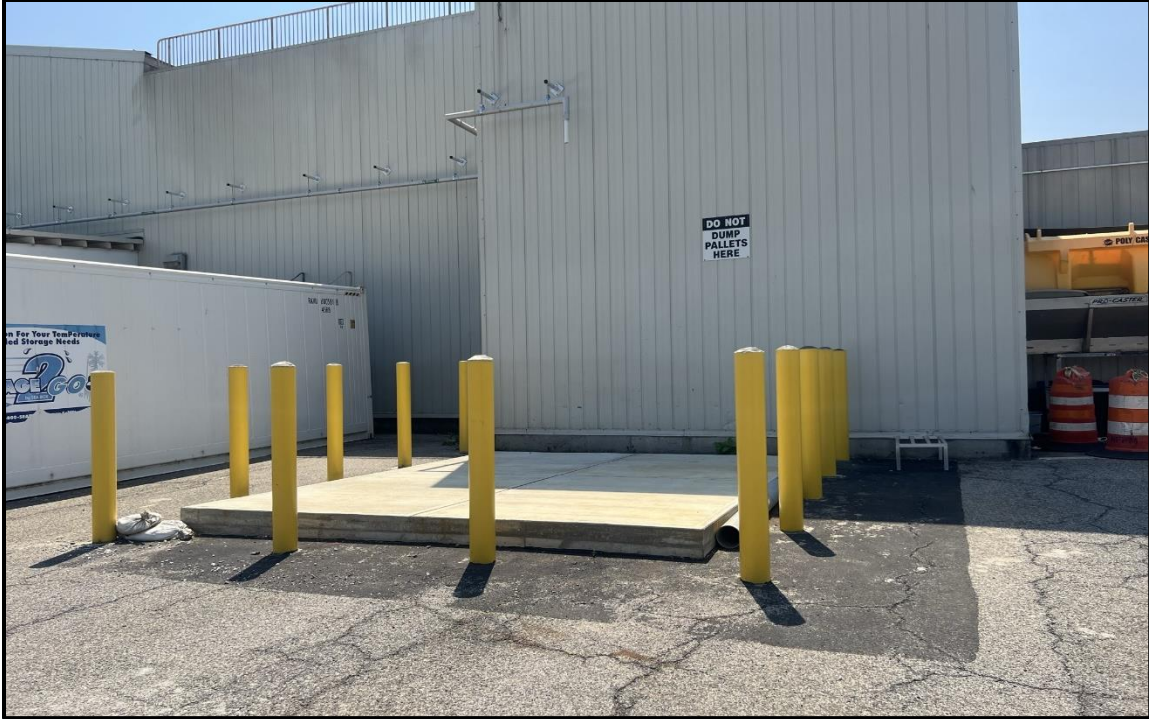
Photo 1: Facing south in the northern portion of Site, along the western dock; nitrogen tank foundation slab, constructed in July 2023, in good condition with engineering controls in place.

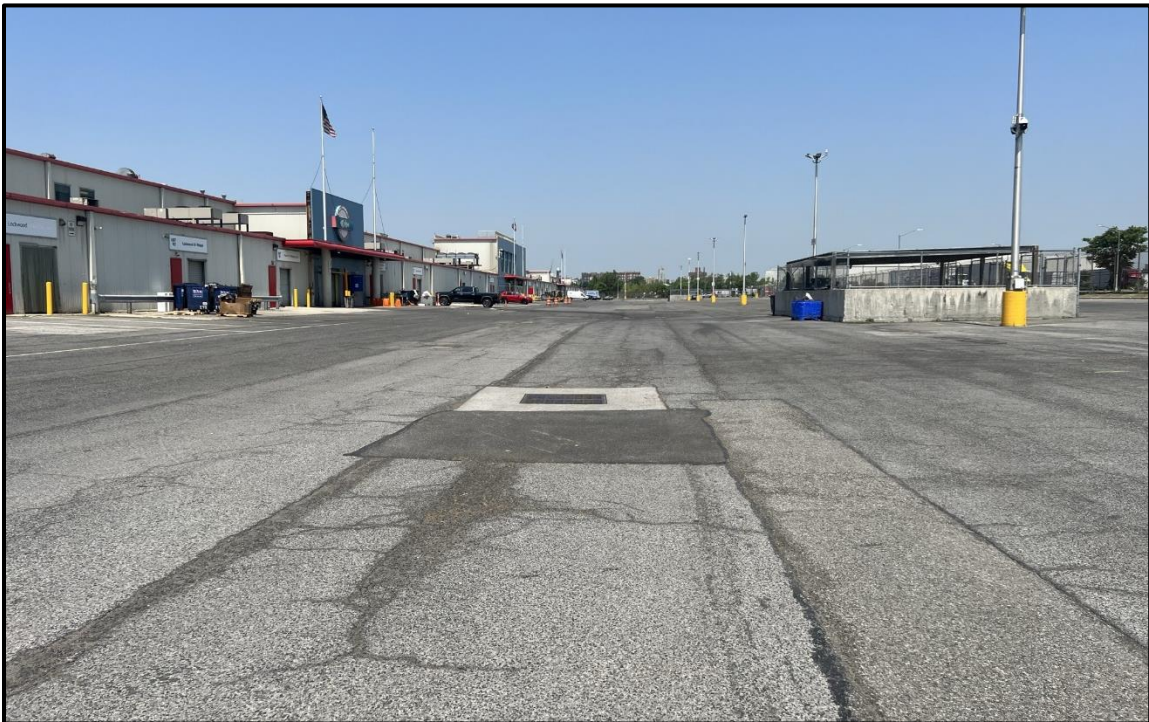
Photo 2: Facing northwest in the eastern portion of Parcel B; area of pavement repair completed in September 2023, as well as prior asphalt patching and utility repair efforts. Minor cracking present.

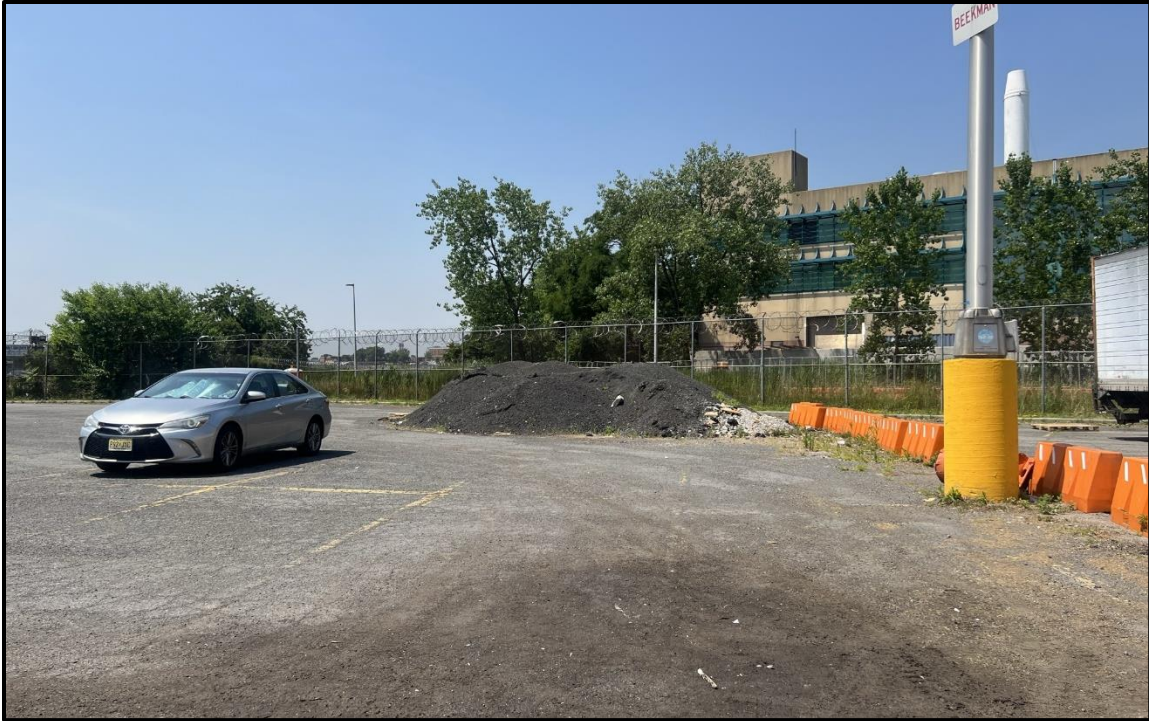
Photo 3: Facing west in the western portion of Site, adjacent to the New York City Department of Environmental Protection Sewage Treatment Plant (NYCDEP STP); stockpiling of asphalt millings from previous onsite pavement repair efforts. Surrounding asphalt in fair condition, with minor cracking.

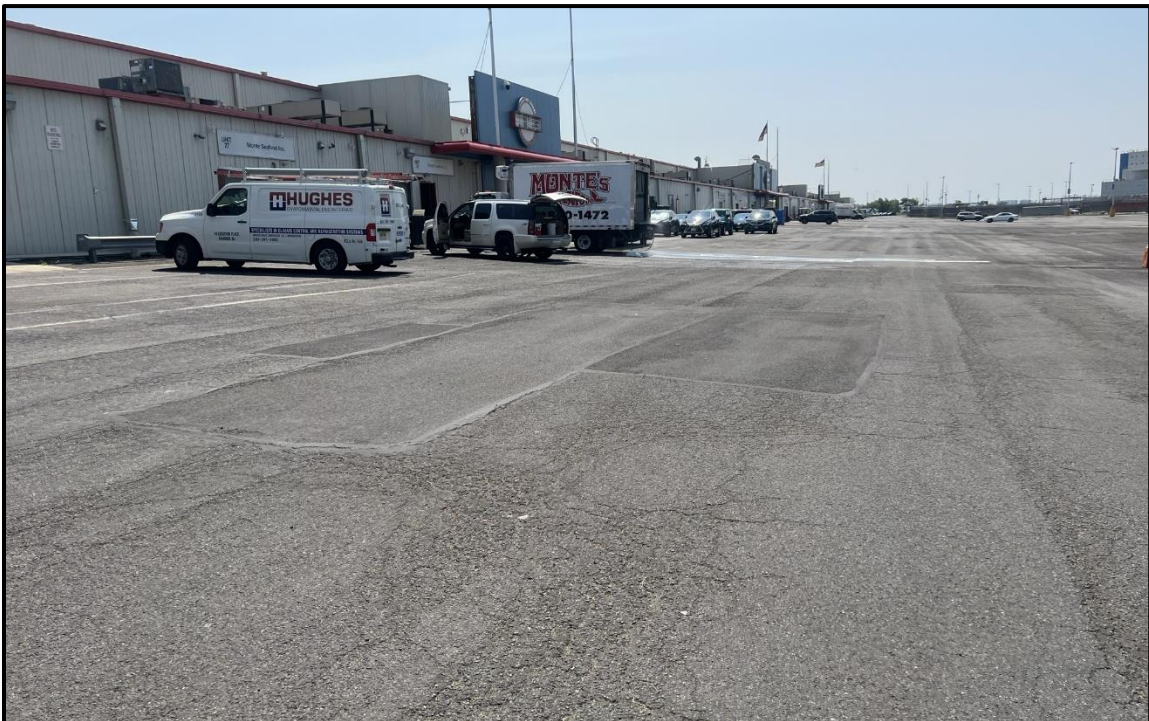
Photo 4: Facing south in the northwestern portion of Site; areas of pavement repairs completed in June and September 2023. Minor cracking present.

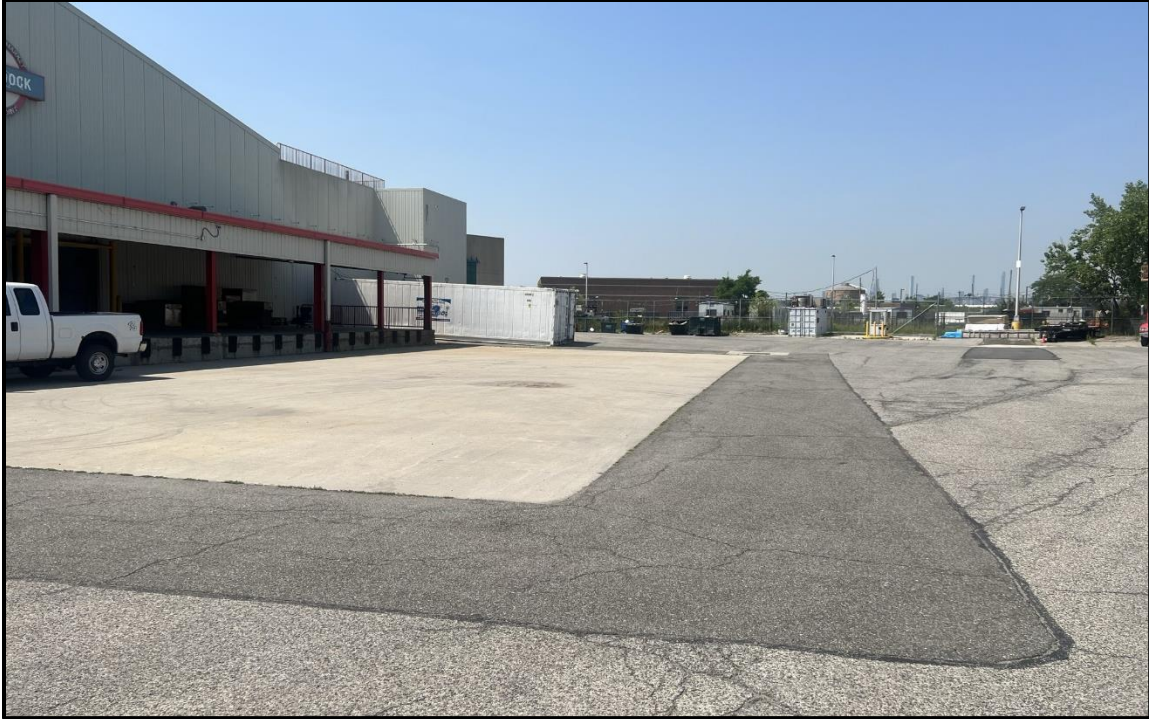
Photo 5: Facing west in northern portion of Site; former patching and reinforced concrete pad along the western dock in fair condition. Minor cracking in asphalt.

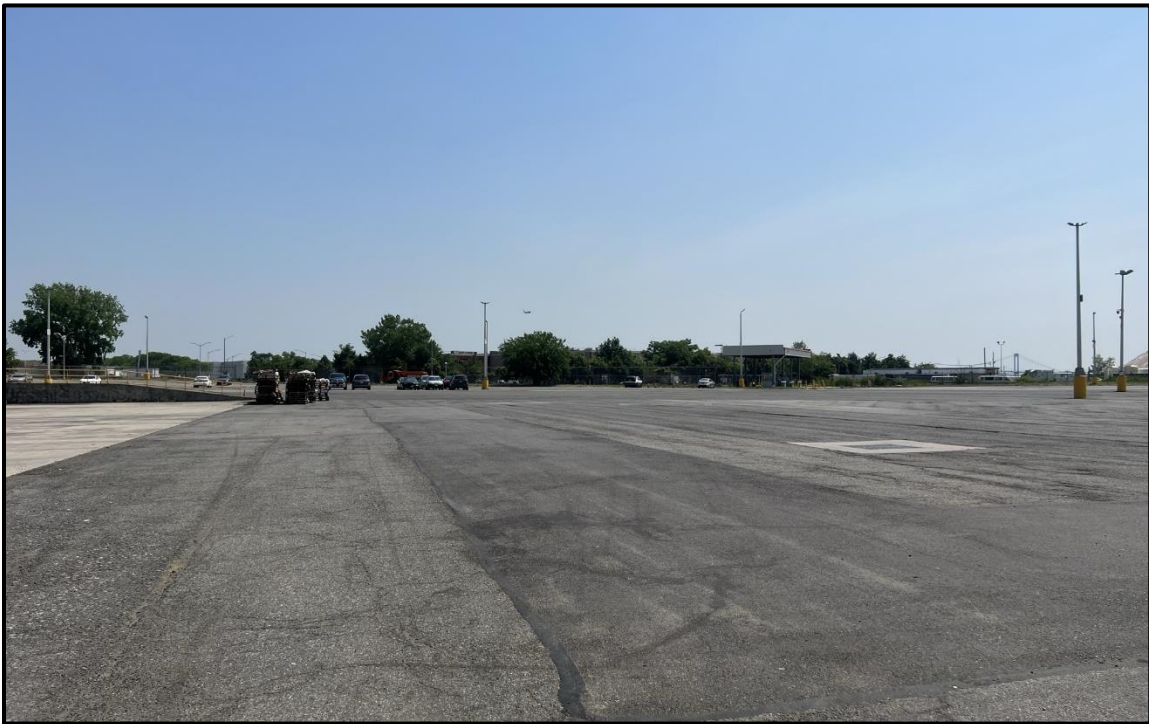
Photo 6: Facing east in the southern portion of Site; areas of pavement repair completed in September 2023. Reinforced concrete pad asphalt in fair condition. Minor cracking in asphalt present.

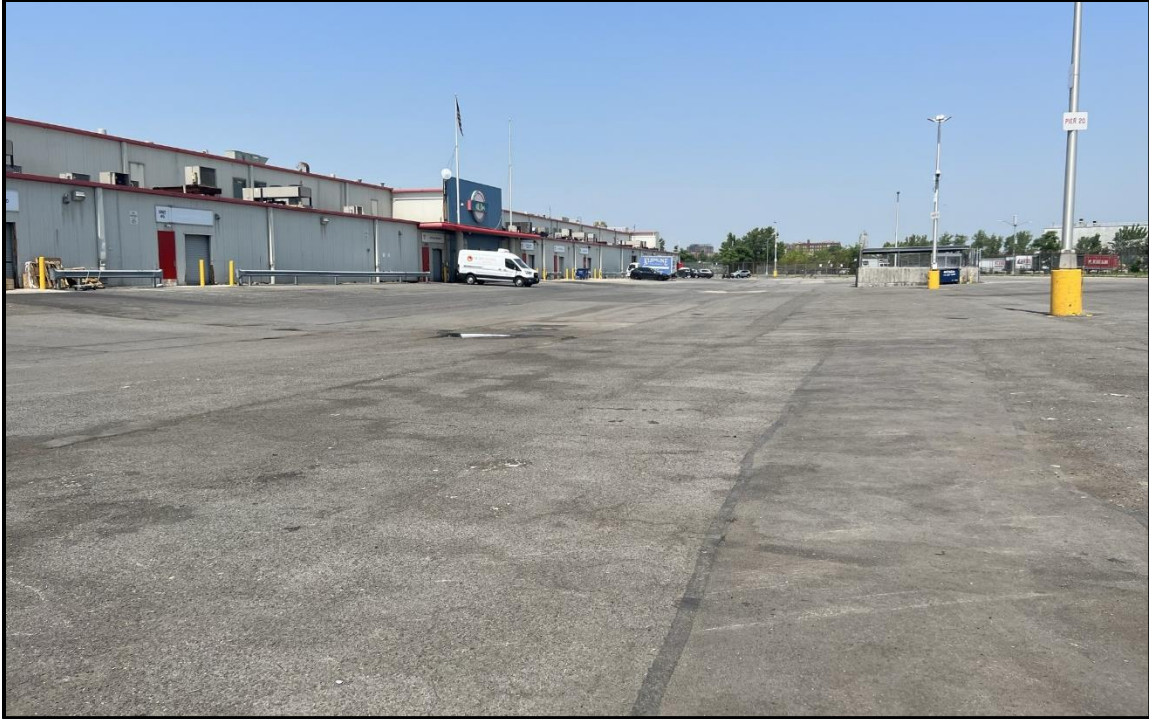
Photo 7: Facing northwest in the eastern portion of Site; engineering controls are still in place. Normal wear (minor cracking and potholes) from heavy truck traffic and patching from prior repair efforts noted.

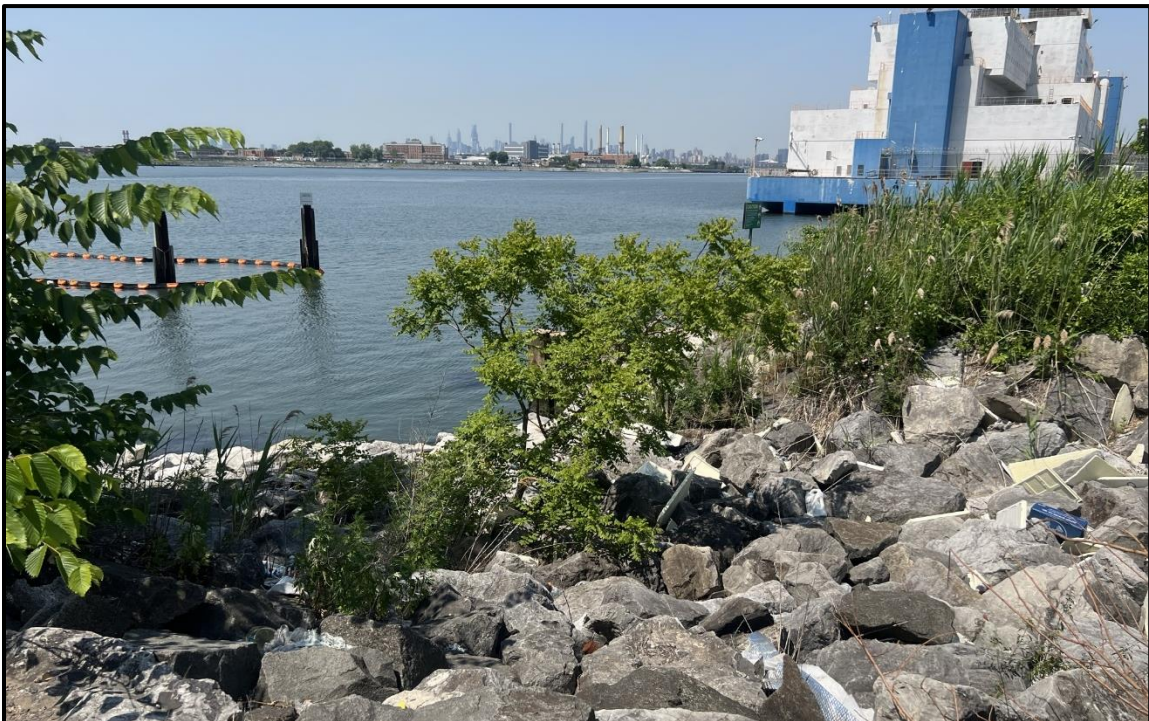
Photo 8: Facing south along the southern perimeter of Parcel B; bulkhead along the East River in fair condition.

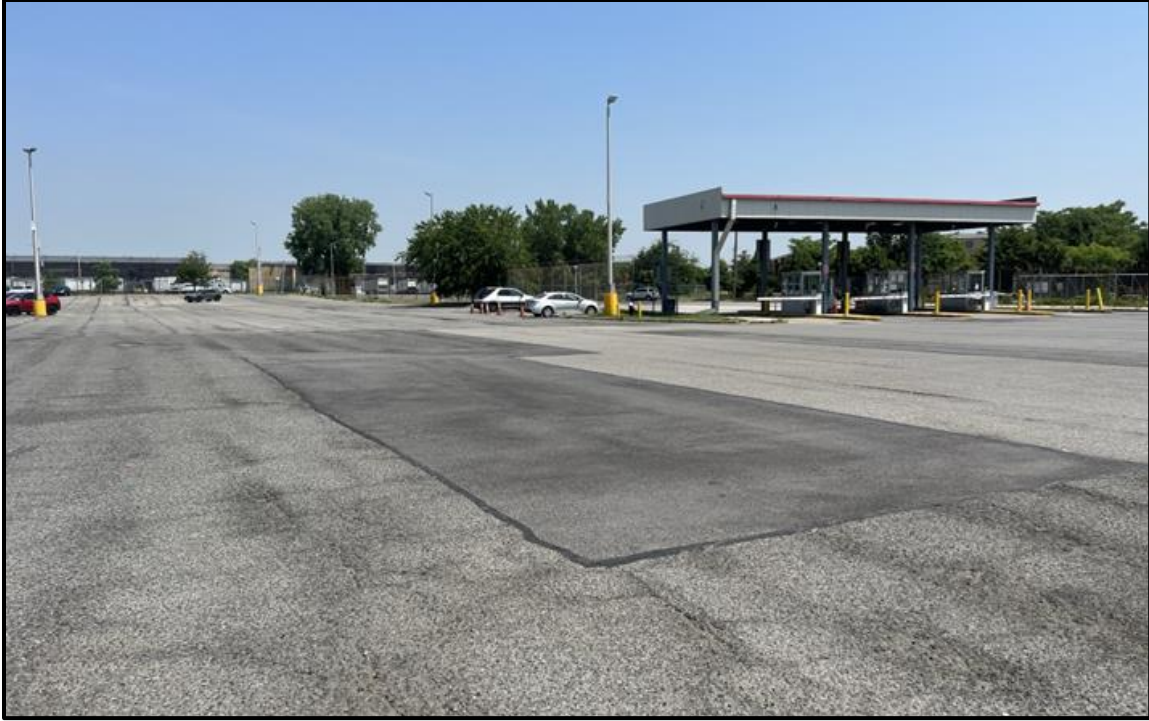
Photo 9: Facing northeast in the eastern area of Site, near facility entrance; area of asphalt repair completed in September 2023. Minor wear in existing surrounding pavement.

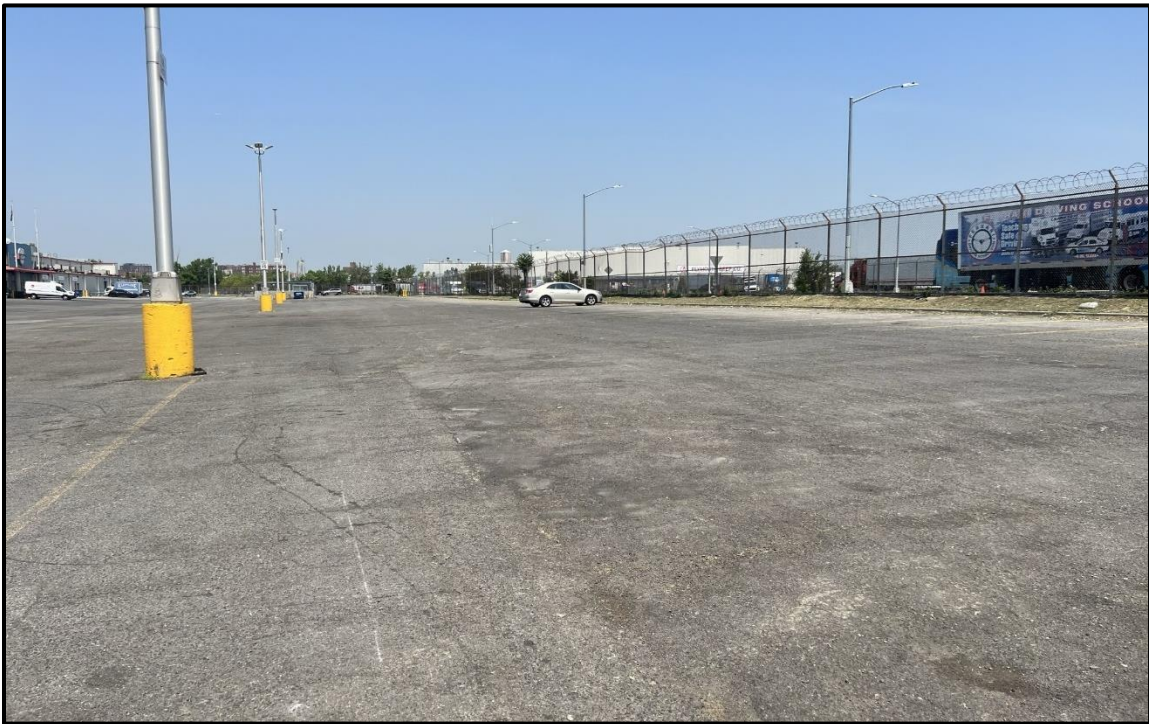
Photo 10: Facing north along eastern perimeter of Parcel B; minor cracks and potholes noted. Unpaved area along fenceline in fair condition, with vegetation noted.
