Con Edison Former MGP Site (OU-2)  
White Plains, NY  
Final Engineering Report  
Photo Log

Pre-Remediation Site Conditions  
Removal of Previous Fencing  
October 29, 2008

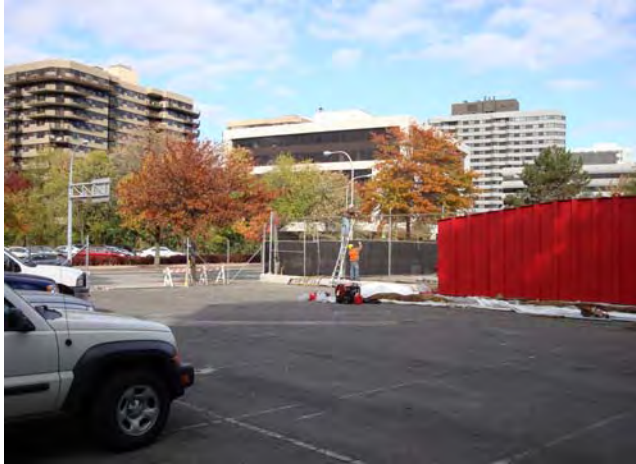
Pre-Remediation Site Conditions  
Switchyard Area (area behind fence)  
November 2, 2008

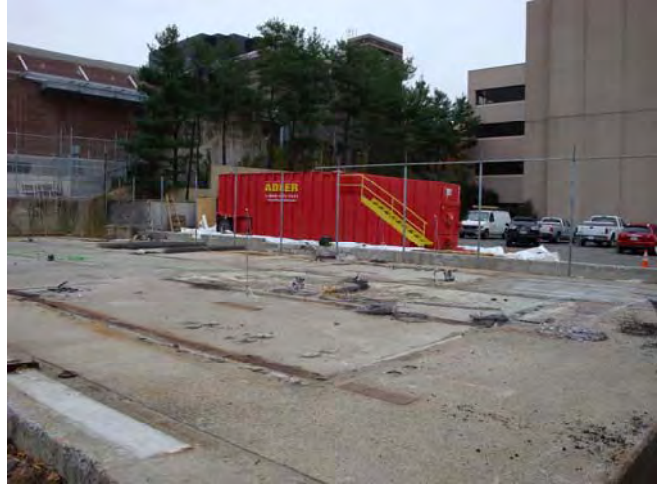
Pre-Remediation Site Conditions  
South Side of Parking Lot  
November 2, 2008

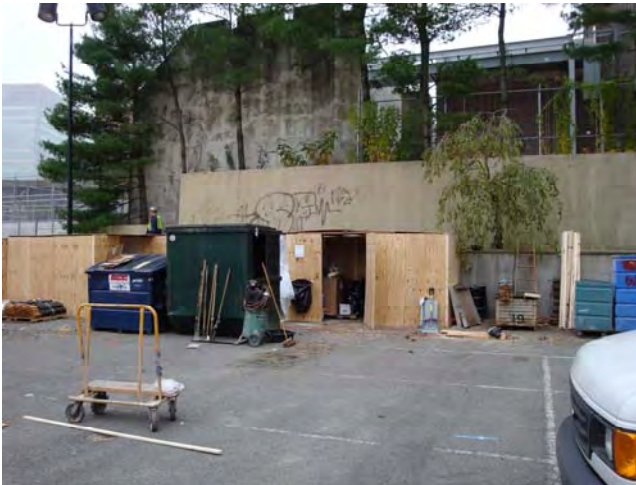
Pre-Remediation Site Conditions  
Switchyard Area (area behind fence)  
November 2, 2008

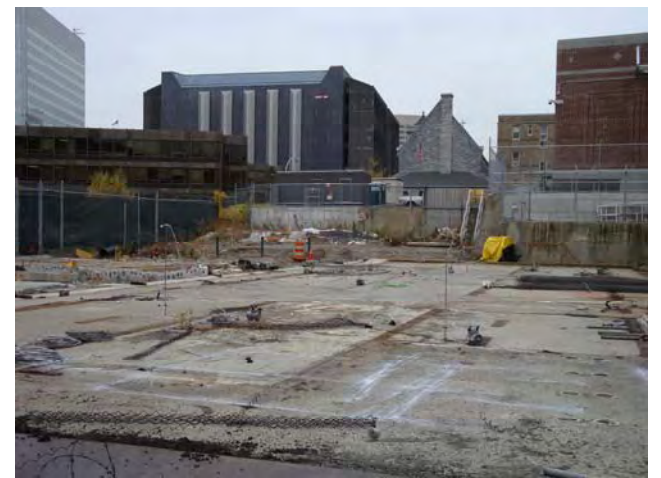
Con Edison Former MGP Site (OU-2)  
White Plains, NY  
Final Engineering Report  
Photo Log

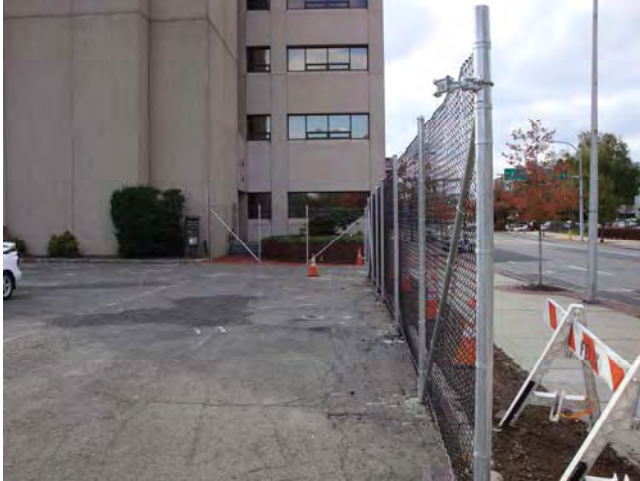
Pre-Remediation Site Conditions  
Installation of Privacy Fabric on Temporary Fencing  
October 30, 2008

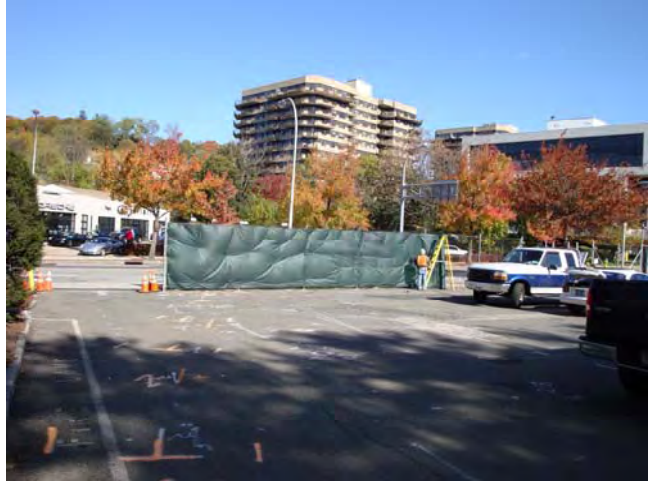
Pre-Remediation Site Conditions  
North Central Area Facing East  
November 6, 2008

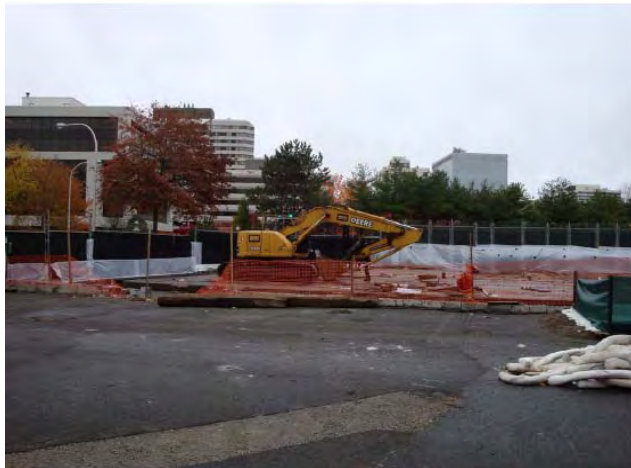
Pre-Remediation Site Conditions  
South Central Area Facing East  
November 6, 2008

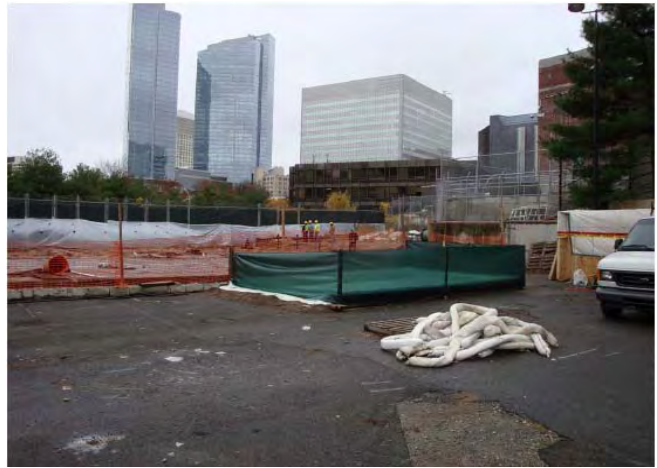
Con Edison Former MGP Site (OU-2)  
White Plains, NY  
Final Engineering Report  
Photo Log

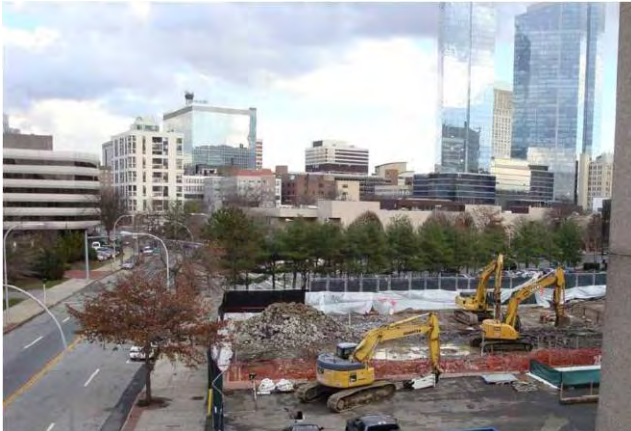
Switchyard Demo & Asbestos Abatement  
Excavation of Switchyard Foundation  
December 3, 2008

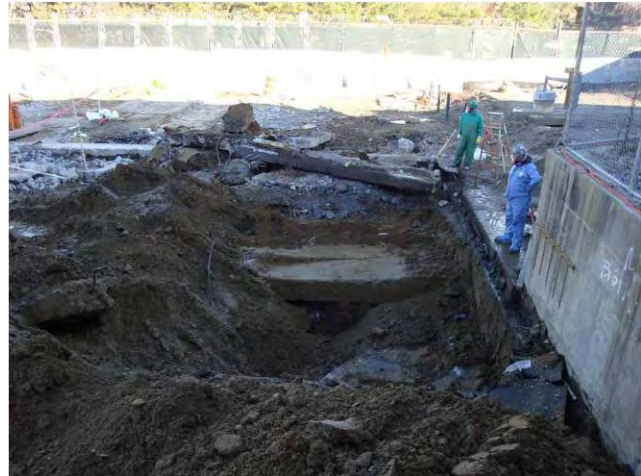
Con Edison Former MGP Site (OU-2)  
White Plains, NY  
Final Engineering Report  
Photo Log

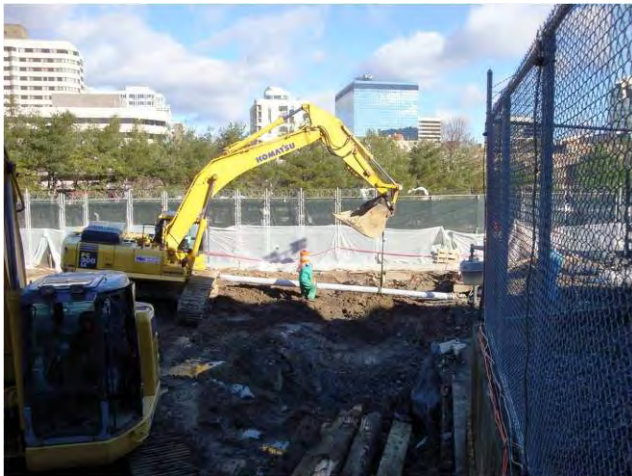
Switchyard Demo & Asbestos Abatement  
Removal of Switchyard Foundation Elements  
December 16, 2008

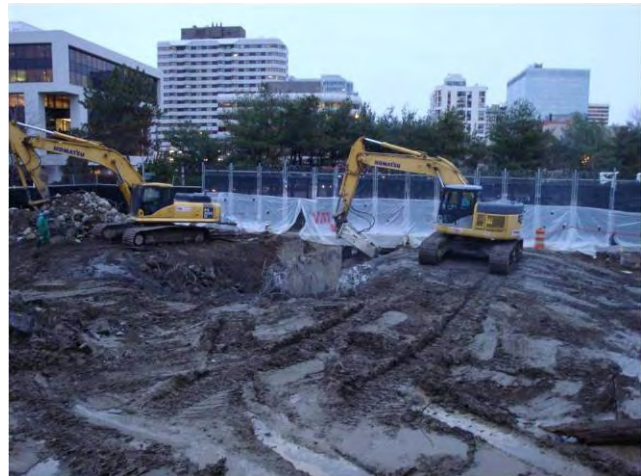
Con Edison Former MGP Site (OU-2)  
White Plains, NY  
Final Engineering Report  
Photo Log

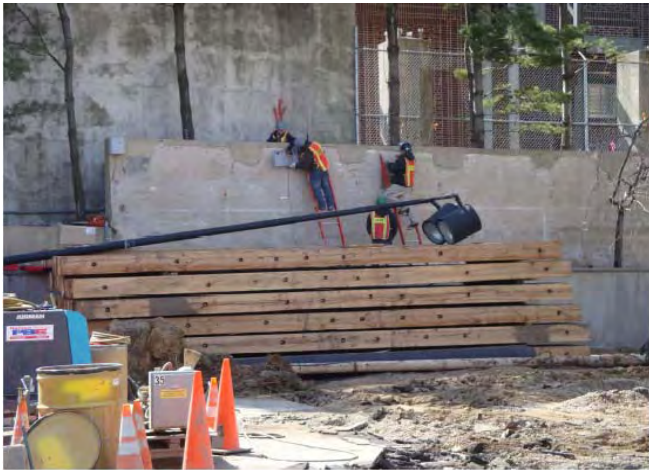
Instrumentation & Monitoring  
Crack Gauge Photo  
July 1, 2009

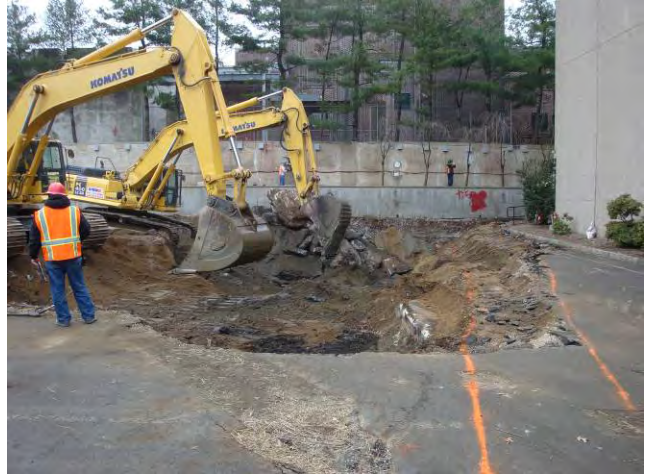
Demo of Structures for West Side  
Remnant Foundation to be Excavated  
March 26, 2009

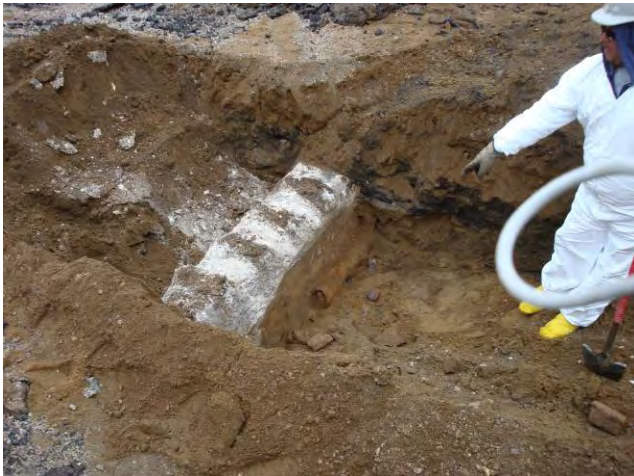
Demo of Structures for West Side  
Excavated Subsurface Structures  
March 26, 2009

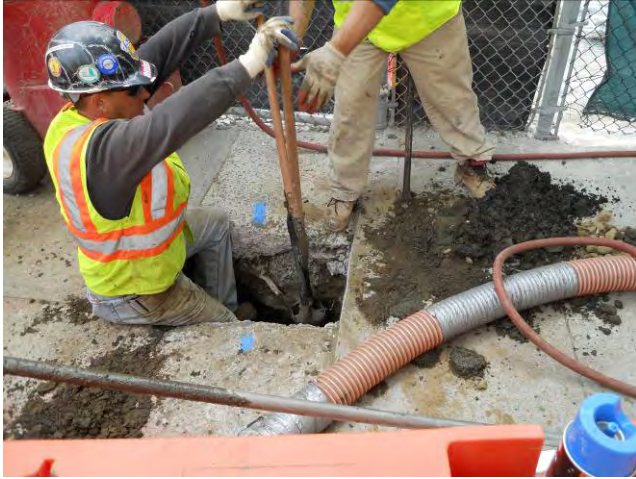
Sidewalk Borings  
Grout Observed in Sidewalk Sub-base in Hand Clearance  
for SW-4  
May 12, 2010

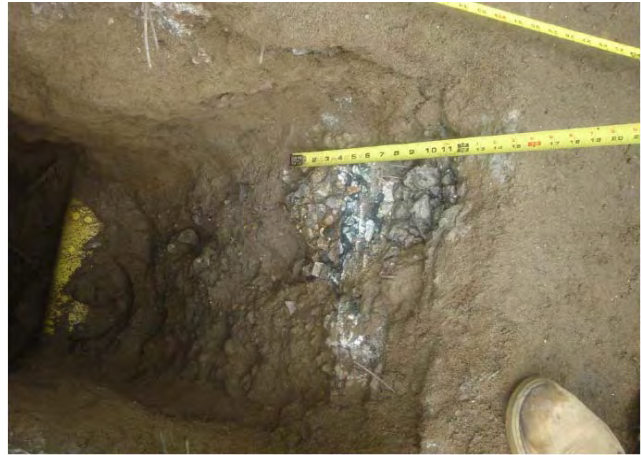
Sidewalk Borings  
Drilling and Collecting Samples for SW-3  
May 17, 2010

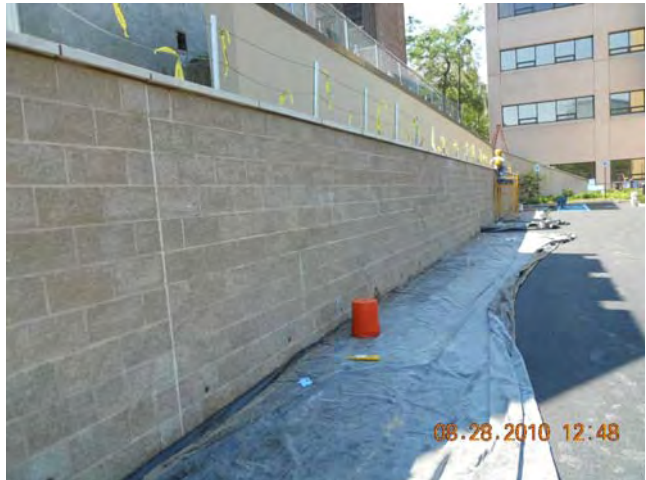
Con Edison Former MGP Site (OU-2)  
White Plains, NY  
Final Engineering Report  
Photo Log

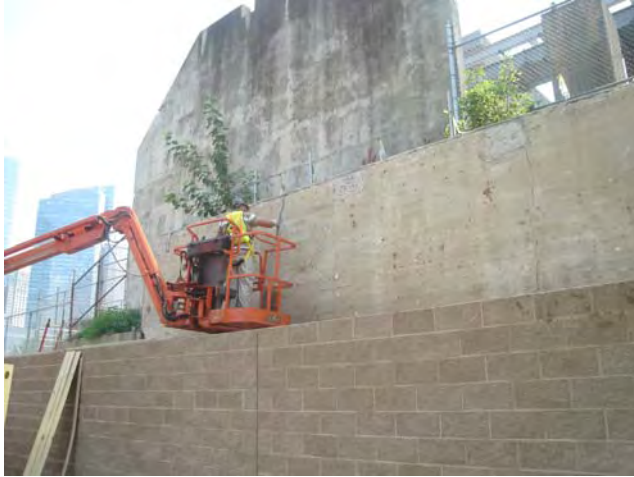
Site Restoration – Retaining Wall Stucco Installation  
Z-stud Installation Over Crack #4  
August 14, 2010

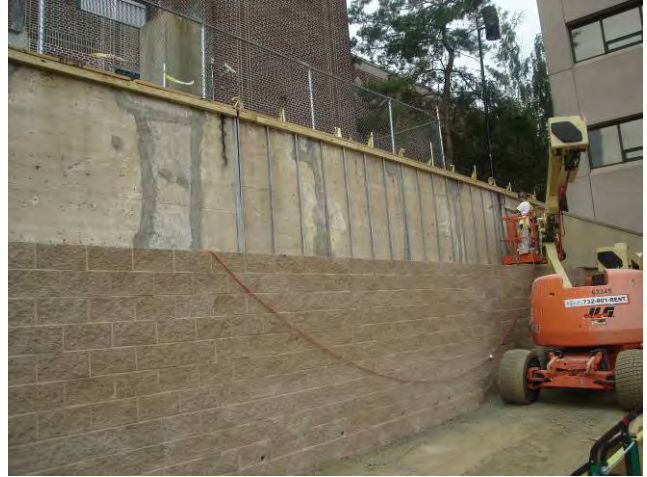
Site Restoration – Retaining Wall Stucco Installation  
Z-stud Installation Over Crack #11  
August 14, 2010

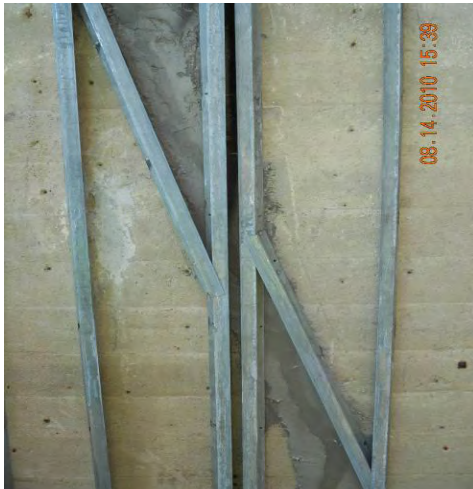
Site Restoration – Retaining Wall Stucco Installation  
Dens Glass Sheeting Installation  
August 16, 2010
