**REMEDIAL ACTION SUMMARY REPORT**  
**(Including Sub-slab Soil Gas Evaluation & Vapor Intrusion Investigation Report)**

**Site # V-00456-3**  
**Index # W3-0884-01-05**

**Congers Colonial Plaza**  
**285 Route 303**  
**Congers, New York 10920**

**December 7, 2005**

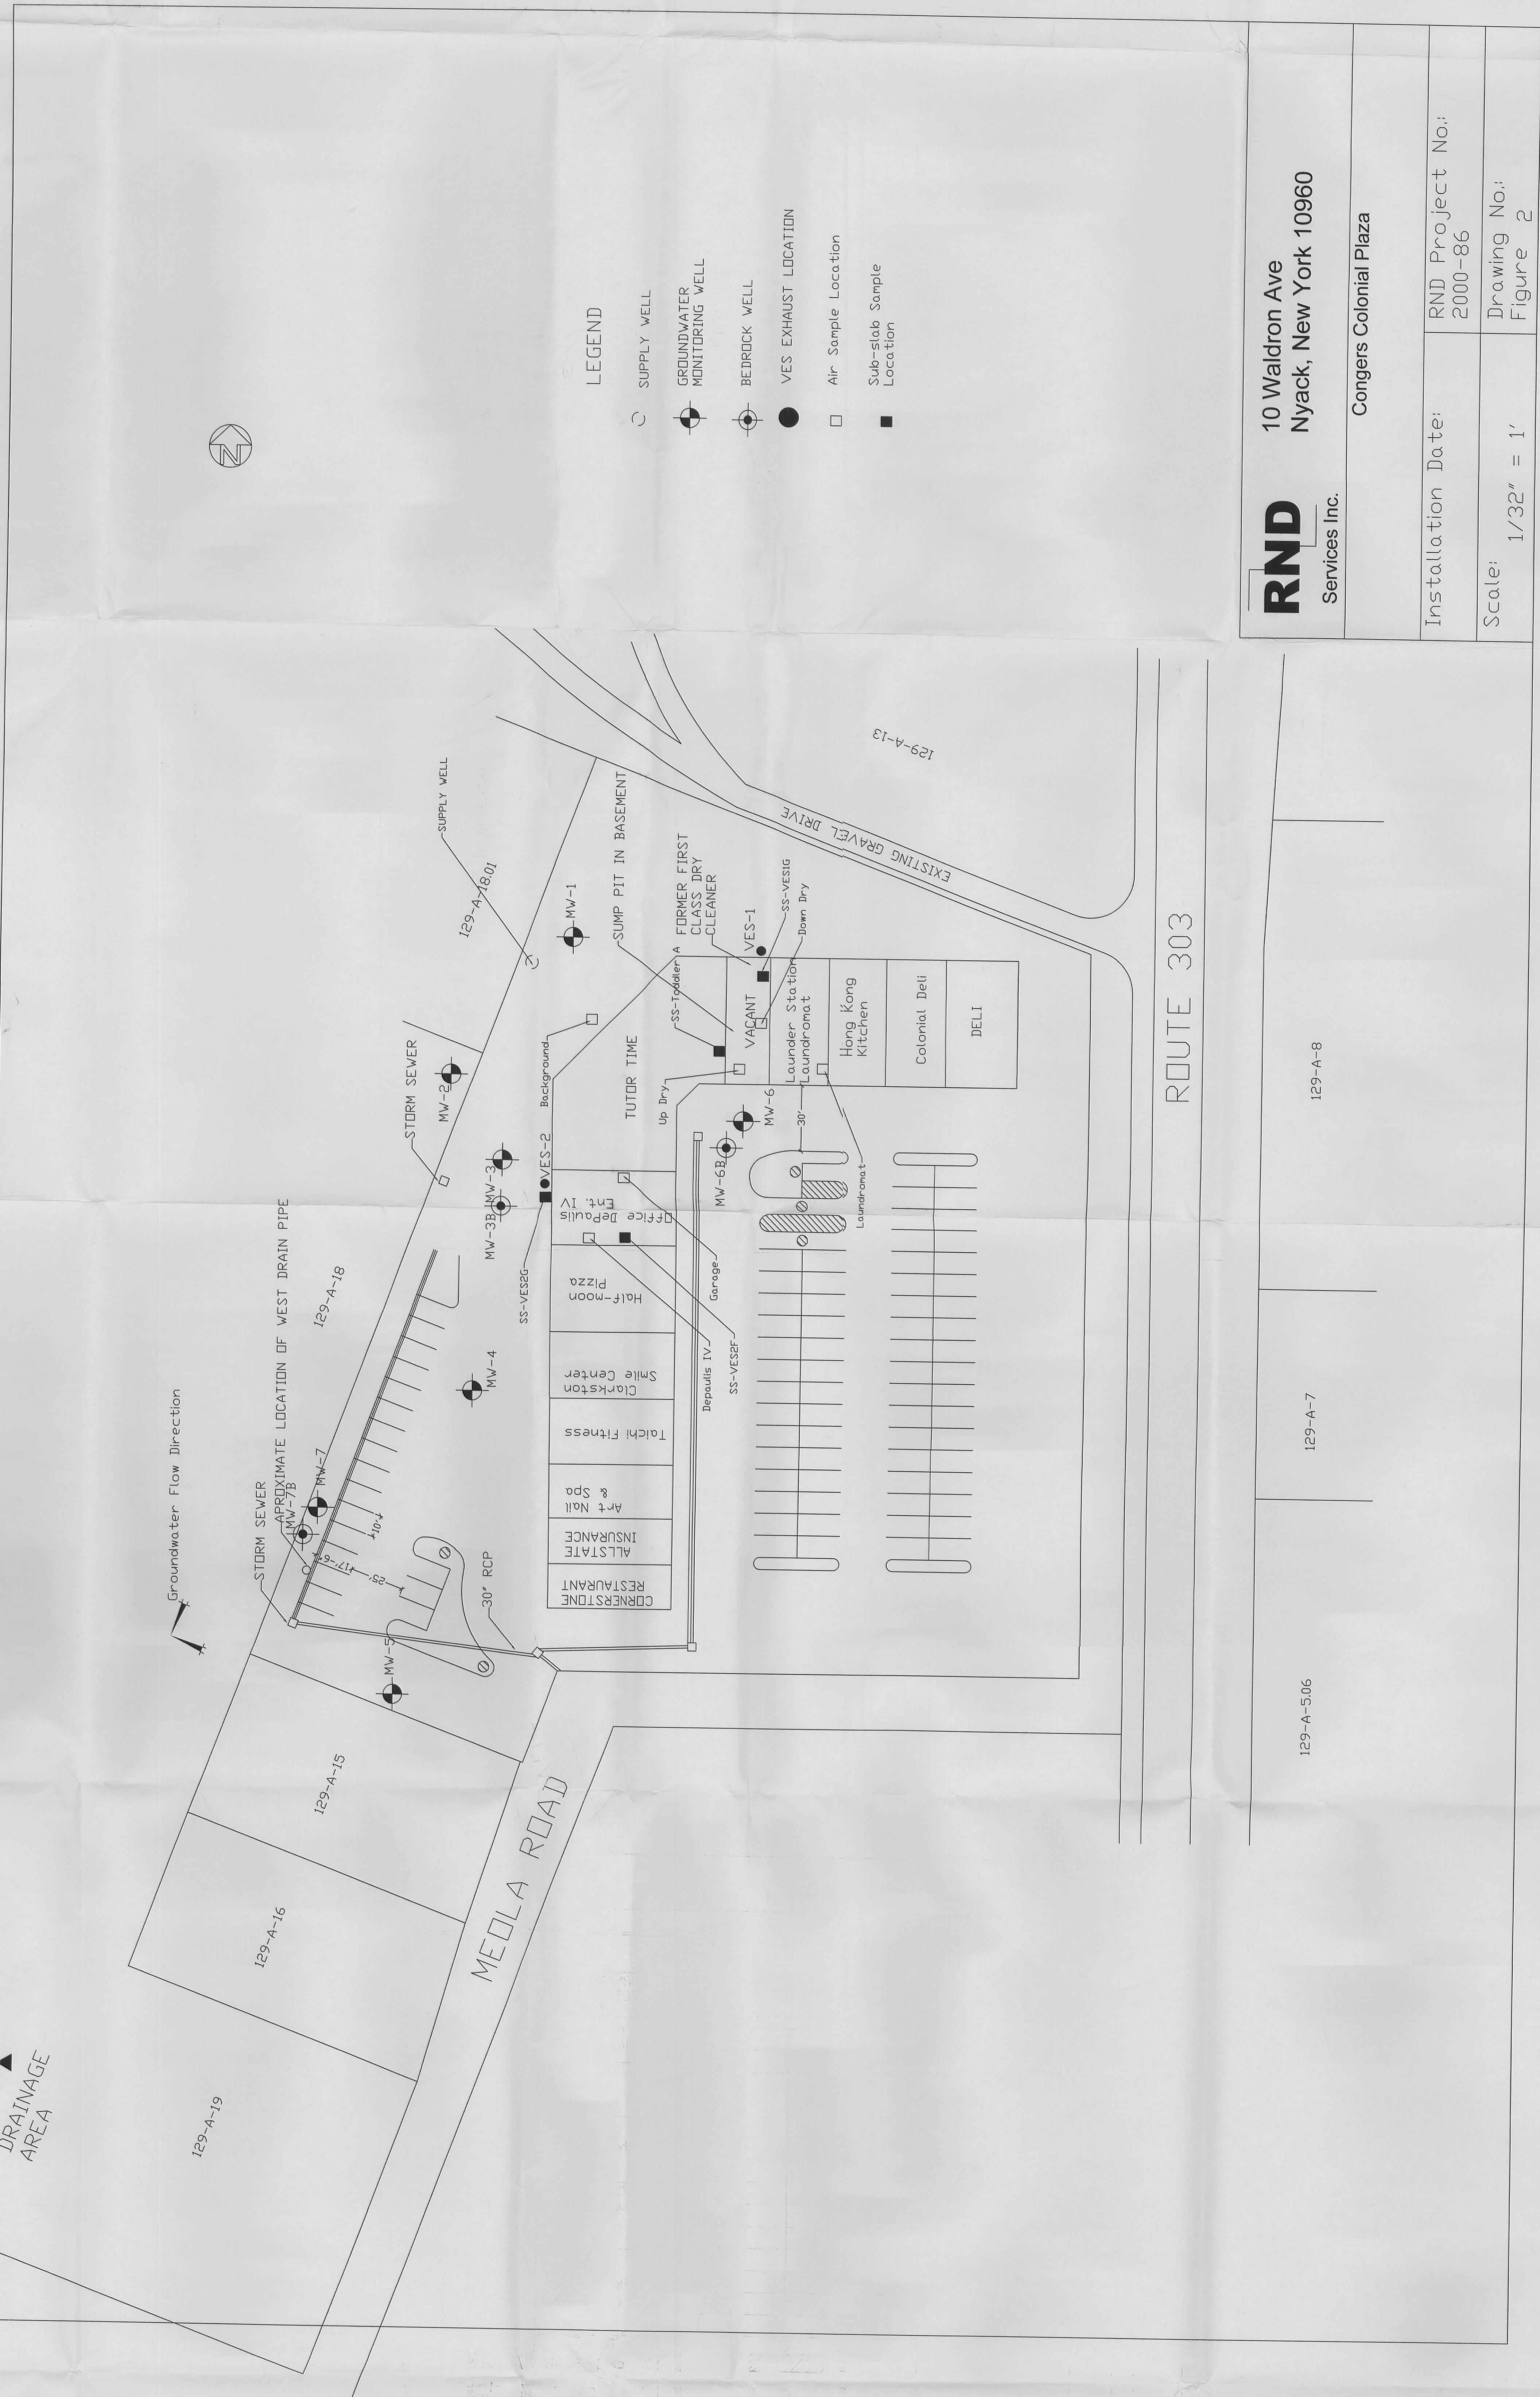
Drawing No.:  
Figure 2

A general site plan of the Property is provided as **Figure 2**. The Property is bordered on the north by a gravel driveway beyond which is an adjacent property owned by Orchard Realty, Inc., which is currently vacant. To the south of the Property is Meola Road beyond which is a small residential community consisting of four single-family dwellings. To the west of the Property is undeveloped woods and to the east of the Property is New York State Highway #5002 i.e. Route 303. Rockland Masonry, a masonry supply center and an office building are located along Route 303, east of the subject site. In the southwestern section of the Property is a low lying swamp area that is bermed and serves as a drainage basin for surface run-off from the Property.

A Sub-slab Soil Gas Evaluation & Vapor Intrusion Investigation Work Plan was prepared for the property and approved by the NYSDEC and the NYSDOH on November 22, 2005. The work was implemented November 24, through November 28, 2005. The work plan was prepared in order to evaluate the sub-slab soil gas (SSSG) conditions at the Tutor Time facility at the Congers Colonial Plaza and to determine the potential for vapor intrusion in the adjacent structures to the east and south of Tutor Time. To remediate the PCE spill three (3) potassium permanganate applications have been conducted (one below the slab of the former drycleaner and 2 injections of MW-3). The purpose of this investigation was to determine if residual volatile organic vapors, specifically, PCE vapors exists in unacceptable levels below the concrete slab. The work conducted was governed by the NYSDOH Soil Vapor Intrusion Guidance Document and directives from the NYSDEC Division of Environmental Remediation. The work was conducted after the Vapor Extractions Systems (which are normally in continuous operation) had been turned off. All indoor air samples were collected on 11/27/05 after the systems had been off for approximately 84 hours and all SSSG samples were collected on 11/28/05 after the systems had been off for approximately 108 hours. This work was conducted while the heating systems were in operation. All sampling locations are identified on **Figure 3**.
