**Re: Malone (Amsden Street) Former MGP Site**  
**Site #: V00469**  
**IRM Pre-Design Investigation Report for Tax Parcel 98.81-1-4 (Former Carter Property, property now owned by Travis Pritchard)**

This letter presents findings of a pre-design investigation (PDI) at Tax Parcel 98.81-1-4 (a.k.a. Pritchard property) that was completed during the weeks of July 22 and July 29, 2013. The objective of the PDI was to further assess the absence/presence and distribution of manufactured gas plant- (MGP-) related wastes previously encountered in the subsurface soil on Tax Parcel 98.81-1-4 and along the adjacent riverbank, with the intent of defining the limits of removal to be performed as an Interim Remedial Measure (IRM). This tax parcel is located approximately 300 feet north of National Grid's Malone (Amsden Street) former MGP site (the Site) located at 25 Amsden Street in Malone, Franklin County, New York (Figure 1). The presence of MGP-related wastes on Tax Parcel 98.81-1-4 and the adjacent riverbank appears to be associated with the Site. The PDI was completed in accordance with a New York Department of Environmental Conservation- (NYSDEC-) approved work plan titled "IRM Pre-Design

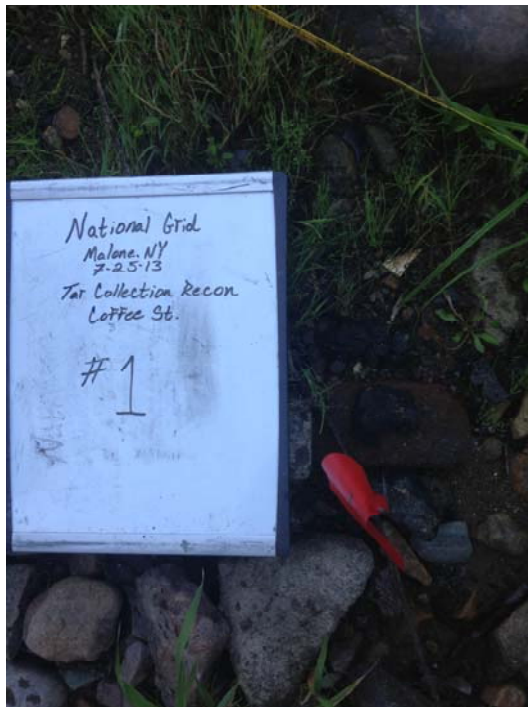
| Observation Location | Distance South of Northern Property Line (ft) | Distance from Water's Edge (ft) | Description |
|---|---|---|---|
| RBT-1 | 5 | 3 | Four pieces of hardened tar; each piece 2" to 3" diameter; flat. |

All of the tar pieces observed along the riverbank were manually removed and placed in a NYSDOT-approved 55 gallon drum and stored on the Amsden Street Site for future treatment/disposal by National Grid. Two representative samples were collected from the tar pieces for laboratory analysis: one sample was collected from the taffy-like tar at RBT-9 (labeled as WC-Bank-1) and one sample was collected from the hardened tar pieces (labeled as WC-Bank-2). The samples were analyzed for the following parameters:

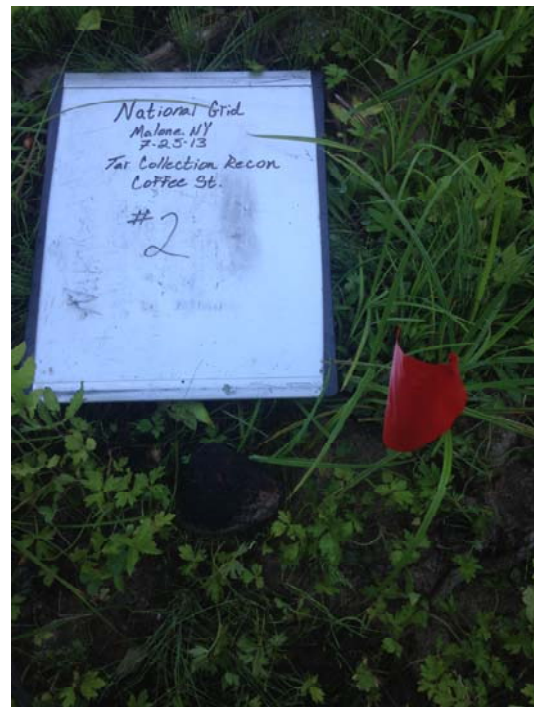
| Observation Location | Distance South of Northern Property Line (ft) | Distance from Water's Edge (ft) | Description |
|---|---|---|---|
| RBT-2 | 20 | 6 | One piece of hardened tar; 3" diameter; flat; embedded fabric. |

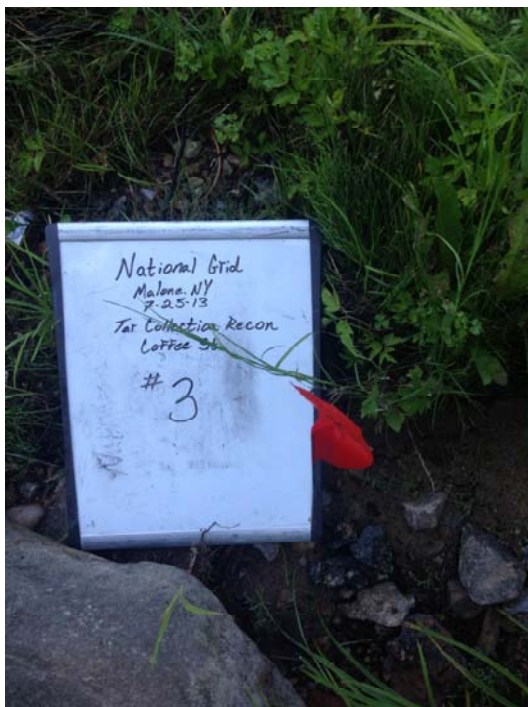
| Observation Location | Distance South of Northern Property Line (ft) | Distance from Water's Edge (ft) | Description |
|---|---|---|---|
| RBT-3 | 33 | 2 | Five pieces of hardened tar; 1" diameter; round. |

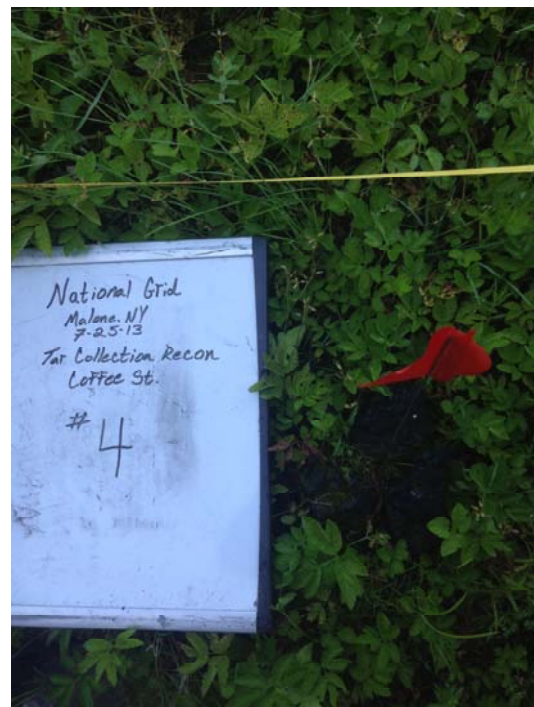
| Observation Location | Distance South of Northern Property Line (ft) | Distance from Water's Edge (ft) | Description |
|---|---|---|---|
| RBT-4 | 41 | 8 | Three pieces of hardened tar; 2" to 3" diameter; moss covered. |

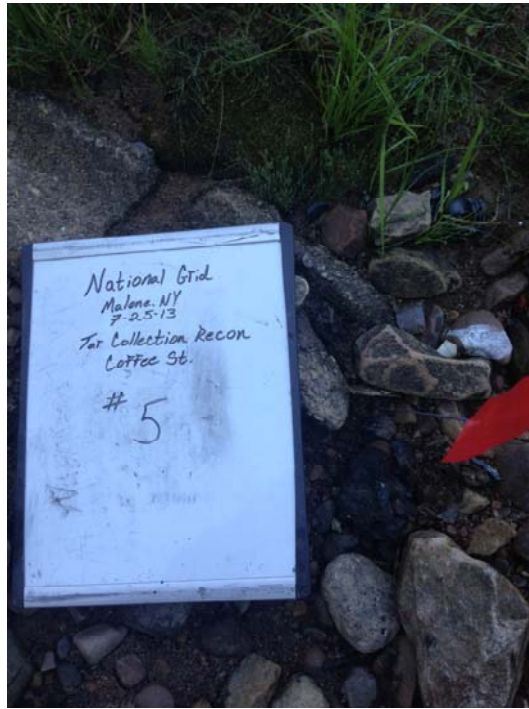
| Observation Location | Distance South of Northern Property Line (ft) | Distance from Water's Edge (ft) | Description |
|---|---|---|---|
| RBT-5 | 44 | 4 | Three pieces of hardened tar; 1" to 3" diameter. |

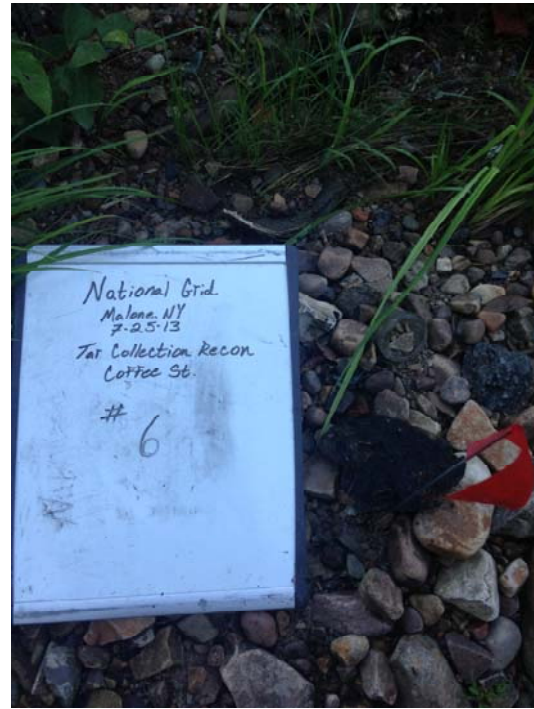
| Observation Location | Distance South of Northern Property Line (ft) | Distance from Water's Edge (ft) | Description |
|---|---|---|---|
| RBT-6 | 59 | 9 | One piece of hardened tar; 5" diameter; round. |

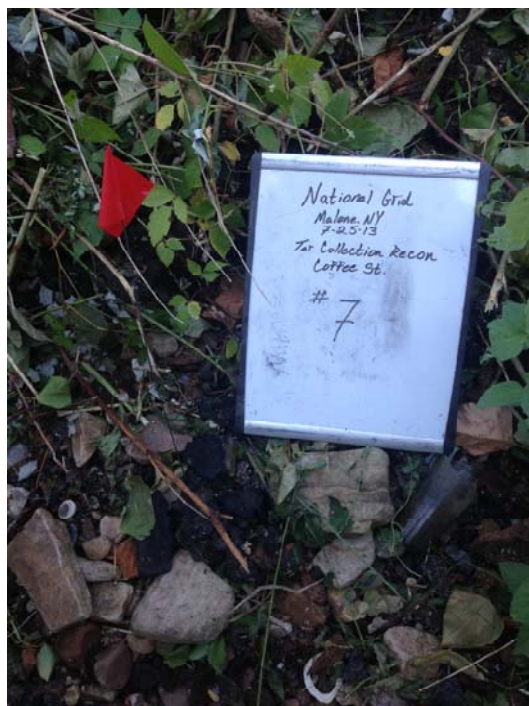
| Observation Location | Distance South of Northern Property Line (ft) | Distance from Water's Edge (ft) | Description |
|---|---|---|---|
| RBT-7 | 131 | 4 | Eleven pieces of hardened tar; 1" to 3" diameter. |

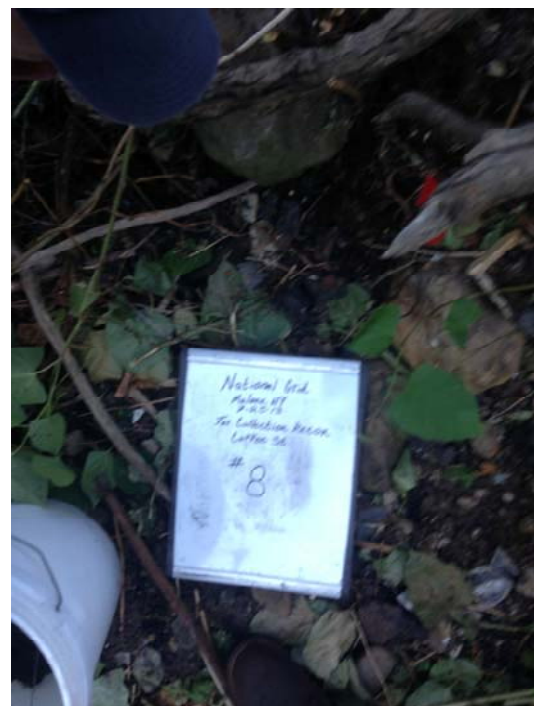
| Observation Location | Distance South of Northern Property Line (ft) | Distance from Water's Edge (ft) | Description |
|---|---|---|---|
| RBT-8 | 169 | 4 | Eleven pieces of hardened tar; 1" to 3" diameter; at base of ash tree. |

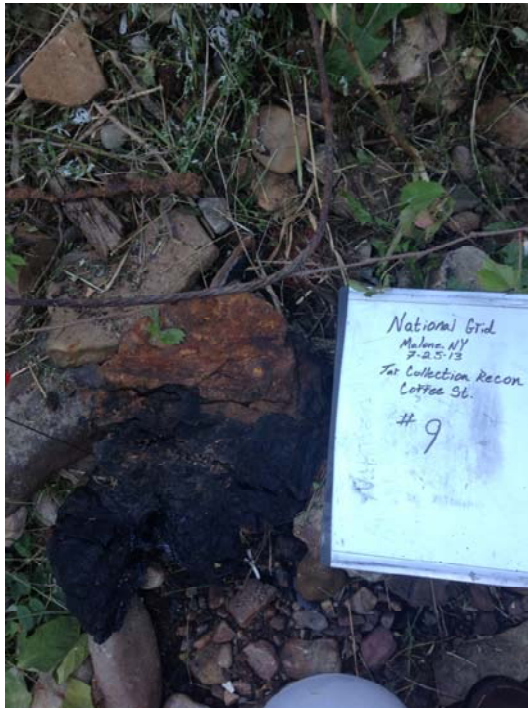
of the northern property line or south of the southern property line. In general, the tar pieces ranged from approximately 1 to 10 inches in diameter, were hardened/stiff, and exhibited an MGP-like odor when broken apart. The exception was a tar patty that was observed at RBT-9. The tar at this location had a taffy-like appearance and measured approximately 1.5-feet diameter with an approximate 2-inch thickness. The tar at RBT-9 had an appearance similar to the tar observed at CTP-2 in August 2011.

| Observation Location | Distance South of Northern Property Line (ft) | Distance from Water's Edge (ft) | Description |
|---|---|---|---|
| RBT-9 | 215 | 3 | One tar patty; taffy-like; ~ 1.5' oval; 2" thick; embedded in bank. |

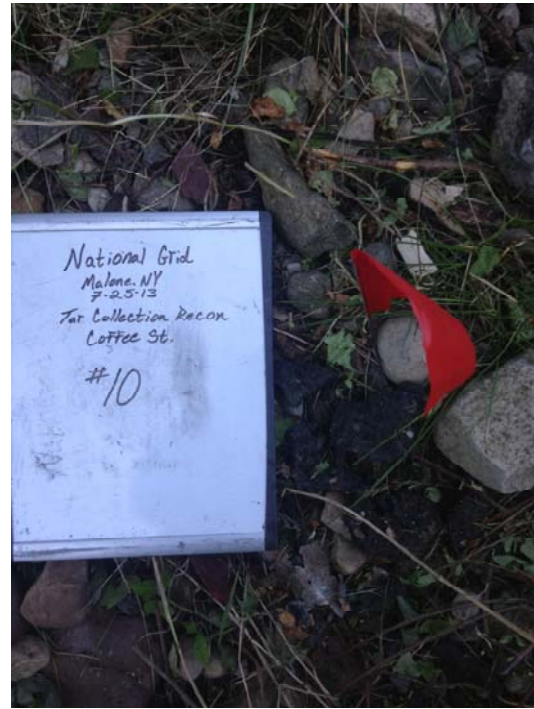
| Observation Location | Distance South of Northern Property Line (ft) | Distance from Water's Edge (ft) | Description |
|---|---|---|---|
| RBT-10 | 276 | 3 | Eight pieces of hardened tar; seven pieces 1" to 3"; one piece 6" to 10". |

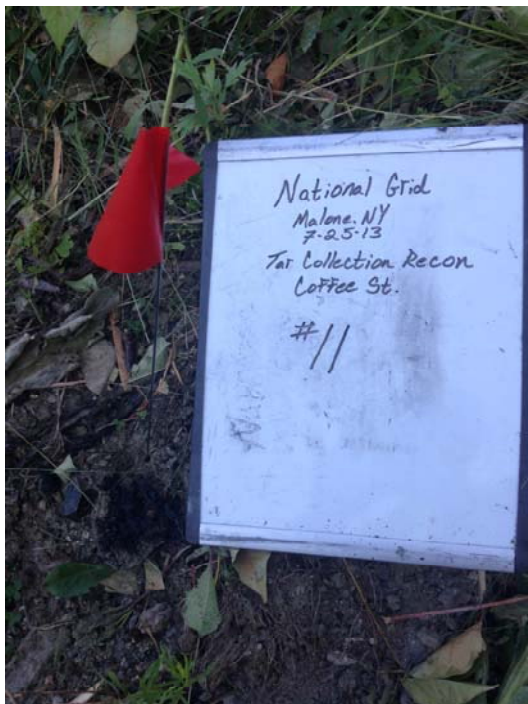
| Observation Location | Distance South of Northern Property Line (ft) | Distance from Water's Edge (ft) | Description |
|---|---|---|---|
| RBT-11 | 311 | 10 | One piece of hardened tar at top of bank; 2" diameter. |

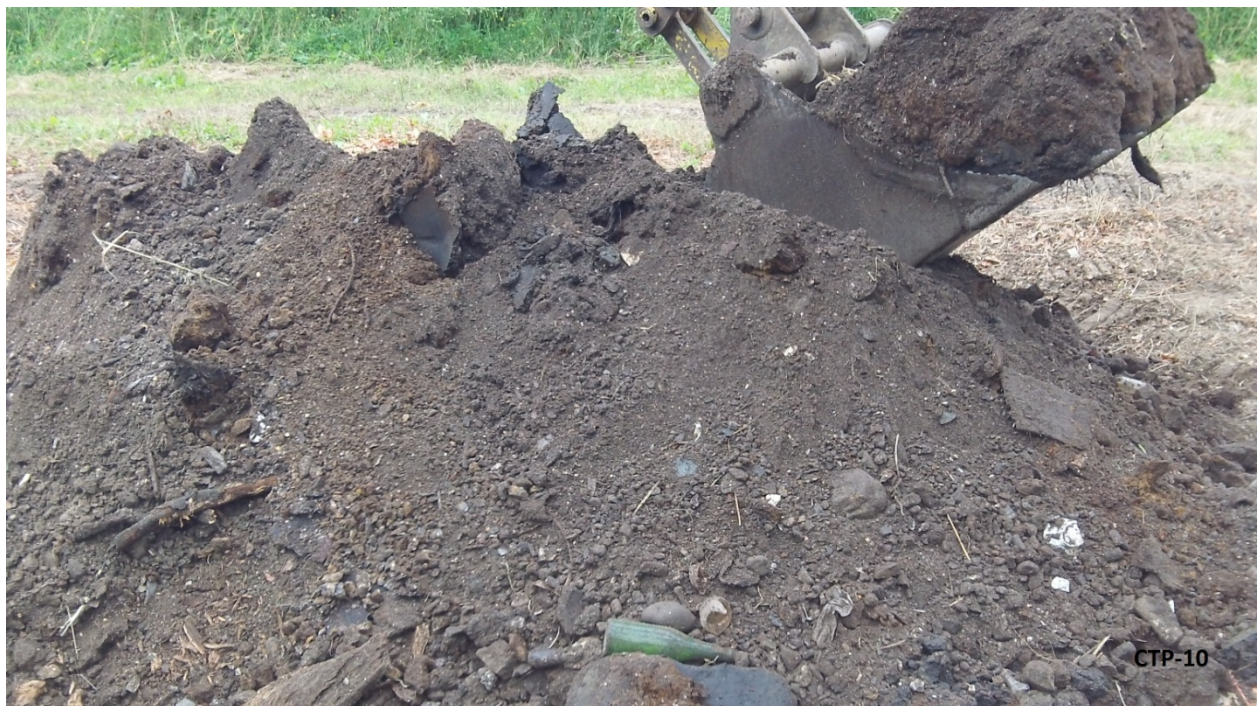
Potential MGP-related wastes were not observed by personnel on-site in any test pits. A faint petroleum-like odor and grey stained soil was observed at test pit CTP-10 at approximately 4 to 6 feet below grade; however, the PID did not detect any volatile organic vapors from this material.
