Re: *Malone (Amsden Street) Former MGP Site*
Site #: V00469
Final Remedial Investigation Report and Project Schedule

NATIONAL GRID MALONE (AMSDEN STREET) FORMER MGP SITE REMEDIAL INVESTIGATION	
SITE MAP	
ARCADIS Design & Consultancy for natural and built assets	FIGURE 1

NATIONAL GRID
MALONE (AMSDEN STREET) FORMER MGP SITE
REMEDIAL INVESTIGATION

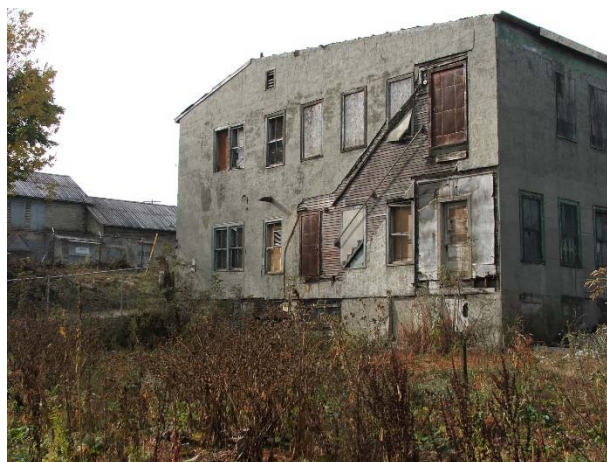
Figure 1-1 Carter building on adjacent property, looking southwest

Immediately north of the site and MGP operations area, a small parcel (currently owned by Mr. Timothy Carter) is occupied by an unused, two-story warehouse building. The building was previously used as a warehouse for furniture, garment manufacturing, and production of rubber goods. The nearest residence is located on the adjacent property north of the site. A paved parking lot is located immediately south of the site, with several commercial stores located further to the south. Based on a review of an Environmental Data Resources, Inc. (EDR) report (see the attached CD), the property to the south has three closed NYSDEC spill reports (#9506718, #9508013, and #9808391). In addition, a soil

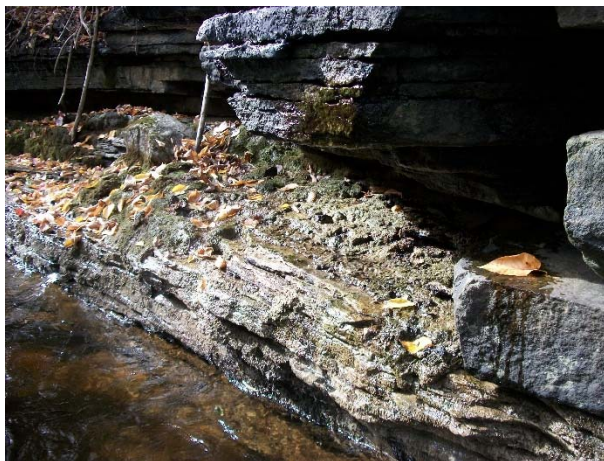
Figure 3-1 Bedrock ledge located along riverbank adjacent to the site

groundwater erosion and weathering along bedding planes near the river. The thickness of the sandstone beds at the site ranges from less than 1 inch to several inches, and generally less than 1 ft. Examination of retrieved bedrock cores, and a measurement of the attitude of an exposed bedrock outcrop near the former powerhouse foundation, indicates that the sandstone beds are essentially flat-lying (i.e., no measurable dip direction). Few vertical fractures (joints) were identified during examination of bedrock cores; however, vertical fracturing is generally rarely observed in vertical coreholes.

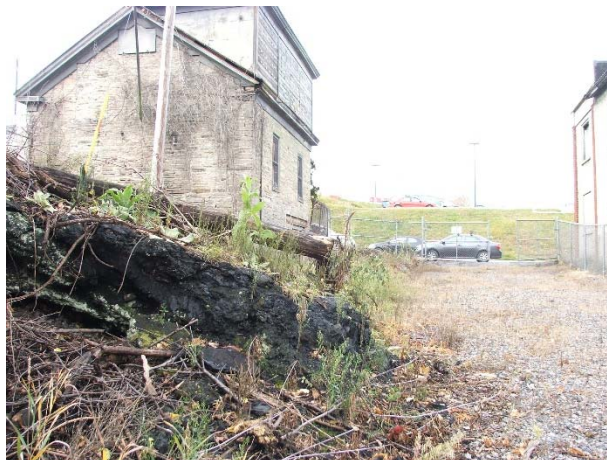
Figure 3-2 Solid tar observed on ground surface of site, looking toward Amsden Street, former MGP building on left

- Tar is primarily observed within the approximate upper 5 ft of overburden in the southern half of the site (Figure 10). Tar is observed at greater depths within the footprint of the southern gas holder.

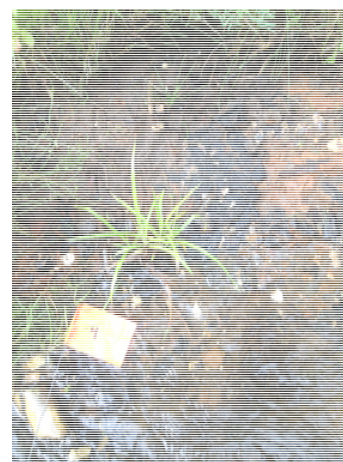
Figure 3-3 Tar observed at RBT-4A (see Figure 3)

As discussed in both reports, the forensic evaluations found that tar observed on the Pritchard Property had a PAH compositional signature similar to that of the tar observed on the site, and all tar samples were produced by the same process. National Grid concluded that, given the proximity of the MGP site to the Pritchard Property, the former MGP cannot be ruled out as the source of the tar on the Pritchard Property. As discussed in Section 1.4.4, National Grid conducted an IRM on Tax Parcel 98.81.1.4 in September 2014 to remove the tar observed on the riverbank and in two test pits (CTP-1 and CTP-2; Figure 3) further inland from the riverbank. As of the date of this RI Report, the tar observed on Tax Parcel 98.81-1-3.200 remains in place.

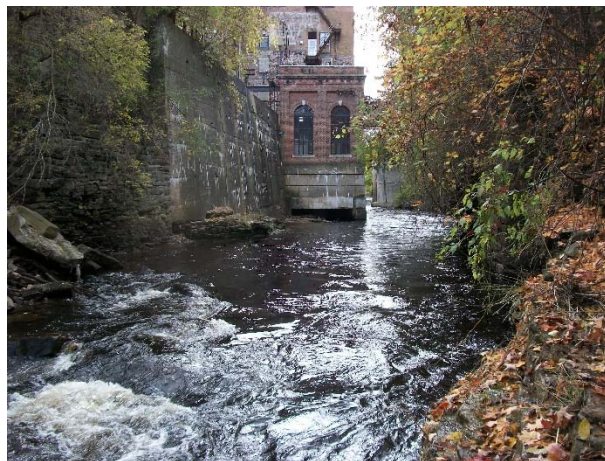
Figure 3-5 Channelized section of river immediately upstream from site

Throughout all investigated reaches, the riverbed consists of quartz and feldspar-rich unsorted sands and gravels with an armoring of cobbles and boulders underlain by bedrock. Due to the high stream energy within the investigated reaches, very little fine-grained sediment is present. Where finer grained sediment is observed, it is limited to isolated pockets located around obstructions – behind the upstream dam and power-generator building and behind debris, tree roots, and boulders located on the streambed.

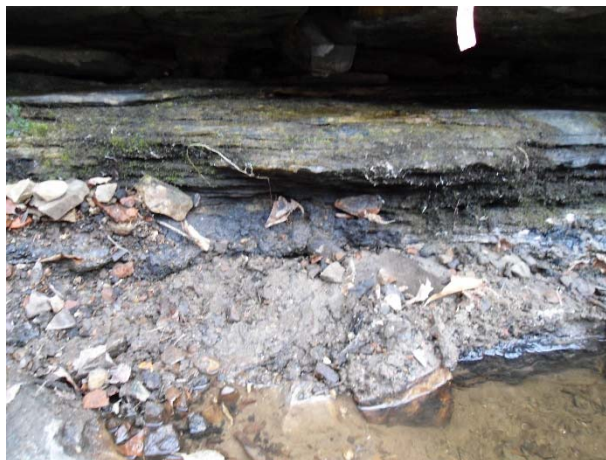
Figure 3-6 Tar patty located at edge of river adjacent to the site

1. Adjacent to the site – A solidified tar patty was observed on the bedrock surface at the base of the slope immediately downslope from the portion of the site where the former MGP structures are located. The edges of the tar patty were delineated during the sediment sampling program. The patty is elongated in the direction of the river, is approximately 30 ft long, and extends approximately 5 ft out from the bottom of the slope and into the river. The tar patty appears to have originated from overland flow of tar down the steep slope of the site. Solidified tar was also observed immediately upstream from the
