Subject: Interim Remedial Measure Pre-Design Work Plan
Fort Edward (Canal St.) Non-Owned Former MGP Site
Fort Edward, Washington County, Site #V00472

IRM PRE-DESIGN WORK PLAN
SOIL BORING PLAN

Attachment I Photographic Log, Ft. Edward (Canal St.), August 14, 2007

Attachment II Photographic Log, Ft. Edward (Canal St.), August 15, 2007

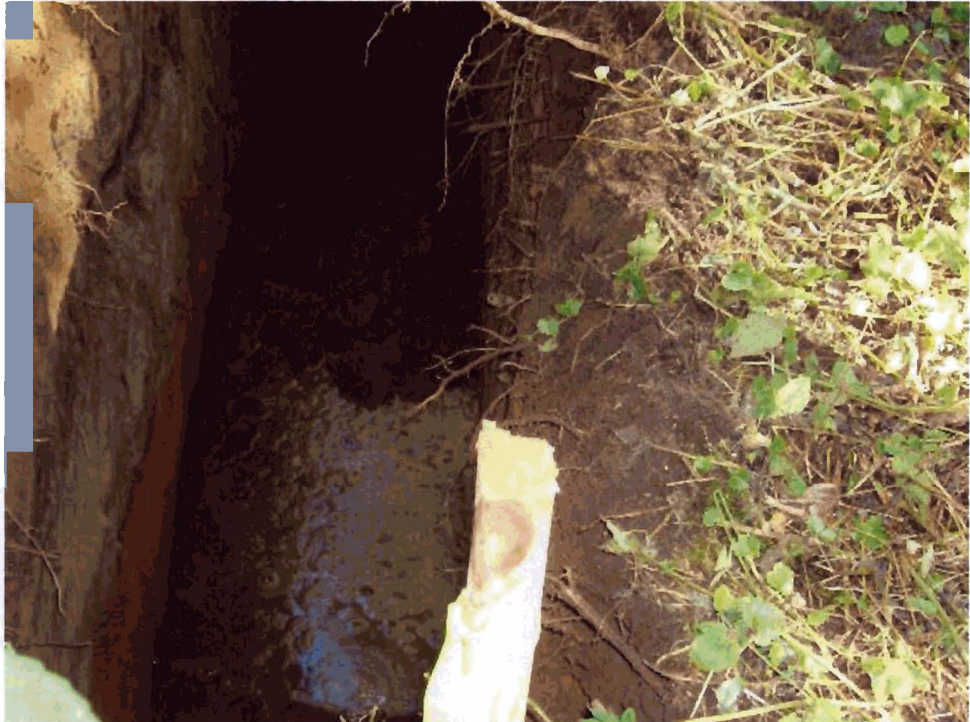
Photograph ID: 3

Date: Aug 14, 2007	
Location: TP-9 South	
Direction: Looking north	
Comments: Groundwater entering test pit excavation at 7.5 ft. bgs

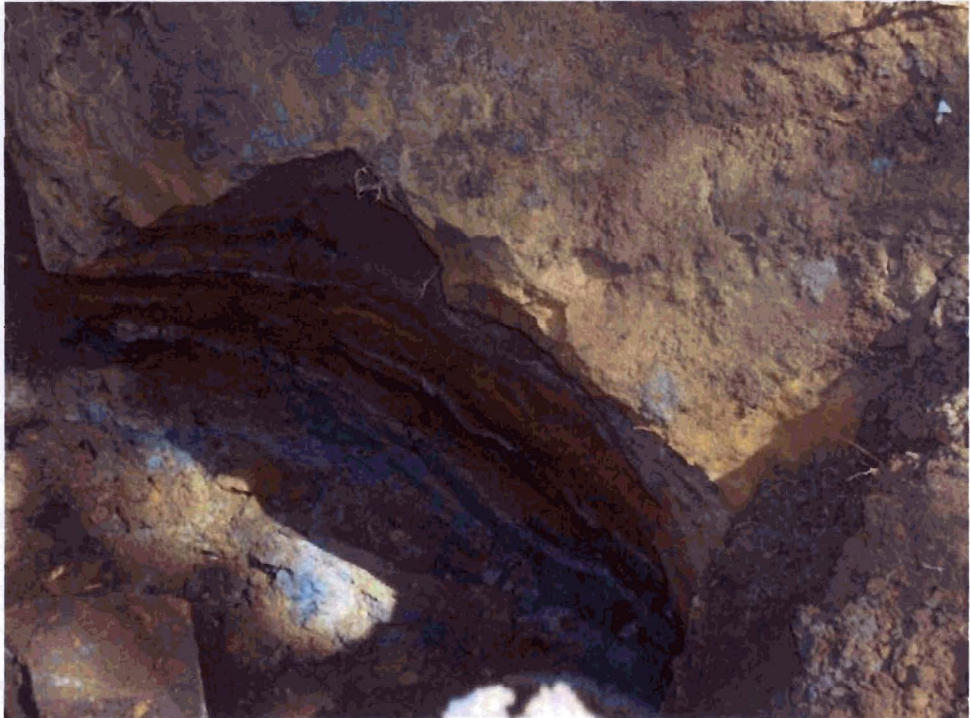
Photograph ID: 4

Date: Aug 14, 2007	
Location: TP-9 midway	
Direction: Looking north	
Comments: Pocket of bluish colored soils at 5.5 - 6 ft. bgs

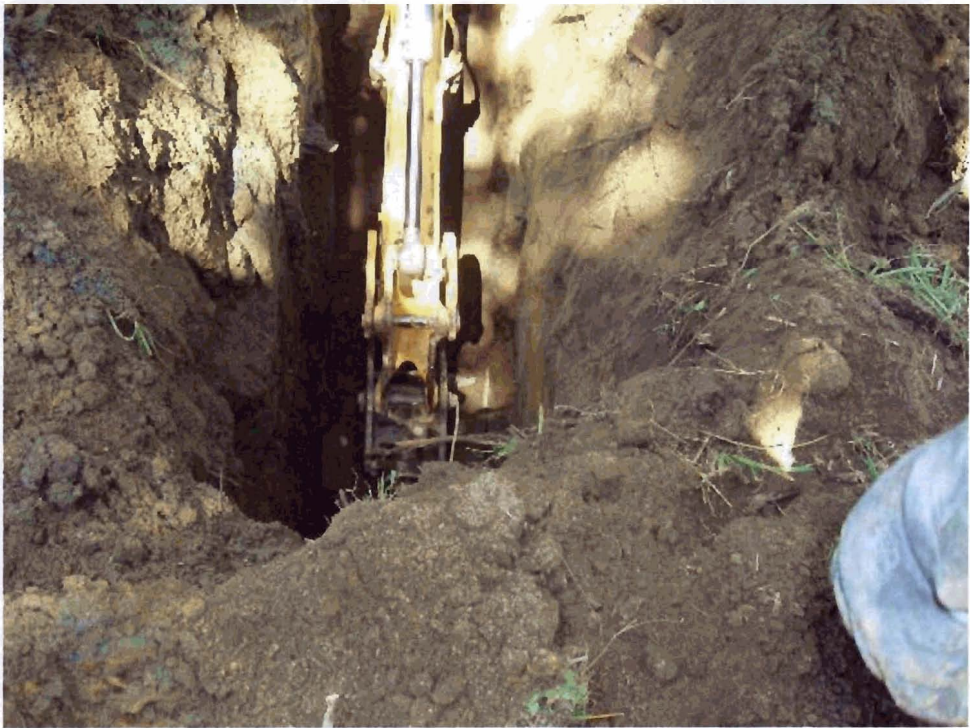
Date: Aug 14, 2007			
Location: TP-9 midway			
Direction: Looking north			
Comments: Excavated to 9 ft. bgs. No additional MGP residual noted.			
Photograph ID: 6

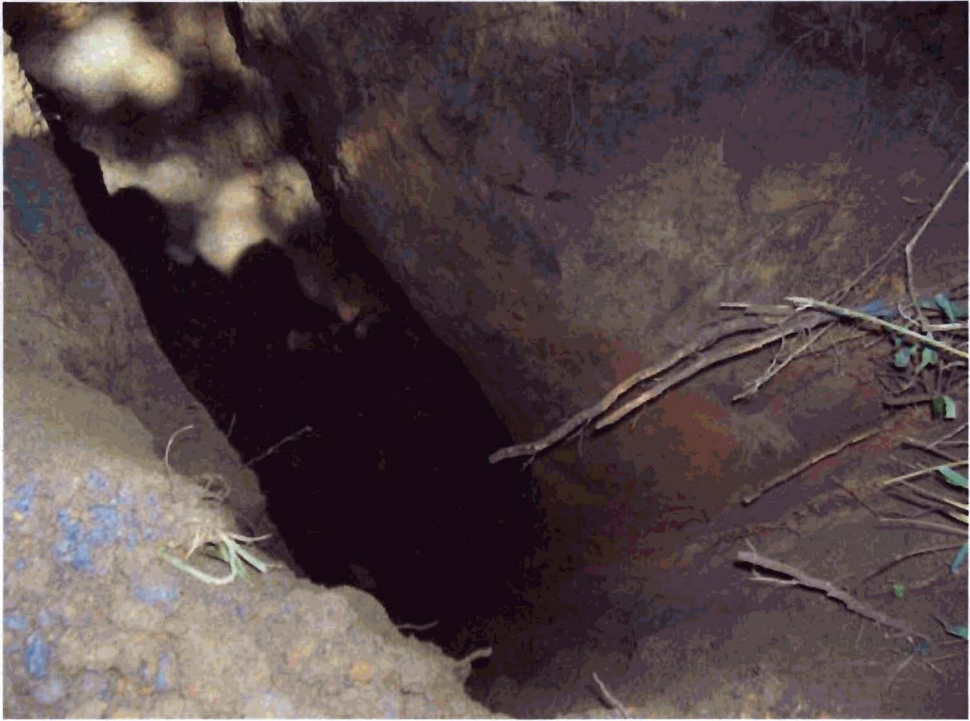
Date: Aug 14, 2007			
Location: TP-9 midway			
Direction: Looking northeast			
Comments: Close up of pocket of bluish colored soils (center of photo) at 5.5 - 6 ft. bgs

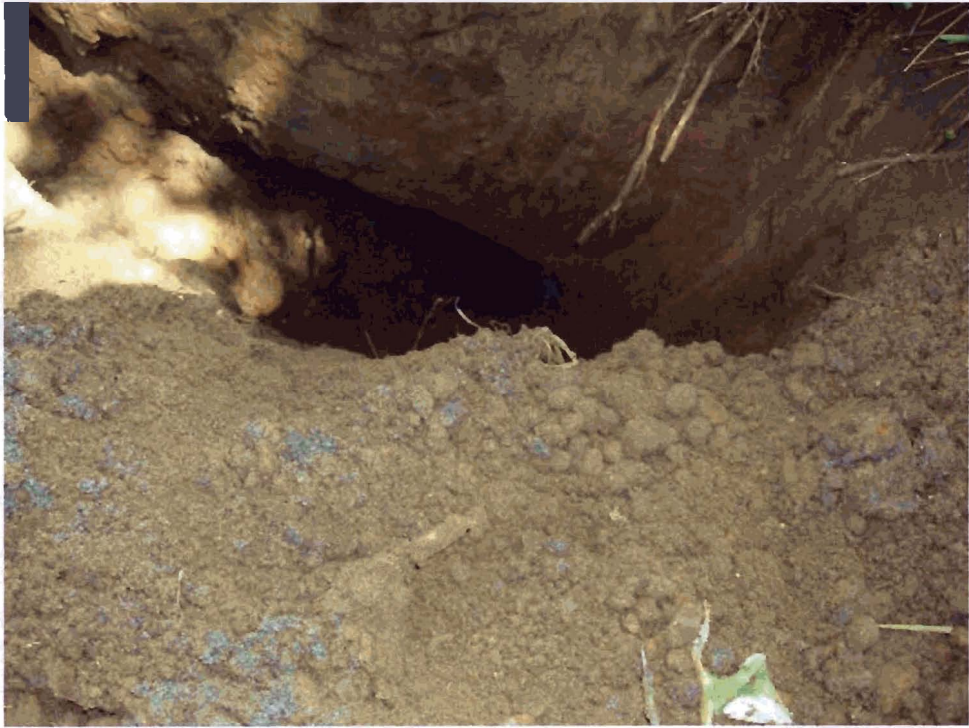
Date: Aug 14, 2007			
Location: TP-9 midway			
Direction: Looking west			
Comments: Close up of pocket of bluish colored soils (center of photo) at 5.5 - 6 ft. bgs			
Photograph ID: 8

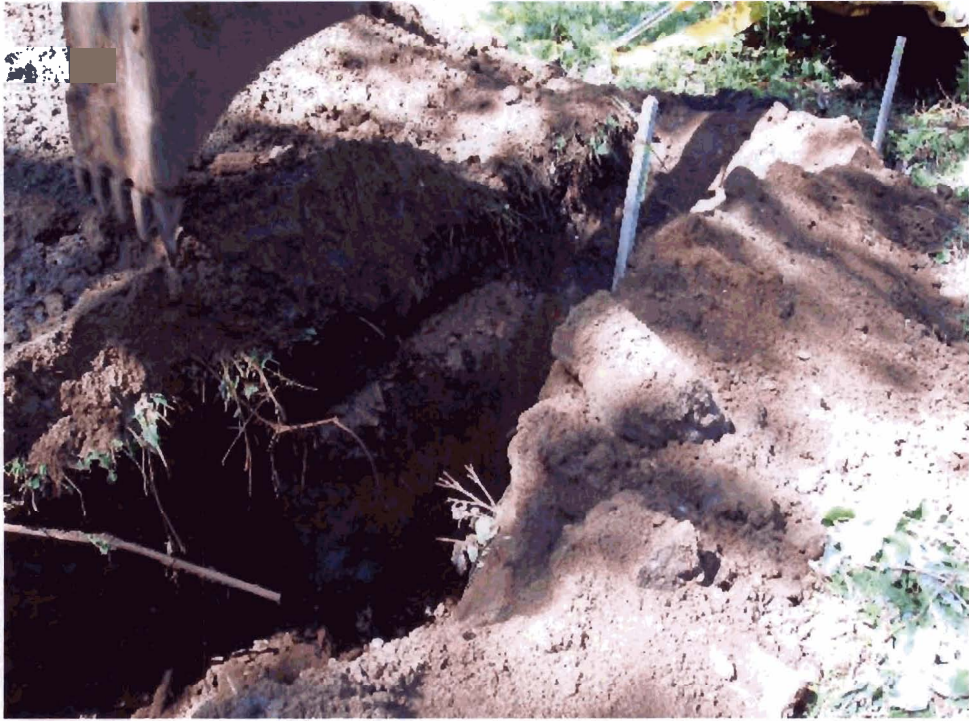
Date: Aug 14, 2007			
Location: TP-9 north end			
Direction: Looking west			
Comments: Ash pocket (center of photo) encountered at 1.5 - 3 ft. bgs

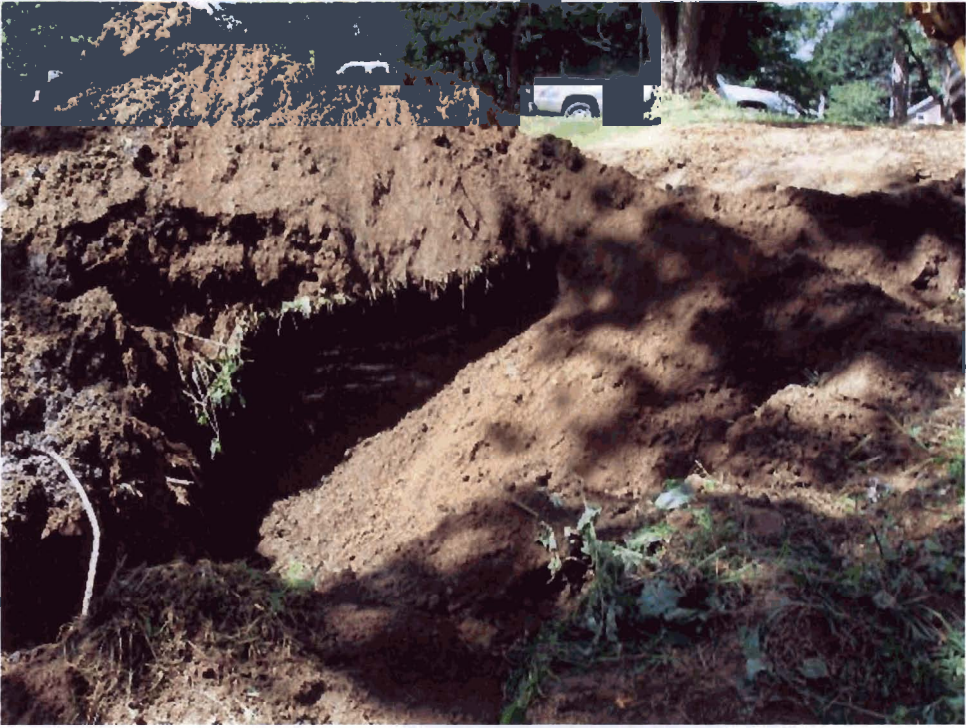
Date: Aug 14, 2007	
Location: TP-9 north end	
Direction: Looking west	
Comments: Ash pocket (white striations at center of photo) encountered at 1.5 - 3 ft. bgs	
Photograph ID: 10

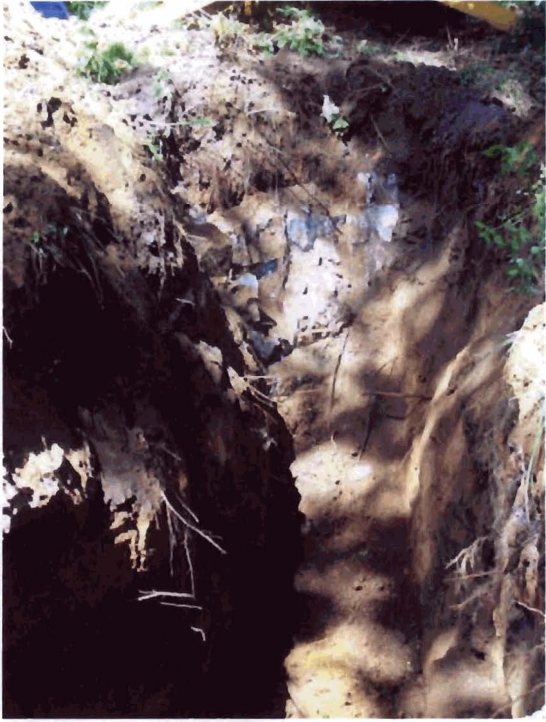
Date: Aug 14, 2007	
Location: TP-9 north end	
Direction: Looking northwest	
Comments: Block structure at endpoint of test point. Did not attempt to advance excavation past this structure.

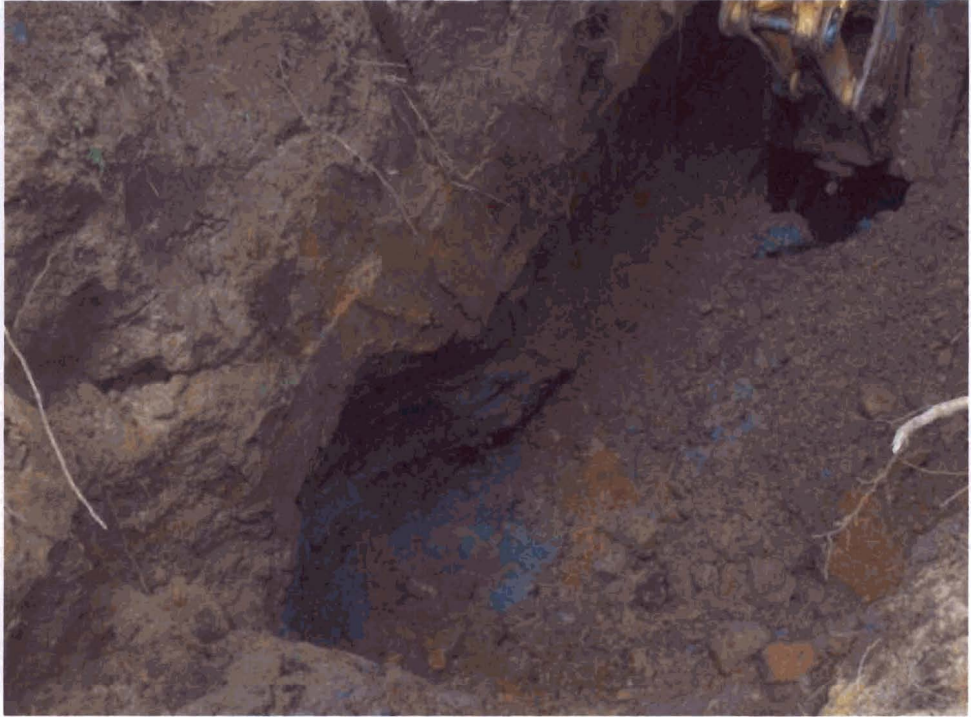
Date: Aug 22, 2007			
Location: TP-10			
Direction: Looking north-northeast			
Comments: Close-up of bluish colored soils at 6 - 6.5 ft. bgs. Excavation opened more, some sloughing of side soils into area.

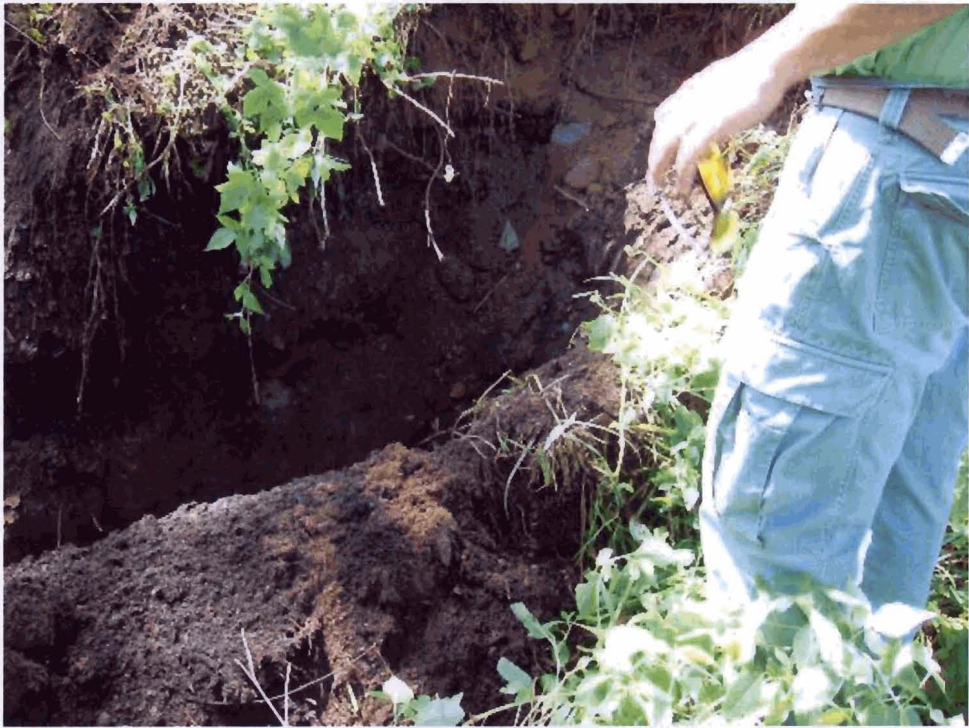
Date: Aug 14, 2007			
Location: TP-11			
Direction: Looking west			
Comments: Pocket of dark colored soils encountered along a clay tile pipe	Photograph ID: 14		
Date: Aug 14, 2007

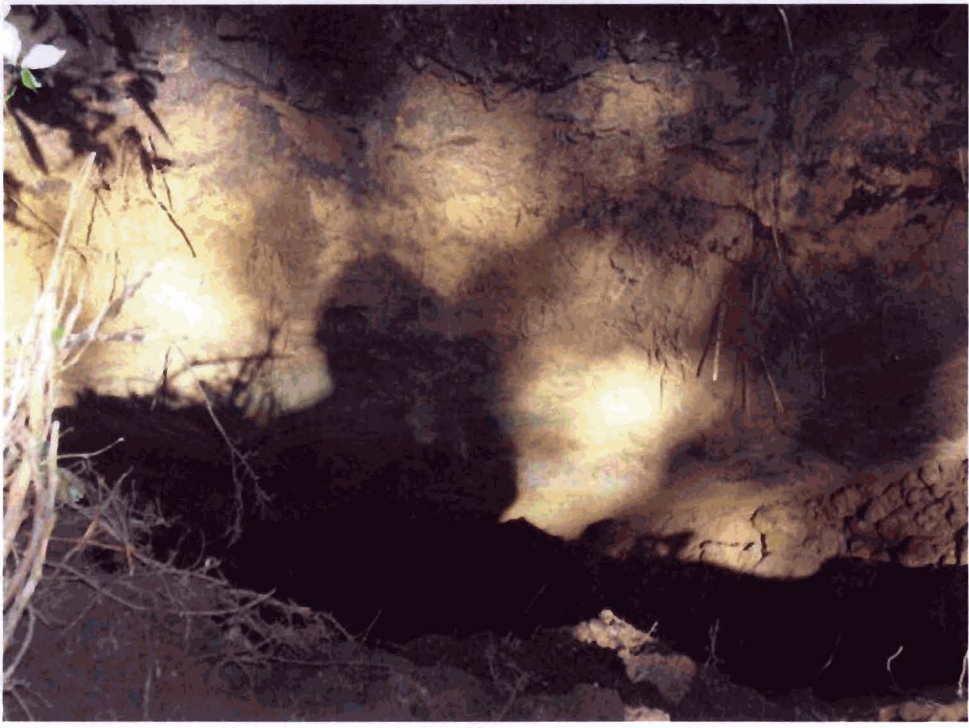
Location: TP-11			
Direction: Looking east			
Comments: Colored soils on eastern wall of test pit opposite clay pipe.

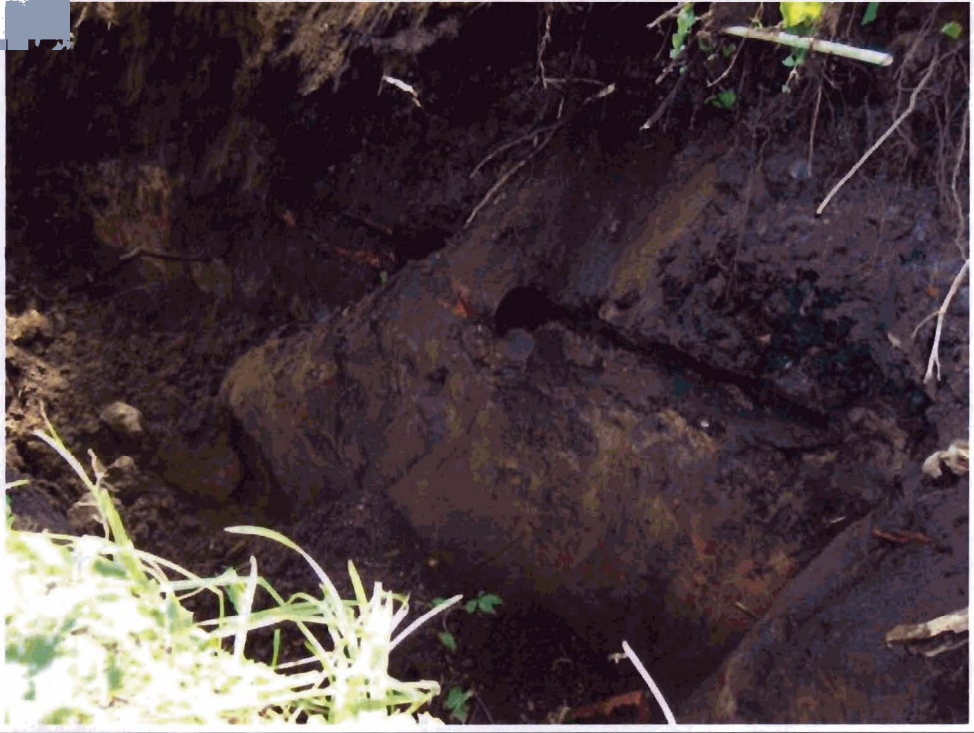
Date: Aug 14, 2007			
Location: TP-11			
Direction: Looking west			
Comments: Clay pipe uncovered during test pit. Colored soils below pipe level. Ash and other fill materials above pipe.			
Photograph ID: 16

As anticipated, soils with a bluish color potentially impacted by MGP residuals were observed near the juncture of TP-9, TP-10, and TP-11. While attempting to determine the extent of these soils to the north of this juncture point, a clay tile pipe was found within TP-11 on August 14, 2007. The tile pipe connected to a steel tank that contained stiff coal tar. An additional location of bluish-colored soils was observed along TP-15 (**Figure 1**). The presence of ash was observed in test pits TP-9, TP-11, TP-13, and TP-14, as shown on **Figure 1**. A steel pipe was unearthed between the former gas house and the location of an underground

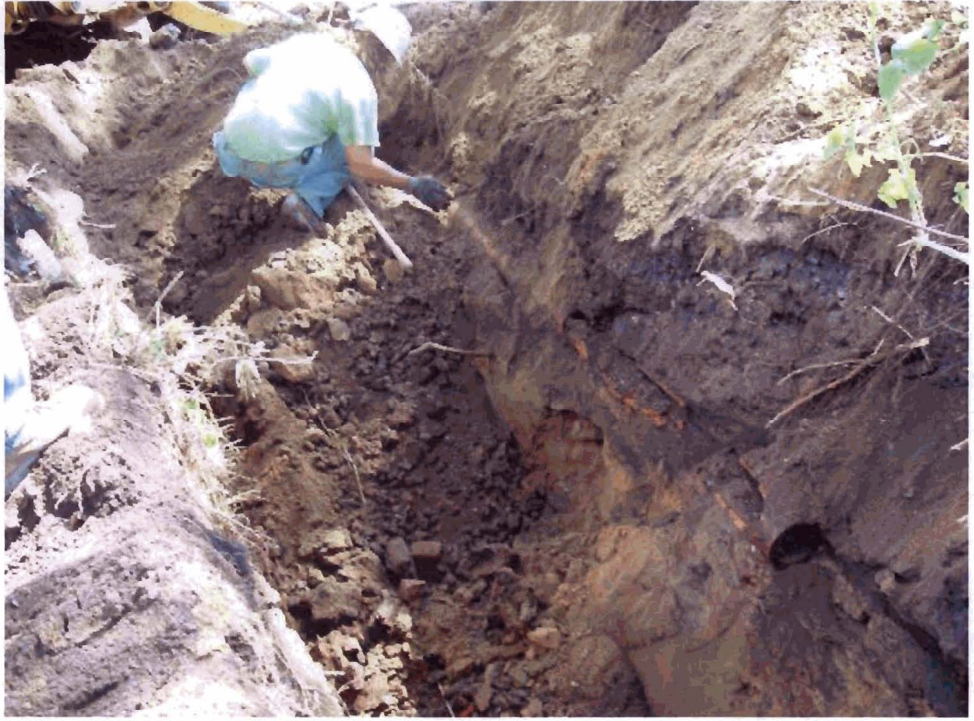
Date: Aug 14, 2007			
Location: TP-11			
Direction: Looking south			
Comments: Extent of clay tile pipe excavated, terminating near junction point of TP-5, TP-6, and TP-9.

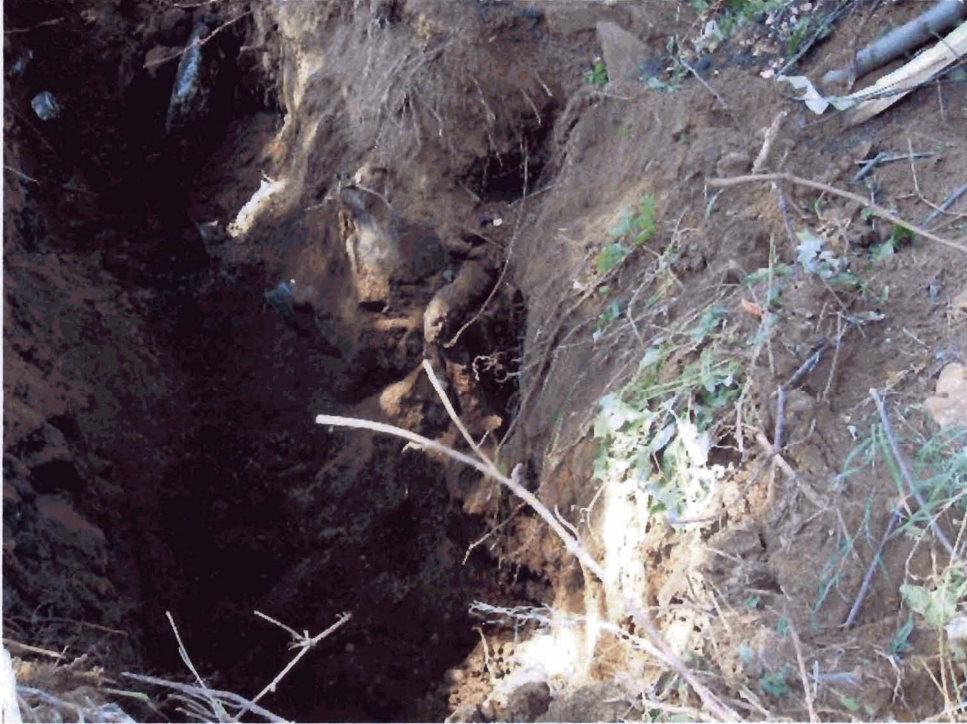
<p>Photograph ID: 17</p> <p>Date: Aug 14, 2007</p> <p>Location: TP-11</p> <p>Direction: Looking north</p> <p>Comments: Pipe (center of photo) connecting a metal drum or tank to the clay tile pipe. The metal structure was found to contain solid tar-like material.</p>

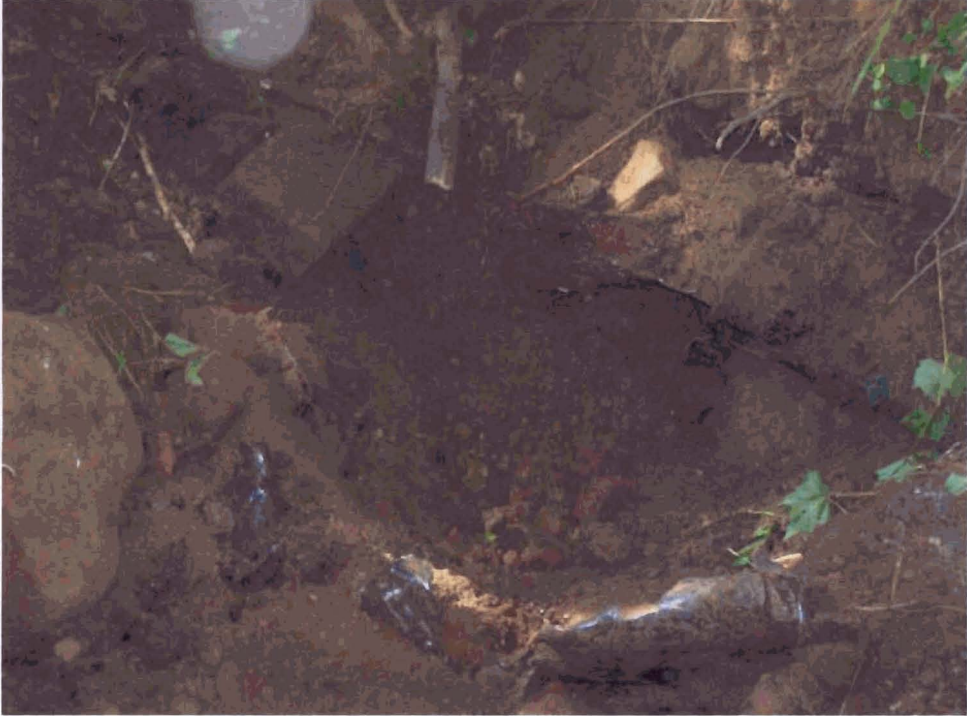
<p>Photograph ID: 18</p> <p>Date: Aug 14, 2007</p> <p>Location: TP-11</p> <p>Direction: Looking north</p> <p>Comments: Metal drum or tank structure at north end of TP-11. Thin metal construction with debris and tar-like material as fill in center.</p>

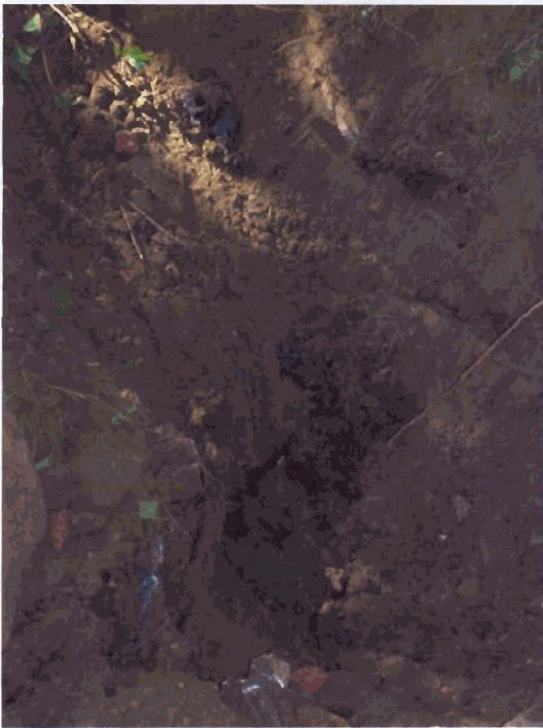
Date: Aug 14, 2007			
Location: TP-11			
Direction: Looking northwest			
Comments: Eastern edge of drum or tank structure.			
Photograph ID: 20

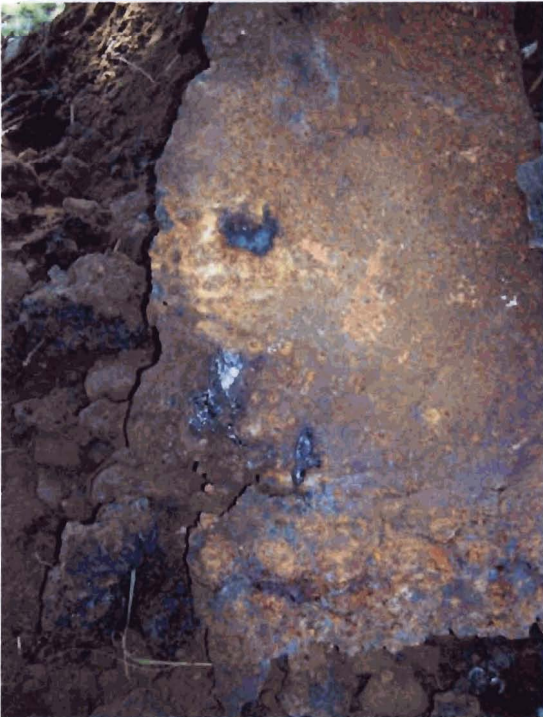
Date: Aug 14, 2007			
Location: TP-11			
Direction: Looking west			
Comments: Top piece or roof of metal drum or tank structure of thin metal, riveted construction. Viscous tar-like material sticking to metal piece.

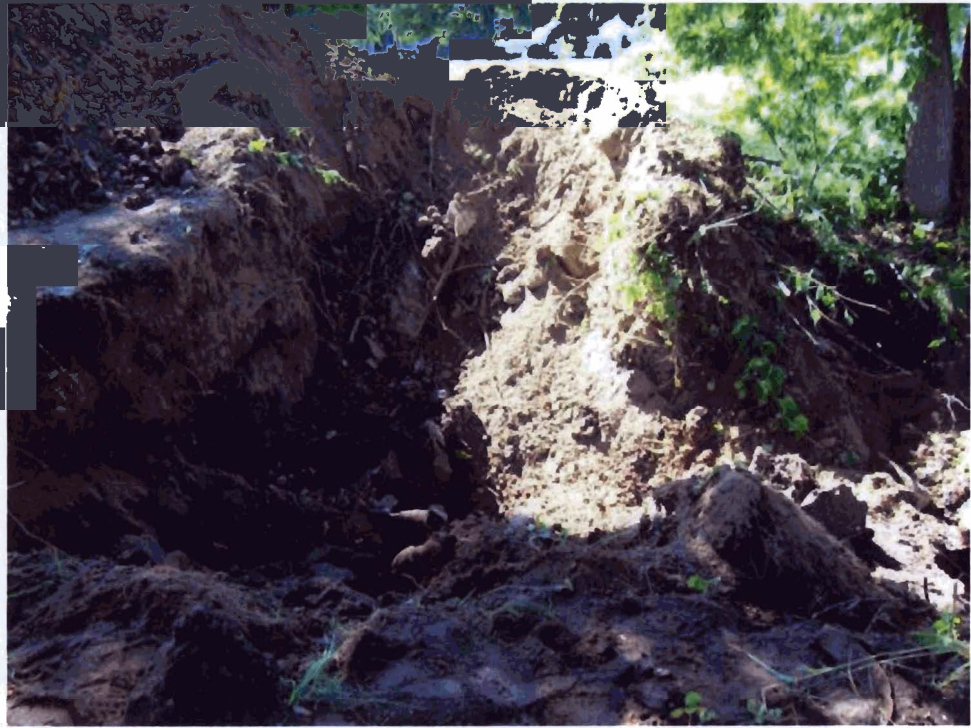
Date: Aug 14, 2007	
Location: TP-11	
Direction: Looking west	
Comments: Eastern edge of slope excavated to uncover metal drum or tank structure.	
Photograph ID: 24

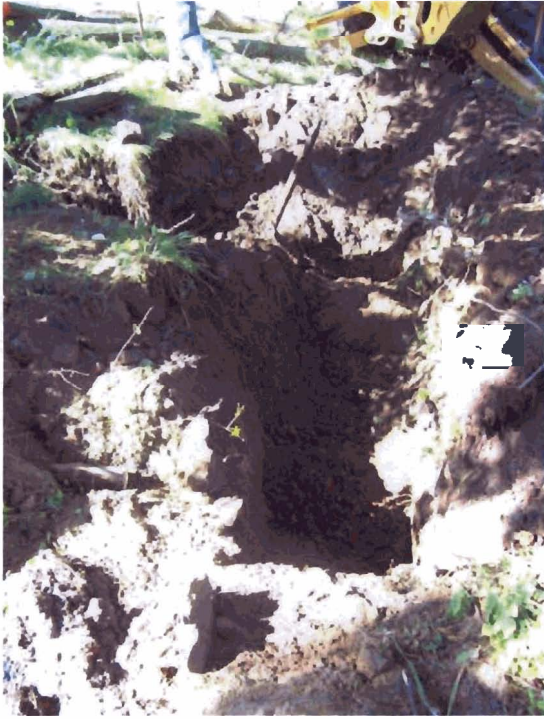
Date: Aug 14, 2007	
Location: TP-12	
Direction: Looking north	
Comments: Test pit opened along toe of slope from former building foundation. Additional structures and piping discovered.

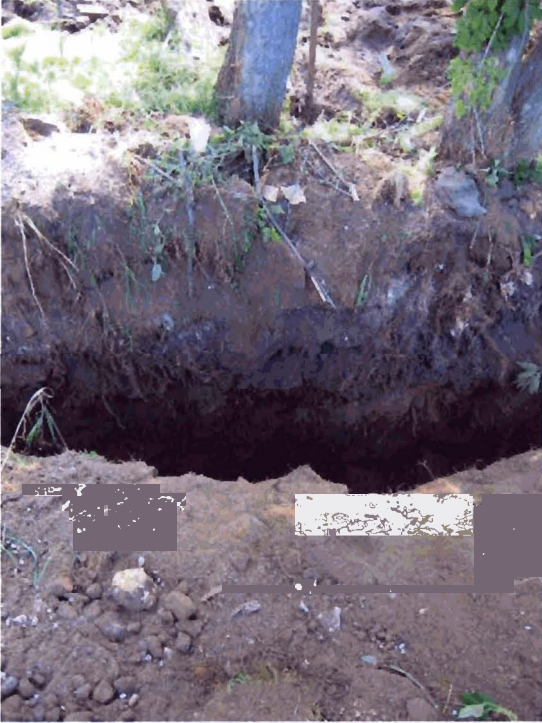
Date: Aug 15, 2007			
Location: TP-13			
Direction: East			
Comments: Ash and coal in the top 3 ft. of TP-13. This ash layer pinches out 18 ft. to the south.			
Photograph ID: 6

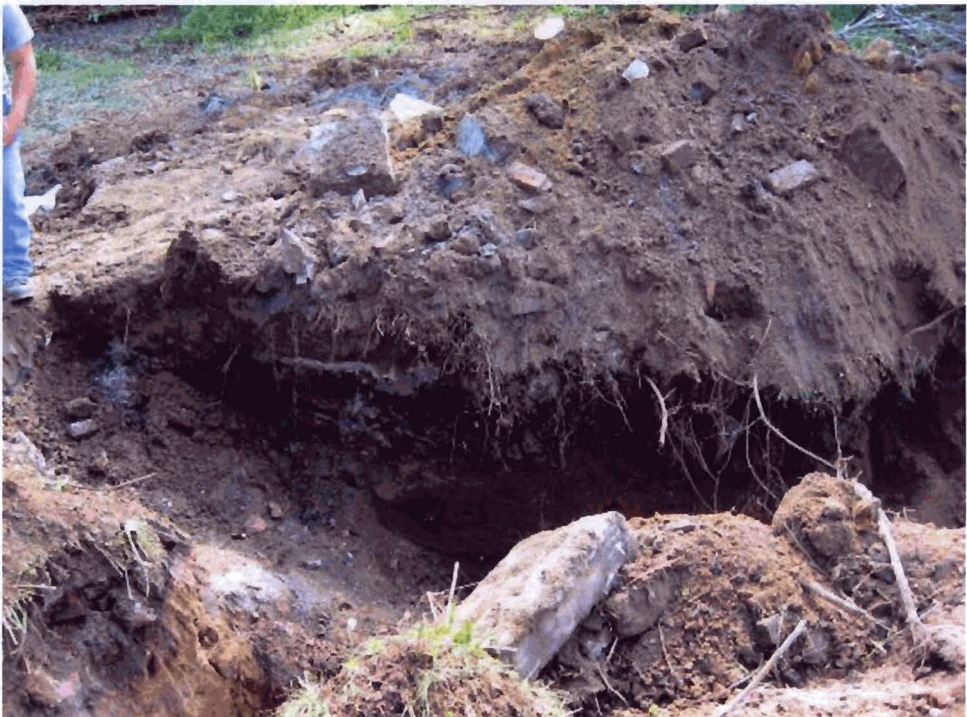
Date: Aug 15, 2007			
Location: TP-14			
Direction: West			
Comments: Start of TP-15, ash and other fill in the top 1.5 ft. to 2 ft. of the excavation.

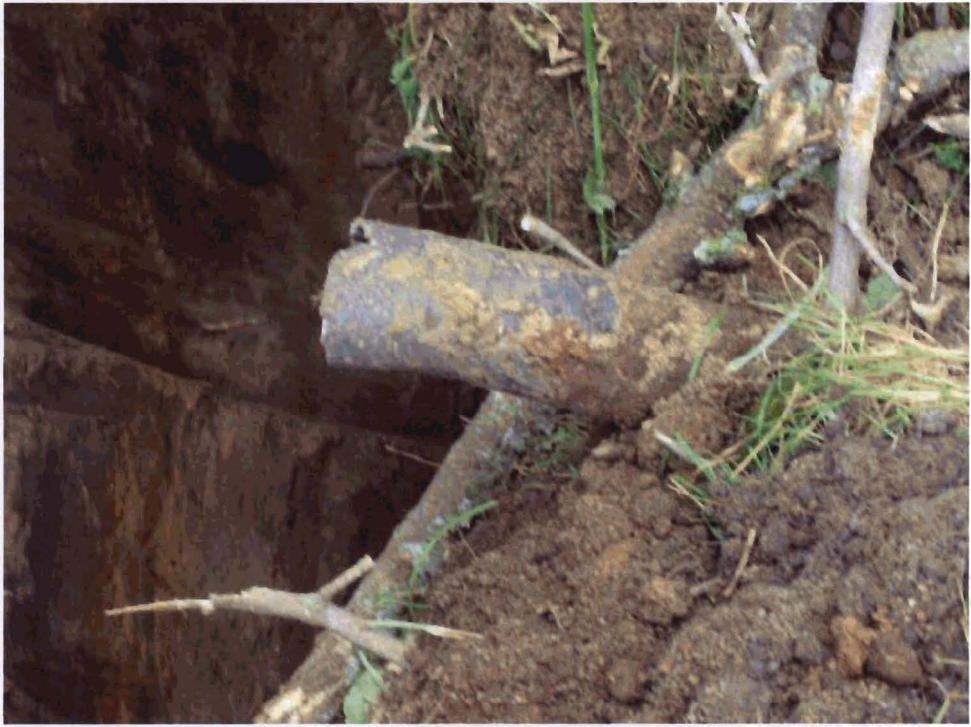
Date: Aug 15, 2007			
Location: TP-15			
Direction: North			
Comments: Metal pipe found in TP-15 headed in the direction of the unknown structure			
Photograph ID: 10

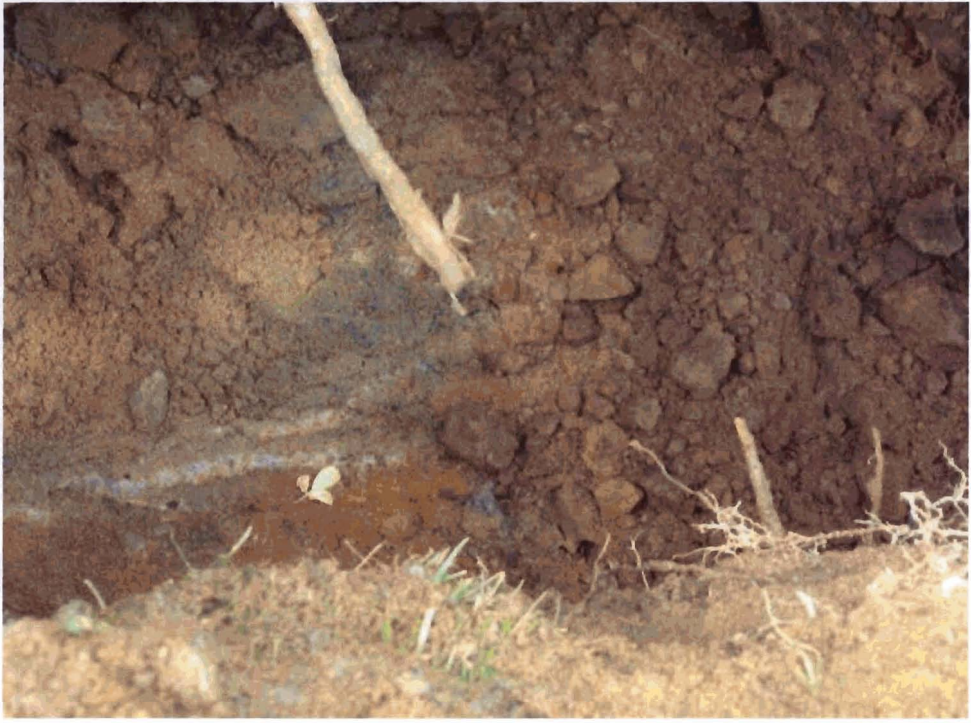
Date: Aug 15, 2007			
Location: TP-15			
Direction: North			
Comments: Blue soil 6.5 ft bgs in a pocket of soil 7 to 12 feet east of the start of TP-15.
