**Re:** Sediment and Seep Sampling Report  
Watertown (Anthony St.) Non-Owned Former MGP  
Site # V004736  
Watertown, Jefferson County

This letter presents the results of additional work conducted to support the Remedial Investigation (RI) at National Grid's Anthony Street Non-Owned Former Manufactured Gas Plant (MGP) site located on J.B. Place in Watertown, New York. The additional work was completed by ARCADIS on behalf of National Grid in general accordance with the following communications and correspondence:

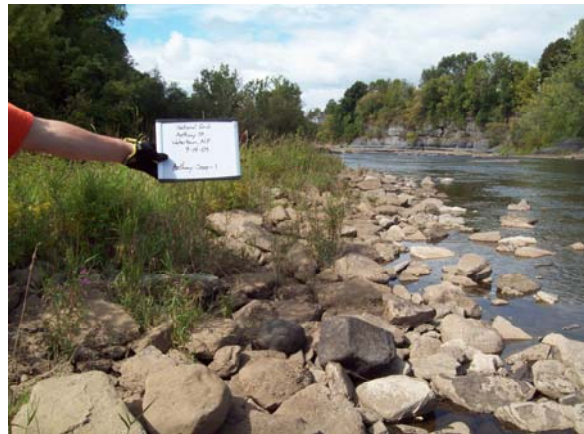
Sediment probing was conducted prior to sampling along the waters edge from approximately 75 feet downstream from the rafting building to the first set of downstream rapids (approximately 500 feet downstream from the ARO building). The purpose of the probing was to determine locations of soft sediment that could be targeted for sampling. The results of the probing suggest that the river in this area runs on bedrock and the river bottom is void of substantial “sampleable” sediment. The findings of the sediment probing were discussed in the field with the NYSDEC, and the NYSDEC agreed to sample the first downstream depositional area along the south shore of the river. A sand, gravel, and cobble deposit located along the south shore of the river approximately 1,000 feet downstream from the ARO building, and immediately downstream from the “beer caves”, was identified by the NYSDEC and ARCADIS as the first depositional area downstream from the site (seen in the photo to the right). The depositional area extended approximately 150 feet along the rivers edge and extended into the river approximately 40 feet at its widest point. Sediment samples were collected from this depositional area, as follows:

- SED-1 - upstream edge, coinciding with the location of a seep (where SEEP-1 was collected as discussed later);
- SED-2 – downstream edge of depositional area; and
- SED-3 - midpoint of depositional area.

Sediment samples were collected using stainless steel trowels as heavy gravel and cobble armoring prevented the use of core or dredge type samplers.

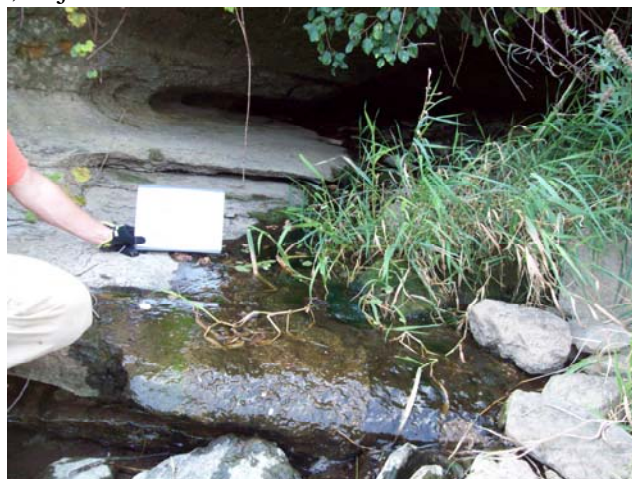
Due to the relatively dry period on the first day of sampling, only one seep sample (SEEP-1) was collected on September 14, 2009 (shown in the photo to the right). As previously mentioned SEEP-1 was located at the upstream edge of the sediment depositional area and in the general vicinity of the beer caves. The seep appeared to be flowing from a solution widened horizontal fracture at the base of the rock face, just above the water's edge. The seep flow rate was estimated to be approximately 1 to 2 liters per minute. The seep sample was collected using a peristaltic pump and disposable polyethylene tubing.

Table 2 summarizes the VOCs, SVOCs, and total cyanide detected in seep samples SEEP-1 through SEEP-4. As shown in Table 2, constituents were not detected in seep samples SEEP-2, SEEP-3, and SEEP-4 and only trace amounts of VOCs were detected in seep sample SEEP-1. None of the VOCs detected in SEEP-1 are known to be related to MGP sites. As such, it does not appear that the MGP is affecting the quality of groundwater seeping from the riverbank adjacent to the site.

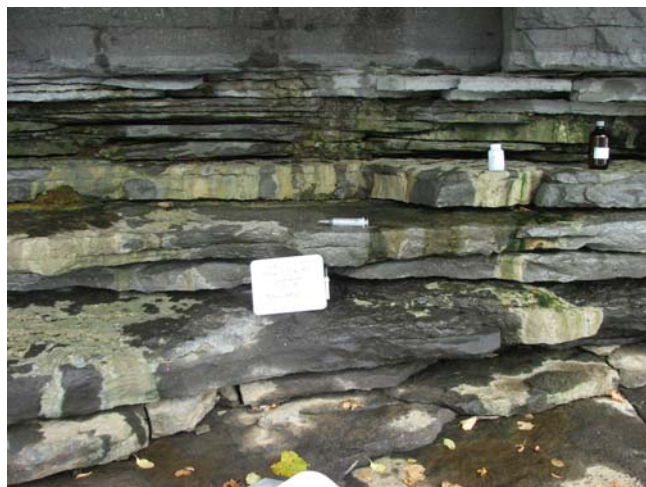
seeps [SEEP-2 (seen in the photo to the left) and SEEP-3] along the Black River rock face adjacent the site. The locations of these seep samples are shown on Figure 2. Only a small amount of water was observed to flow from both of these seep locations. As such, ARCADIS used disposable, laboratory-grade syringes to collect the samples from water puddling on the rock surface.
