Re: Remedial Investigation Interim Data Summary  
Ogdensburg (King Street) Non-Owned Former MGP Site  
Ogdensburg, New York  
Site # V00479-6

This letter presents an interim data summary report of Remedial Investigation (RI) work completed to date at National Grid's non-owned former manufactured gas plant (MGP) site (the "site") located on King Street in Ogdensburg, New York. The RI activities were initiated by National Grid in January 2006 and continued through October 2006. Based on the results presented herein, National Grid recognizes that additional RI work will be required at this site. As such, we are providing this interim summary to the New York State Department of Environmental Conservation (NYSDEC) in advance of a proposed meeting between National Grid and NYSDEC. The purpose of this meeting would be to discuss potential data gaps and potential additional investigations to complete the RI. A brief summary of the RI data collected so far is provided below.

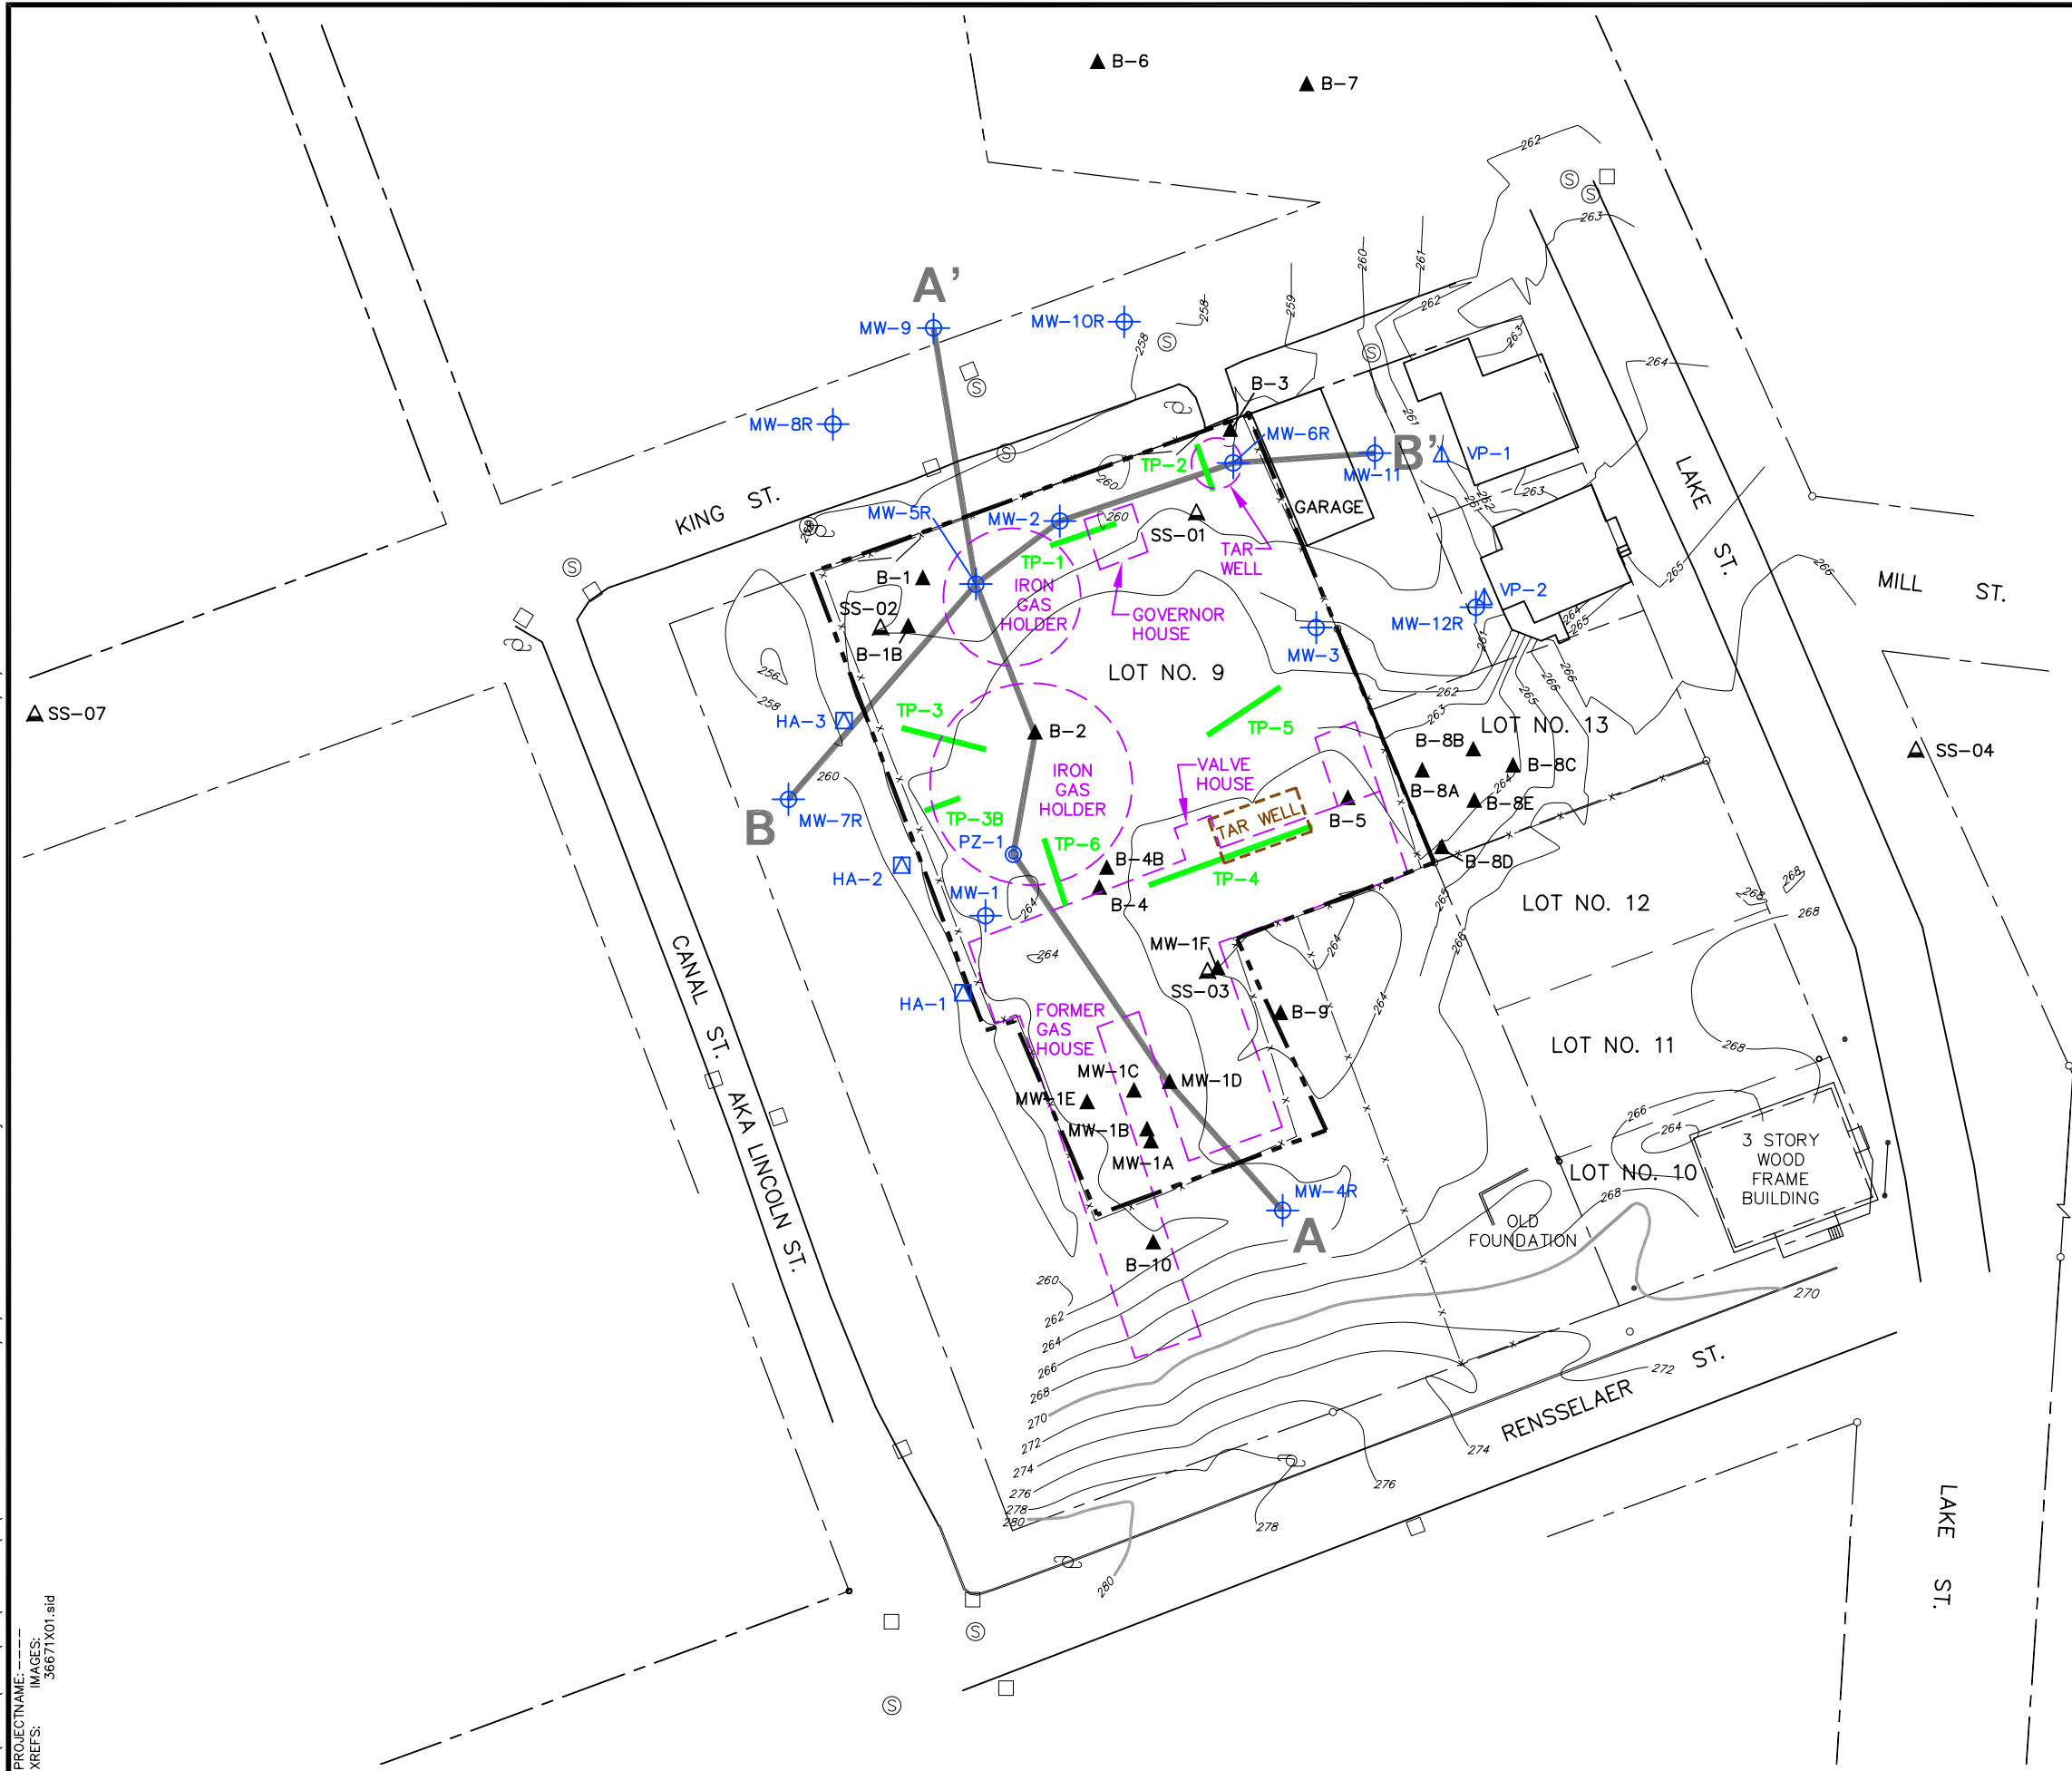
FIGURE  
1

The findings of the RI fieldwork are summarized below in terms of the media investigated. The RI investigation locations are shown on Figure 1.

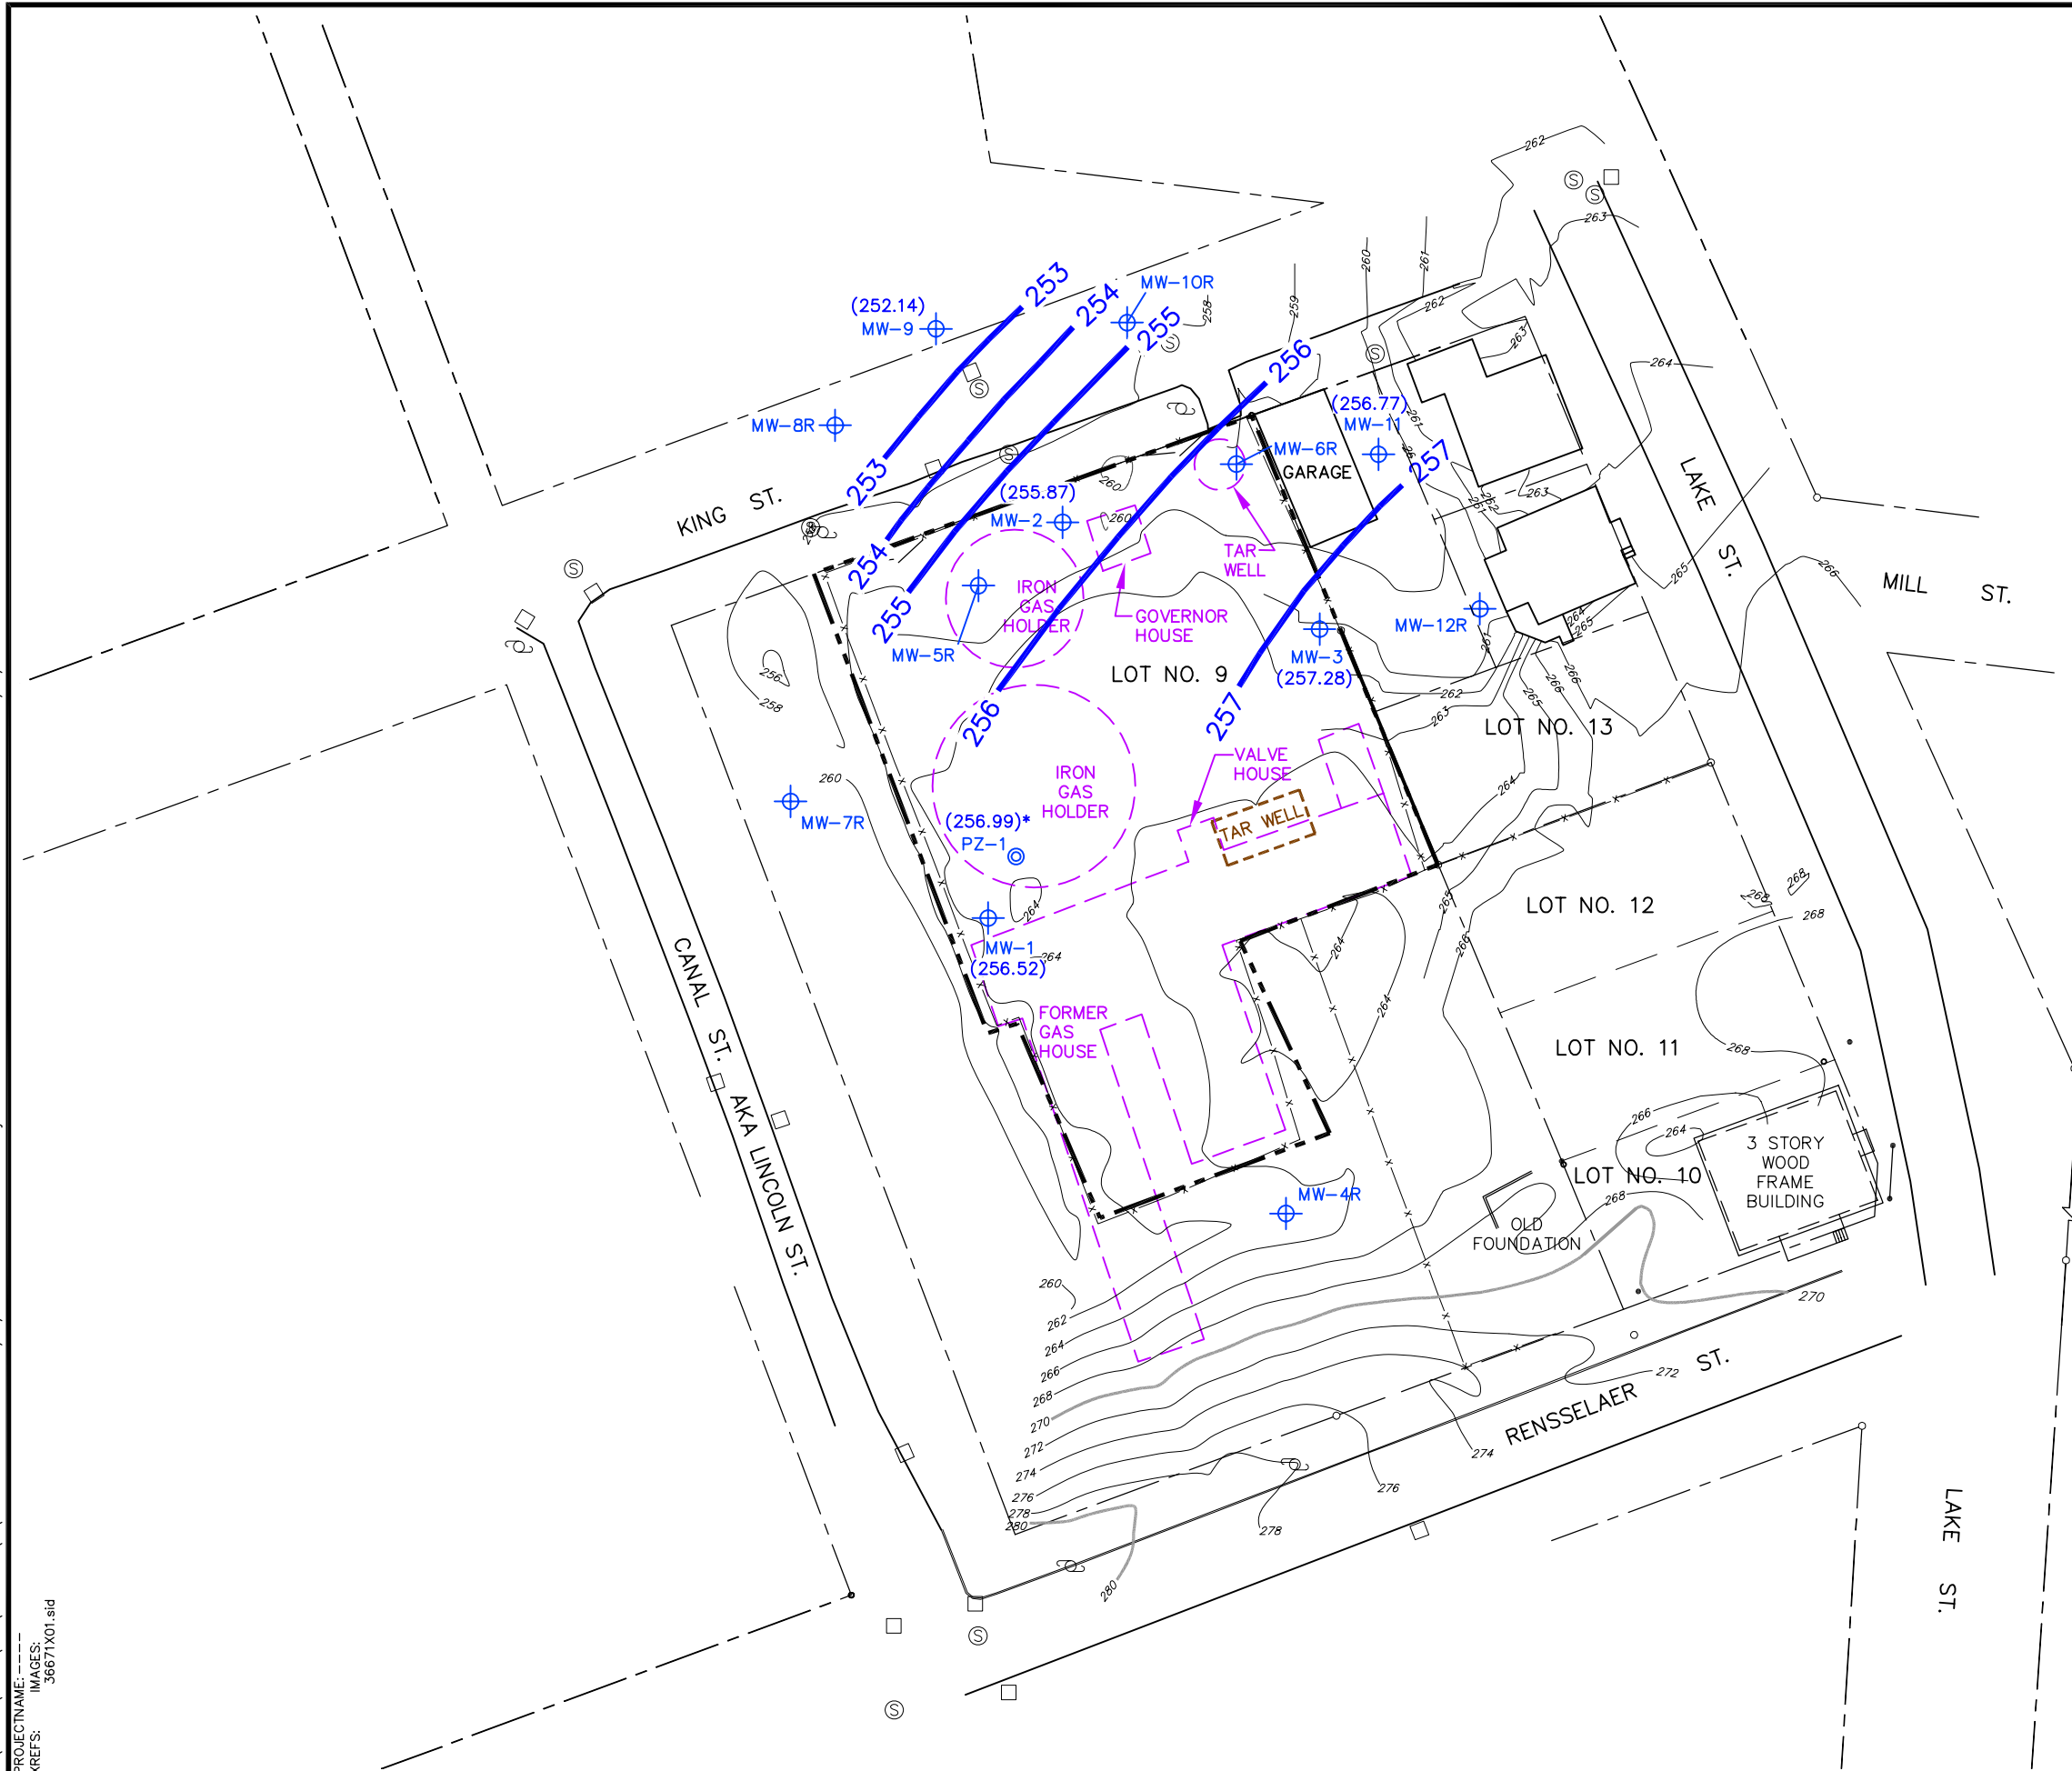
| <br>an ARCADIS company | FIGURE<br>3 |

Groundwater levels were measured in site monitoring wells on June 12, 2006 and October 2, 2006. The water-level measurements and converted water elevations are provided in Table 4. The October 2, 2006 round of water levels was used to prepare the water table and shallow bedrock potentiometric elevation maps presented on Figures 3 and 4. Water levels observed in piezometer

The onsite overburden groundwater exists in a relatively thin saturated zone of unconsolidated material. The saturated thickness of the soils on and around the site is approximately 2 to 6 feet where measured; however, due to the apparent excavation of bedrock in the area of the former holder, the saturated thickness of soils inside the holder is approximately 11 feet. As shown on Figure 3, overburden groundwater moves northwest in the direction of the St. Lawrence River. Overburden groundwater is derived from infiltration of precipitation falling on site and from groundwater flow onto the site from the southeast. Some of this groundwater likely moves downward into the shallow bedrock, at least during seasonally wet periods. Downward and upward vertical gradients are observed in areas where overburden wells and bedrock wells are in close proximity, as follows: MW-2 and MW-5R: upward; MW-3 and MW-12R: downward; MW-11 and MW-6R: downward; and MW-9 and MW-8R/MW-10R: upward.
