Remedial Investigation Report

Former Manufactured Gas Plant Site
King Street, Ogdensburg, New York

DRAFT
Remedial Investigation Report

Former Manufactured Gas Plant
Site, King Street, Ogdensburg,
New York

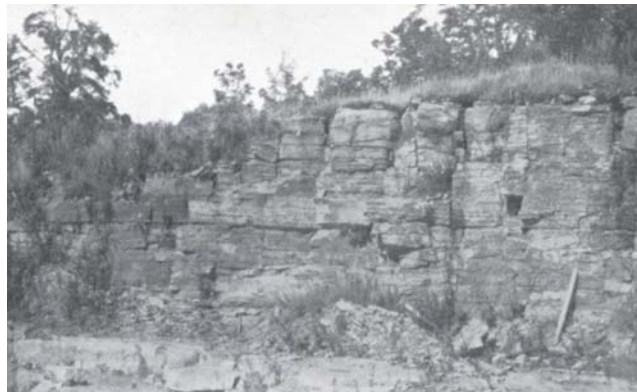
Figure 3.1: Quarry Face in Ogdensburg Dolostone

The Ogdensburg Formation is present at or near the ground surface from Ogdensburg southwest toward Morristown and northeast beyond Hogansburg and into Canada. Bedrock exposures are sparse in the vicinity of Ogdensburg due to the generally low topographic relief and veneer of till and marine/lacustrine clay overburden. At Hogansburg, located northeast of Ogdensburg, the St. Regis River Valley provides excellent exposures of the Ogdensburg Dolostone. In the riverbed, the thick-bedded dolostone contains hard chert lenses that weather in relief.

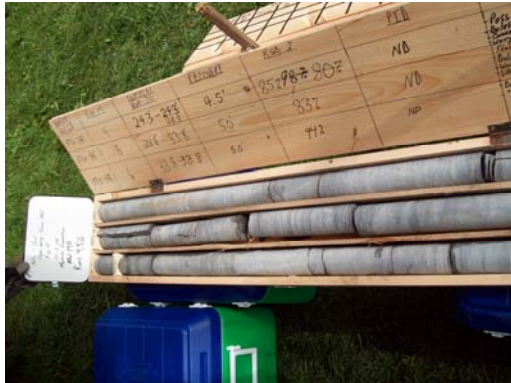
Figure 3.3: Bedrock Core Retrieved from MW-19R (24.3 to 38.8 feet below grade)

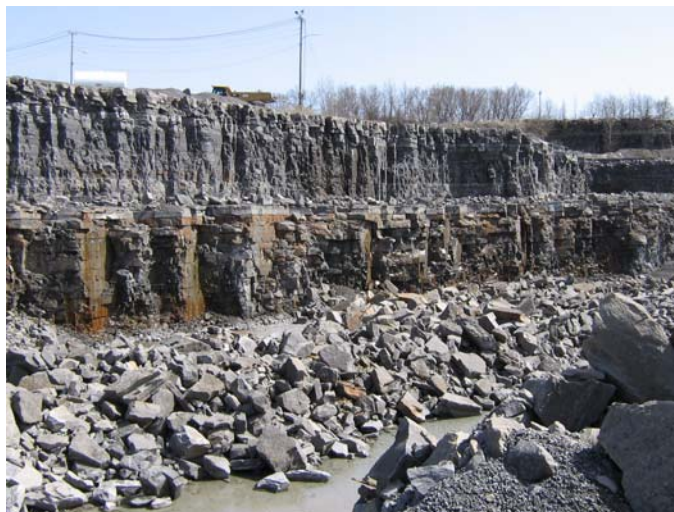
Figure 3.4: Hanson Quarry; notice near vertical joint sets.

Very few vertical bedrock fractures (joints) were observed in the rock cores collected during the RI; however, based on outcrop observations, vertical jointing is prevalent in the Ogdensburg Formation. Observations made in the nearby Hanson Quarry, indicate that the joints in the Ogdensburg formation are near vertical and are generally spaced 5 to 10 feet apart. Joints observed in the quarry were usually confined vertically to a particular section of bedrock – that is, a joint could extend through 10 to 20 feet of rock, and then terminate above or below a more competent section of rock.

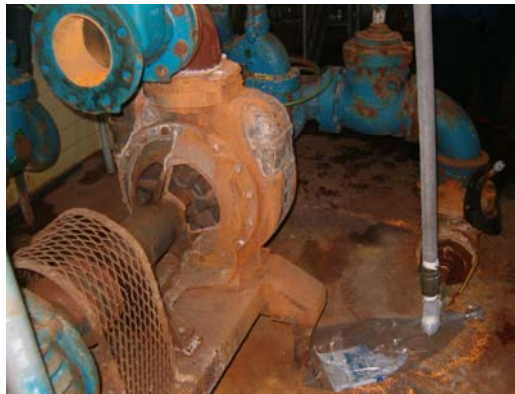
Figure 3.5: PW-1

- This well is located inside the northern portion of the plant (Figure 2).
- The well casing sticks up approximately 2-feet above the concrete floor.
- The well casing appears to be steel and approximately 10 to 12-inches diameter.
- The well casing is rusted and is connected to a pump located on the floor adjacent to the well.
- The electricity to the pump has apparently been disconnected and the pump is no longer connected to the process piping.
- An approximately 2-inch diameter galvanized steel pipe is connected to the well head; the pipe extends approximately 10 to 15 feet straight up toward the ceiling, then takes a 90-degree bend; it is unknown where the pipe leads.

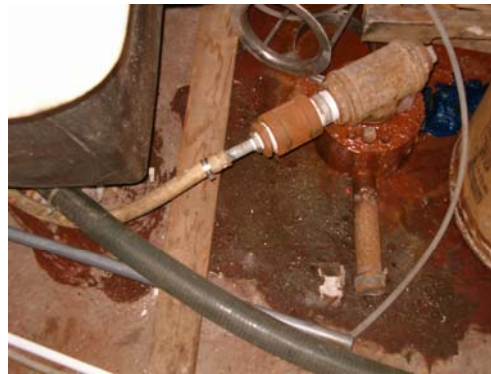
Figure 3.6: PW-2

- This well is located near the southwestern corner of the facility, approximately 100 feet northwest of the site.
- The well casing sticks up approximately 4-inches above the concrete floor.
- The well casing appears to be steel and approximately 8 to 10-inches diameter.
- The well casing is rusted and is capped with a bolted-on cover.

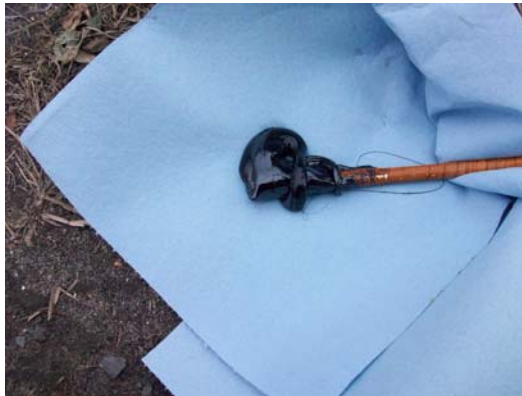
- The NAPL observed at most investigation locations is dark brown to black in color, highly viscous and exhibits a distinct naphthalene-like odor. These characteristics are typical for coal tar.
- The majority of NAPL-containing soil/bedrock occurs below the water table, indicating that the NAPL is denser than water.
- Of the wells that screen across NAPL-containing soils or bedrock fractures (MW-1, MW-6R, MW-7R, MW-8R), NAPL has accumulated in one well (MW-8R). The NAPL in this well accumulates in the bottom of the well, indicating that the NAPL is a DNAPL.

Figure 3.7: Tar recovered from MW-8R
