**ANNUAL SITE MANAGEMENT REPORT
FROM AUGUST 2010 TO MARCH 2012
METROPOLITAN AVENUE CAMPUS (Q686)
91-30 METROPOLITAN AVENUE
FOREST HILLS, NY
VCP AGREEMENT # V-00500**

Date of Issue: March 19, 2012

ATC Associates Inc. Project No. 015.19125.1354

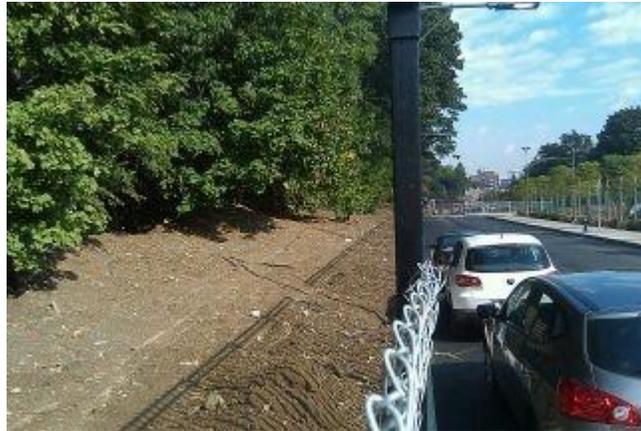
- 9:30 AM Shaw on site.
- I arrived on site and inspected the blower unit behind the school building. The blower unit was operating.
- An on/off switch was installed on the outside of the unit and there was also a green light display indicating that the blower unit was operating without problems.
- Along the walk to Metropolitan Avenue, I noticed large amounts of soil had been moved to the other side of the driveway fencing, towards the railroad tracks. The soil appeared to excess soils from the site and it filled the entire swale that use to run across this property. The approximate depth appeared to be 4' to 6' and the width appeared to extend approximately 10' horizontally. We are concerned that this soil may have been piled on monitoring well SCA-7. Mike Sherwood discussed this issue to Al Daub and asked him address it with Contractor ASAP.
- Picture of the soil is shown below:

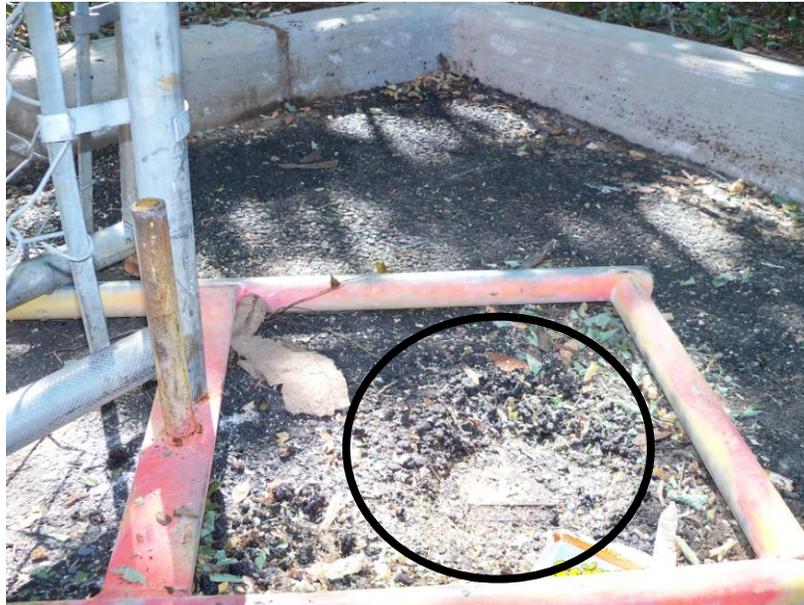
- 11:45 AM Shaw on site.
- I arrived on site and inspected the blower unit behind the school building. The blower unit was operating.
- The on/off switch was on and there was also a green light display indicating that the blower unit was operating without problems.
- I looked at monitoring well SCA-8A in the pavement near the blower unit. The monitoring well had been partial paved over and appeared to be capped approximately 2 inches below the pavement.
- Al Daub was informed of this monitoring well and was also asked to address the backfill placed over the fence near the railroad tracks with Contractor ASAP. It appears that this soil pile has covered over monitoring well SCA-7.
- Picture of monitoring well SCA-8A is shown below:

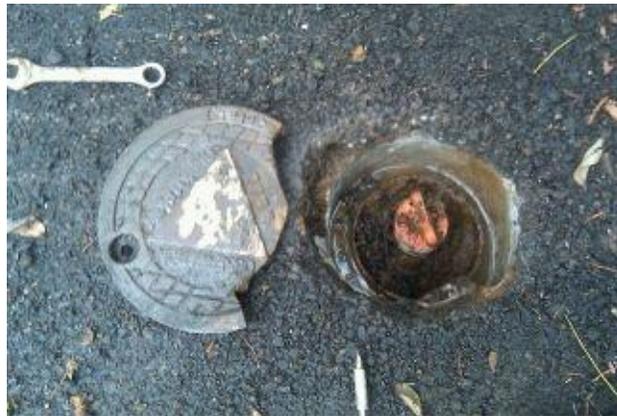
- As I removed the asphalt around the manhole, I began to realize the cover was broken. I continued to remove asphalt until I could lift the cover off.

- Once I got the cover off, I realized there was no housing installed on top of the casing for the manhole cover to sit in. Also, the paving contractor had allowed asphalt to fall inside the casing around the PVC pipe. I cleaned out the monitoring port as best as possible with my tools. See the picture below:

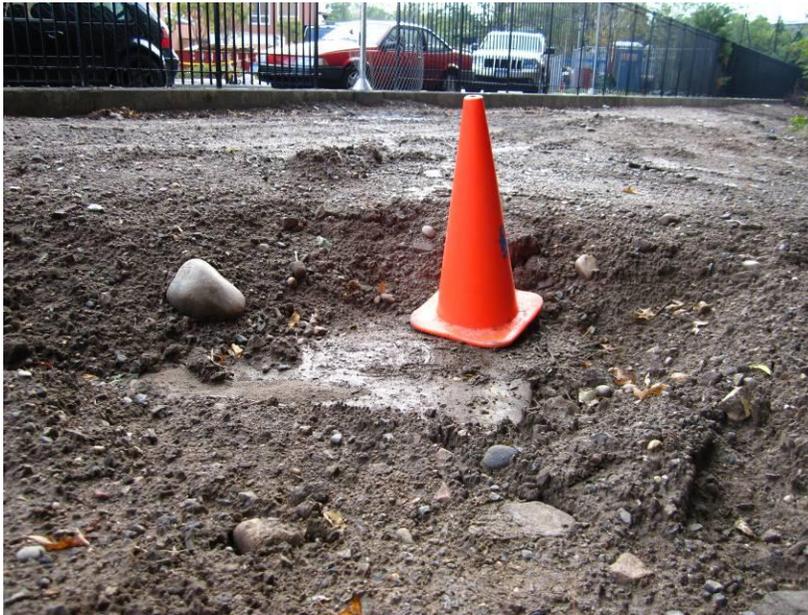
- 9:00 AM Shaw on site.
- I arrived on site and inspected the blower unit behind the school building. The blower unit was operating properly. The green light indicating normal performance was on.
- I inspected monitoring well SCA-8A in the parking area near the blower unit. No changes had been made to the condition on the monitoring well.
- I walked over to the approximate location of monitoring well SCA-7 which was been previously backfilled over. When I reached the location, I noticed that the contractor had dug down and found this monitoring well. The top cover was exposed and had a construction cone next to it, see the picture below:

- I did not have my tools with me today so I was unable to open the cover. However, the cover and casing appeared to be in good condition, just dirty from the soil cover.
- On the next inspection, I will open this monitoring well and recheck the status of the SCA-8A.
- 9:30 AM Shaw off site.

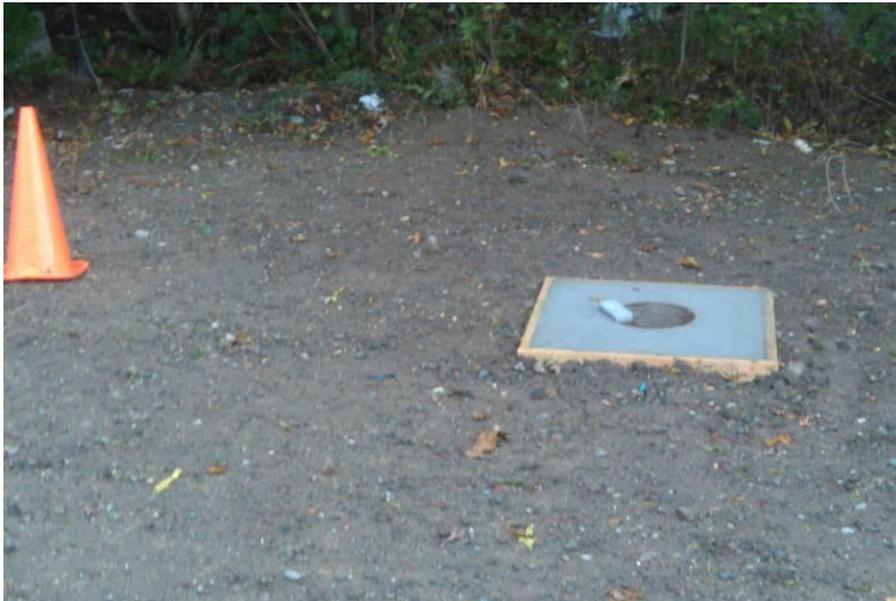
- 8:45 AM Shaw on site.
- I arrived on site and inspected the blower unit behind the school building. The blower unit was operating properly. The green light indicating normal performance was on.
- I inspected monitoring well SCA-8A in the parking area near the blower unit. No changes had been made to the condition on the monitoring well.
- I walked over to the approximate location of monitoring well SCA-7 which was previously found beneath backfill on my last inspection. When I reached the location, I noticed that the contractor adjusted the manhole to meet the new grade. I did not access the new encased manhole as the surrounding soils were saturated. See the picture below:

- On the next inspection, I will try to open this monitoring well SCA-7 and recheck the status of SCA-8A.
- I spoke with Al Daub before leaving the site who informed me that the BMS system was still very early in the process of being completed.
- 9:15 AM Shaw off site.

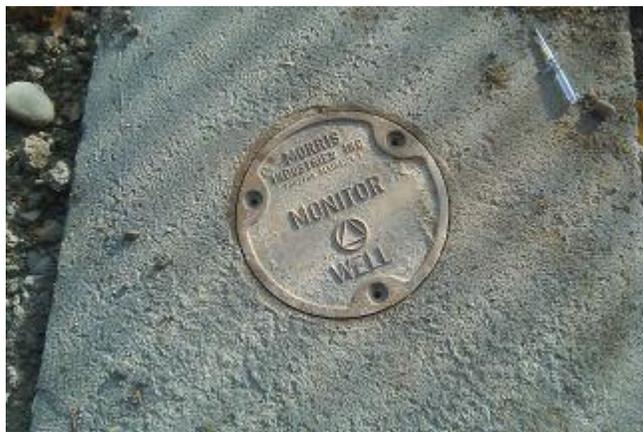
Top of cover:

- 8:45 AM Shaw on site.
- I arrived on site and inspected the blower unit behind the school building. The blower unit was operating properly. The green light indicating normal performance was on.
- I inspected monitoring well SCA-8A in the parking area near the blower unit. No changes had been made to the condition on the monitoring well.
- I walked over to the location of monitoring well SCA-7. The conditions were dry today and I inspect the newly encased well. The top cover was not bolted shut. When I lifted the cover, the PVC pipe within the monitoring well was intact. The PVC height has not been adjusted and is approximately 18" below the new top of casing. Two pictures of this are shown below:

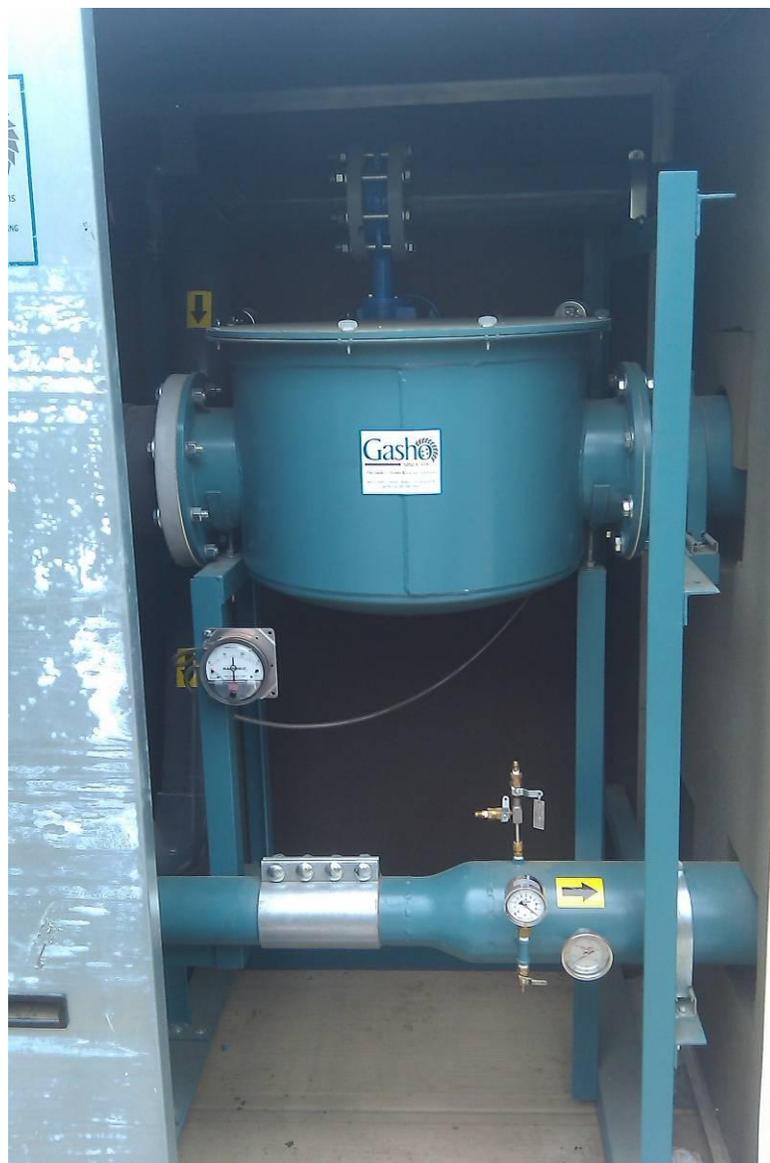
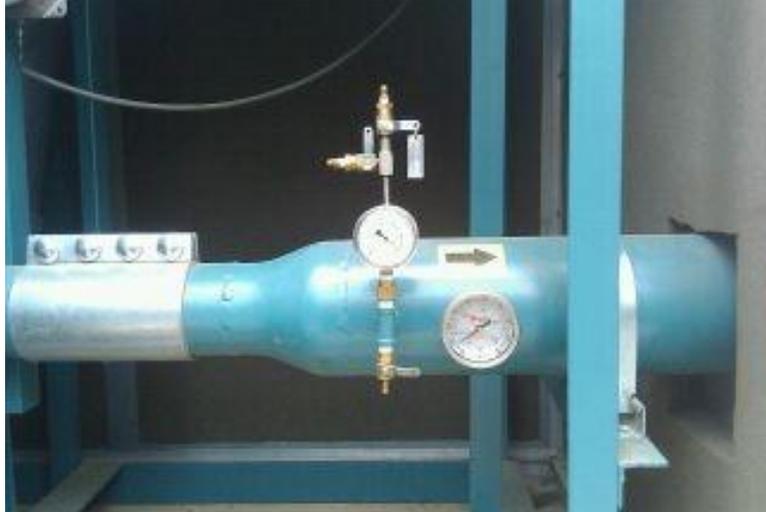
- 10:30 AM Shaw on site.
- I arrived on site and inspected the blower unit behind the school building. The blower unit was operating properly. The green light indicating normal performance was on.
- The gate to access the unit was unlocked, so I entered to inspect the inside of the blower unit. I lifted the exterior door off the unit and took photos of the instrumentation, see below. It appears that the contractor had installed the pressure gauges but I did not see a flow switch installed within the unit.

- The SCA project officer, Al Daub, was in a meeting but I did speak with him after the inspection and he will get back to me on the flow switch situation. The BMS for this school is not operational yet.
- The next inspection will be on Dec 14th.
- 11:00 AM Shaw off site.

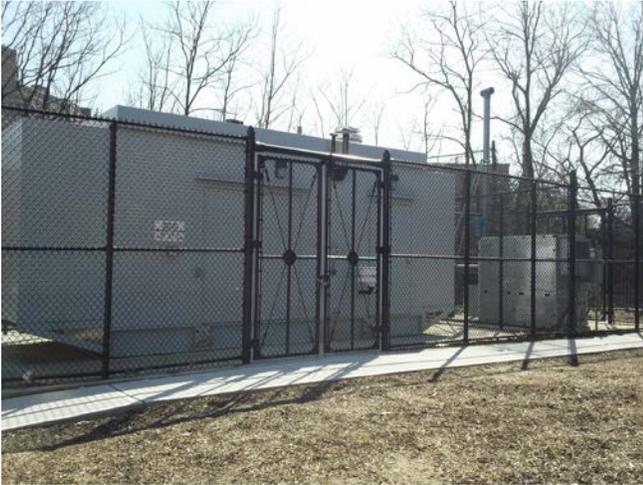
Photo 1: View of the SSDS fan unit housing.

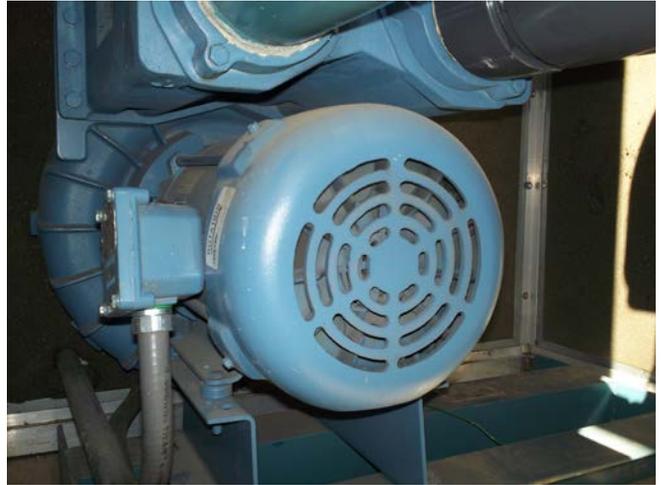
1. The BMS was not installed at the time of inspection but efforts are underway to commission the BMS;
2. The SSDS fan unit and indicator lights were operational;
3. Rust or other debris in the vicinity of the post, sleeve and discharge cap at the SSDS stack vent was not observed;
4. Rust of other debris in the vicinity of the inline filter was not observed; and
5. All gauges were observed to be functioning.

Photo 2: View of SSDS fan unit observed on March 6, 2012.

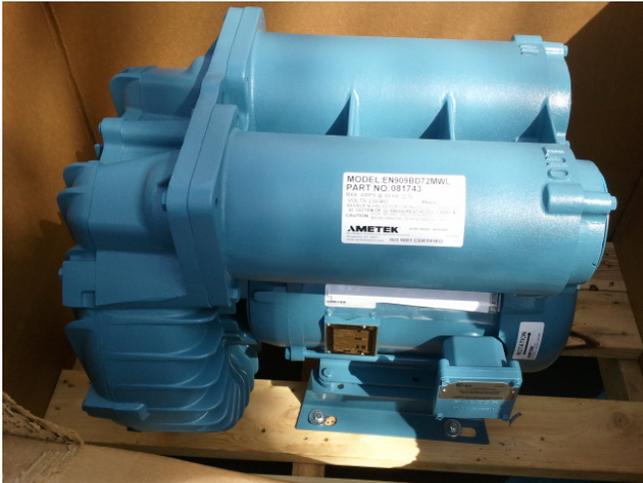
Photo 3: View of spare SSDS fan unit delivered on March 12, 2012.

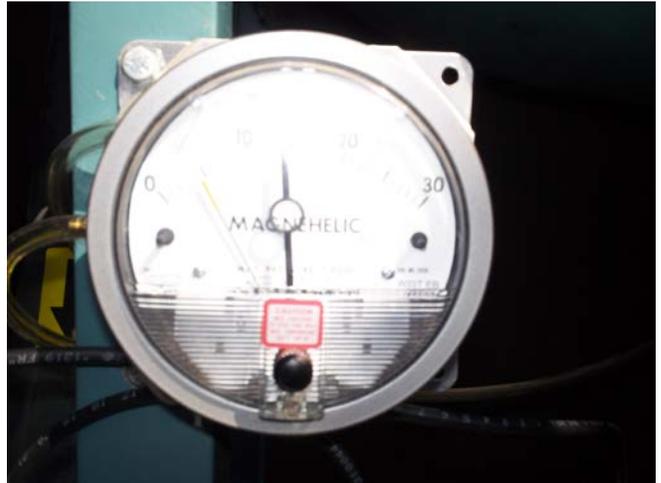
Photo 4: View of SSDS vacuum gauge.

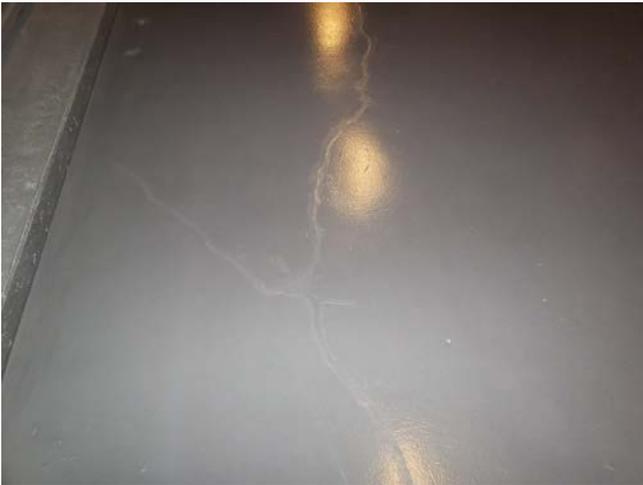
The ¼" size cracks in the basement Room 0021 previously observed by ATC has been sealed with cementitious grout in February 2012. It is unknown what the potential cause of the crack was, but custodial staff was advised to immediately patch any visible significant future cracks.

Photo 5: View of sealed crack in Room 0021.

- a) The quarter (1/4) inch cracks should be sealed; however, it is not necessary to repair the hairline cracks at this time. In addition, the potential cause for the cracks should be investigated to determine if anything can be done to prevent future cracking. Please note that one of cracks is in the cellar (room 0021) and it needs to be repaired.
- b) In addition to sealing the cracks, the indoor air in room 0021 must be sampled to ensure that the air quality is appropriate in the School and to verify the integrity of the cover system (slab).
- c) A spare blower must be available at all times.
- d) Please confirm/certify that all indicator lights associated with the engineering controls are functioning properly.
- e) The custodian must be instructed to fill the Monthly Inspection Checklists.

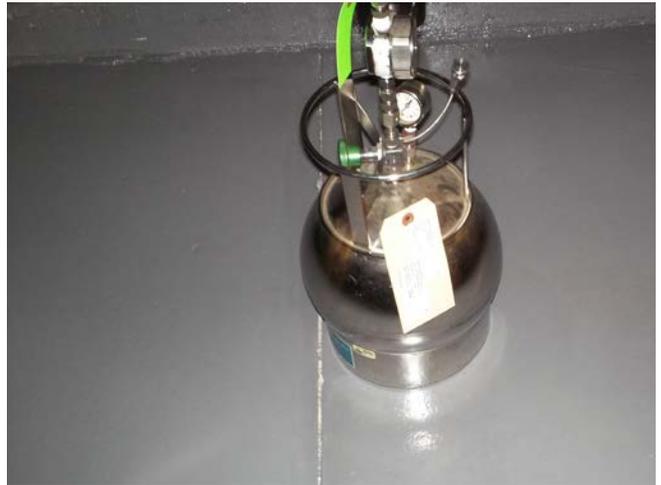
A sample was placed in close proximity to the sealed crack in the basement floor of Room 0021 and three other samples were placed in representative areas in the basement and on the 1st floor. One sample was placed outdoors. Sampling protocols, analysis and data evaluation followed NYSDOH guidelines "Guidance for Evaluating Soil Vapor Intrusion in the State of New York" dated October 2006.

Photo 6: View of summa canister in Room 0021.

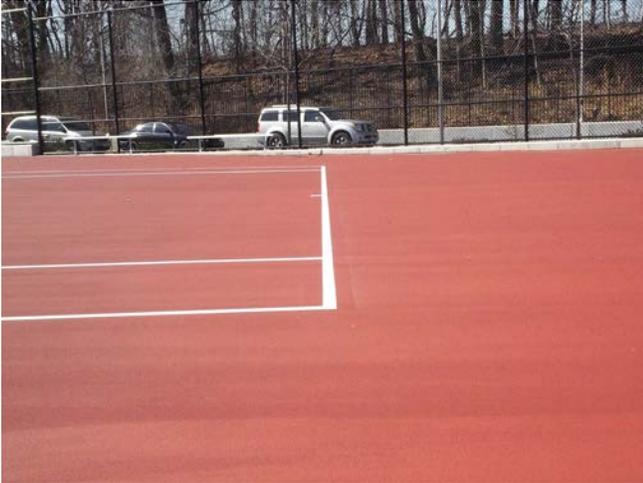
Photo 7: View of tennis court cover.

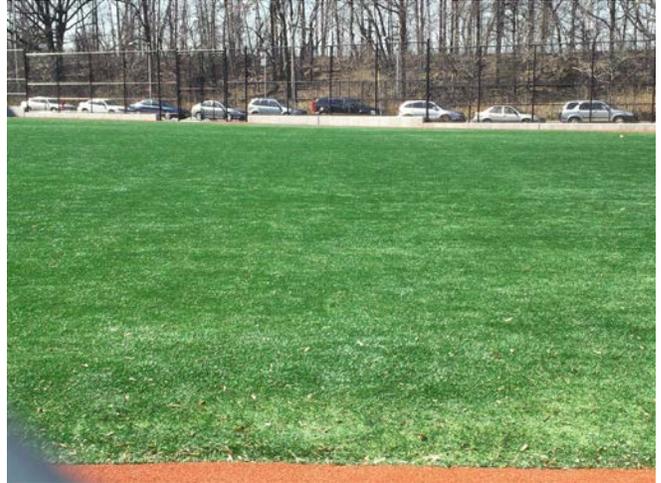
Photo 8: View of artificial turf on baseball field.

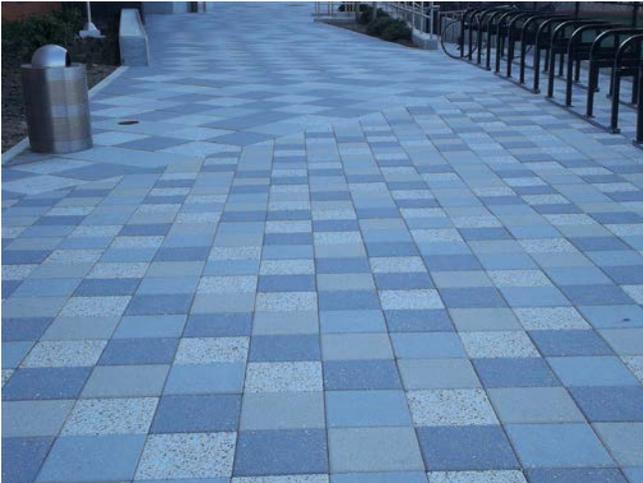
Photo 9: View of typical sidewalk pavers.

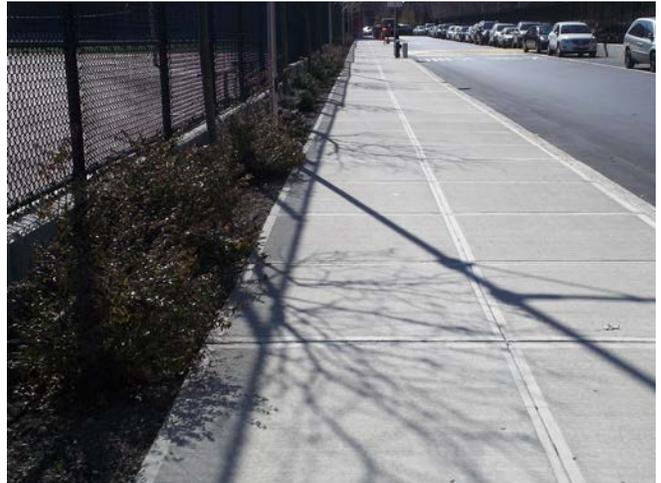
ATC inspected the composite cover system around the perimeter of the property including the paved and unpaved areas. There was no evidence of pavement removal. No structures have been constructed on the unpaved areas. There were no signs of soil washing or erosion. There were no signs of intrusive activities such as drilling, digging, trenching, grading or excavating. ATC also inspected the artificial turf and observed no apparent holes, cracks or deterioration. All significant exterior cracks previously observed by ATC in February 2011 have been sealed and/or repaired throughout the past year.

Photo 10: View of typical concrete sidewalk and vegetation cover.
