**ANNUAL SITE MANAGEMENT REPORT
FROM MAY 2015 TO FEBRUARY 2018
METROPOLITAN AVENUE CAMPUS (Q686)
92-34 METROPOLITAN AVENUE
FOREST HILLS, NY
VCP AGREEMENT # V-00500-2**

Date of Issue: March 20, 2018
Date of Revision 1 Submission: July 10, 2018
Date of Revision 2 Submission: November 26, 2018

ATC Project No. Z214YI1025

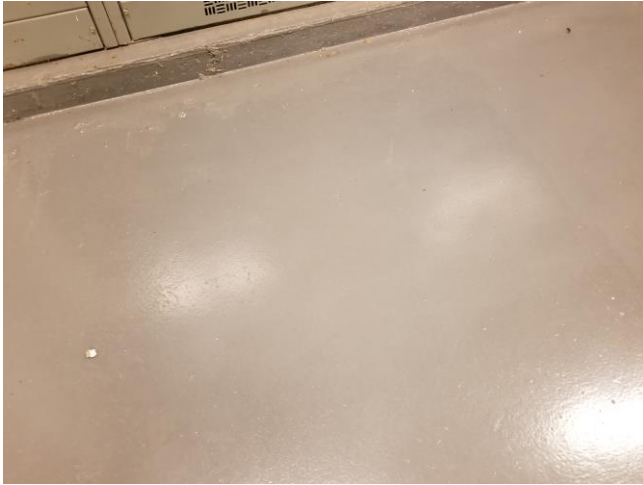
Photo 1: View of typical bare concrete floor in Room 0021.

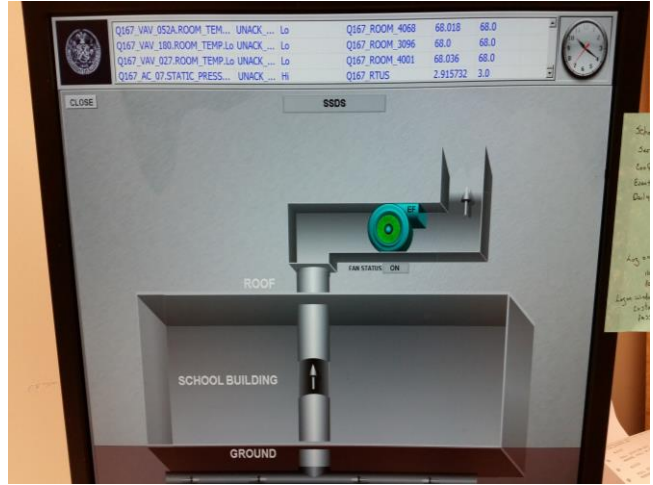
During the latest inspection, ATC observed that the SSDS fan was operational. The outlet pressure gauge was working properly. The Building Management System (BMS) was connected to the SSDS and functioning properly.

Photo 2: View of BMS connected to the SSDS fan unit (2017).

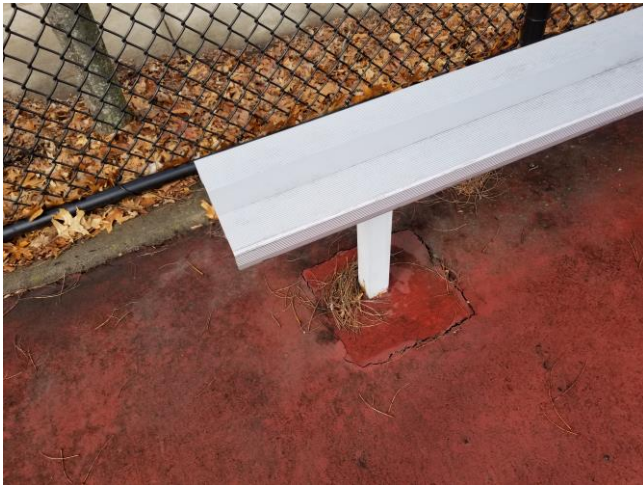
ATC inspected the composite cover system around the perimeter of the property including the paved and unpaved areas. ATC observed minor cracks on the roadway, sidewalk, artificial turf, tennis court and playground; however these cracks do not compromise the cover system. Although these cracks are minor, ATC advised the custodial staff that these cracks should be monitored during monthly inspections for any significant change in the width of the cracks. Significant cracks observed during these inspections will require patching with cement or grout material. Some loose pavers were also observed throughout the main entrance to the Blue Building. ATC was informed that minor perimeter cracks and loose pavers were repaired/replaced on August 27, 2018. ATC verified these repairs during the September 17, 2018 follow-up inspection.

Photo 3: View of typical minor crack on the tennis court.

ATC observed also exterior minor cracks on the roadway, sidewalk, artificial turf, tennis court and playground and some loose pavers around the building. Although these cracks are minor, ATC advised the custodial staff to repair or seal them to prevent further deterioration. ATC verified that these cracks were repaired on September 17, 2018.

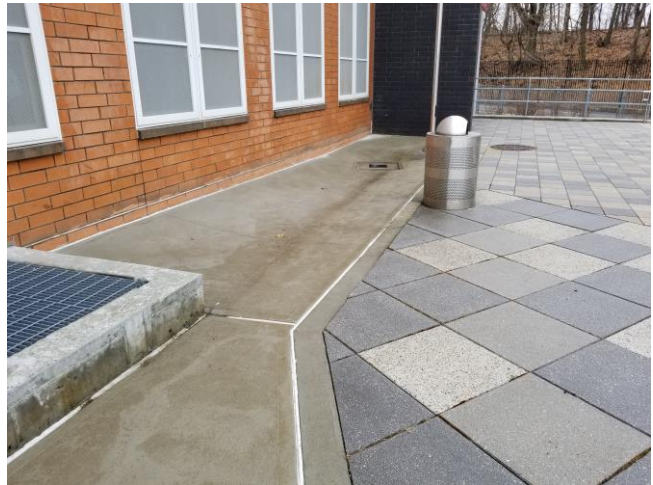
Photo 4: View of typical pavers.

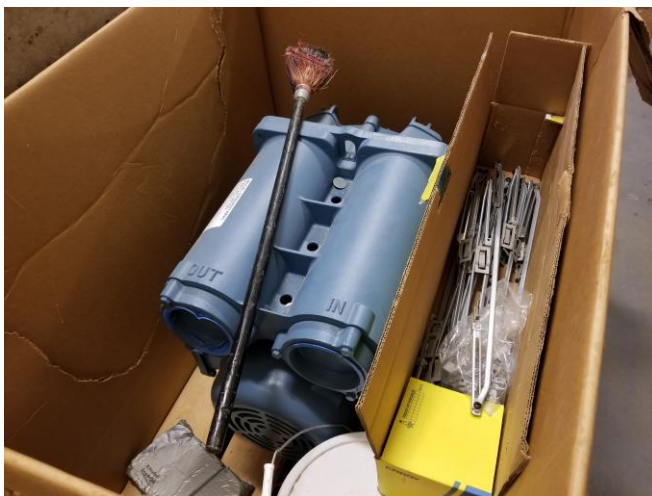
Photo 5: View of spare SSDS fan motor in Room 0005.

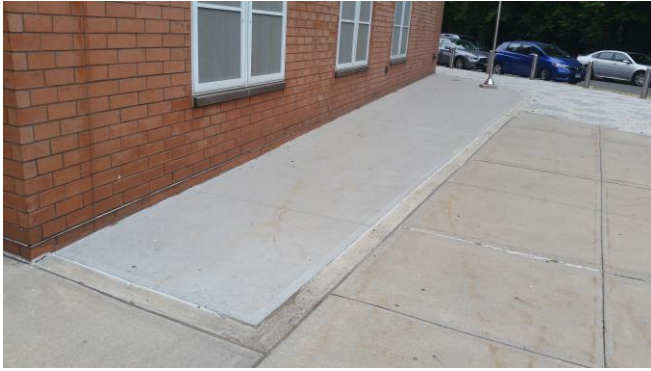
Photo 7: View of repaired pavers around the perimeter of the school.

5. Exterior minor cracks were observed on the roadways, sidewalks, artificial turf, tennis court and playground as well as some loose pavers observed sporadically around the building were repaired on August 27, 2018;

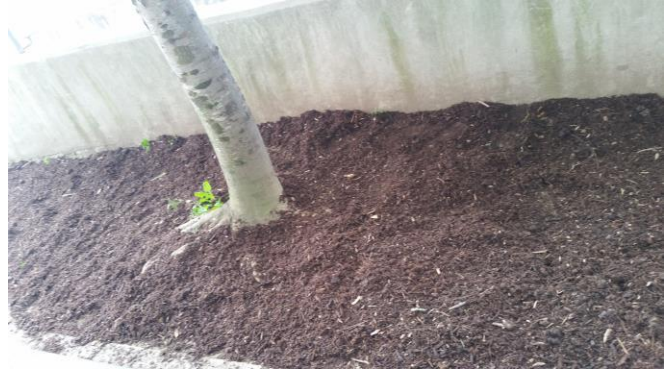
No structures have been constructed on the unpaved areas. There were no signs of soil washing or erosion except for the landscaped areas adjacent to the northwest and southwest entrances of the school buildings (observed during the 2017 and 2018 inspections). These areas were addressed and verified during ATC's visit on June 13, 2018 as follows:

Photo 8: Areas of eroded soil topped with top soil and mulch on May 17, 2018.

- Northwest corner of school (Red side): ATC was informed that three inches of top soil and mulch mix (250 square feet) were placed on May 17, 2018 along with planted vegetation to replace eroded soil.
- Southwest corner of school (Green side): ATC was informed that three inches of top soil and mulch mix (350 square feet) were placed on June 13, 2018 around existing vegetation.

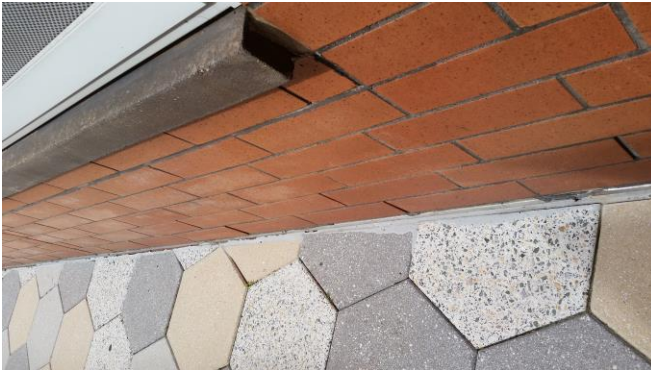
Photo 9: View of recaulked areas around the perimeter of the school.

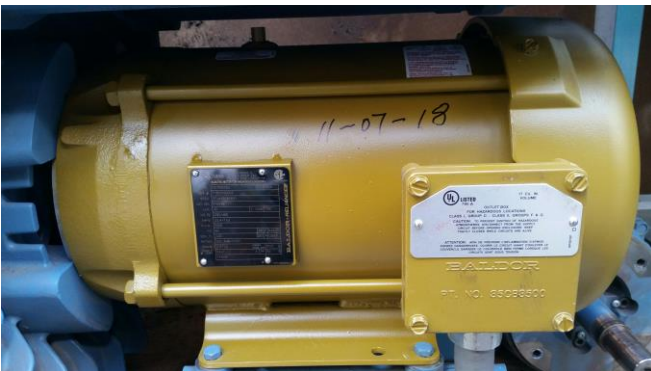
Photo 11: View of new motor installed on November 7, 2018.

1. The SSDS fan was operational, however, per the O&M Plan, the blower sealed bearings require replacement every two years. As such, the motor and sealed bearing were replaced on November 7, 2018.
2. The SSDS indicator lights were operational;
3. All gauges were observed to be functioning except for the outlet pressure gauge during the 2017 and 2018 annual inspections. The outlet pressure gauge replaced on September 17, 2018;
4. Rust or other debris in the vicinity of the post, sleeve and discharge cap at the SSDS stack vent were not observed; and
5. Rust or other debris in the vicinity of the inline filter was not observed.

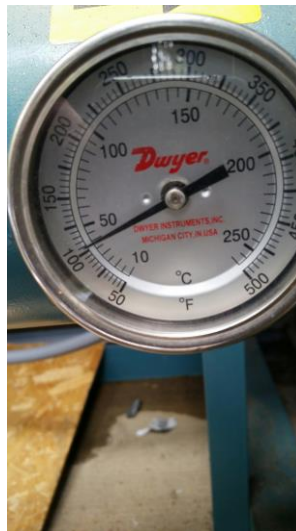
Photo 12: View of new outlet pressure gauge installed on September 17, 2018.

1. The BMS has been fully commissioned;
2. The SSDS fan was operational. The motor and sealed bearings were replaced on November 7, 2018;
3. The SSDS outlet pressure gauge was replaced on September 17, 2018;
