# **Bloody Brook**

**LIVERPOOL, NEW YORK**

## **Periodic Review Report July 31, 2019 to July 31, 2020**

Lockheed Martin Corporation  
497 Electronics Parkway  
Building EP-6, Room 100B  
Liverpool, New York 13088

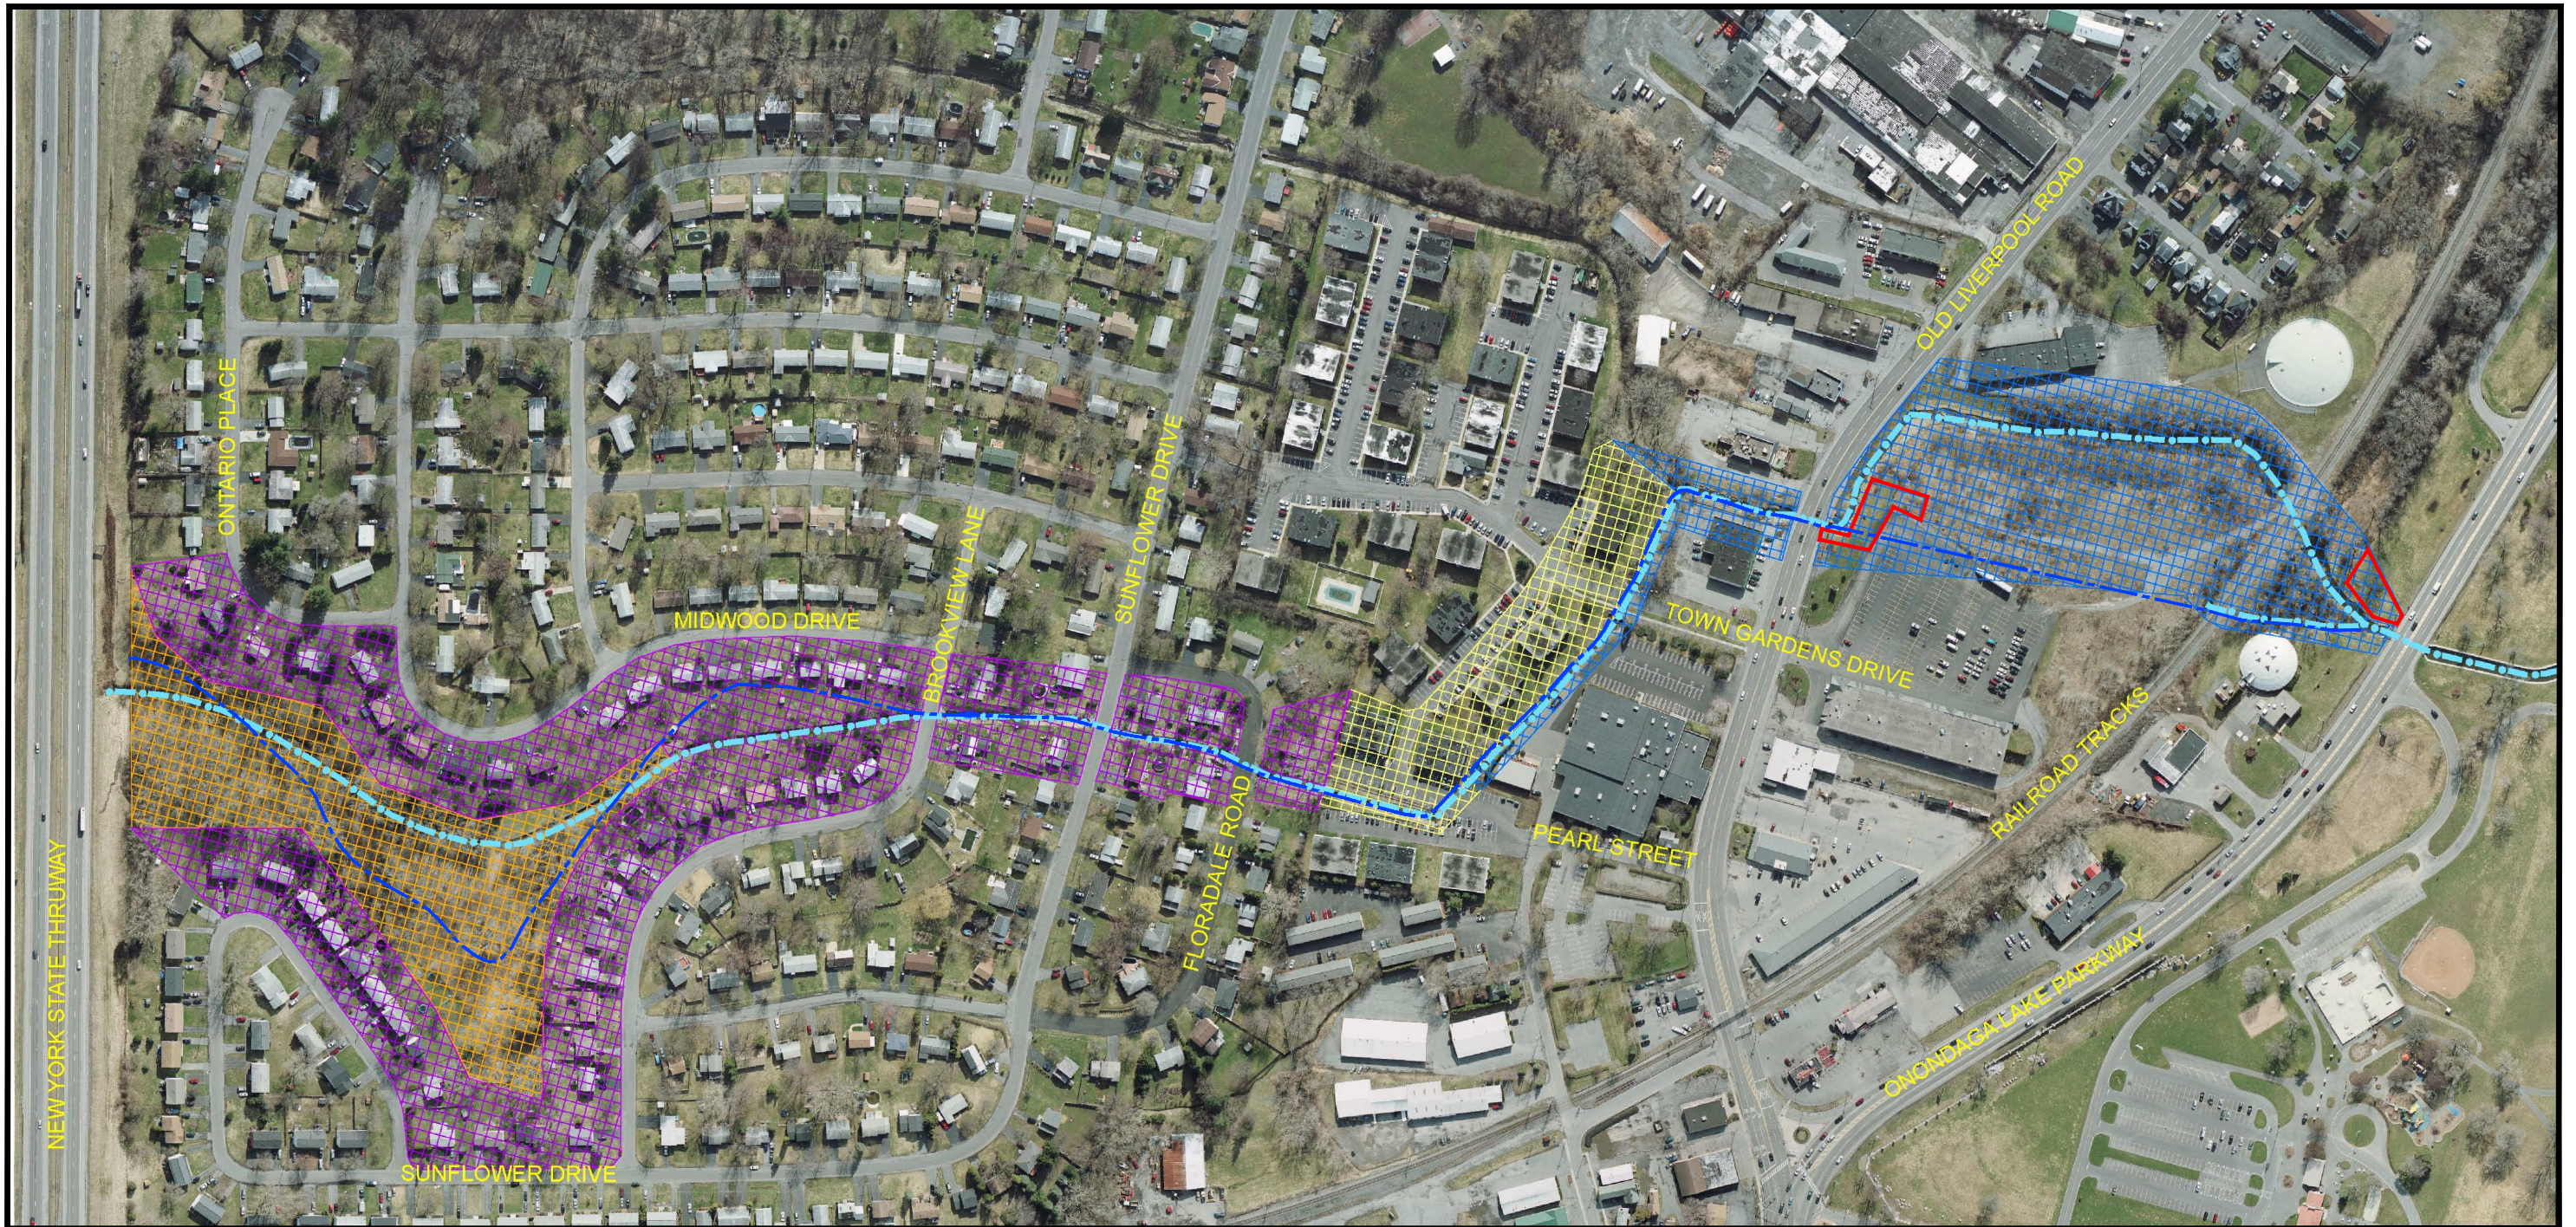
SITE AREA MAP

The site is located in the town of Salina, and a portion of the site is located in the Village of Liverpool, Onondaga County, New York. Site location and area maps are included as Figures 1 and 2, respectively. The site consists of the West Branch of Bloody Brook (WBBB) and Bloody Brook from below the confluence of the west and middle branches of Bloody Brook (collectively referred to as WBBB). Also included in the site is soil surrounding the WBBB and Bloody Brook downstream of the Thruway and ending at the upstream side of the Onondaga Lake Parkway. This portion of the site is approximately 5,000 feet long and flows through lands of varied use including a wooded area, a residential area, an apartment complex, and a commercial/light industrial area.

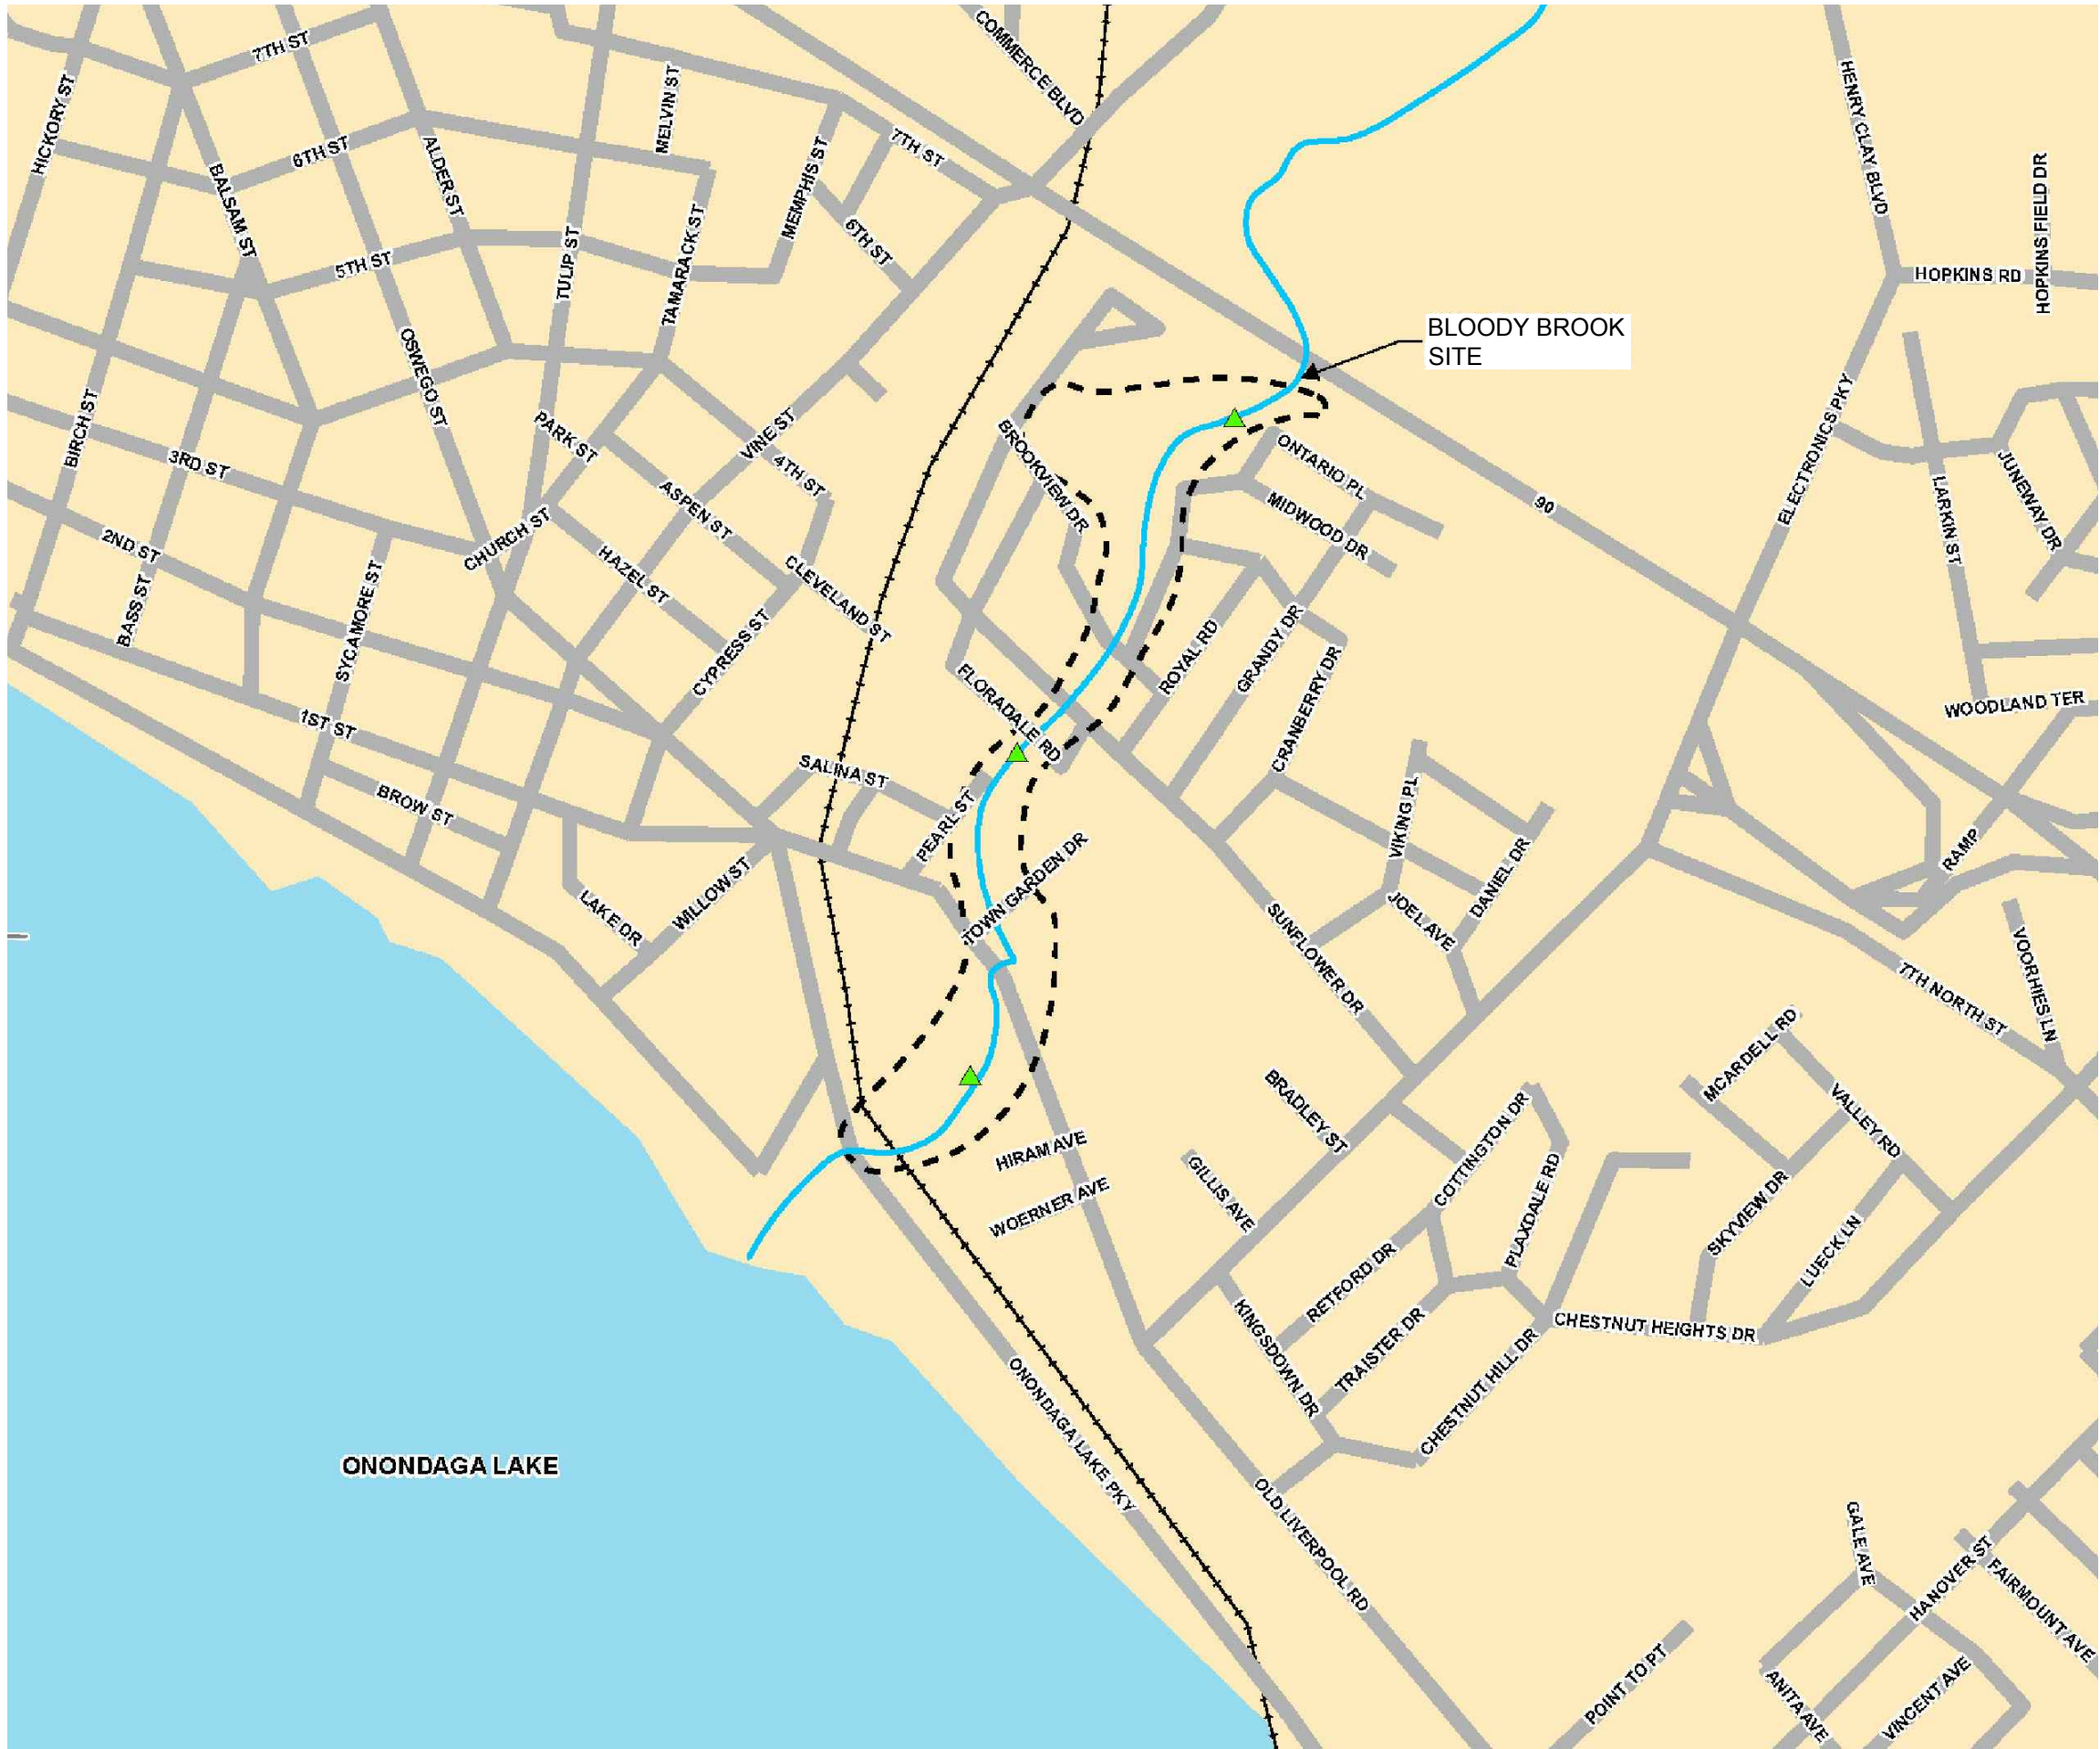
LOCKHEED MARTIN CORPORATION  
BIOLOGICAL MONITORING LOCATIONS

In July 2014, biota samples were collected from within the Bloody Brook site to evaluate possible cadmium exposure for aquatic receptors prior to the start of remediation activities in the WBBB. Samples were collected from three general locations in WBBB, including an upper location (between Ontario Place and Cranberry Drive), a middle location (downstream from Floradale Road), and a lower location (upstream from Onondaga Lake Parkway). See Figure 4 for approximate sample locations. The 2014 data were provided to New York State Department of Environmental Conservation (NYSDEC) in the September 9, 2014 Monthly Progress Report for the Bloody Brook site and were included in Appendix F (Field Sampling Plan [FSP]) of the SMP.

According to the SMP, biota samples were to be collected in 2018 and 2020 from within the Bloody Brook site from the same locations that were sampled during the 2014 baseline sampling to support the evaluation of the effectiveness of the site remedial program in mitigating potential cadmium impacts in WBBB. In accordance with the SMP, crayfish samples were collected on August 13, 2018 using the kick-net method, per the FSP and consistent with the collection methods used during the baseline sampling. Results of the 2018 monitoring indicate the remedy has been effective in mitigating cadmium impacts (AECOM, 2018d). The third and final year of biological monitoring is currently planned for late August 2020. Results for the 2020 sampling will be provided in the 2021 PRR covering the July 31, 2020 to July 31, 2021 reporting period.

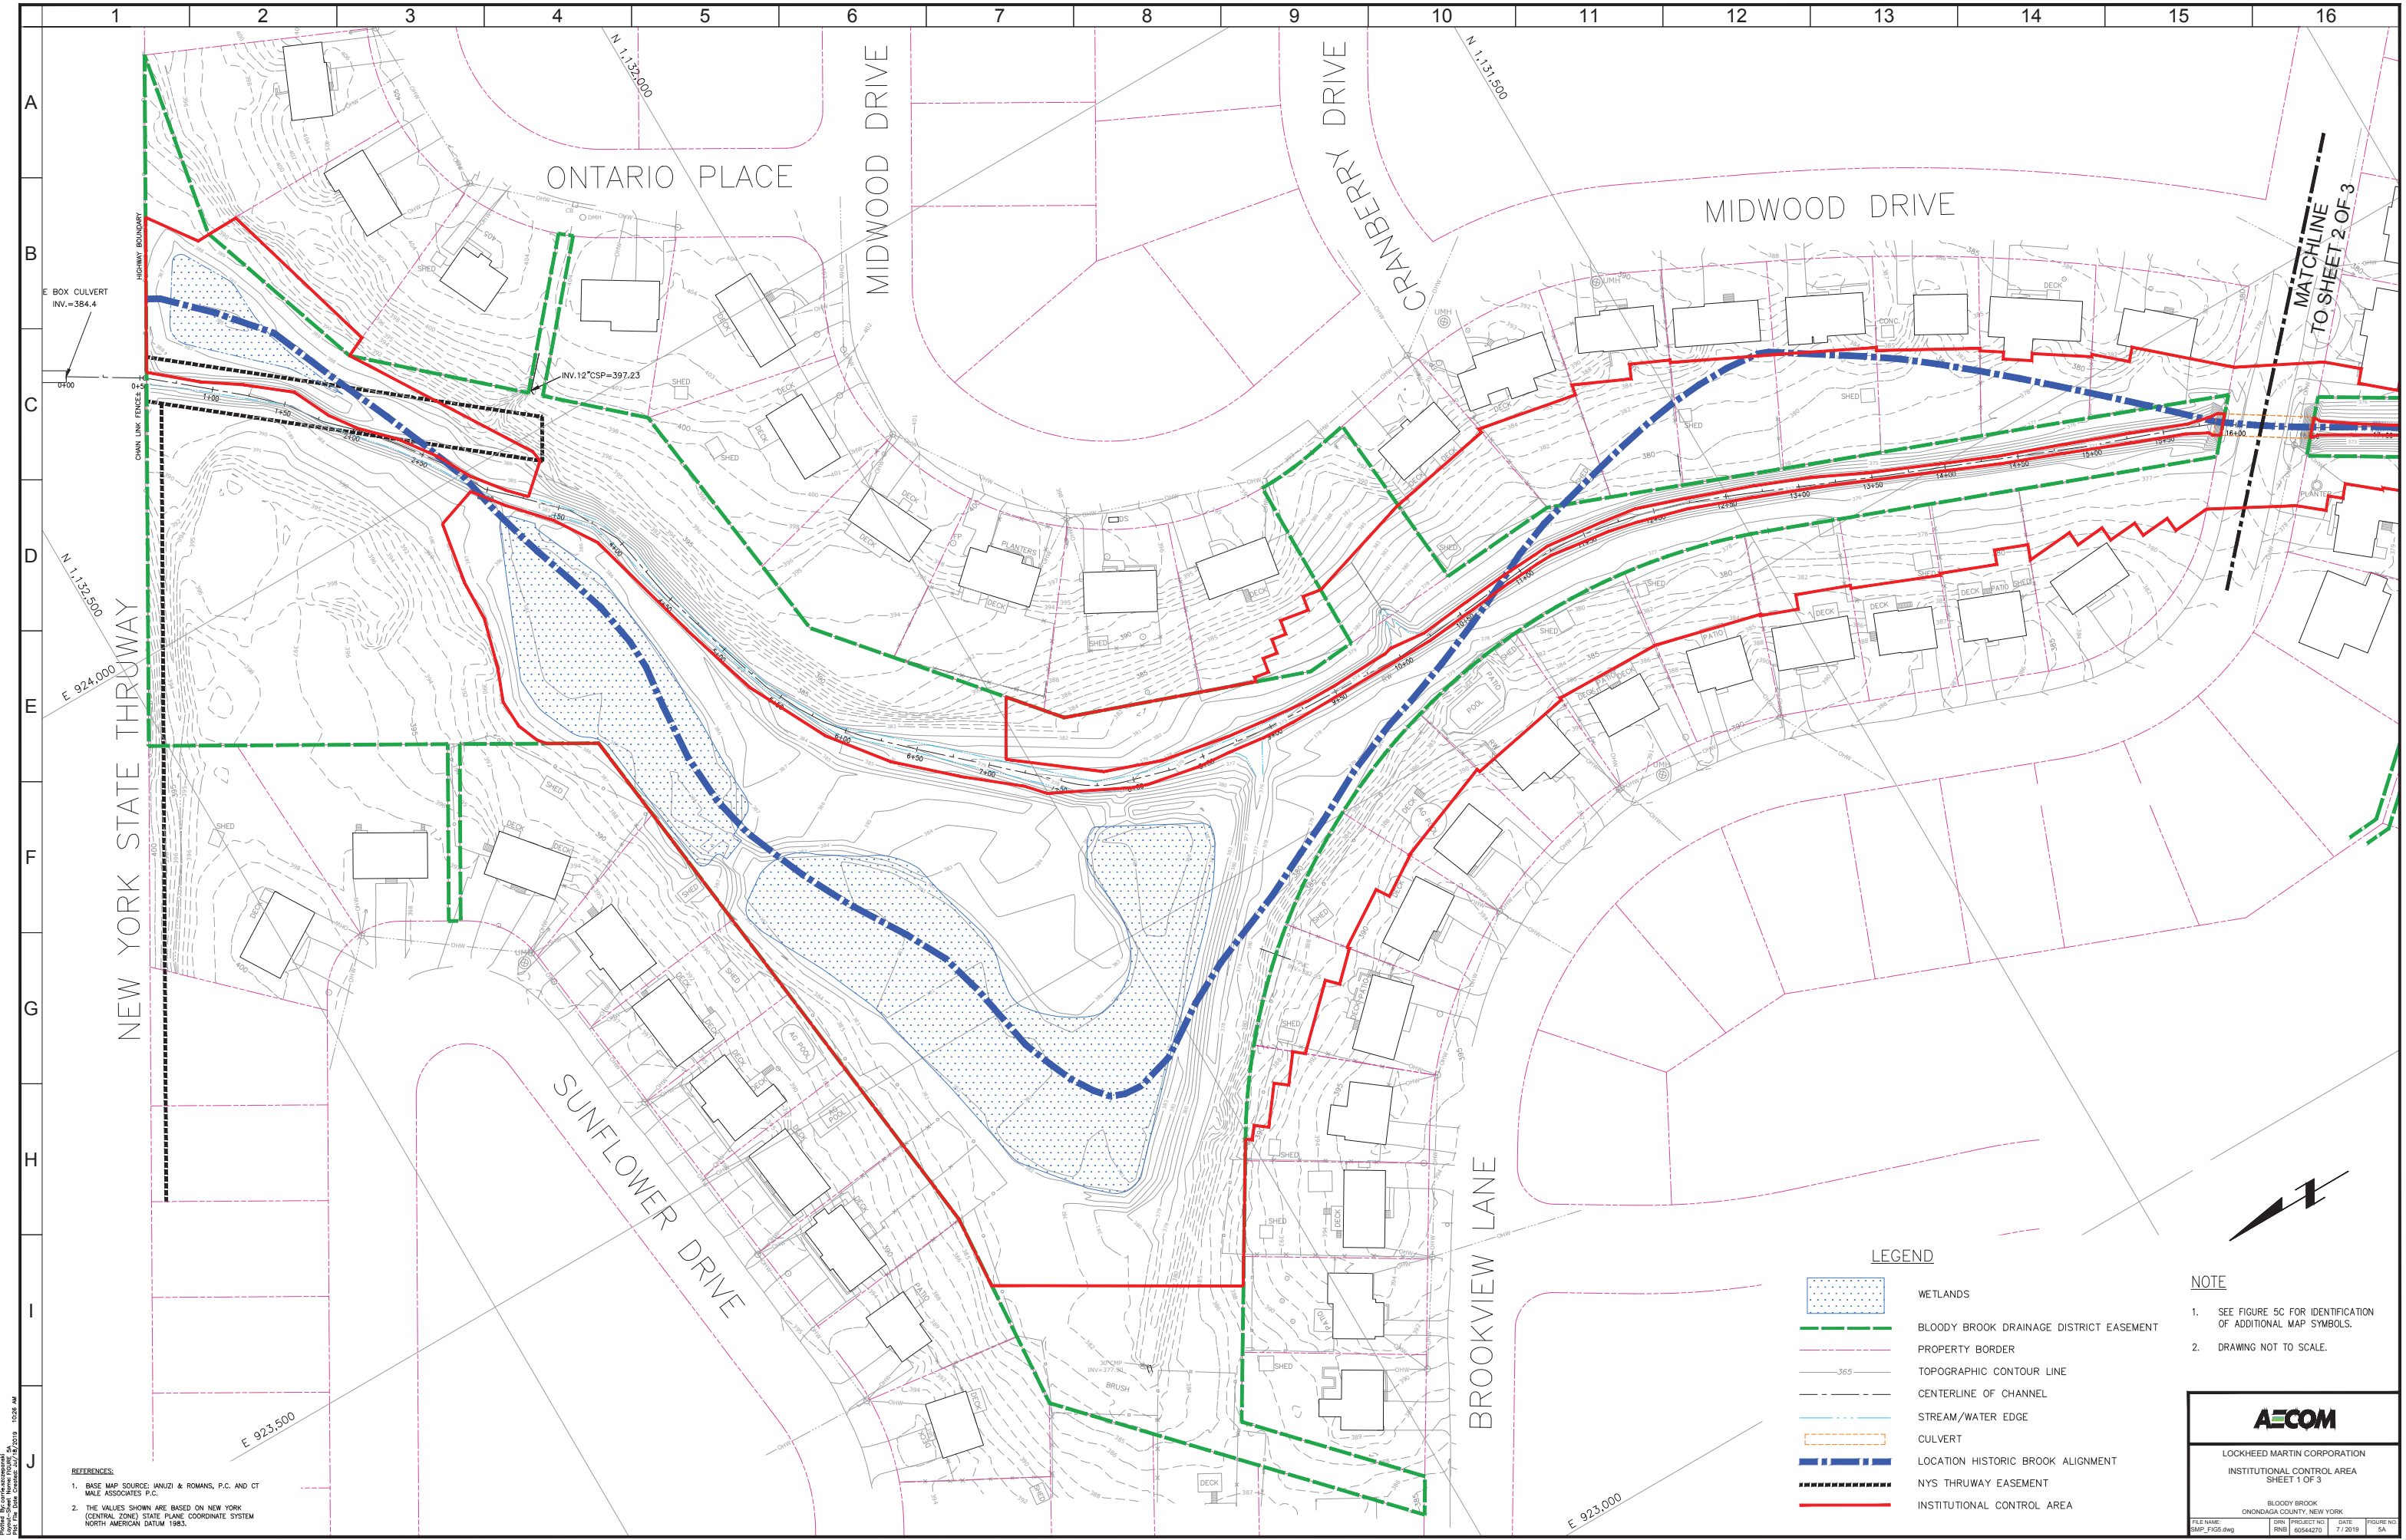
LOCKHEED MARTIN CORPORATION  
INSTITUTIONAL CONTROL AREA  
SHEET 1 OF 3

A series of ICs is required by the 2014 Decision Document and SMP to: (1) implement, maintain and monitor EC systems; (2) prevent future exposure to remaining contamination; and, (3) limit the use and development of the site to appropriate uses for each area. Adherence to these ICs on the site is required by the 2014 Decision Document and is implemented under the site SMP. The IC boundaries are shown on Figures 5A through 5C and include the following:

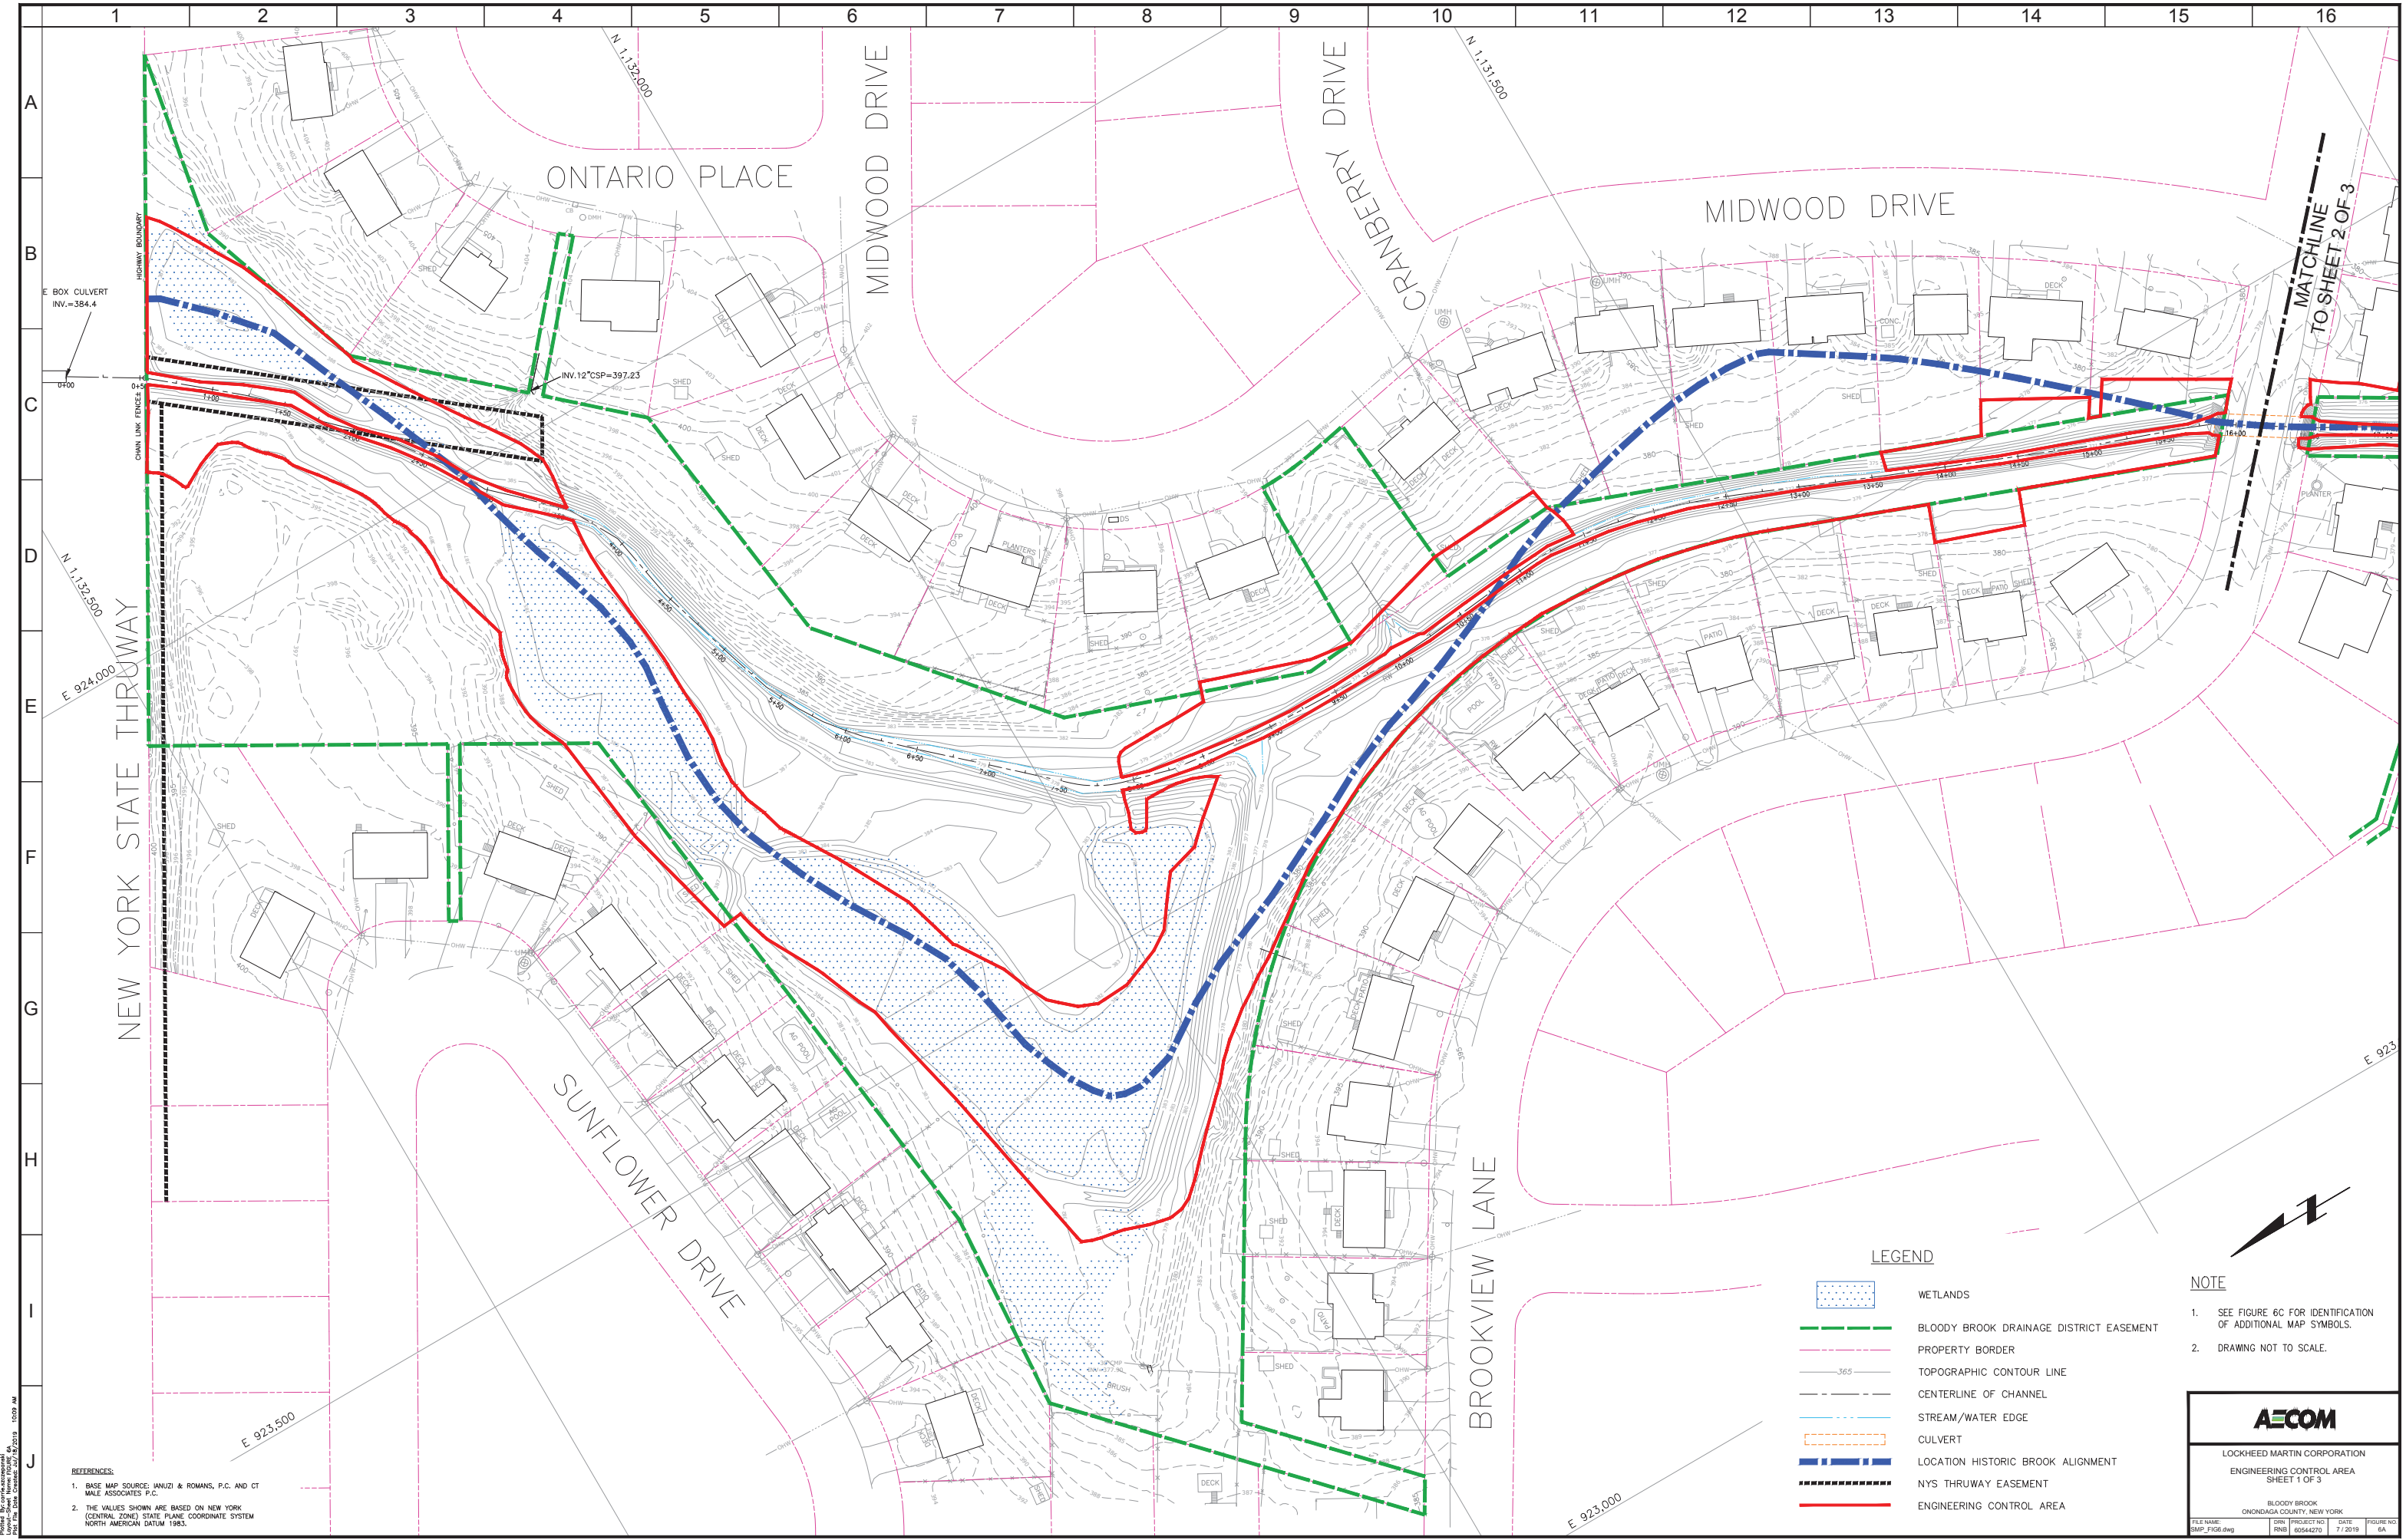
LOCKHEED MARTIN CORPORATION  
ENGINEERING CONTROL AREA  
SHEET 1 OF 3  
BLOODY BROOK  
ONONDAGA COUNTY, NEW YORK  
FILE NAME: SMP\_FIG6.dwg  
PROJECT NO: 00544270  
DATE: 7/2/19  
FIGURE NO: 6A

Exposure to remaining contamination at the site is prevented by a cover system placed over the site in the areas where soil was excavated. This cover system is comprised of a minimum of 24 inches of clean soil and other components as appropriate. Figure 6A through 6C presents the location of the soil cover. The Excavation Work Plan (EWP) provided in the SMP outlines the procedures required to be implemented in the event the cover system is breached, penetrated or temporarily removed, and any underlying remaining contamination is disturbed. Inspection of this cover are included as part of an annual site-wide inspection detailed in the Monitoring and Sampling Plan included in the SMP and is conducted to confirm the soil cover and armoring material remains in place and protective of the underlying soil. From the time of remedy completion through the
