Site Management Plan

**Bon Ton Cleaners
1932 Ralph Avenue
Brooklyn, New York**

Re: **Site Management Plan - Revised
Bon Ton Cleaners
1932 Ralph Avenue, Brooklyn, NY
Site ID No.: V-00512-2**

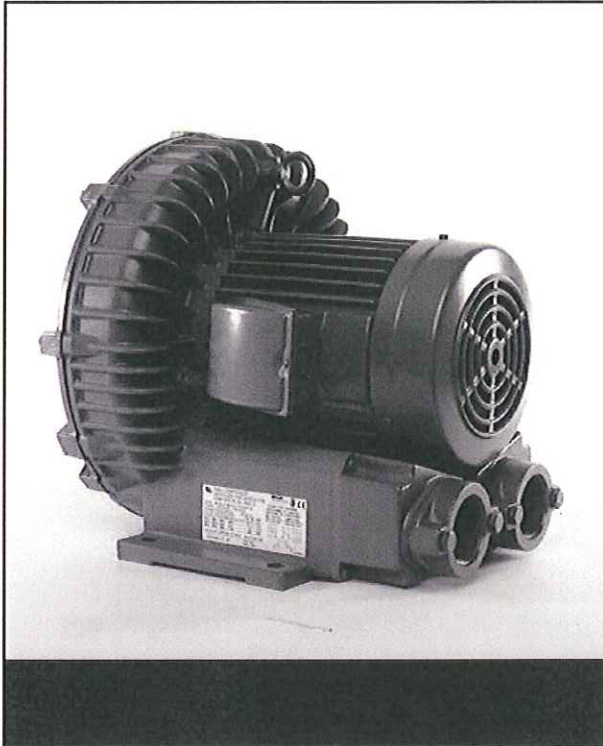
The VFC60 is a single-stage ring compressor with a maximum pressure of 118 in. H₂O, a maximum vacuum of 98 in. H₂O, and a maximum capacity of 206 SCFM. It comes complete with a direct-drive, 4.5 horsepower TEFC motor capable of operating on a wide range of voltages, and on 50 or 60 Hz. A pilot-duty thermal protector is standard equipment on all 3-phase models. All versions have NEMA class B insulation, are UL recognized, CSA certified, and CE. 575 Volt units are CSA certified only.
