Re: Former Brainerd Manufacturing Site #V00519-8
115 North Washington Street, East Rochester, NY
Summary of Decommissioning and Semi-Annual Groundwater Monitoring

**PRETREATMENT SYSTEM DECOMMISSIONING LETTER REPORT,
PHOTOGRAPHS, AND WELL ABANDONMENT LOGS**

Re: Sewer Use Permit 883
Former Brainerd Manufacturing Facility
115 North Washington Street, East Rochester, NY 14445
Decommissioning of Pretreatment System

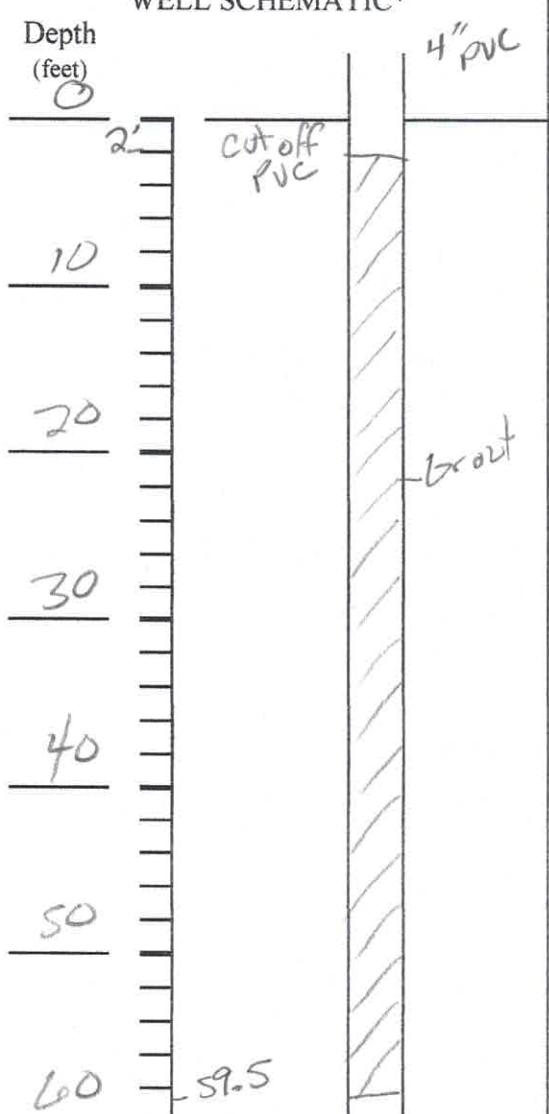
FIGURE 3
WELL DECOMMISSIONING RECORD

Site Name: Former Brainerd MFG	Well I.D.: Pump well B2
Site Location: Int. Brainerd Bldg.	Driller: T. Mangefrida
Drilling Co.: Notnagle Drilling	Inspector: N Sudaci

Interval grouted (FBLS)	<input type="text"/> 59.5'-1'

<u>COMMENTS:</u> Tremie grout abandoned in place. PVC cut off 2' BGS. Surface completion back filled with concrete and finished to match.		* Sketch in all relevant decommissioning data, including: interval overdrilled, interval grouted, casing left in hole, well stickup, etc.

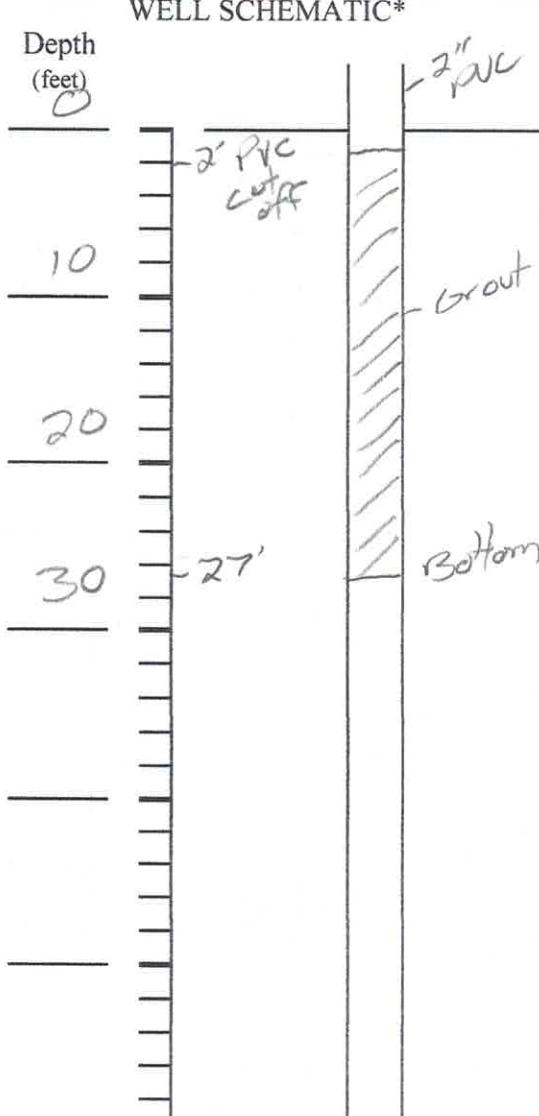
FIGURE 3
WELL DECOMMISSIONING RECORD

Site Name: former Brainerd MFG	Well I.D.: MW-3
Site Location: Int. Brainerd Bldg-	Driller: T. Mangelson
Drilling Co.: Northnagle Drilling	Inspector: N. Suraci
	Date: 4-22-20
DECOMMISSIONING DATA (Fill in all that apply)	
OVERDRILLING	
Interval Drilled	
Drilling Method(s)	
Borehole Dia. (in.)	
Temporary Casing Installed? (y/n)	
Depth temporary casing installed	10
Casing type/dia. (in.)	
Method of installing	
CASING PULLING	
Method employed	
Casing retrieved (feet)	20
Casing type/dia. (in.)	
CASING PERFORATING	
Equipment used	
Number of perforations/foot	30
Size of perforations	
Interval perforated	27'
GROUTING	
Interval grouted (FBLS)	27'-1"

COMMENTS: Tremie grout abandoned in place. PVC cut off 2' BGS. Surface completion backfilled with concrete and finished to match.

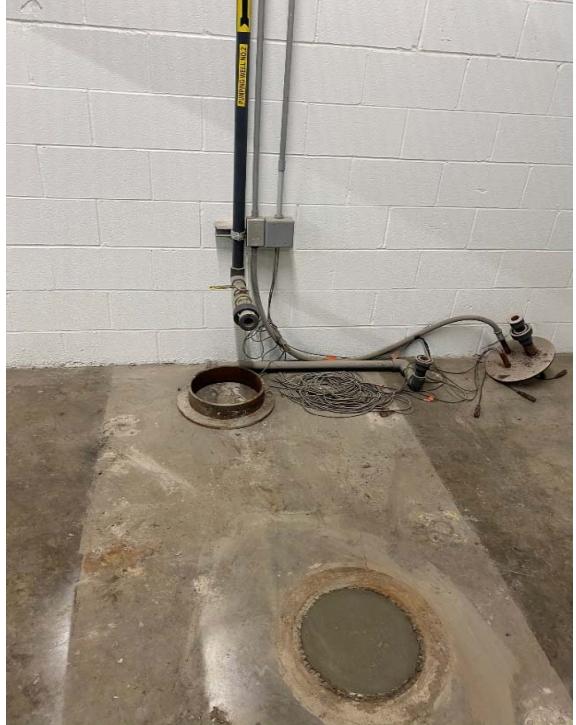
Client Name: Despatch Industries, Inc		Site Location: East Rochester, NY	Project No.: 0040-002-400
Photo No. 1	Date 04/21/20

Direction Photo Taken: South			
Description: Grouting of pumping well PW-2

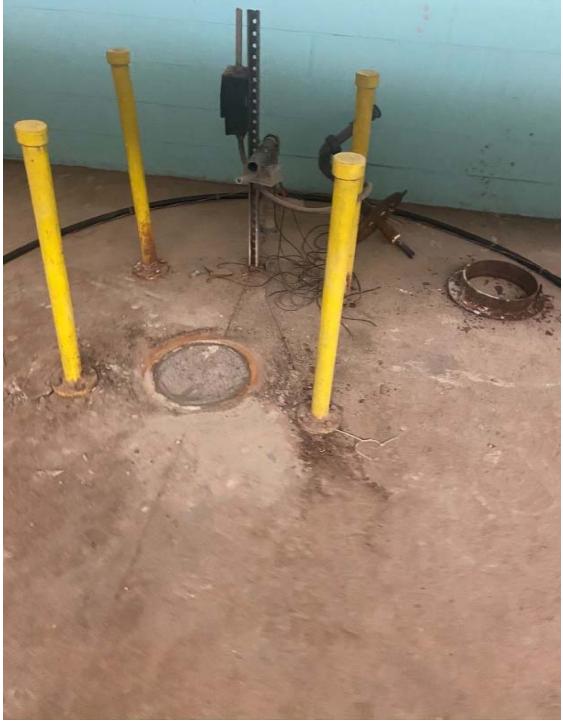
Photo No. 2	Date 04/21/20

Direction Photo Taken: East			
Description: Grouting of pumping well PW-1R

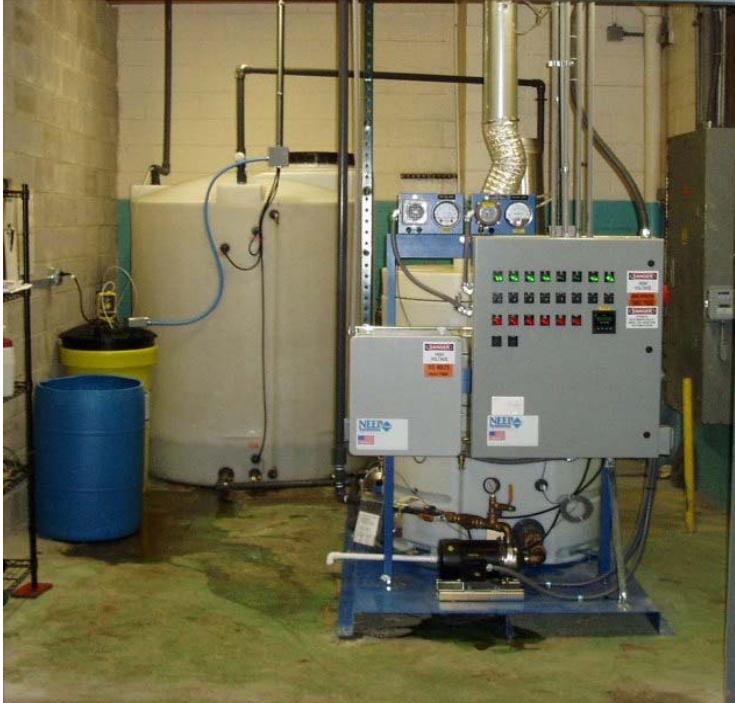
Client Name: Despatch Industries, Inc		Site Location: East Rochester, NY	Project No.: 0040-002-400
Photo No. 3	Date

A photograph showing a pretreatment system in a industrial setting. The system consists of a large white vertical tank, a smaller blue drum, and a control panel with various gauges and valves. The floor is concrete and shows some staining. The background includes brick walls and other industrial equipment.	
Direction Photo Taken: West			
Description: Pretreatment system prior to decommissioning.

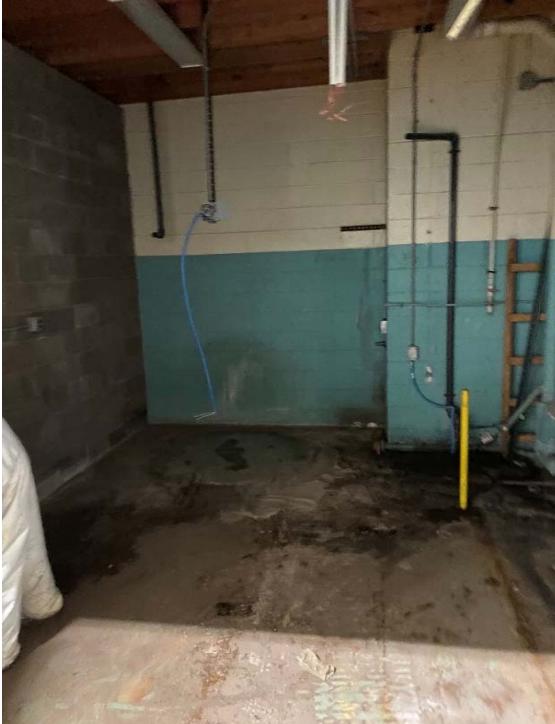
Photo No. 4	Date 04/24/20

A photograph of a pretreatment room after equipment has been removed. The room has concrete floors and walls. There are pipes hanging from the ceiling and some equipment on the floor. A person's legs are visible in the bottom left corner, providing a sense of scale.
Direction Photo Taken: North		
Description: Pretreatment room following equipment removal.

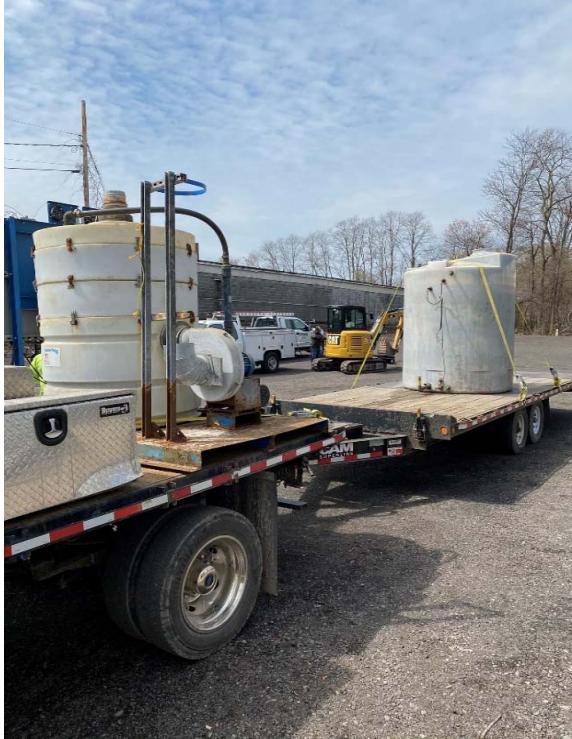
Client Name: Despatch Industries, Inc		Site Location: East Rochester, NY	Project No.: 0040-002-400
Photo No. 5	Date 04/24/20

A photograph showing a large, white cylindrical industrial tank or pretreatment system being transported on a flatbed trailer. The trailer is hitched to a truck and is parked on a gravel surface. In the background, there are some trees, a building, and other construction equipment.	
Direction Photo Taken: North			
Description: Removal of pretreatment system equipment

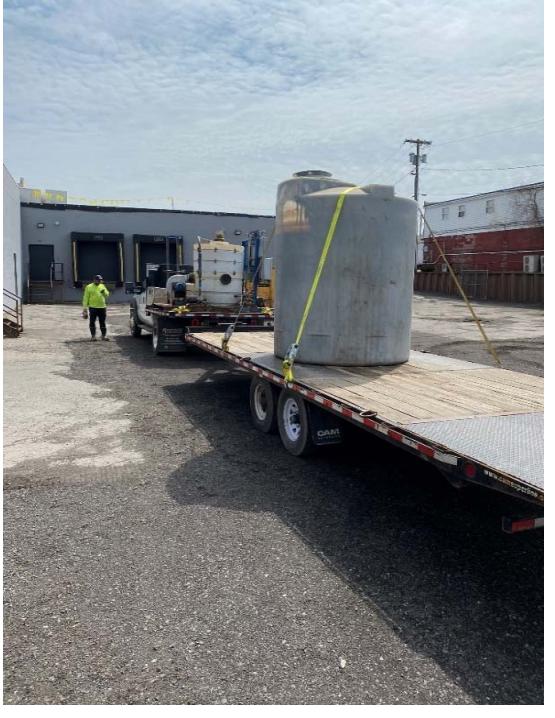
Photo No. 6	Date 04/24/20

A photograph showing a large, white cylindrical industrial tank or pretreatment system being transported on a flatbed trailer. The trailer is hitched to a truck and is parked on a paved surface. A worker in a yellow vest is standing near the trailer. In the background, there are buildings and utility poles.	
Direction Photo Taken: South			
Description: Removal of pretreatment system equipment
