# Periodic Review Report

Former Brainerd Manufacturing Facility  
East Rochester, New York  
NYSDEC Site No. V00519-8

March 2021

**FORMER BRAINERD MANUFACTURING FACILITY SITE  
(VOLUNTARY CLEANUP SITE NO. V00519-8)**

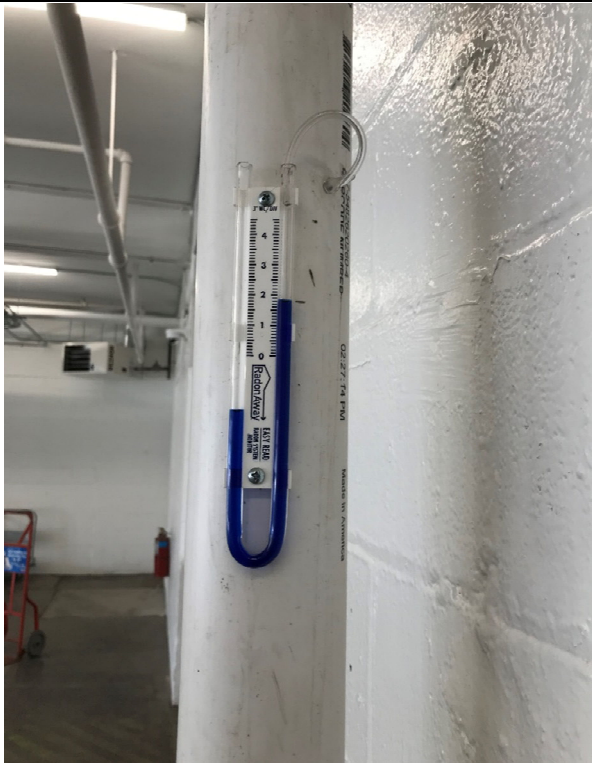
| <b>Description:</b><br>ASD Manometer and extraction point (Manometer 4). | | |

During the annual Site Inspection performed on February 4, 2021, the inspector verified that the ASD system was operating properly, as indicated by the readings on the vacuum gauges. At the time of the Site inspection ASD system Manometer 6 was inaccessible

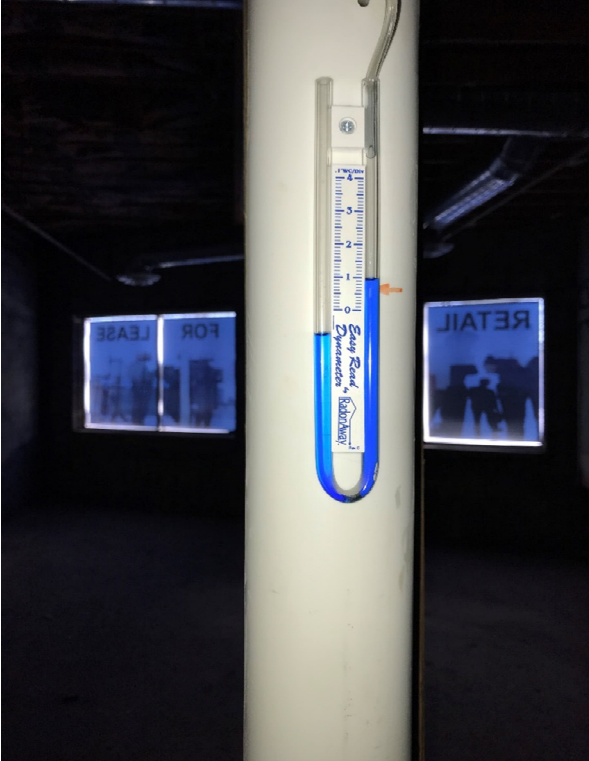
| <b>Description:</b><br>ASD Manometer and extraction point (Manometer 5). | | |

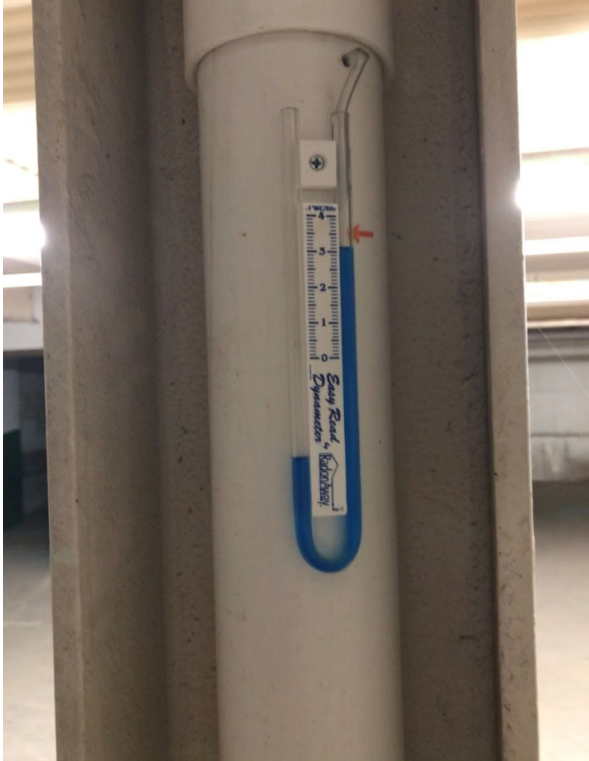
| <b>Description:</b><br>ASD Manometer and extraction point (Manometer 2). | | | |

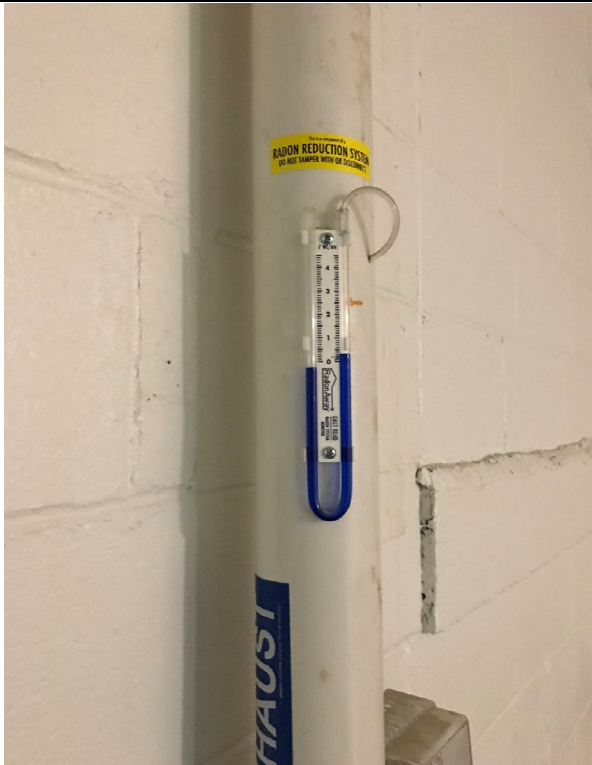
| <b>Description:</b><br>ASD Manometer and extraction point (Manometer 1). | | |

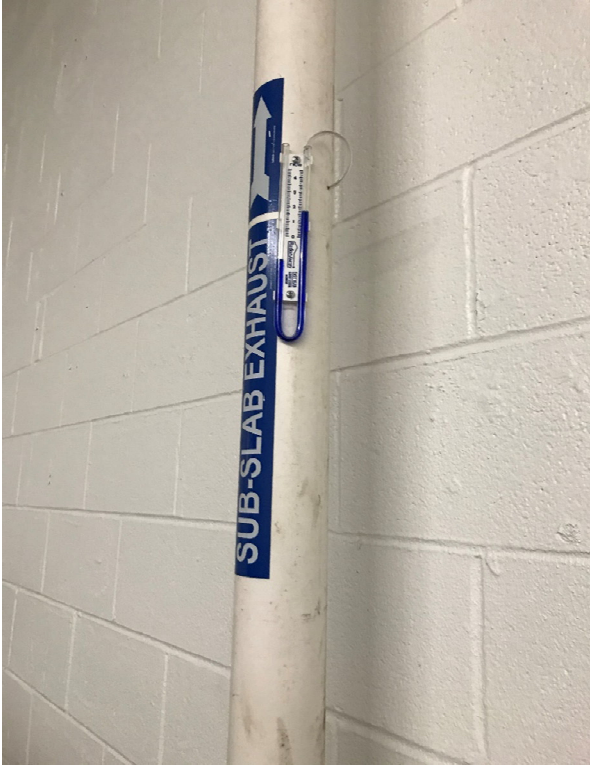
| <b>Description:</b><br>ASD Manometer and extraction point (Manometer 3). | | | |

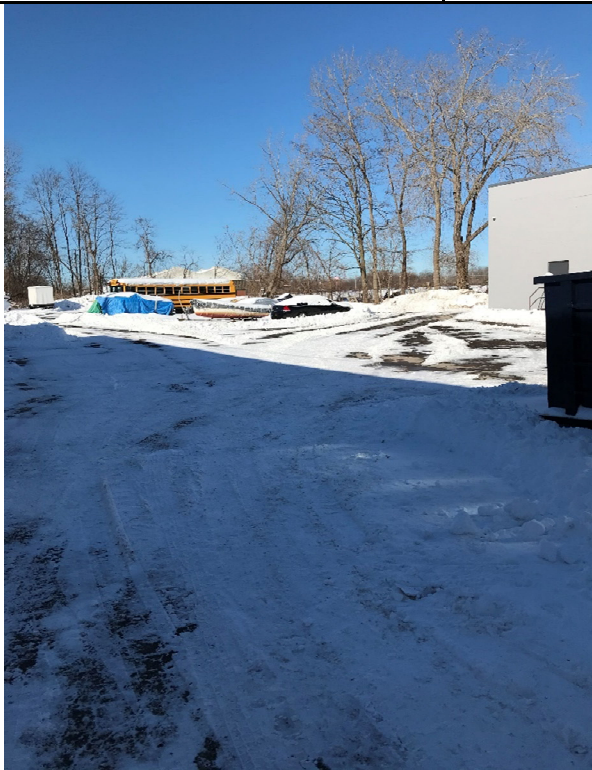
| <b>Description:</b><br>Cover area. | | | |

- Cover System – The cover system, including building foundations, concrete sidewalks, asphalt and gravel driveways and parking areas, and a nominal 25-foot long by 20-foot-wide engineered cover area are all being maintained in compliance with the SMP.

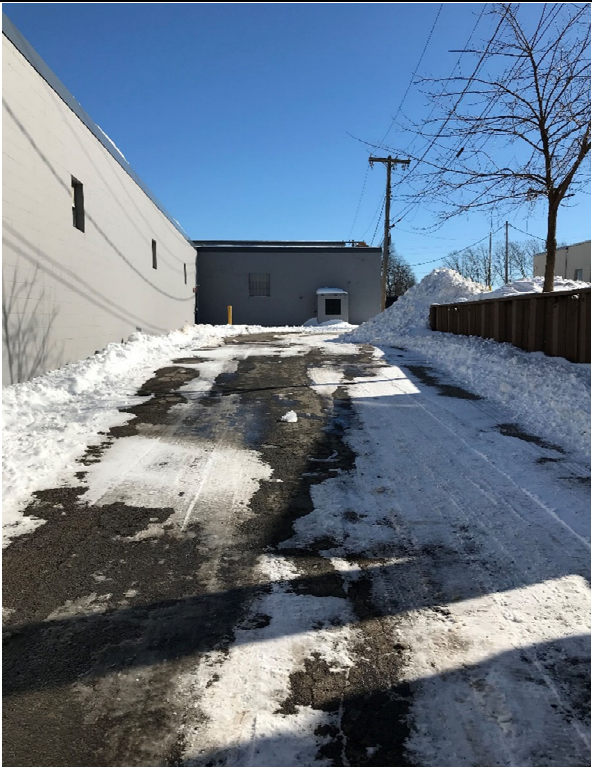
| <b>Description:</b><br>Building and former gPRO system. | | |

On October 22, 2019, Nothnagel Drilling, Inc. decommissioned the gPro groundwater treatment systems and three associated reinjection wells (grouted in place) located along Monroe Street (Figure 2).
