**NYSDEC VOLUNTARY CLEANUP
PROGRAM
FINAL
REMEDIAL INVESTIGATION WORK PLAN**

**1170 ATLANTIC AVENUE
BALDWIN, NEW YORK 11510**

**VCP # V00523
ATC PROJECT NUMBER 15-75181-0023**

**NYSDEC VOLUNTARY CLEANUP PROGRAM
FINAL REMEDIAL INVESTIGATION WORKPLAN
SAFEGUARD STORAGE PROPERTIES LLC FACILITY
1170 ATLANTIC AVENUE
BALDWIN, NEW YORK 11510**

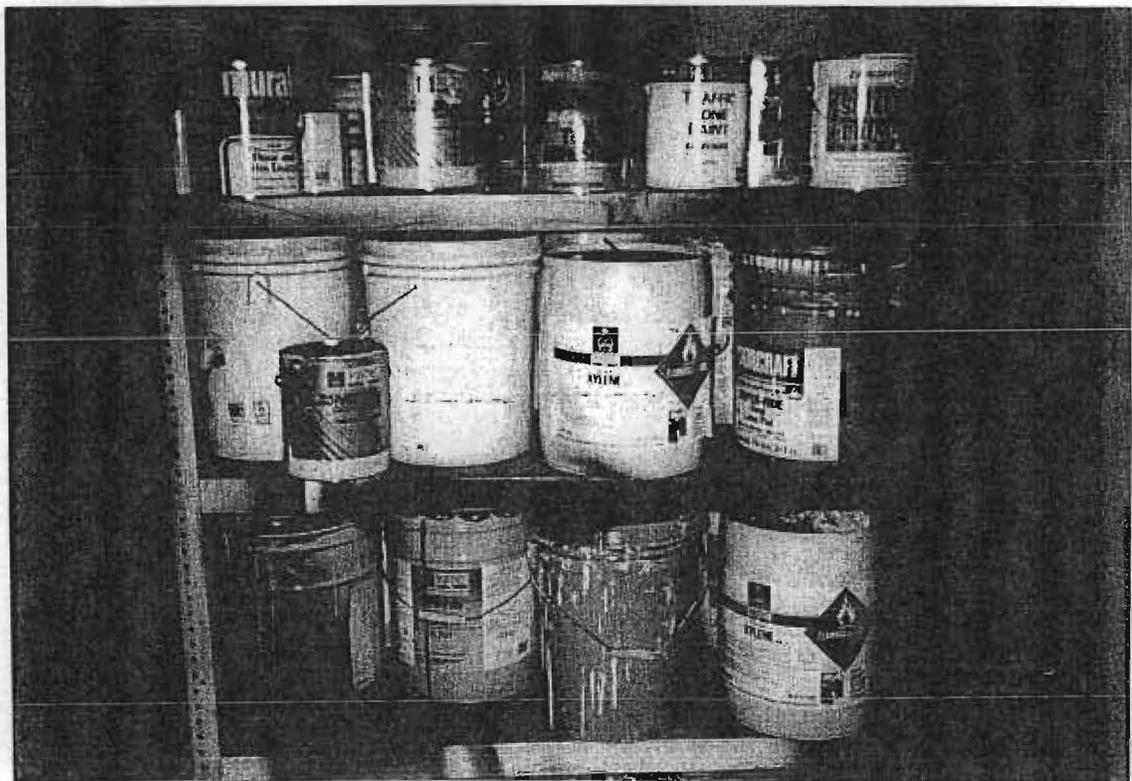
Xylenes and Paint Cans in Storage area.

The 1997 ESA was conducted when the prior tenant, Lightalarms, occupied the Site. At that time, ATC observed evidence that hazardous materials were used at the Site, including paints and solvents. The paint and solvent containers were stored on shelves without any floor stains evident, but were not locked in a chemical storage cabinet. According to the Site contact at that time, these materials were used during painting activities which ceased in 1995 due to neighborhood complaints about the odors generated. At that time, a spray booth with a permitted exhaust to the outside of the building was used to spray paint light fixtures and other components. The xylene and toluene were historically used to clean the paint spray guns.
