**CSXT RIVER STREET DERAILMENT SITE  
DREDGING INTERIM REMEDIAL MEASURE SUMMARY REPORT  
480 RIVER STREET  
ROCHESTER, NEW YORK**

May 20, 2005

*Prepared by:*  
**AMEC Earth & Environmental, Inc.**  
Edison Plaza, 2<sup>nd</sup> Floor  
155 Erie Boulevard  
Schenectady, New York 12305

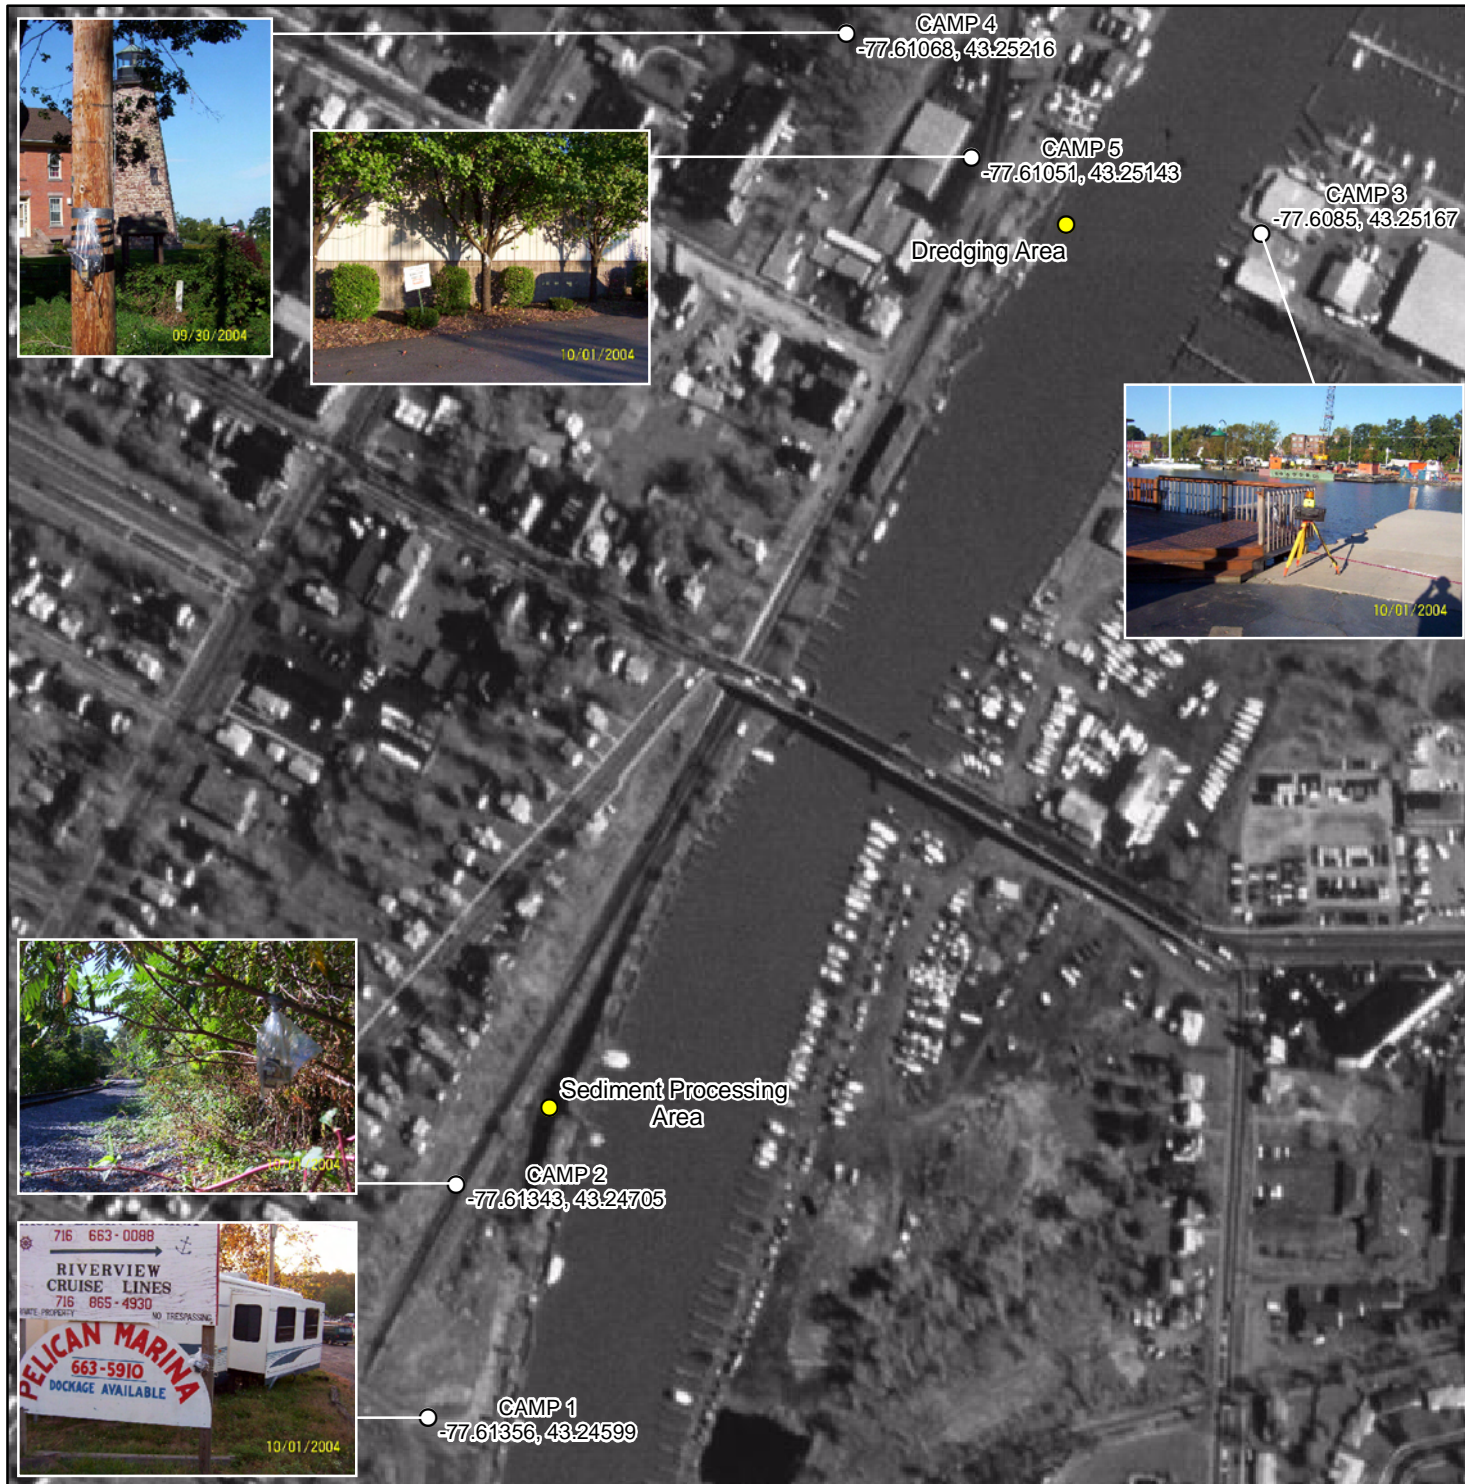
## Community Air Monitoring Plan Integrated Sampling Locations

The above samples were collected at the Sediment Processing Area, 110 Petten St. Rochester, NY 14612  
Aerial Imagery Source: USGS  
Projection: NAD 83 UTM Zone 18N  
Map Created: 16 May 2005

Sampling locations were chosen based upon the proximity of sensitive receptors to the Site and general wind direction. The five sampling locations are as noted below in and are visually depicted on **Figure 10**:
