**Dry Weather Discharge Evaluation
Work Plan**

Krasdale Foods Inc. Leasehold

Hunts Point Former Manufactured Gas Plant
Bronx, New York

January 2011 (Revised August 2011)

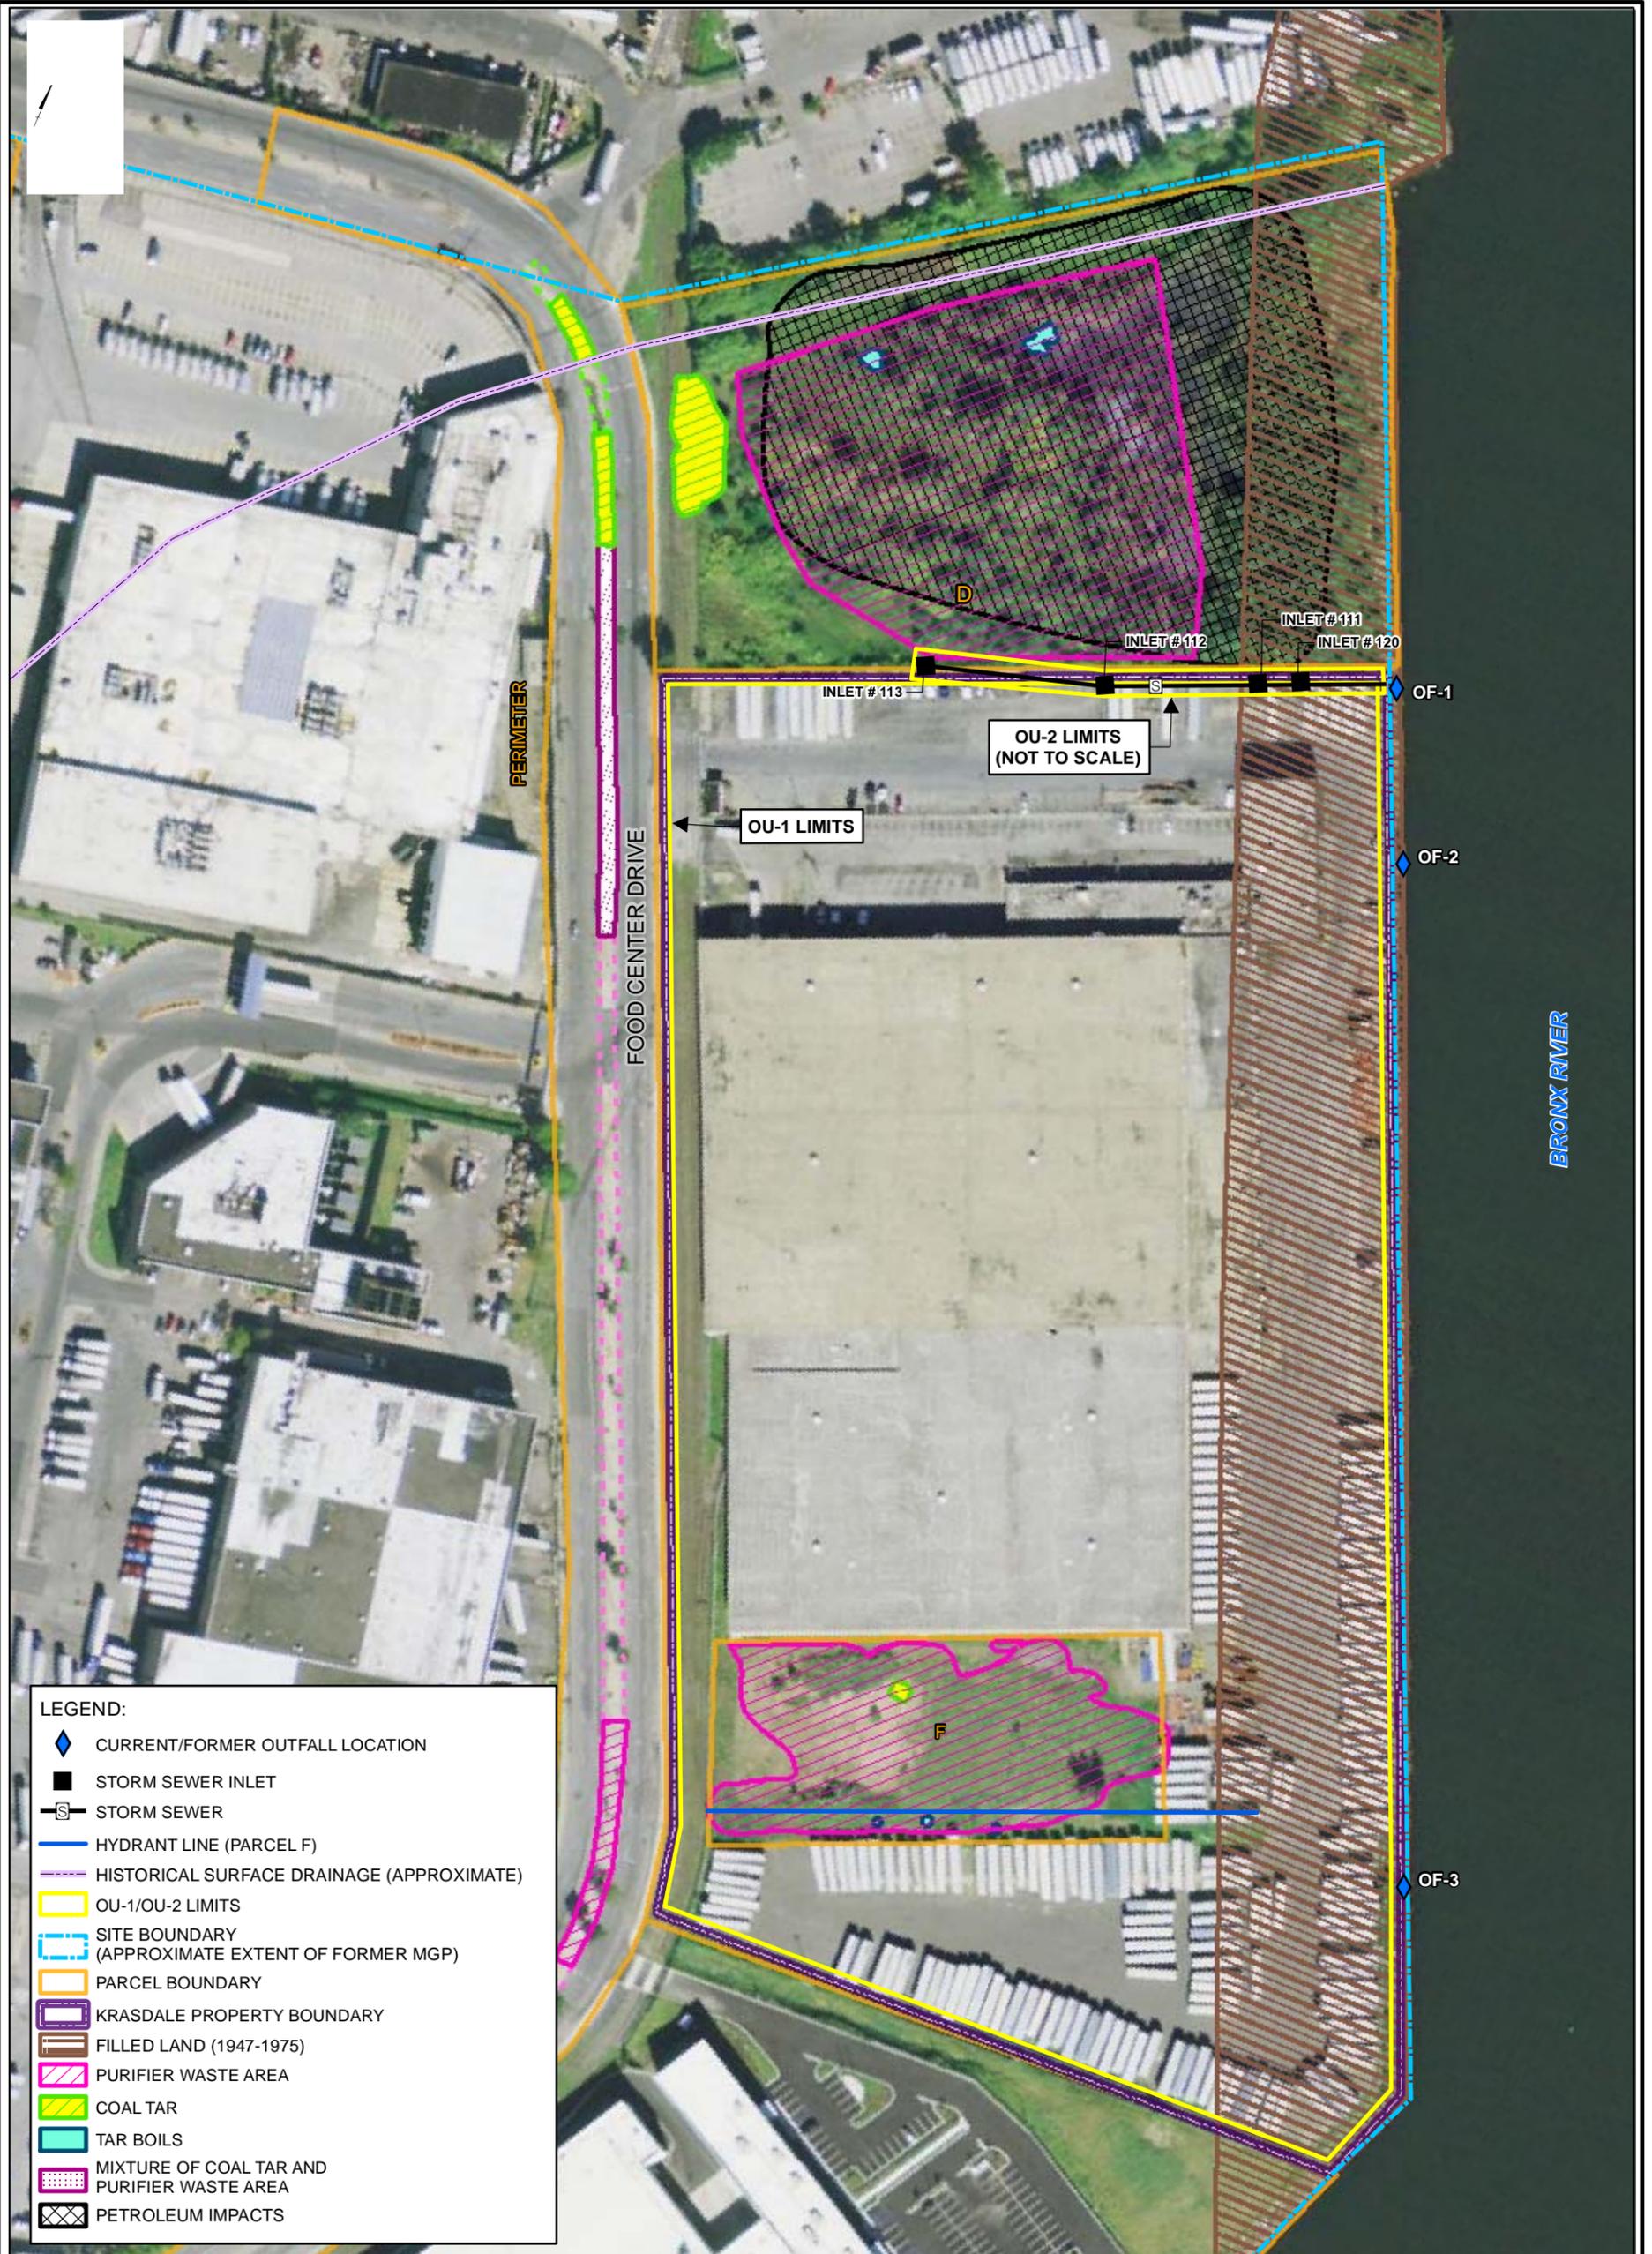
FIGURE
2

Figure 2 shows the approximate locations of the observed impacts on these parcels.

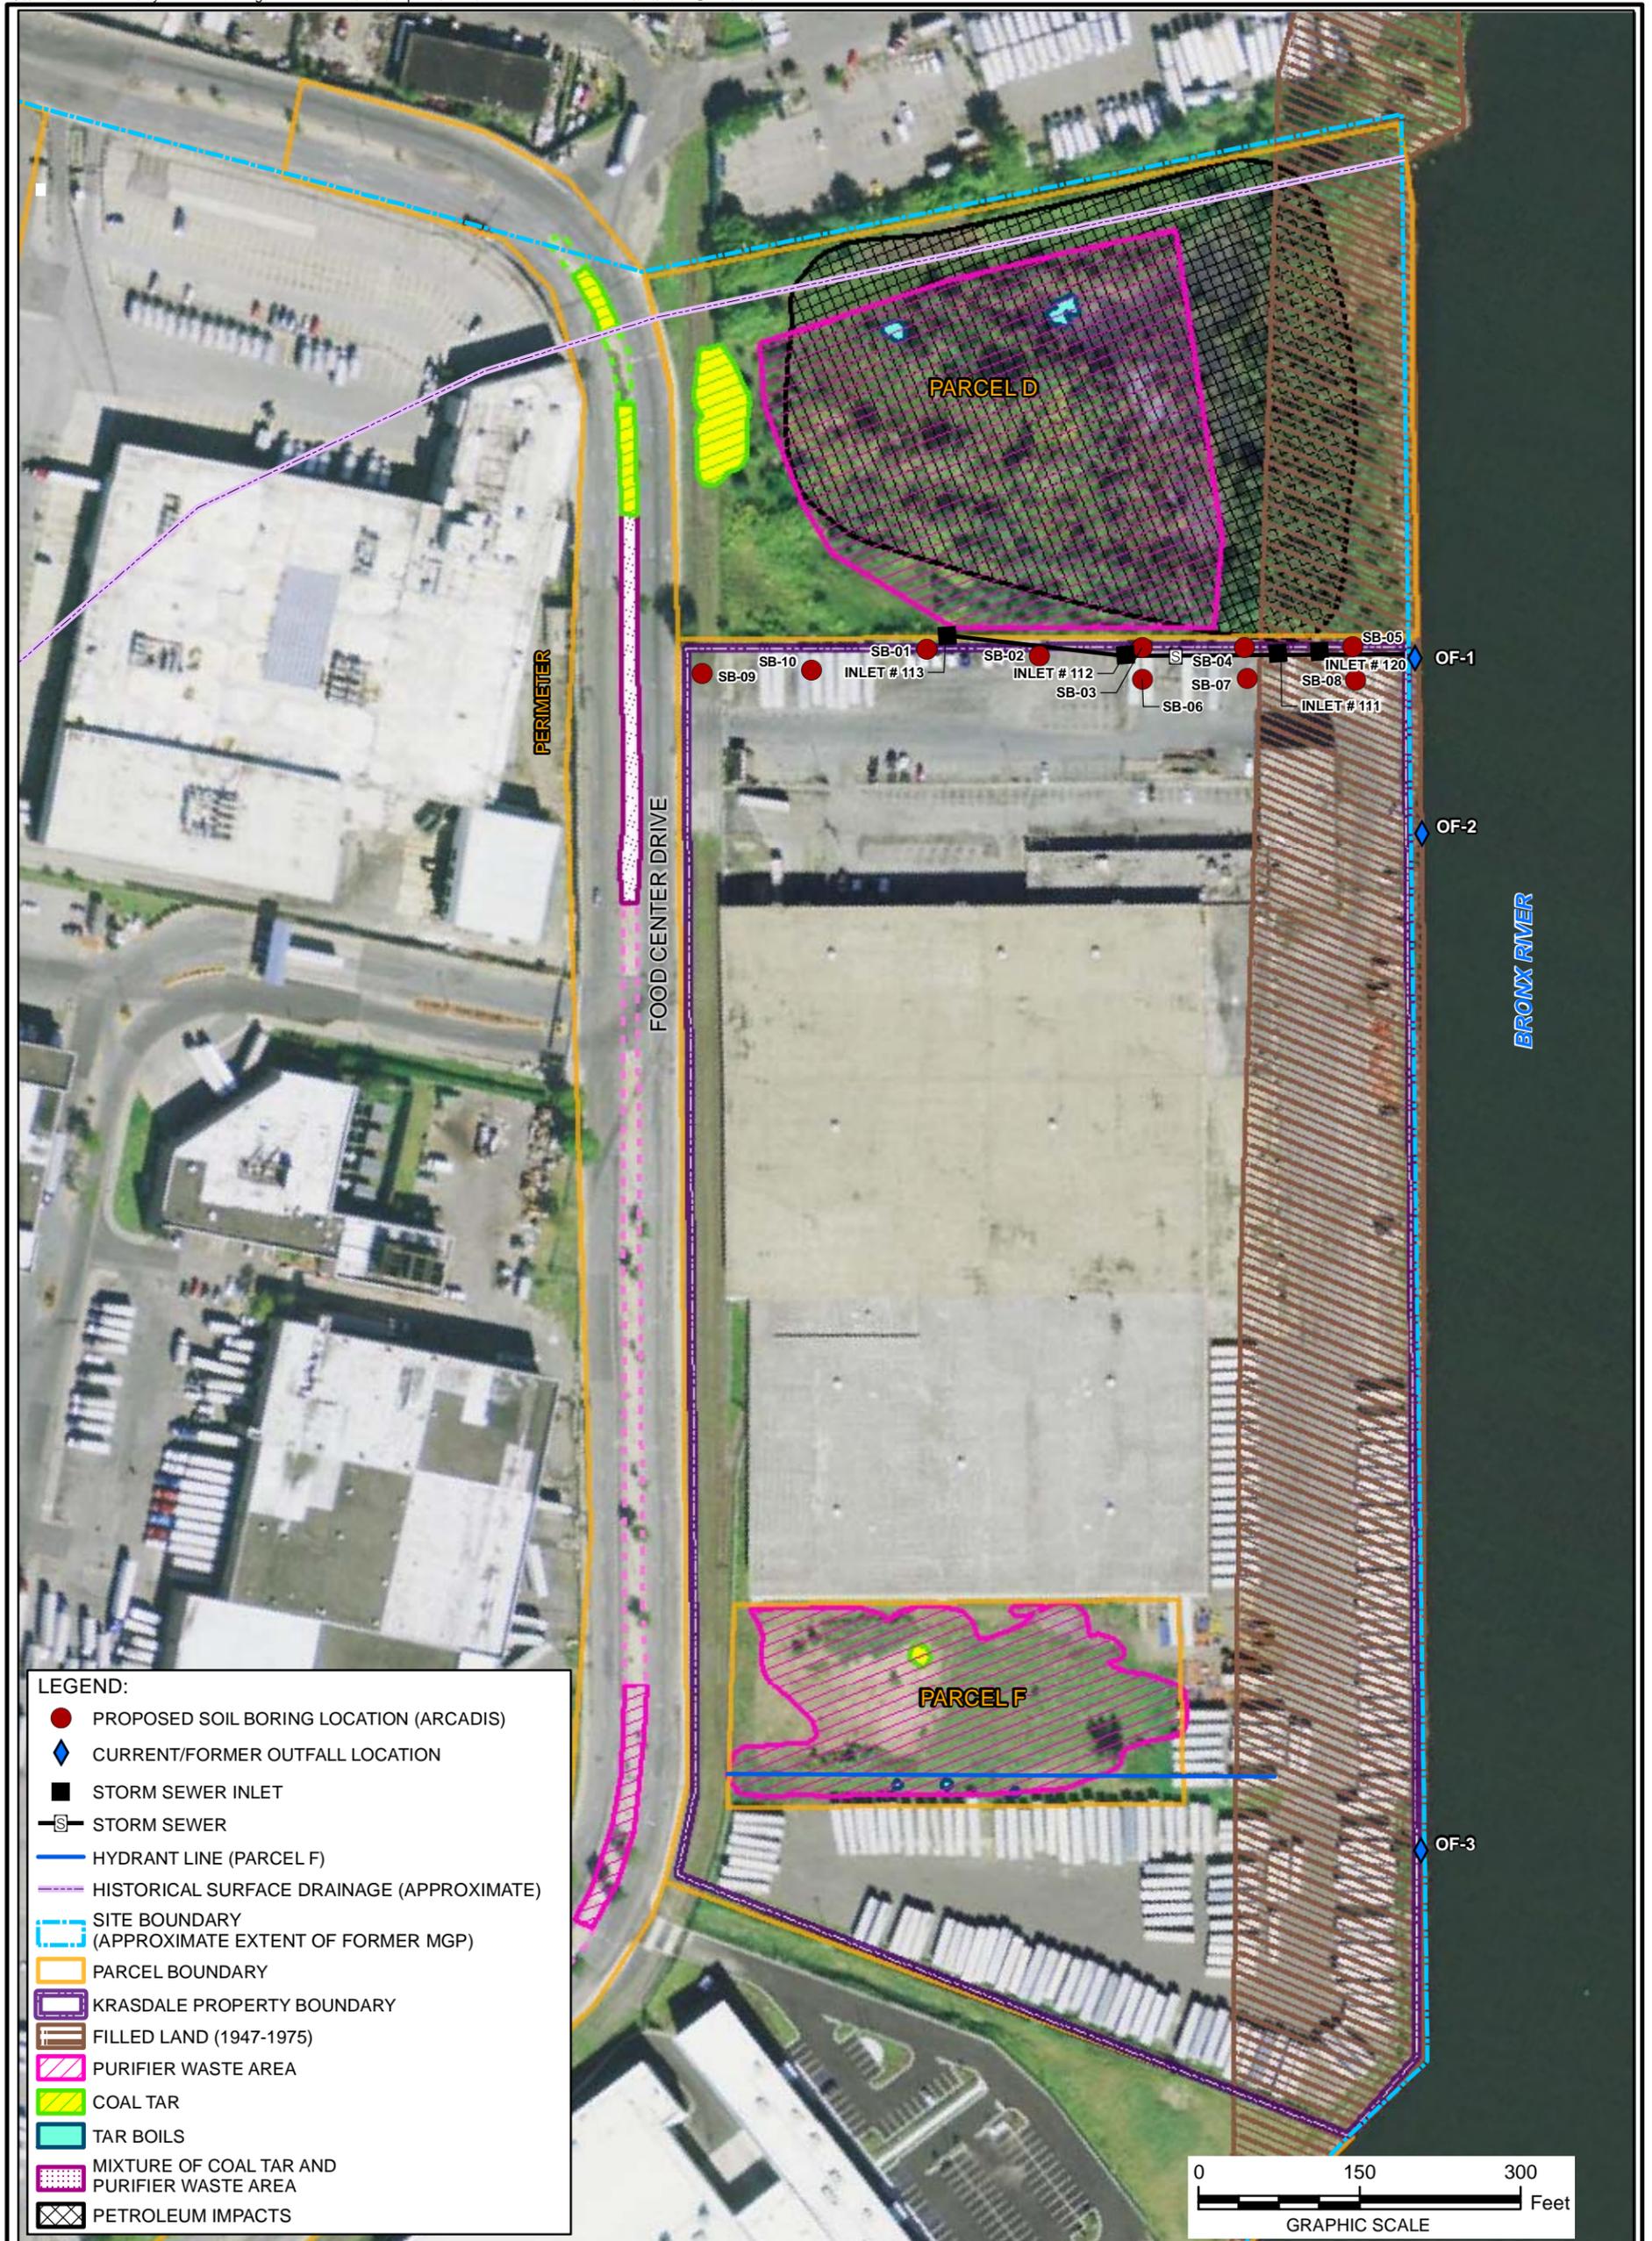
8. DURING SUBSURFACE INVESTIGATION ACTIVITIES, GROUNDWATER SAMPLES WILL BE COLLECTED AT THREE SOIL BORING LOCATIONS.
9. WATER SAMPLES WILL BE COLLECTED FROM STORMWATER INLETS AND OUTFALL OF-1 IF DRY-WEATHER DISCHARGE IS OBSERVED.

- Completion of 10 soil borings (i.e., SB-01 through SB-10) in the general vicinity of OU-2 to evaluate the presence of impacts near the boundary of Parcel D and the Krasdale property and along the storm sewer pipeline.
- Installation of three monitoring wells (i.e., one upgradient, one midpoint, and one downgradient) in the soil borings completed near the storm sewer and collection of groundwater samples from the wells.
- Collection of water samples from the storm sewer catch basins and outfall if a dry weather discharge is observed.

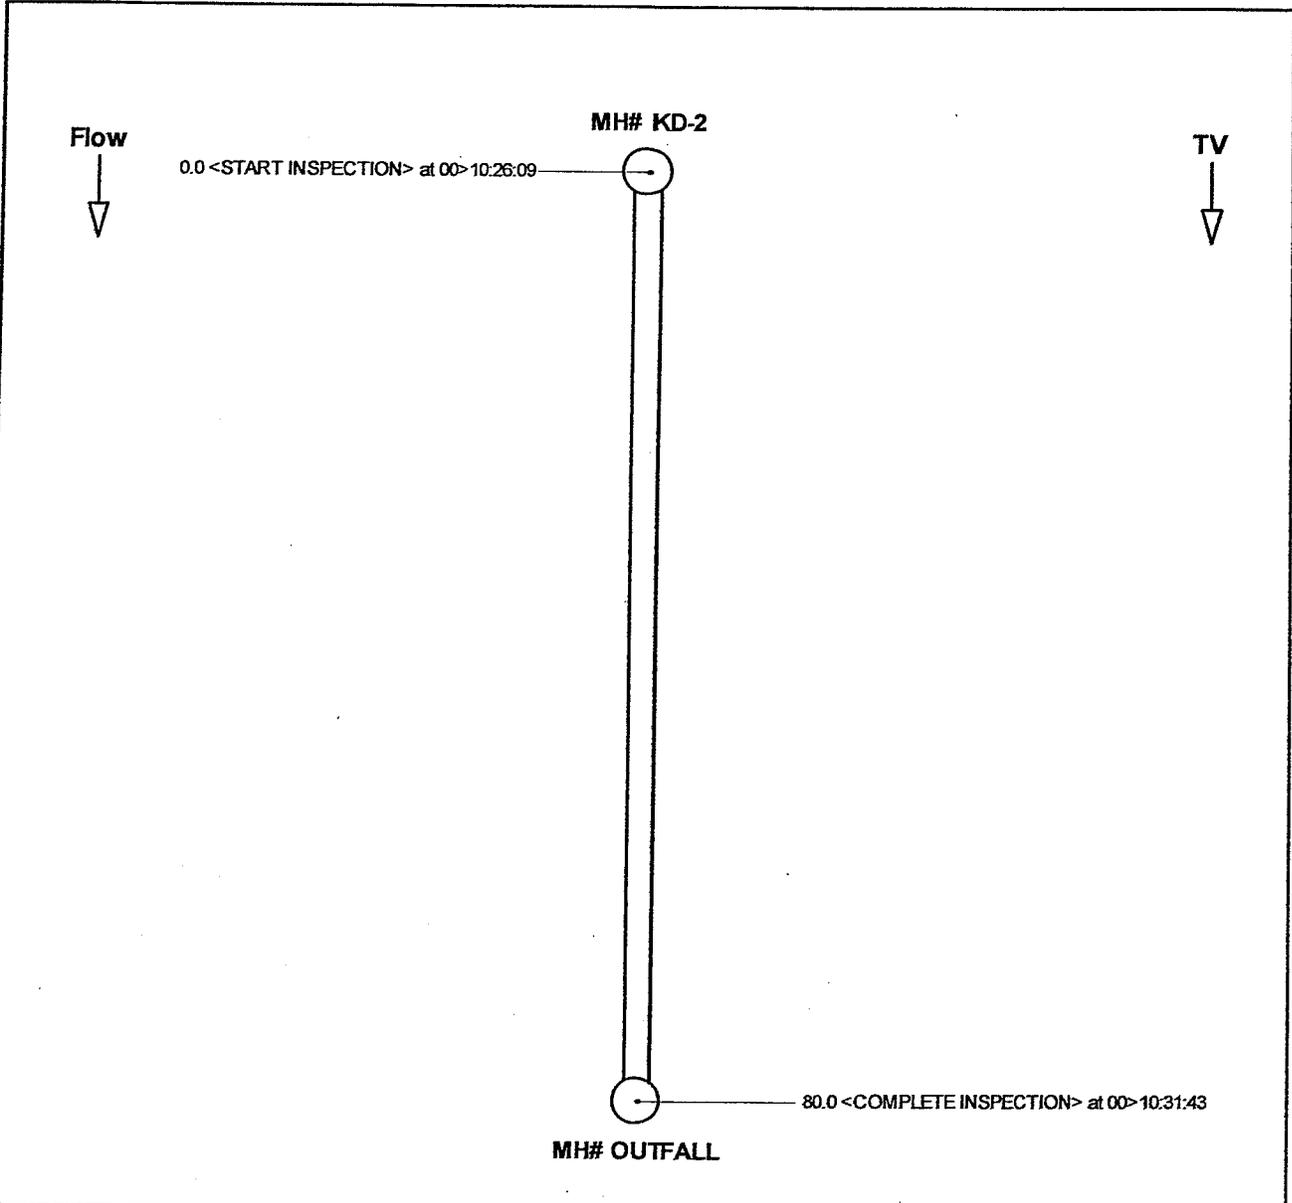
Address:	HUNTS POINT MARKET	Owner: AKRF ENGINEERING PC
MH:	KD-2 to OUTFALL

Footage	SF	CODE	Observation	Modifier	Imag	At	To	Dia	Loss	%	Gals	Str	OM
0.0			<START INSPECTION>	09:54:53									
0.3			SD WEAR LARGE AT 4 TO 8

4.0			SD WEAR LARGE AT 12 TO 12										
4.0			ISSR AT JT 3 TO 9										
			SEALING RING IS VISIBLE										
11.0			SD WEAR LARGE AT 4 TO 8										
15.1			SD WEAR LARGE AT 4 TO 8

15.1			ISSR AT JT 3 TO 9										
			SEALING RING IS VISIBLE										
19.7			SD WEAR LARGE AT 4 TO 8										
22.9			SD WEAR LARGE AT 4 TO 8										
23.0			ISSR AT JT 3 TO 9										
			SEALING RING IS VISIBLE

25.0			SD WEAR LARGE AT 4 TO 8										
31.0			ISSR AT JT 3-9										
			SEALING RING IS VISIBLE										
38.2			SD WEAR LARGE AT 4 TO 8										
39.0			ISSR AT JT 7 TO 10

39.0			SEALING RING IS VISIBLE										
43.9			SD WEAR LARGE AT 4 TO 8										
55.1			SD WEAR LARGE AT 4 TO 8										
69.9			DEBRIS 20% SEC LOSS

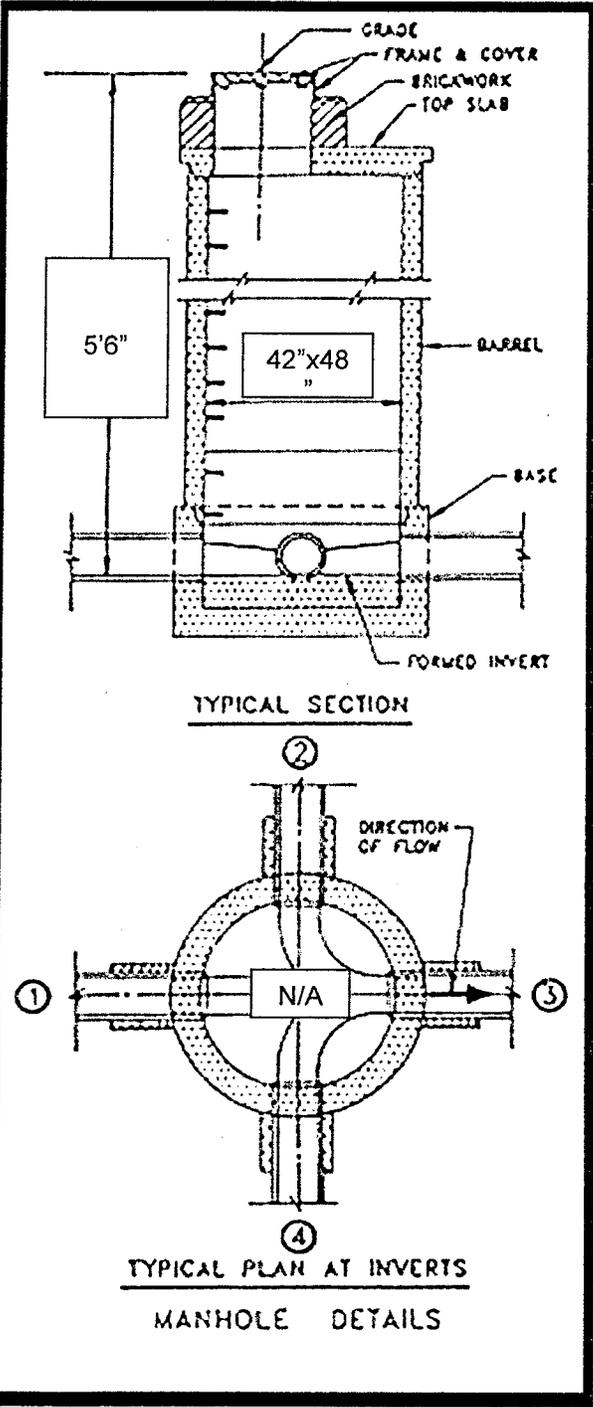
<u>ITEM</u>	<u>DESCRIPTION OF DEFECTS</u>			
COVER	Rusted			
FRAME	Rusted			
BRICKWORK	No			
DOME	No			
MH STEPS	No			
OTHER				
<u>BARREL</u>	Catch Basin			
CONCRETE	Poor – Heavy Erosion			
LEAKS				
OTHER				
<u>BASE</u>				
CONCRETE	Poor – Heavy Erosion			
LEAKS				
pH				
OTHER				
<u>INVERT</u>				
CONCRETE	Poor – Heavy Erosion			
LEAKS				
OTHER				
<u>PIPES</u>	1	2	3	4
SIZE (INCHES)	15"		15"	
PIPE MATERIAL	Cement		Cement	
CROWN pH				
DESCRIPTION OF DEFECTS				
PHOTO INFORMATION (CLICK ON PHOTO)

REMARKS: Bottom of structure has heavy wear erosion

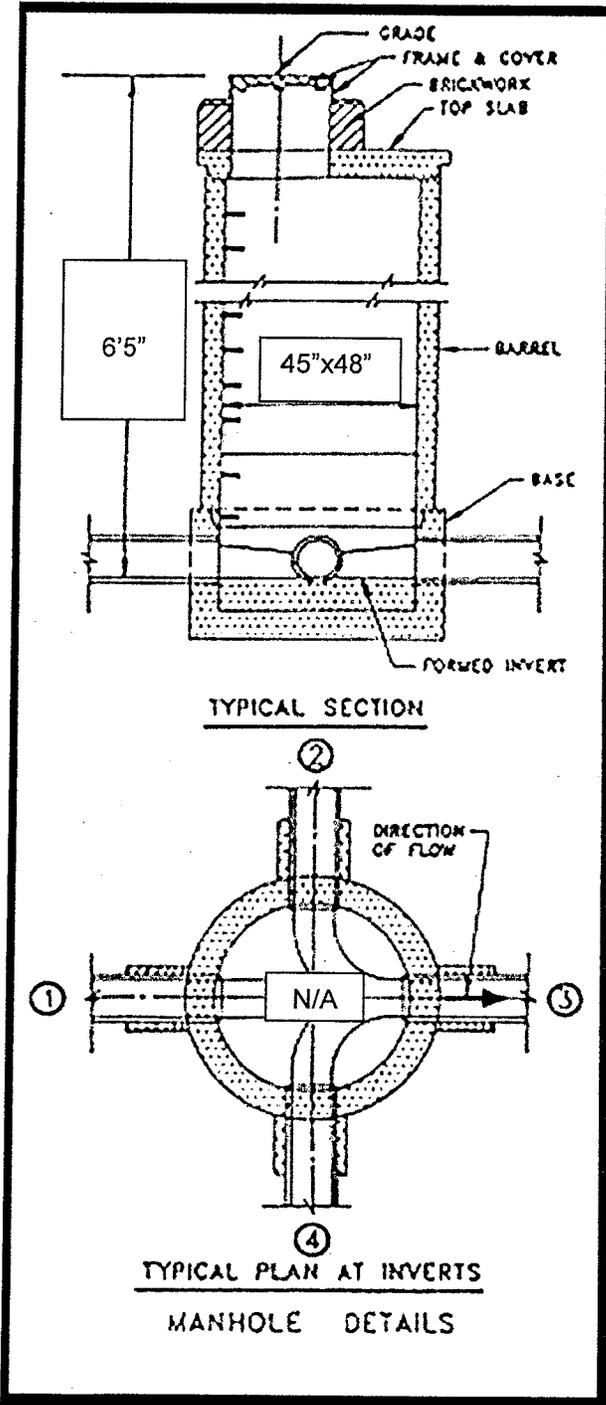
<u>ITEM</u>	<u>DESCRIPTION OF DEFECTS</u>			
COVER	Rusted			
FRAME	Rusted			
BRICKWORK	Wear Erosion			
DOME	No			
MH STEPS	No			
OTHER				
<u>BARREL</u>	Catch Basin			
CONCRETE	Yes – Heavy Erosion			
LEAKS				
OTHER				
<u>BASE</u>				
CONCRETE	Yes – Heavy Erosion			
LEAKS				
pH				
OTHER				
<u>INVERT</u>				
CONCRETE				
LEAKS				
OTHER	Poor – Heavy Erosion			
<u>PIPES</u>	1	2	3	4
SIZE (INCHES)		12"	20"	20"
PIPE MATERIAL		Cement	Cement	Cement
CROWN pH				
DESCRIPTION OF DEFECTS				
PHOTO INFORMATION (CLICK ON PHOTO)

REMARKS: Bottom of structure has heavy wear erosion
