# Periodic Review Report

**Former Orangeburg Pipe Manufacturing – Lowe's Site**

**NYSDEC Site #: V00579**

**April 2020**

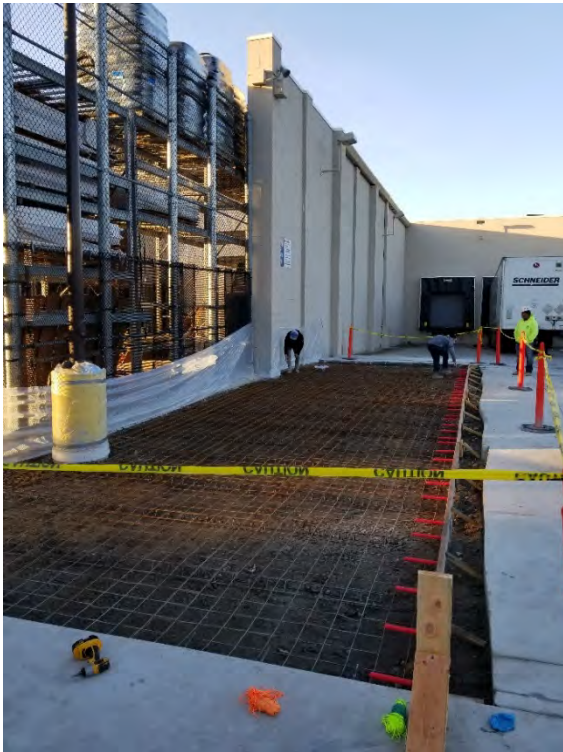
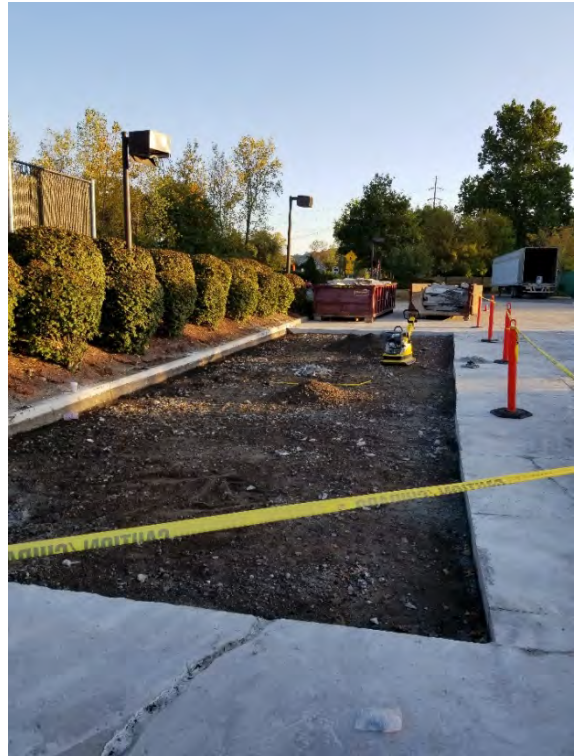
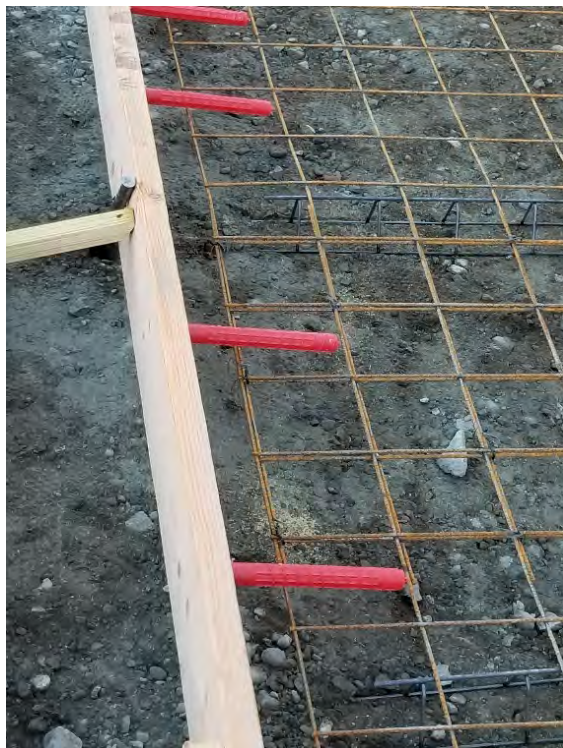
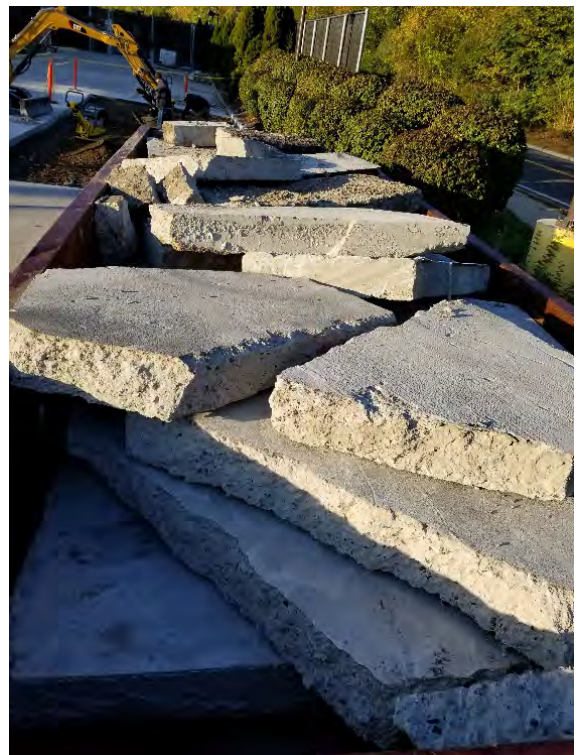
## PHOTO LOG – Concrete Slab Replacement Activity – October 2017

**Photos of Concrete Slab Areas – During Removal**

1. In October 2017, Lowe's removed and replaced several sections of the exterior concrete slab in the general loading dock area off the northwest corner area of the building and the outdoor garden center. The concrete in this area was settling a bit and cracking in several locations. The concrete replacement activities did not disturb the sub-base materials below the concrete slab and did not disturb the historic fill materials below the cap materials. No soils from under the concrete slabs were removed from the site as part of these activities. HDR conducted several site visits during these activities to document that the historic fill material below the cap were not being disturbed. Appendix A contains documentation and photos taken during these concrete slab removal and replacement activities.

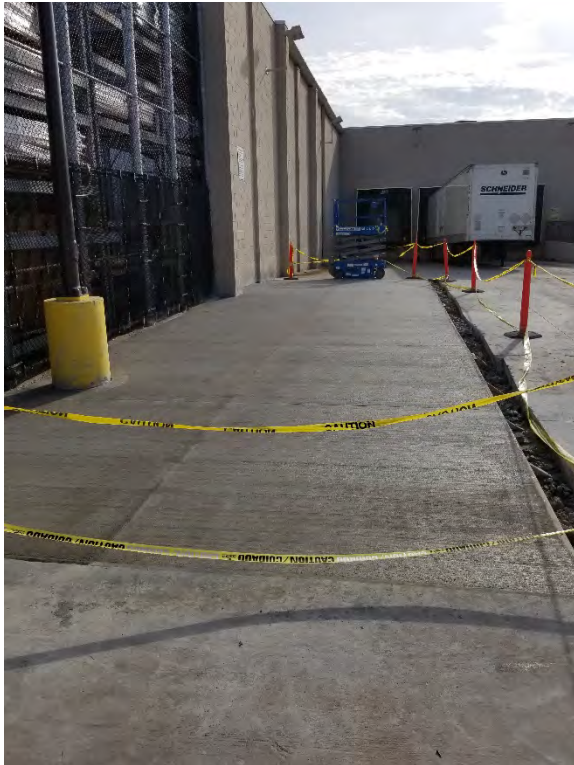
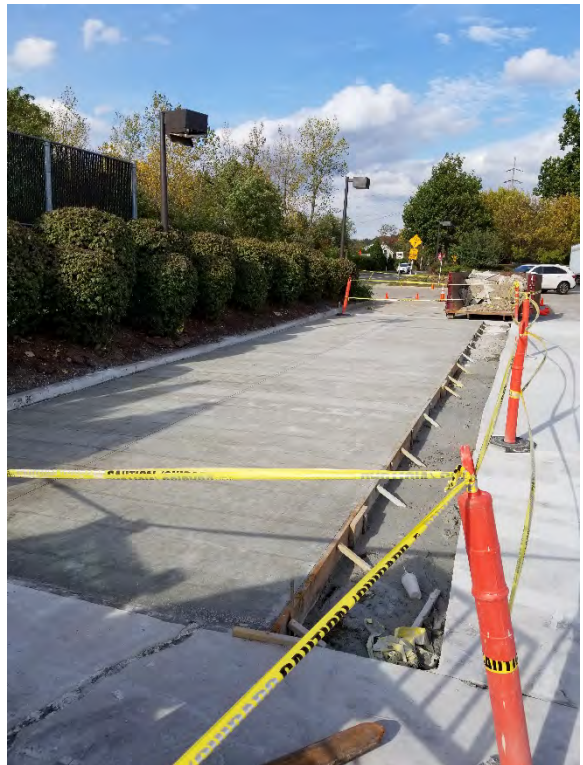
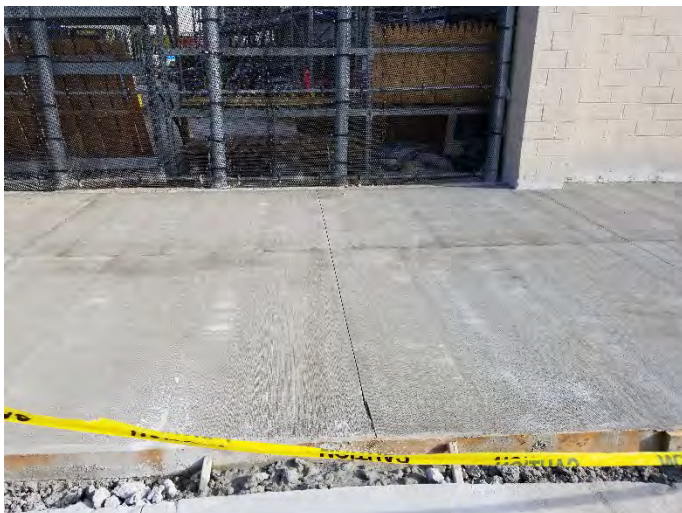
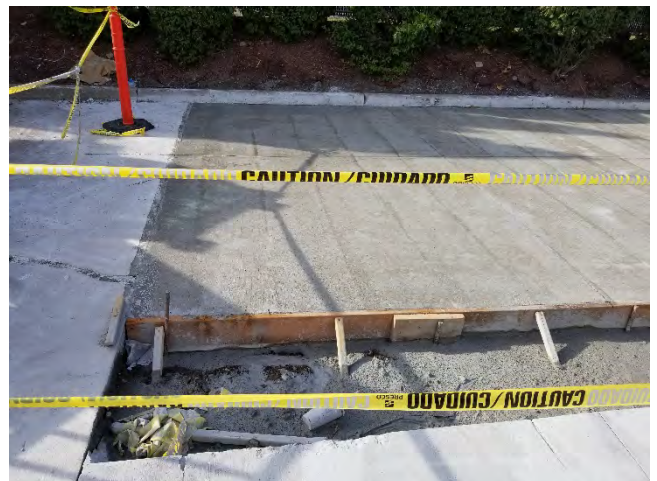
## PHOTO LOG – Concrete Slab Replacement Activity – October 2017

**Photos of Concrete  
Slab Replacement**

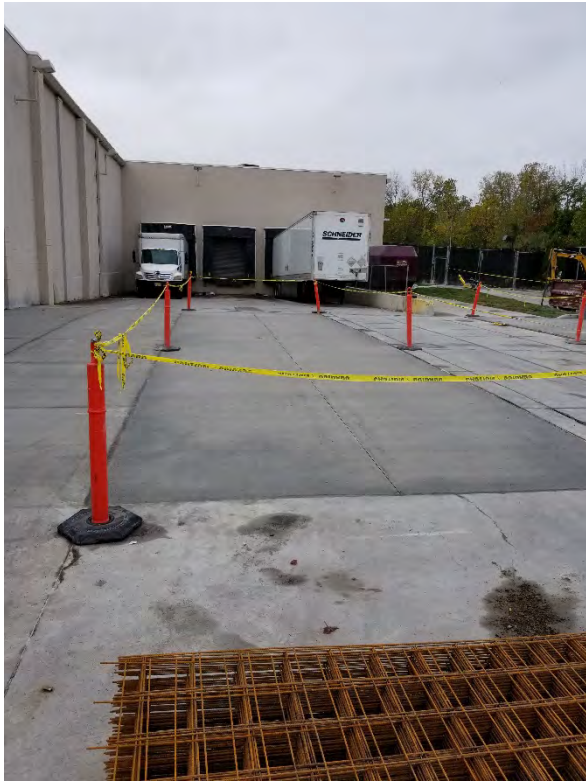
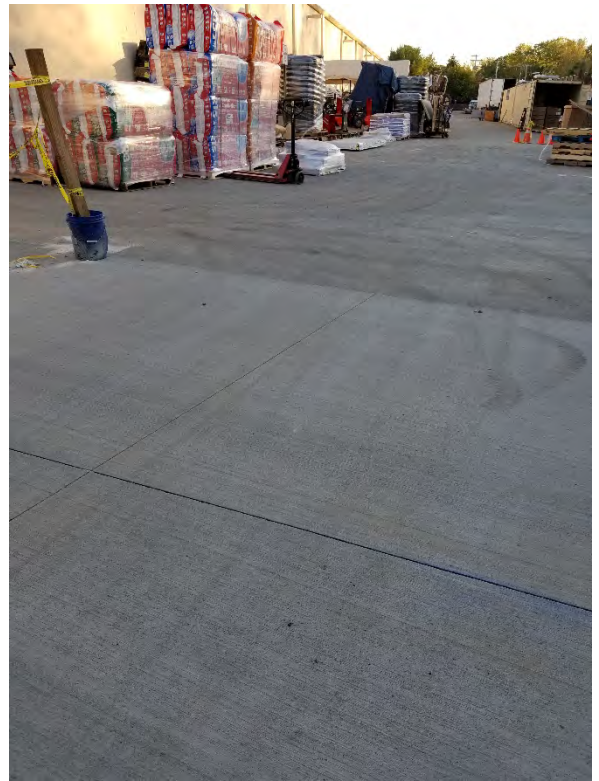
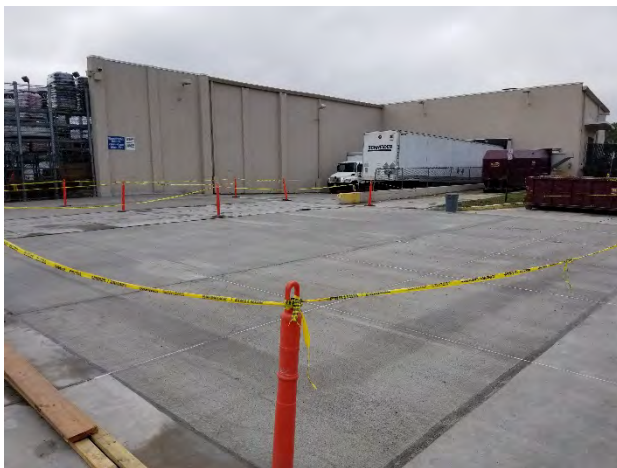
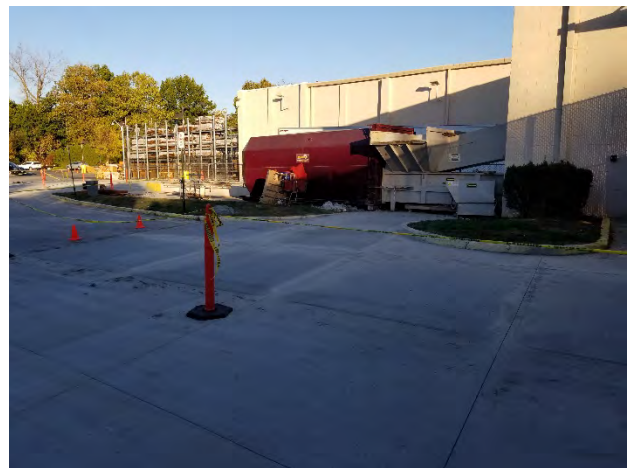
## PHOTO LOG – Concrete Slab Replacement Activity – October 2017

**Photos of Concrete  
Slab Replacement**

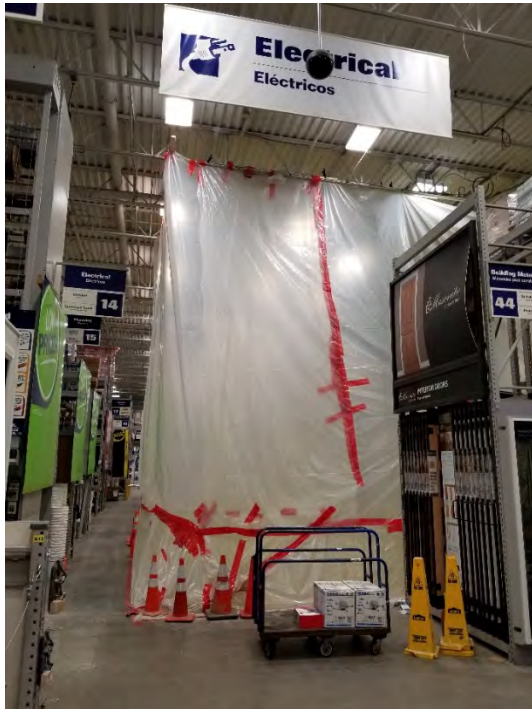
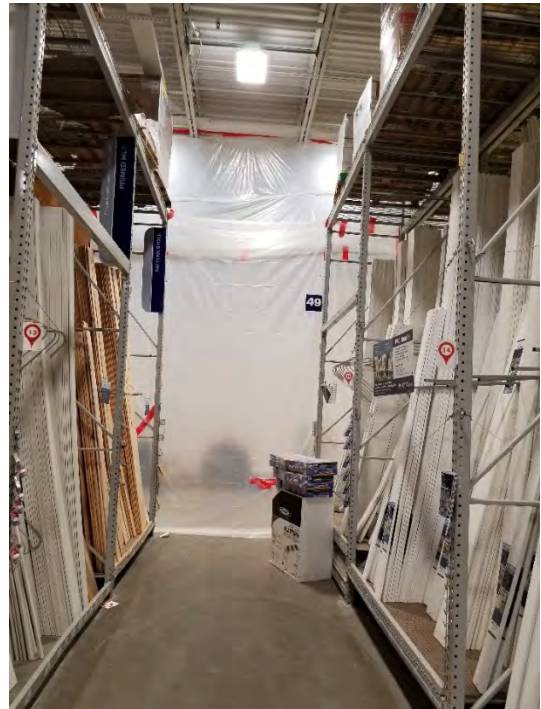
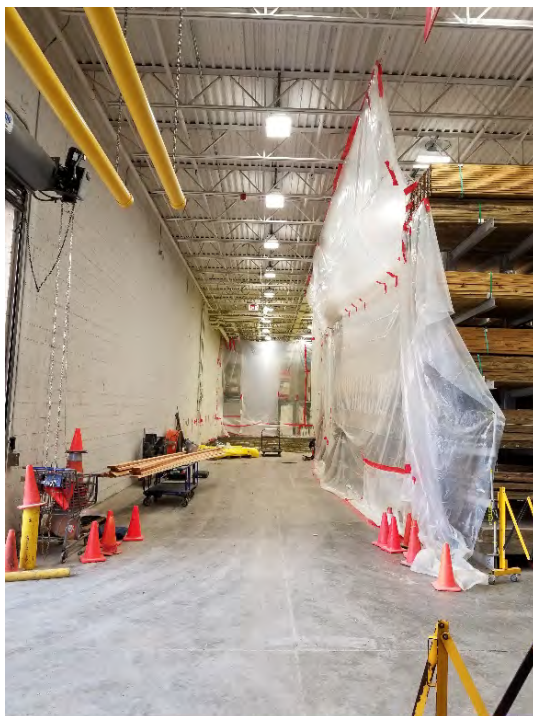
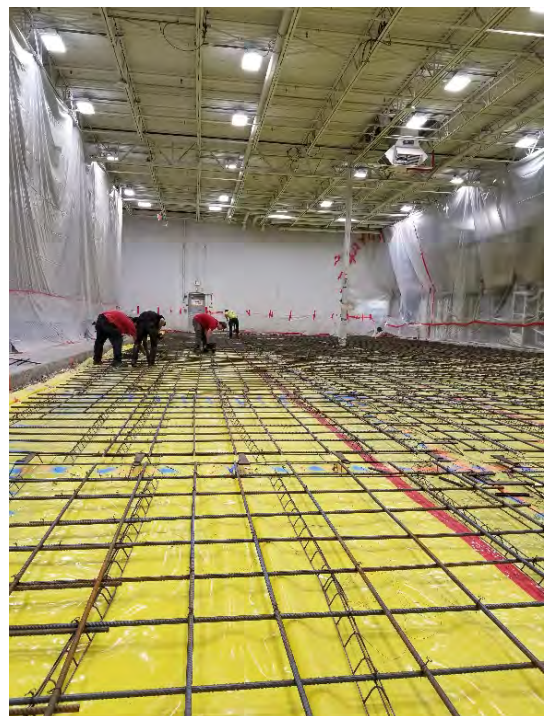
## PHOTO LOG – Concrete Slab Replacement Activity –February 2018

**Photos of Isolated Work Areas Inside Building –  
During Slab Removal & Replacement**

2. In February and March 2018, Lowe's removed and replaced several sections of the interior concrete slab in the lumber area section of the store. It was noted that there has been settlement of the concrete slab in this area of the building for a number of years. Lowe's initially used a process where they injected foam underneath the settling slab sections to bring them back up to the proper grade. After several years of using the foam injection procedures, Lowe's decided that they needed to replace the interior concrete slabs in several locations as the settlement issues persisted in some areas. For the interior concrete slab replacement activities, the area was cleared and prepped and plastic sheeting was installed from floor to ceiling surrounding the work area so the work would not disturb the patrons in the store and dust and/or debris would be contained in the work area. The interior concrete replacement activities did not disturb the sub-base materials below the concrete slab and did not disturb the historic fill materials below the cap materials. No soils from below the concrete slabs were removed from the site as part of this activity. HDR conducted several site visits during this work to document that the historic fill material below the cap was not being disturbed. Appendix A contains photos taken during these concrete slab removal and replacement activities.

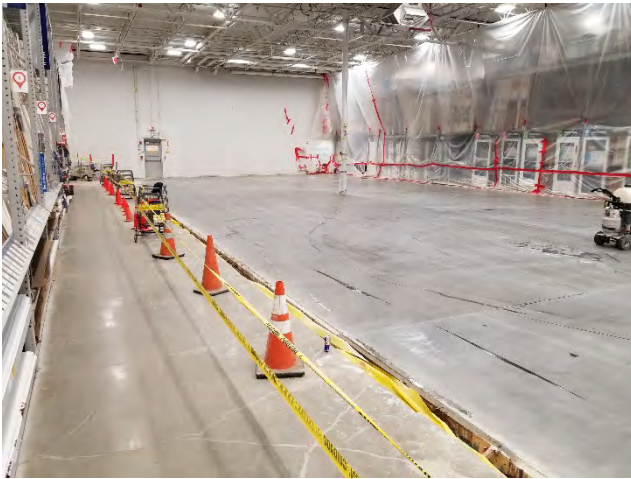
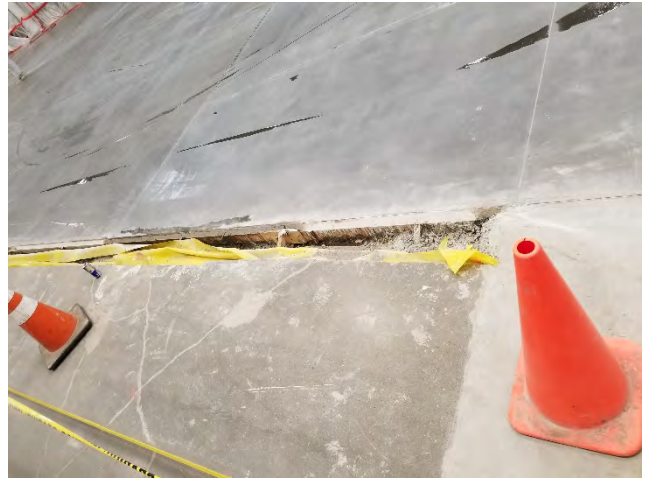
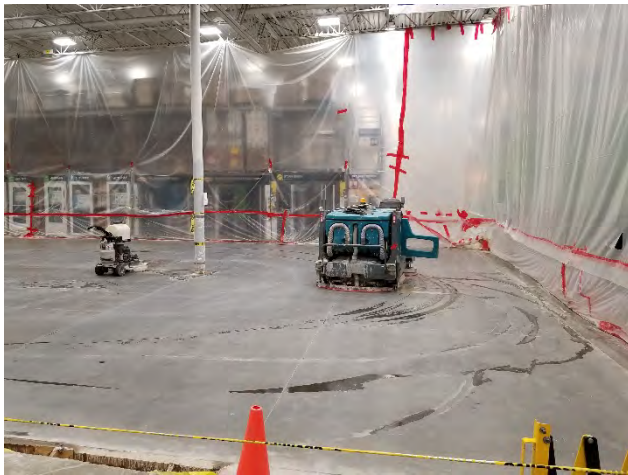
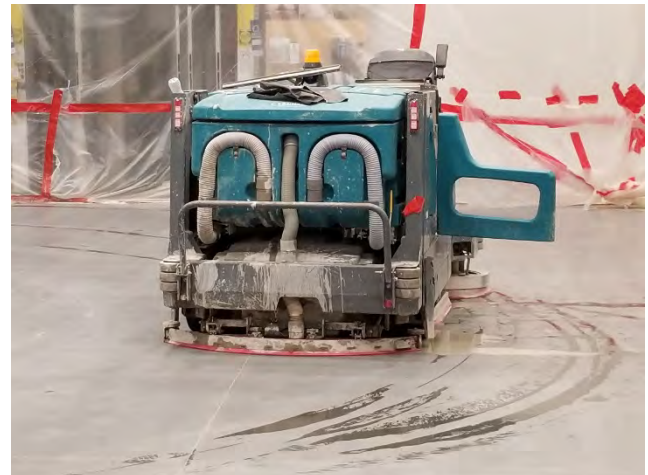
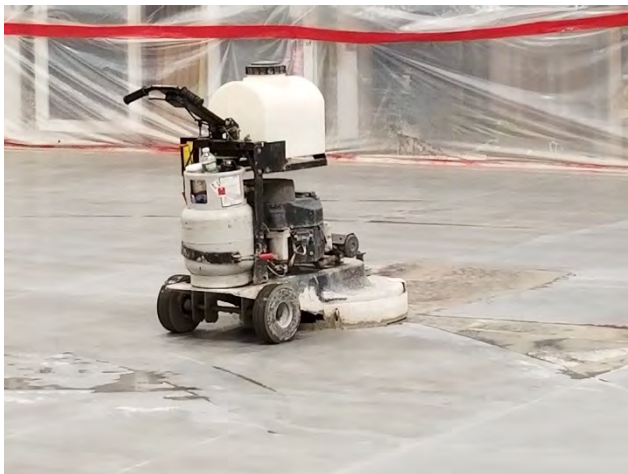
## PHOTO LOG – Concrete Slab Replacement Activity –February 2018

**Photos of Isolated Work  
Areas Inside Building –  
During Slab Replacement**

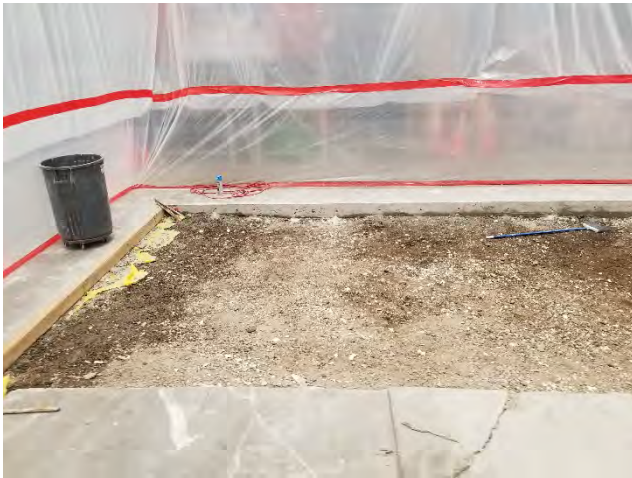
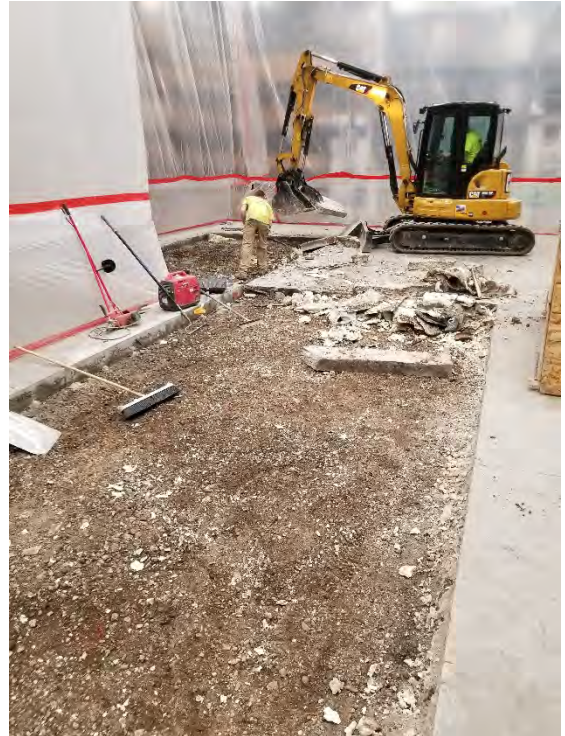
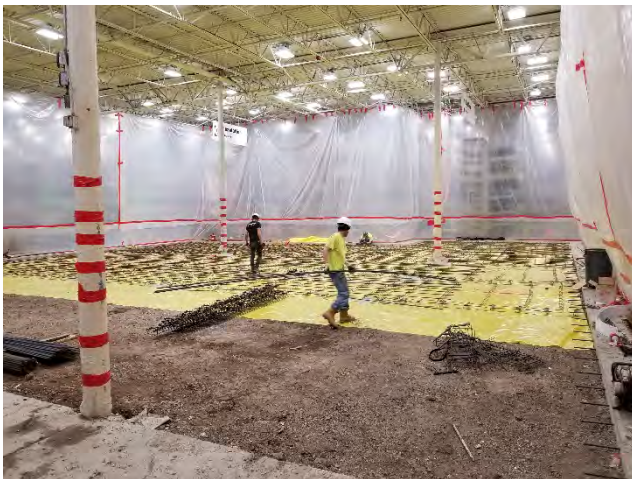
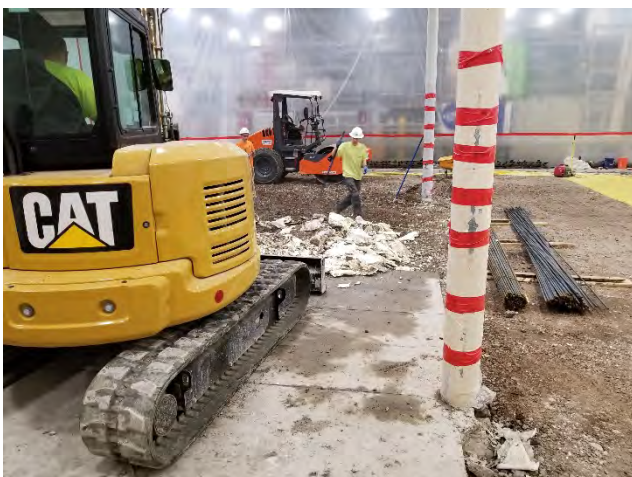
## PHOTO LOG – Concrete Slab Replacement Activity –March 2018

**Photos of Isolated Work  
Areas Inside Building –  
During Slab Removal**

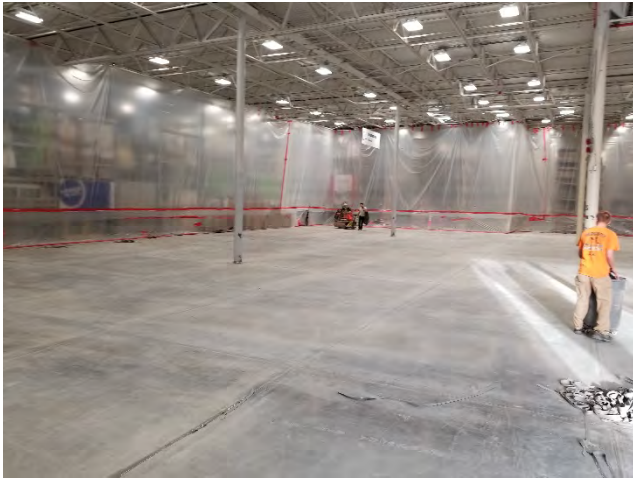
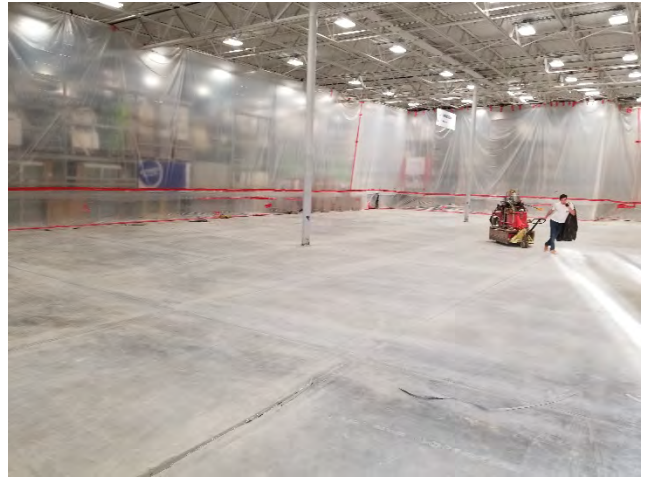
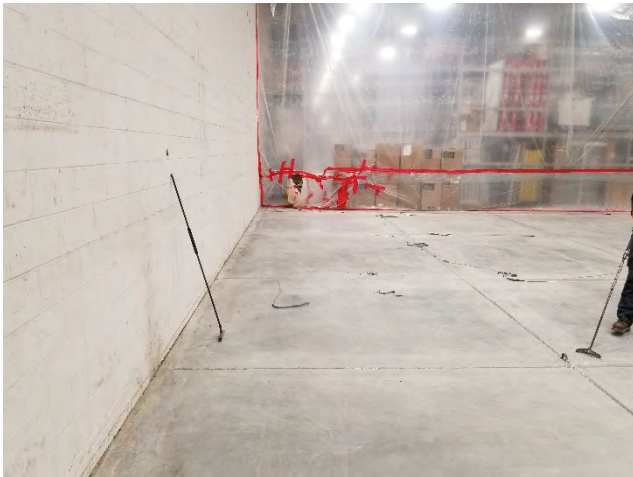
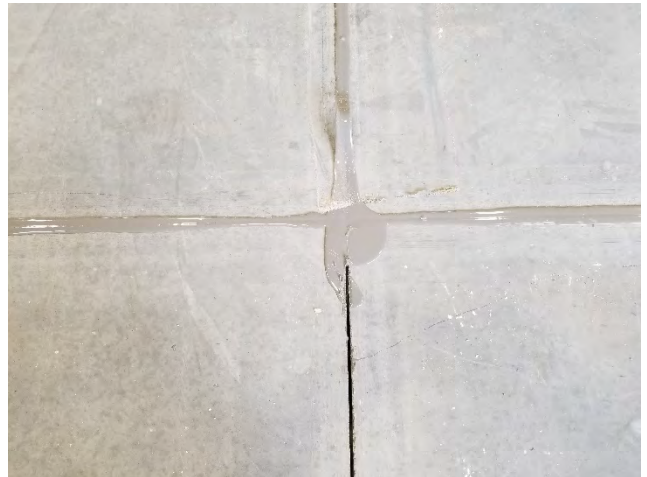
## **PHOTO LOG – Concrete Slab Replacement Activity –March 2018**

**Photos of Isolated Work Areas Inside Building –  
During Slab Replacement**

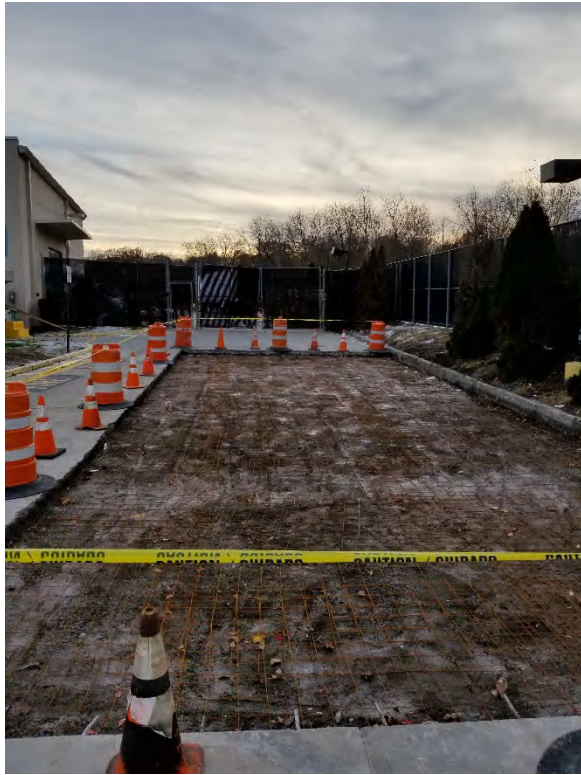
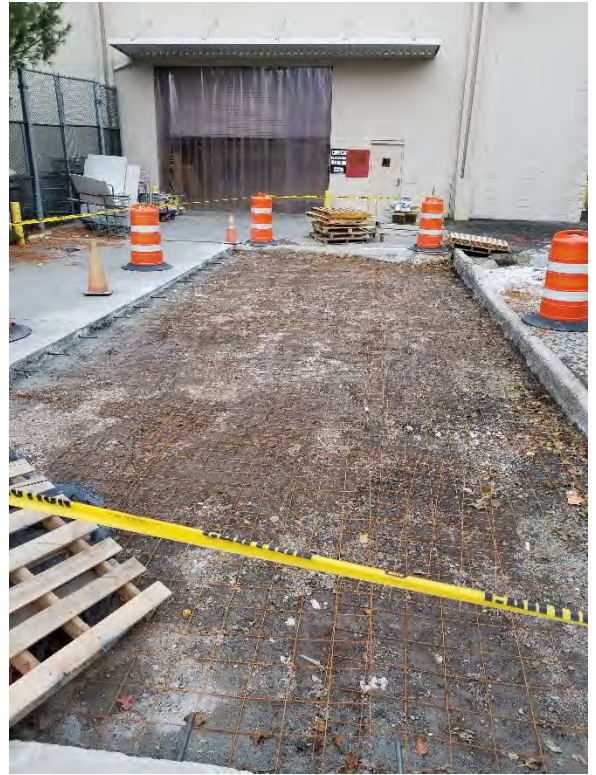
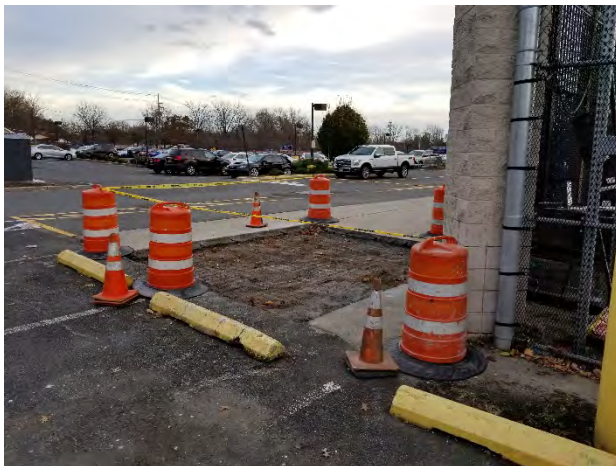
## PHOTO LOG – Concrete Slab Replacement Activity – November-December 2018

**Photos of Concrete Slab Areas – After Removal**

3. In November and December 2018, Lowe's removed and replaced several sections of the exterior concrete slab in the general loading dock area off the northwest corner of the building and the outdoor garden center as well as the storage area along the back of the building and the loading dock area at the southwest corner area of the building. The concrete slabs in these area were settling a bit and cracking in several locations. In addition, Lowe's removed and replaced several sections of the sidewalks along the east and west sides of the property that had settled or cracked or had begun to tilt. The concrete replacement activities did not disturb the sub-base materials below the concrete slab and did not disturb the historic fill materials below the cap materials. No soils from below the concrete slabs were removed from the site as part of these activities. HDR conducted several site visits during these activities to document that the historic fill material below the cap were not being disturbed. Appendix A contains photos taken during these concrete slab removal and replacement activities.

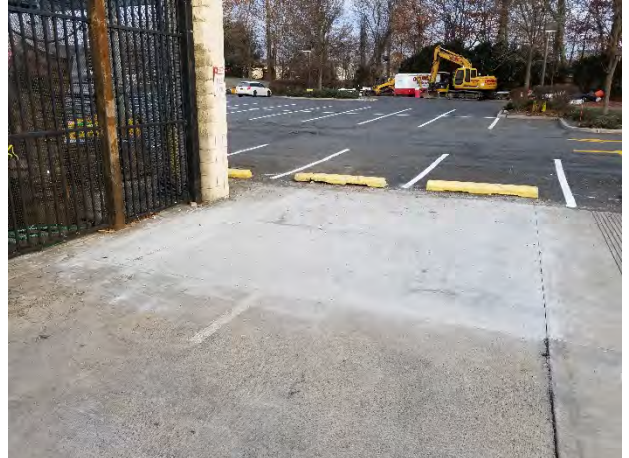
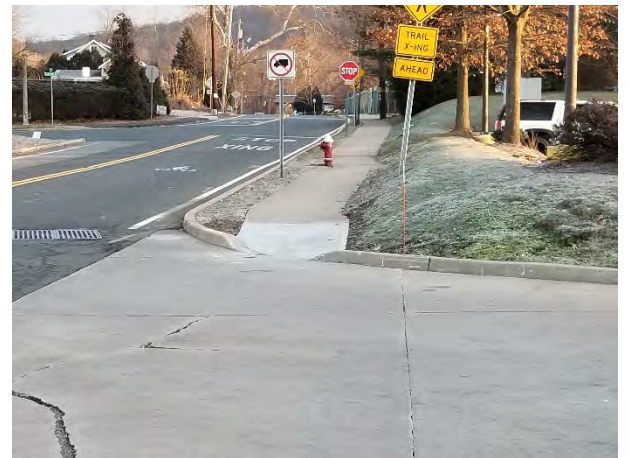
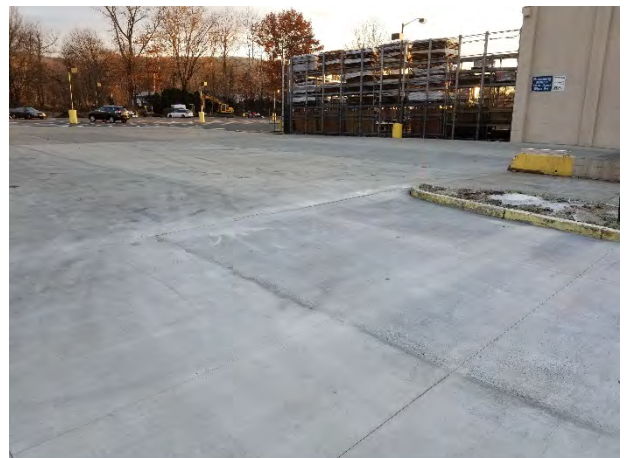
## PHOTO LOG – Concrete Slab Replacement Activity – November-December 2018

**Photos of Concrete Slab Areas – After Replacement**

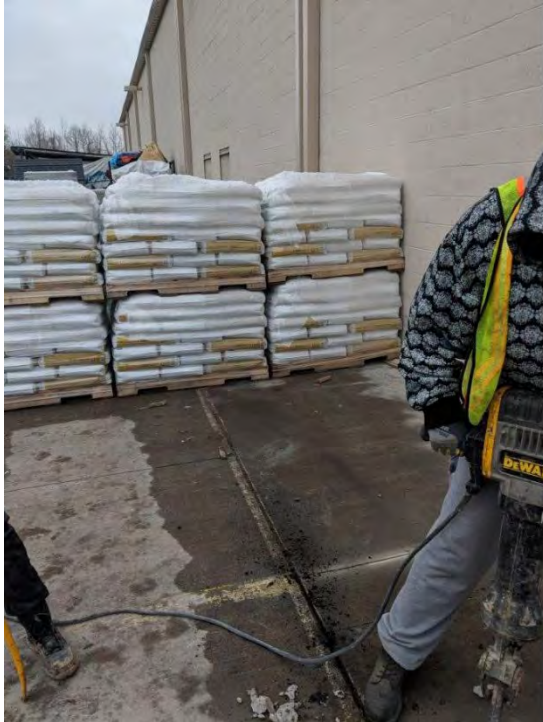
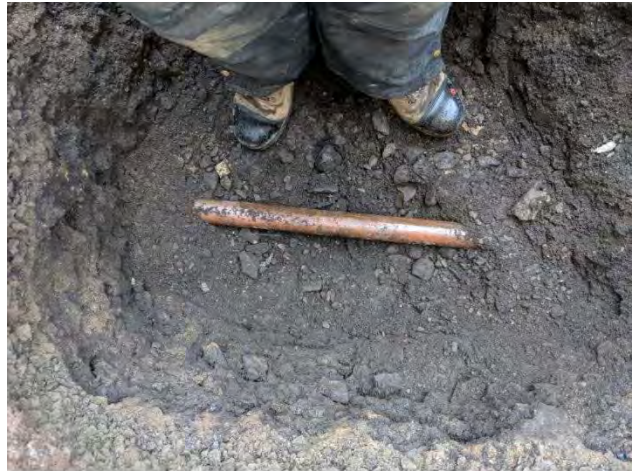
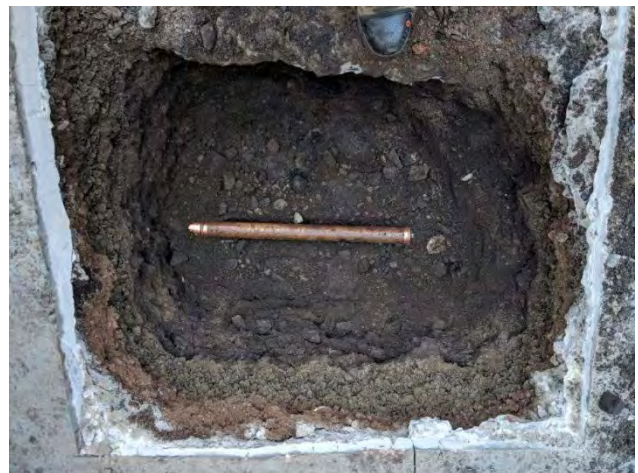
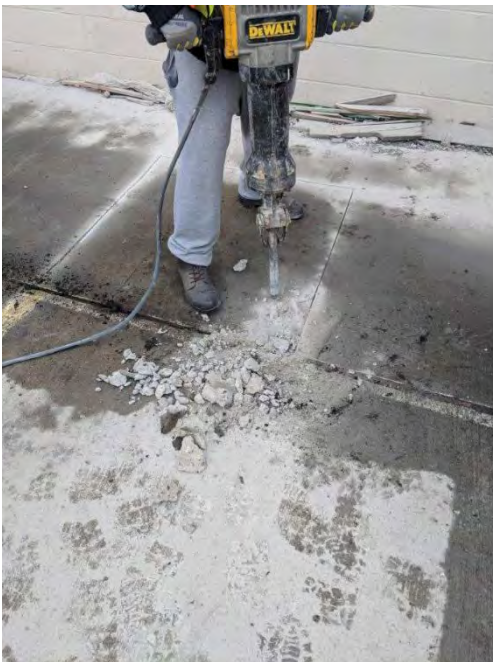
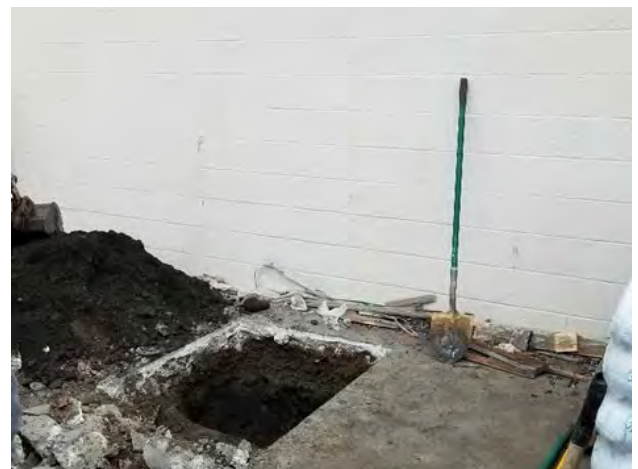
## PHOTO LOG – Water Line Repair Activity – December 2018

Photos of Repair Activities

4. In December 2018, Lowe's informed HDR and Orangeburg Holdings LLC of a suspected water line leak in the area along the back of the building (based on some investigations and water usage records). A leak was identified in a small 2-in. diameter line that ran from the back of the building to another water line running along Greenbush Road. They determined that the leak was just off the back wall of the building. On December 13, 2018 a subcontractor hired by Lowe's saw-cut an approximate 4 ft by 4 ft section of the concrete slab along the back of the building to expose the pipe for repairs. Soil was excavated to approximately 3.5 ft to expose the water line. The excavated soils were placed on plastic and after the repairs were made to the water line, the fill and soils were placed back in the hole. No soils from the excavation were removed from the site as part of this water line repair activity. The following day, the soils in the hole were compacted and the excavation area was capped with a poured concrete slab to match the existing slab. HDR conducted a site visit during the excavation and repair activities to

document that the historic fill material below the cap were not removed from the site. Appendix A contains photos taken during this water line repair activity.

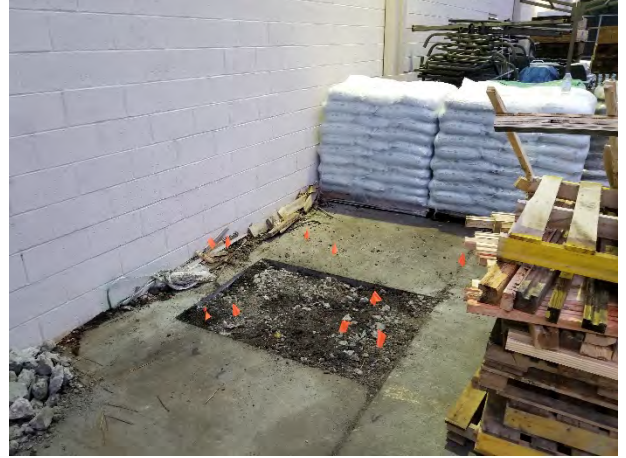
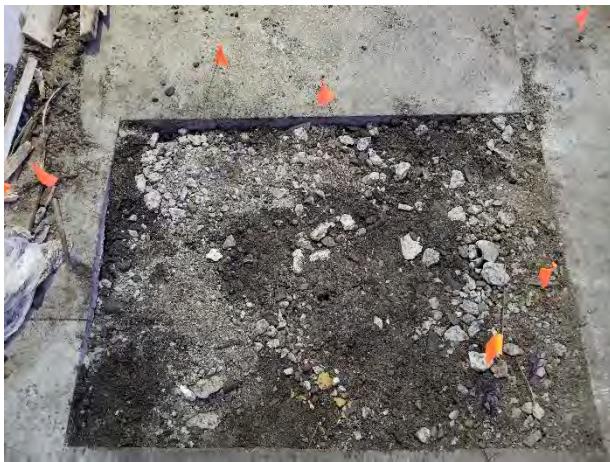
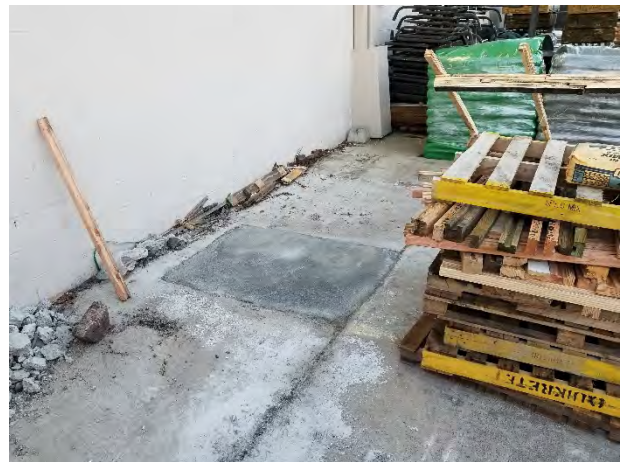
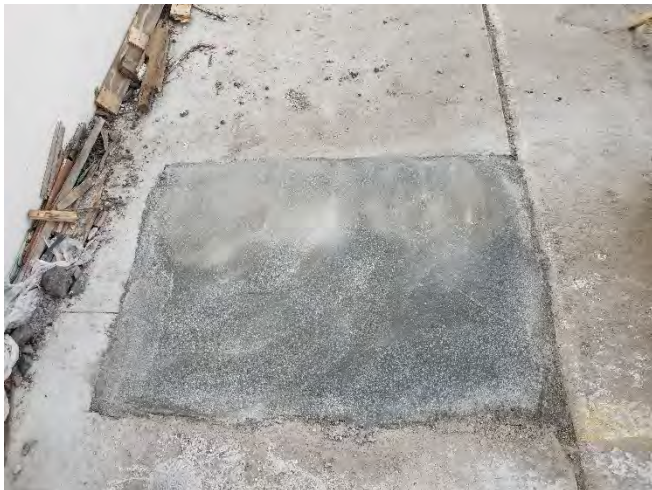
## PHOTO LOG – Water Line Repair Activity – December 2018

**Photos of Cap  
Repair Activities**

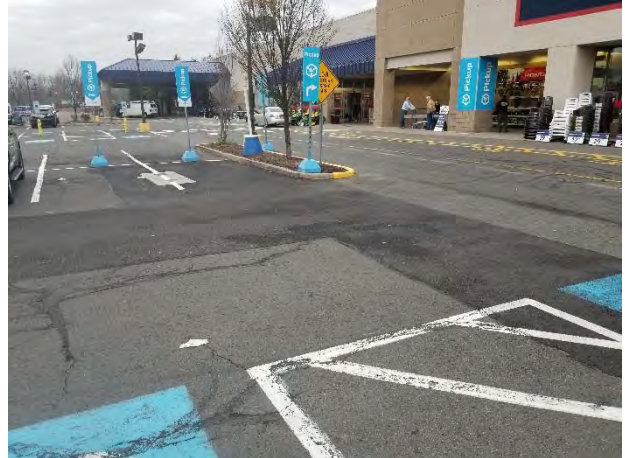
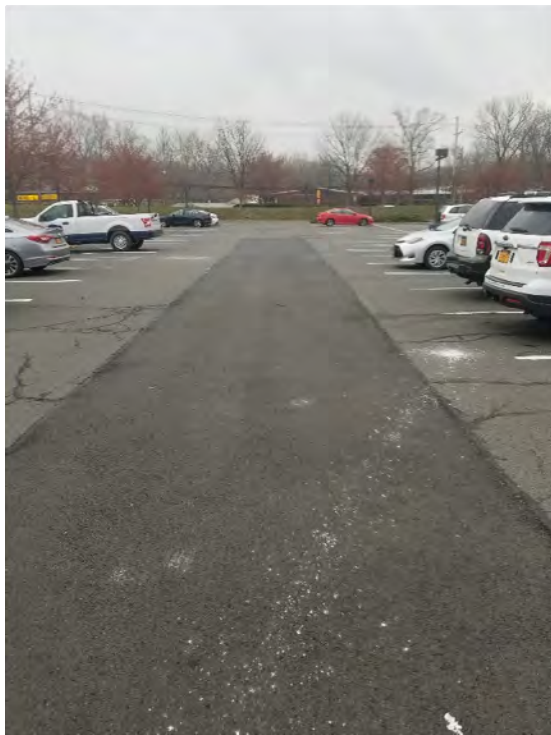
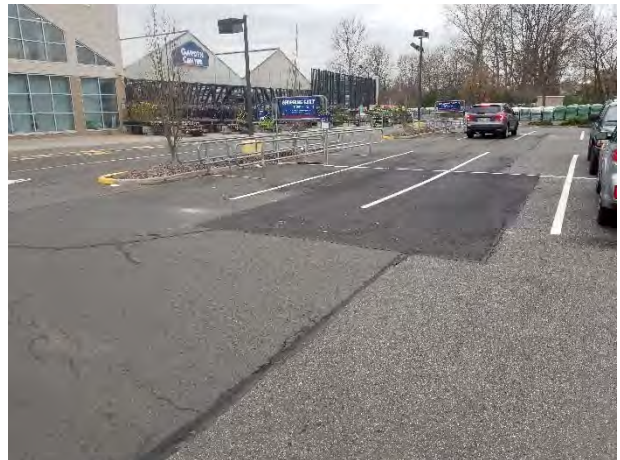
## **PHOTO LOG – Site Cap Condition – April 2020**

**Photos of recent asphalt  
top-coat repairs**

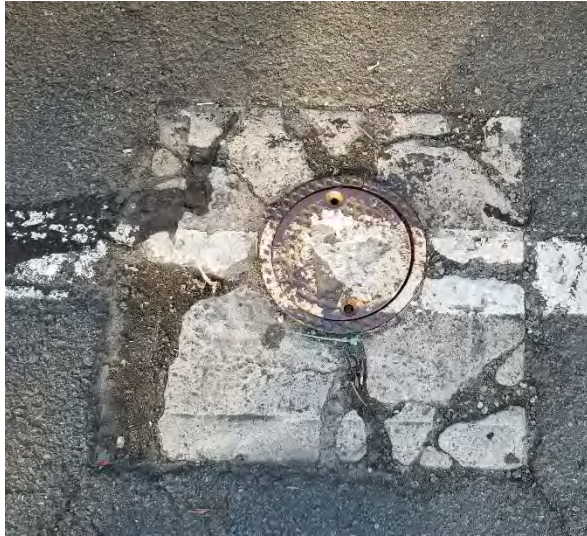
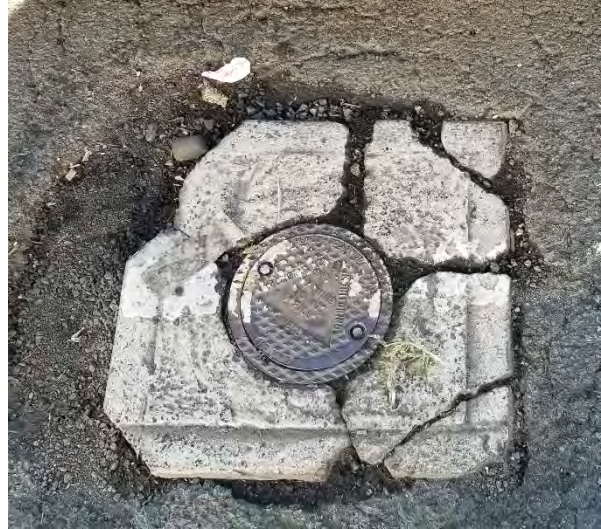
During the July 2019 sampling event, it was determined that the concrete well pads in the parking lot area for two of the monitoring well clusters (MW03-14S & -14D and MW03-27 & -27D) were cracked and damaged from the constant vehicle traffic. Fuels or petroleum-related compounds that leak from a vehicle in the parking lot could seep down through the area of the damaged concrete well pads and impact the groundwater in the immediate area of the monitoring well. The well pads in the parking lot were replaced in March 2020. HDR is assessing the remaining well pads and vaults and will replace them as required.

**MW03-14S & -14D (July 2019 during sampling event).**

1. For each component of the SMP, all requirements were met during the reporting period.
2. There were no requirements that were not met.
3. New compliance plans/schedules are not needed.
4. The concrete well pads in the parking lot that were damaged were replaced and the remaining well pads and vaults will be assessed and replaced as required.

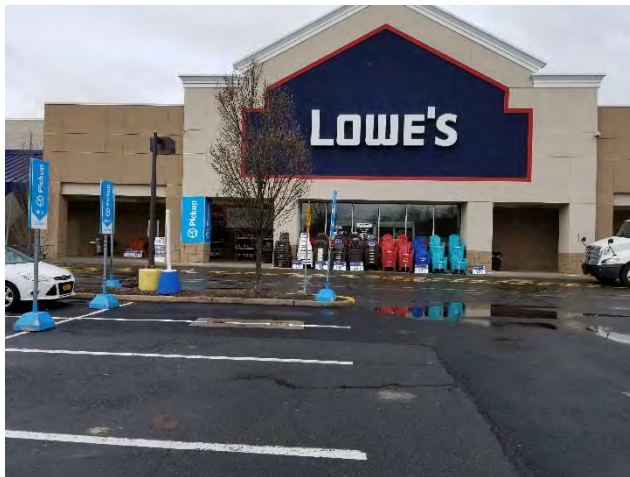
**MW03-14S & -14D (After well pad repairs – Photos taken April 2020).**

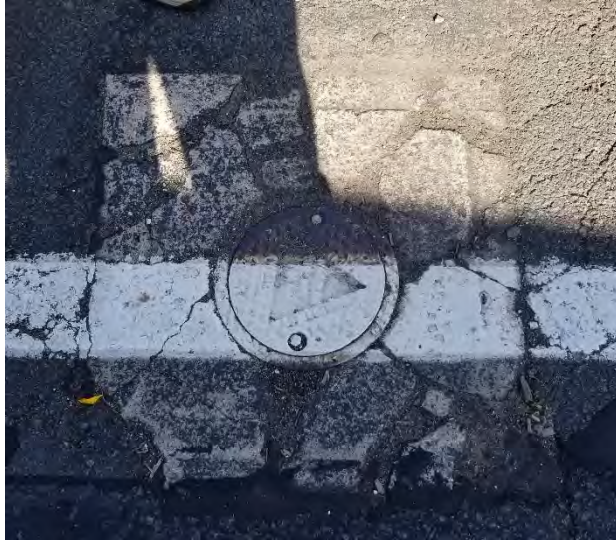
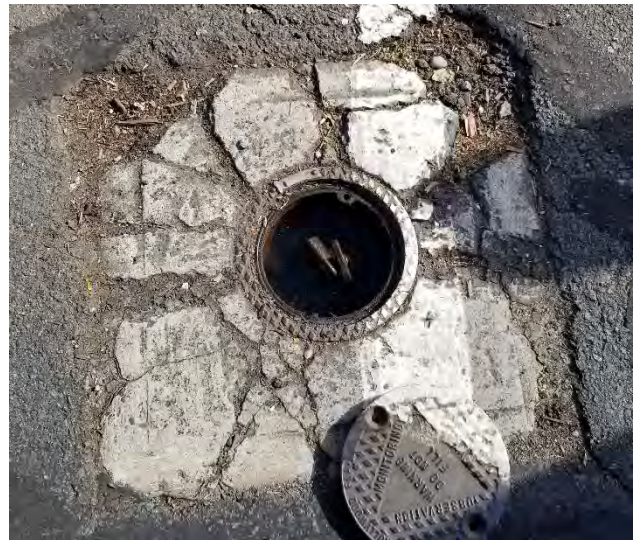
**MW03-27S & -27D (July 2019 during sampling event).**

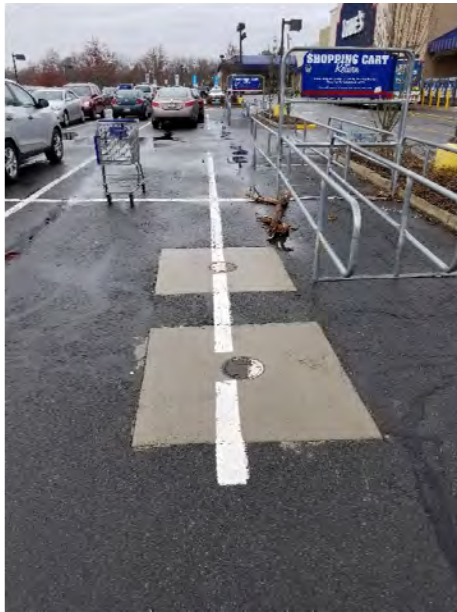
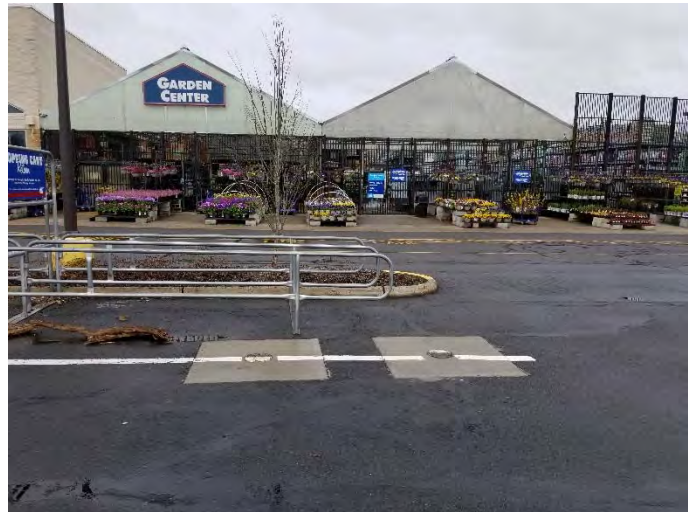
**MW03-27S & -27D (After well pad repairs – Photos taken April 2020).**
